Fiscal Year 2004

Archaeological Site Monitoring and Management Activities along the Colorado
River in Grand Canyon National Park

RCMP Report No. 90
Flagstaff, Arizona

May 2005

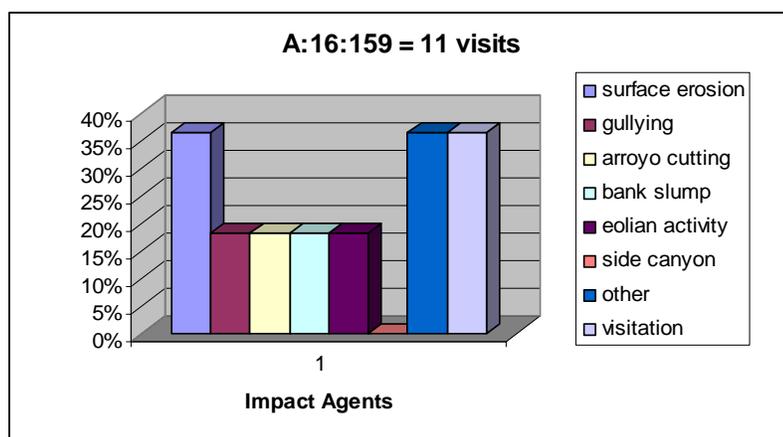
Summary of Monitoring Observations

Rock spalling, surface erosion and visitation have been the most consistent impacts to the site, but even then it has been incipient. It was only in FY92 and FY93 that some channel cutting threatened the site, but aft FY93 these threats retreated. Visitation to the site is evidenced by a faint trail from upstream leading to the site and resulting in the occasional displacement of surface artifacts.

Recent coyote scat was observed in the overhang. The site appears very stable with no physical impacts observed. The grinding slick downslope of the site has 2 grinding surfaces. A trail up to the site exists on an unstable sandy bank. The site has seen minimal physical impacts though visitor-related impacts have been recorded. Access by monitors should be limited, as the upstream route to the site is sandy and visible from the river. Continue monitoring every three years. Access to the site should be from the downriver side of the site.

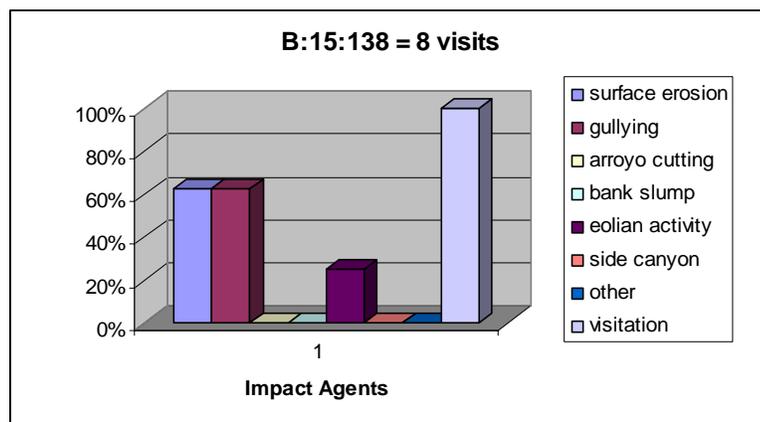
Summary of Monitoring Observations

Since the recording of this site, archaeologists have witnessed site degradation from active physical and visitor-related impacts. Water channeling and soil compaction from visitor use will continue at this site as it has been demonstrated that any attempts to preserve the site have been unsuccessful. Surface erosion and eolian activity have stripped Feature 1 of its surrounding matrix. Active gullying at Feature 2 from 1999 to present does threaten feature integrity. The feature has been recommended for data recovery since 2000. NPS will continue to conduct trail obliteration and vegetation work to deter trailing over the feature and encourage plant growth until a treatment plan is determined for this site, which could include letting the feature erode.

There is a considerable amount of eolian deposition in and adjacent to Feature 1. Feature 2 looks unchanged since the last monitoring visit. Continue annual trail maintenance. Data recovery is recommended for Feature 2 as it is very vulnerable to visitor-related impacts and valuable information could be lost. Currently the outline of the feature is discernable and the contents inside appear undisturbed. Continue annual site monitoring. Trail work was completed during the monitoring visit.

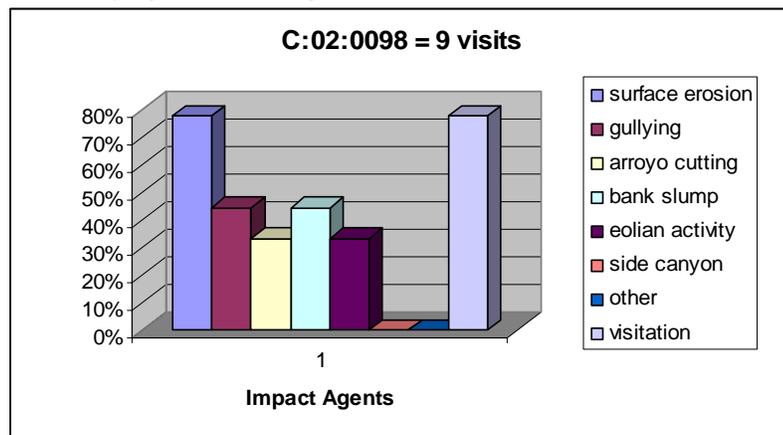
Summary of Monitoring Observations

Surface erosion is incipient throughout the years. It is not until FY99 and FY00 that the monitoring data indicate the site progressively and consistently became active, thus worsen its state. This is observed mostly with channeling erosion and visitation. Active gully down cutting adjacent to the historic inscription resulted in the exposure of prehistoric artifacts. In 2000, continued active gully down cutting resulted in the transition from a gully to an arroyo. The proximity of this site to the river has also resulted in active bank slump. Visitation is prevalent through the site as an access point to the river by anglers.

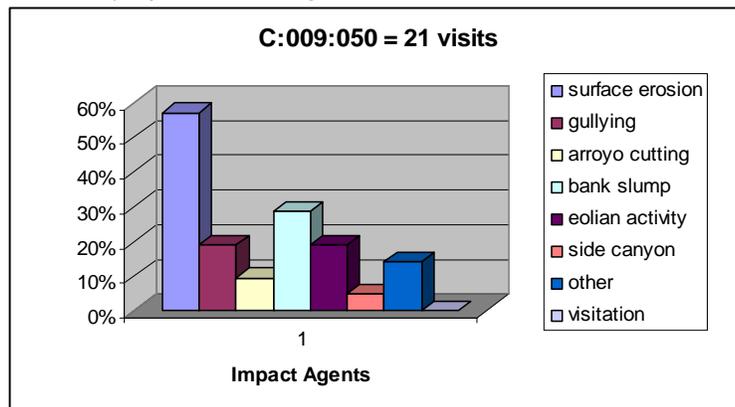
Summary of Monitoring Observations

Surface erosion and eolian activity are incipient and consistently observed throughout the monitoring episodes. It appears that FY92 and FY93 had some water channeling activity but it dissipated in the following years. Because side canyon flooding has the potential to obliterate this site, a water diversion structure was constructed to protect the site. Although the pot cache was removed, no further testing was conducted at the feature. The likelihood of additional vessels or human remains is high however based on the stability represented through the monitoring data, monitoring episodes should be decreased.

Erosion is ongoing from the location of the pot cache and SSW towards the major side canyon drainage. As noted in FY03, sheet wash is active. Vegetation -primarily grasses visible in previous photographs of the FCR are no longer present though there is a good development of cryptobiotic soil crust on the surface. It is recommended that additional vegetation be planted on-site. Consider mulching the slope where the fire-cracked rock is located to encourage additional vegetation growth. The trail does not directly access the site though it is adjacent to the site boundary. No impacts from visitation were observed. Continue to monitor the pot cache location for additional artifacts exposed by erosion. Checkdam monitoring and maintenance should continue annually.

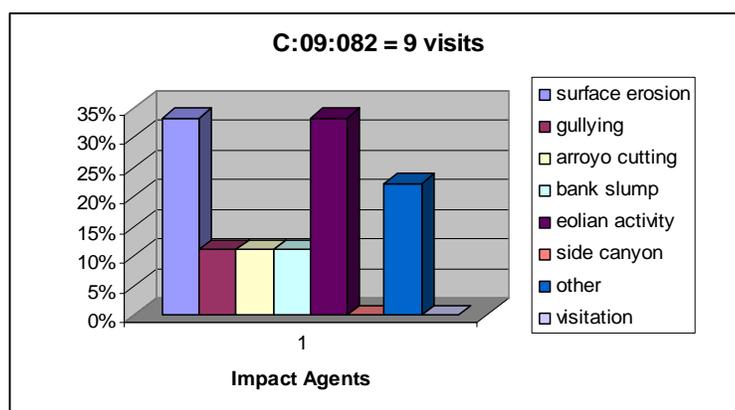
Summary of Monitoring Observations

Incipient eolian movement is the prominent agent impacting the site. However, the erosion or deposition of sediment only allows archaeologists to either find new artifacts or have previous artifacts buried. There have not been any impacts that have threatened the integrity. The gully and arroyo cut identified in FY93 were later determined to be outside the site boundary. Visitation has not been a problem at this site.

Feature 1 has very little change. Feature 2 has minor eolian deflation. This site is in a moderately active dune field and therefore has the potential to cover or uncover the recorded features and expose unrecorded cultural remains. Fire-cracked rock and bone fragments have been found due to eolian reworking. No visitation disturbances were noted. No work is recommended at this time. The monitoring schedule will remain on a five year schedule.

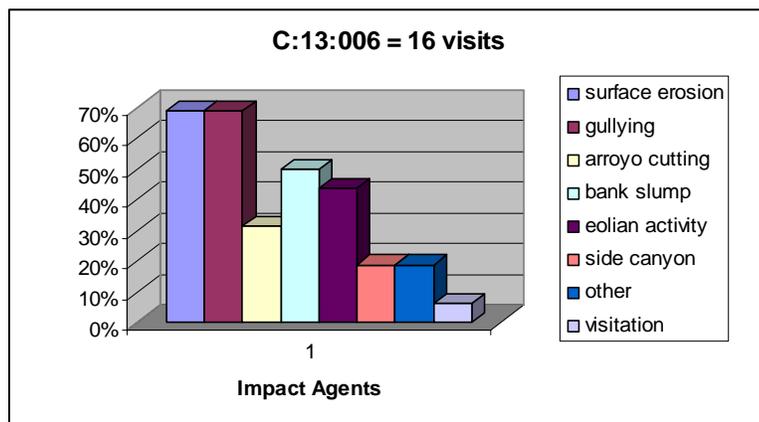
Summary of Monitoring Observations

Surface erosion is the predominant impact to the site, but at a smaller scale. Gullyng followed by bank slump and eolian activity are not as active however, gullyng and bank slump can cause more harm than surface erosion and eolian activity. Active gully down cutting led to the transition from a gully to an arroyo in 2002. Active arroyo cutting on the upper terrace and headward advancement of the drainage indicate continued drainage expansion. Checkdam construction appears to have slowed the drainage down cutting though maintenance is required. Active drainage down cutting and expansion threaten the integrity of this site. Side canyon flooding truncated the mouth of one gully in 1998. Visitation does not occur at this site.

Active erosion is present in the drainage on the upper terrace, but no artifacts are visible in the cut. This cut should be assessed for additional stabilization work. Vegetation is growing in the area where the matting was previously placed. No sign of human visitation was observed. Continue annual monitoring and annual checkdam monitoring and maintenance.

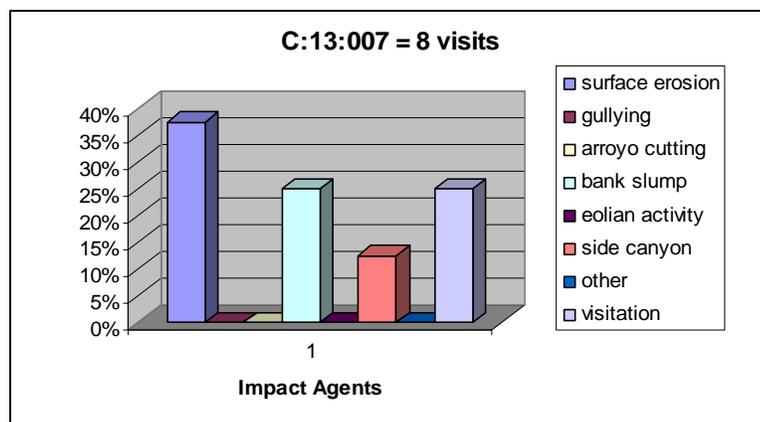
Summary of Monitoring Observations

Surface erosion and bank slump have occurred incipiently since 1991. Arroyo cutting threatens the integrity of Feature 5. How can it threaten it if it has been inactive or absent. Maybe say that although the arroyo cut has been inactive, it poses a major threat to the integrity of Feature 5. Visitation to the terrace and expansion of camp site locations by river-runners is successfully managed by NPS trail crews.

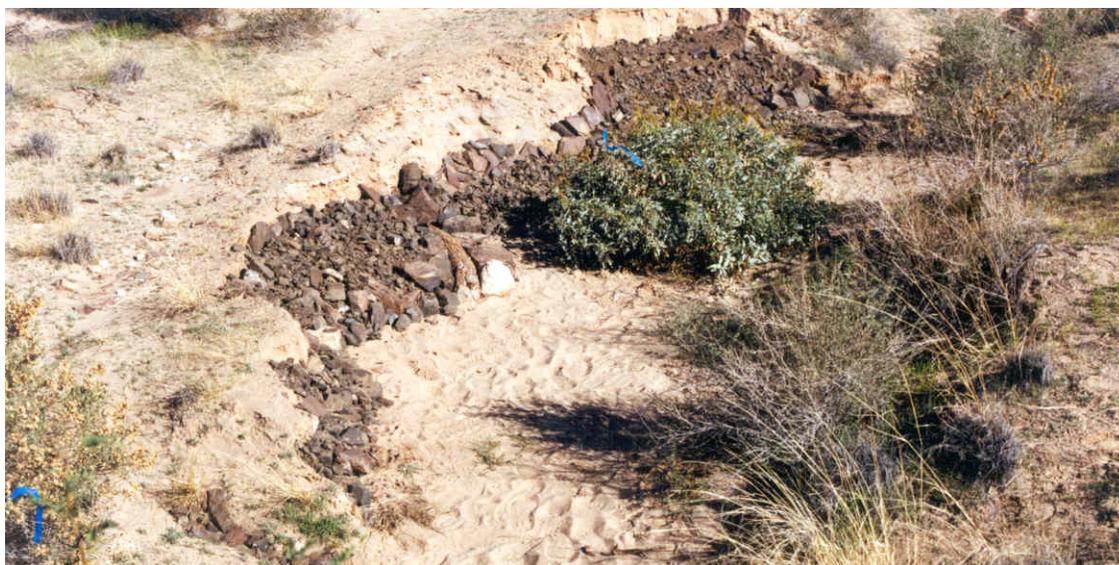
Figure 7. A checkdam protecting a cutbank adjacent to an archaeological feature.

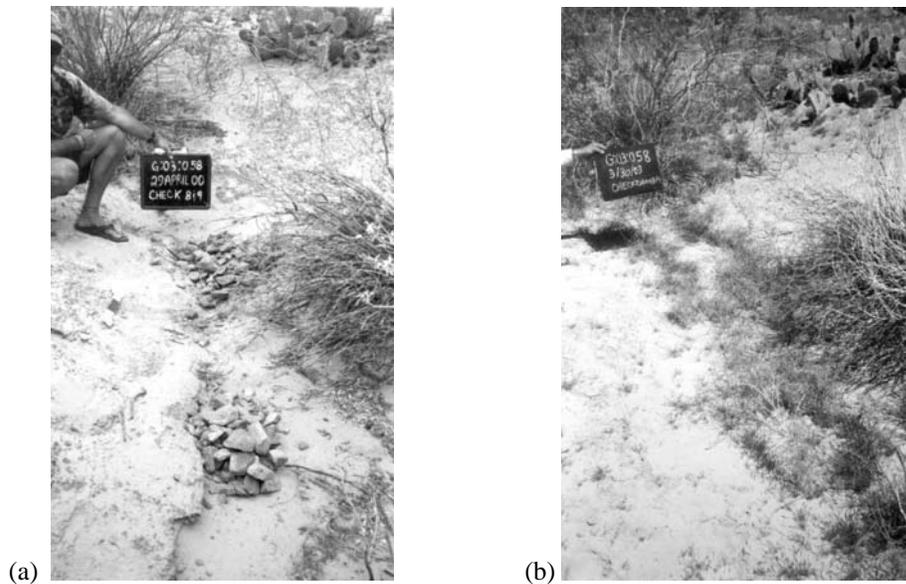
Figure 8. Checkdams installed in 2000 at G:03:058 (a) and complete sediment infilling of drainage, including headcuts and burying of checkdams by 2003 (b).

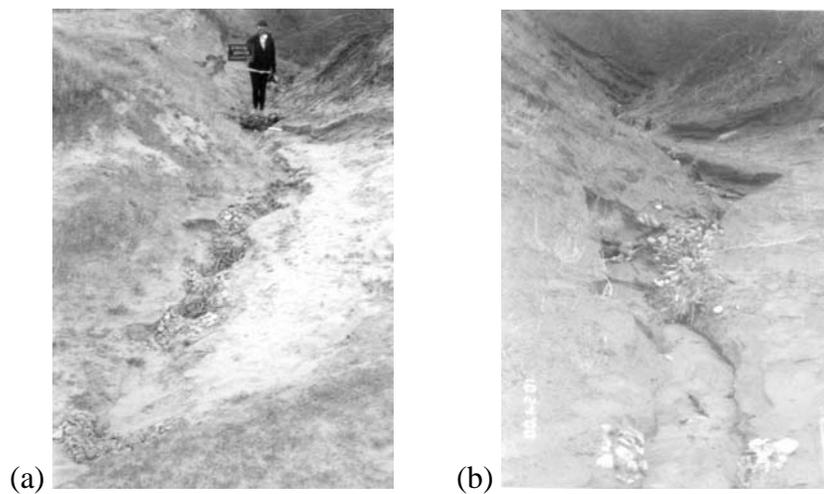
Figure 11. Obliteration of checkdams at G:03:038. (a) immediately following construction in the drainage (b) photographic record of obliterated checkdams. The obliteration of the checkdam at the bottom of the photograph is particularly evident.

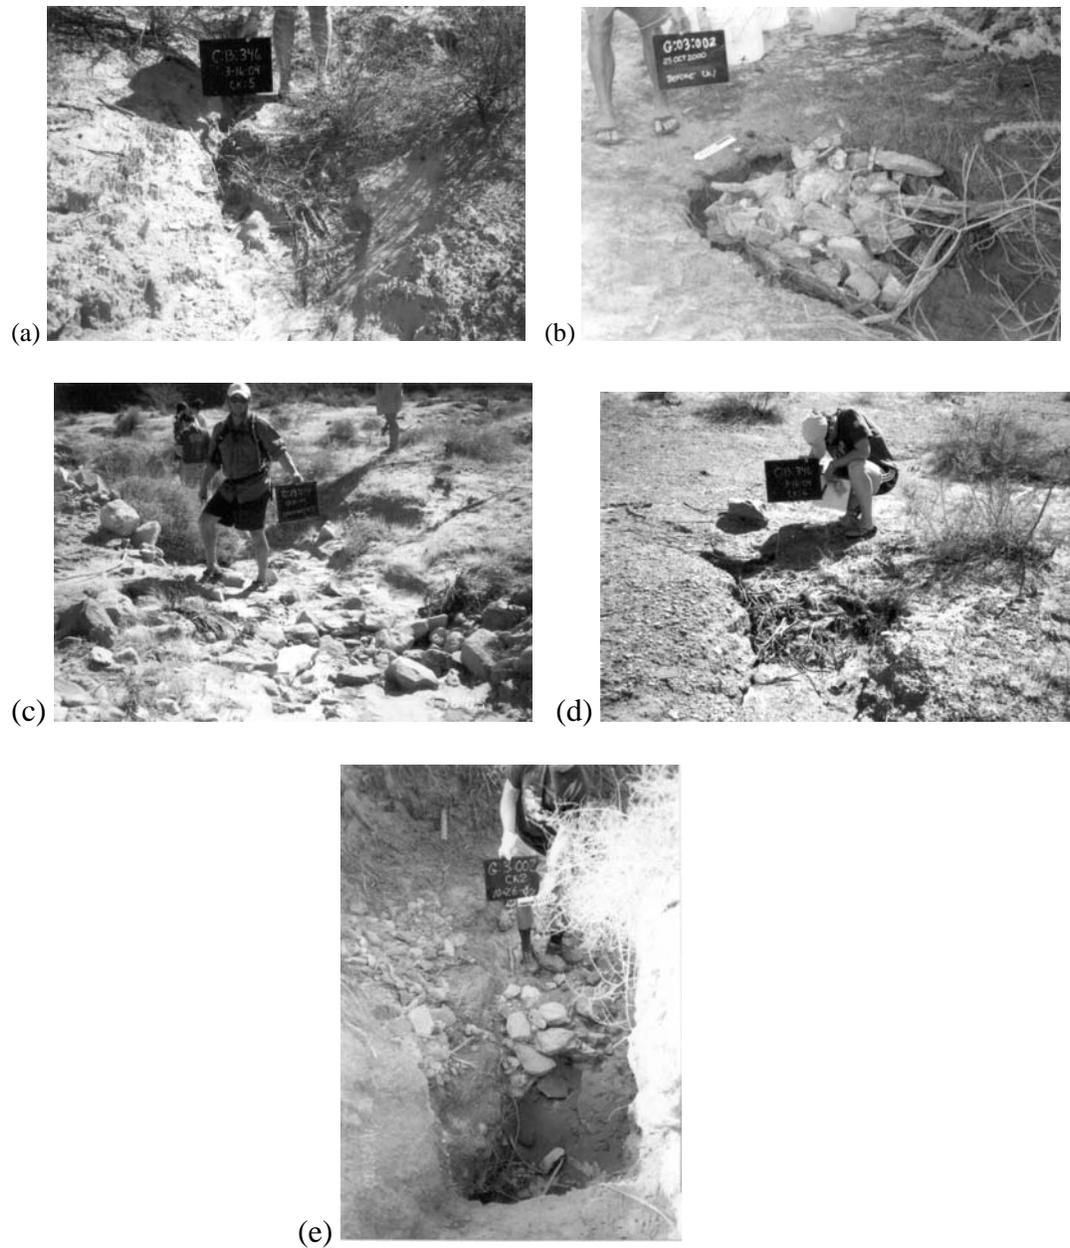
Figure 12. Indicators of active channel downcutting or expansion requiring maintenance work. (a) breaching across the checkdam (b) headward expansion (c) voids present in the rock checkdam requiring infilling and replacement, (d) flanking along the left side of the checkdam and (e) plunge pool.

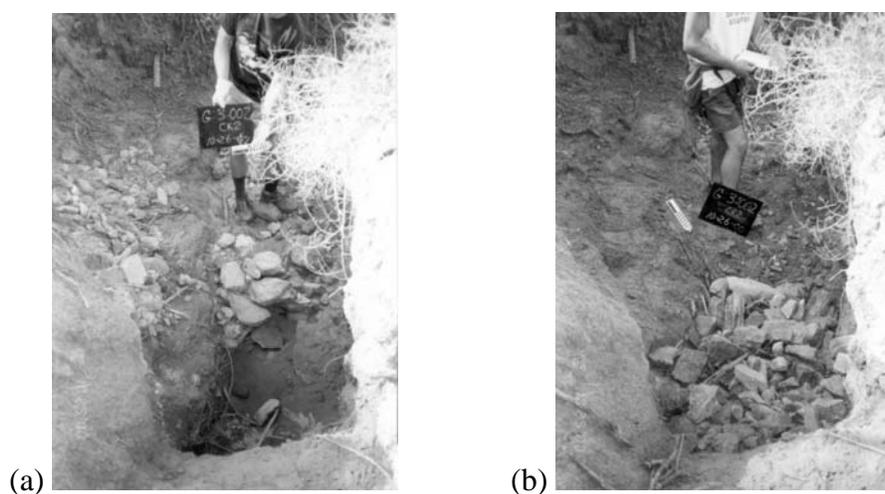
Figure 13. Plunge pool and knickpoint before (a) and after (b) maintenance.

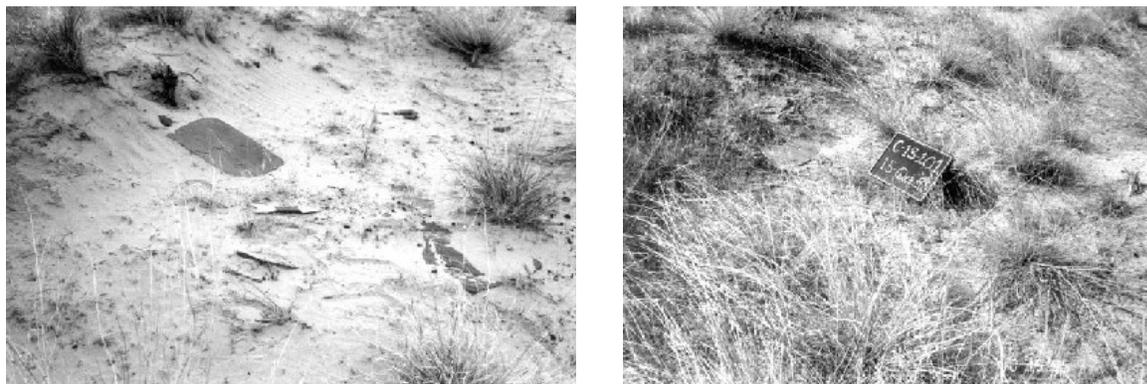
Figure 16. Change through time to a cist at C:13:101 over a 9 year span. Trail re-routing resulted in an absence of visitation and increased grass and cryptobiotic crust growth protecting the site.

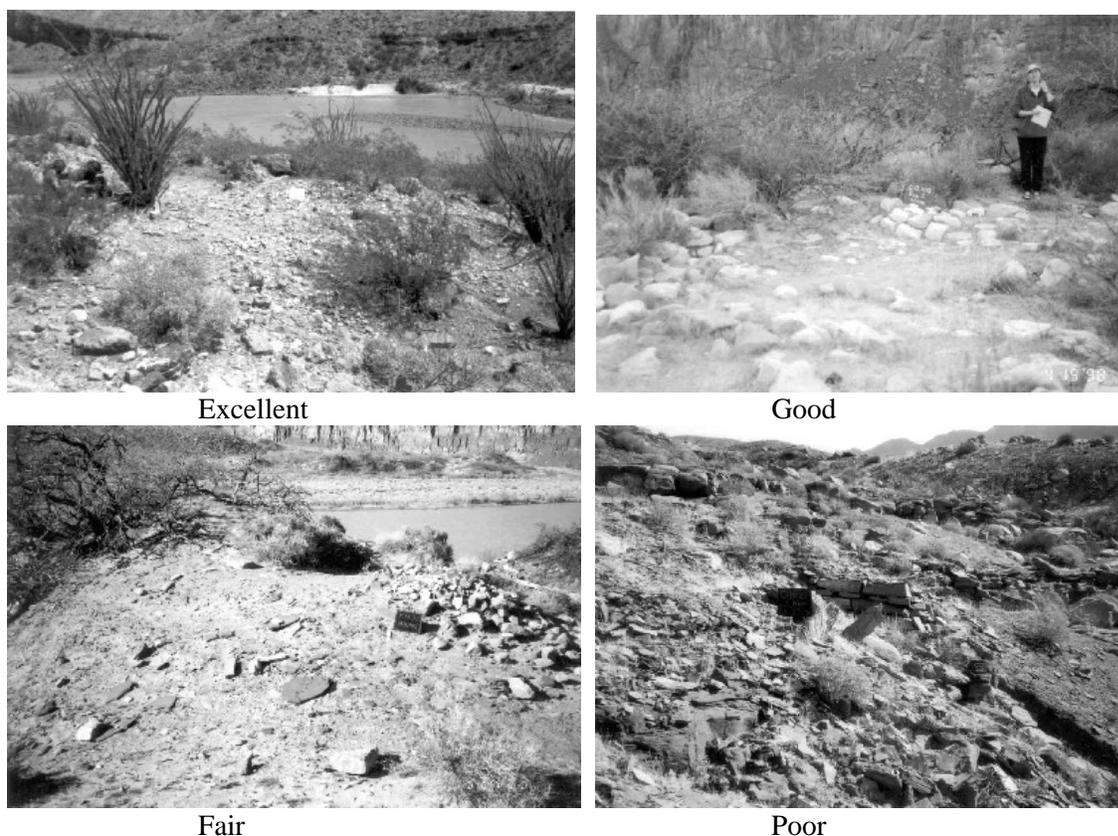
Figure 17. Photos of sites in condition class categories; Excellent G:03:072, Good C:13:100, Fair C:13:070, and Poor C:13:010.
