P 557-420-10772  
NA

Glen Canyon Unit--C.R.S.P.

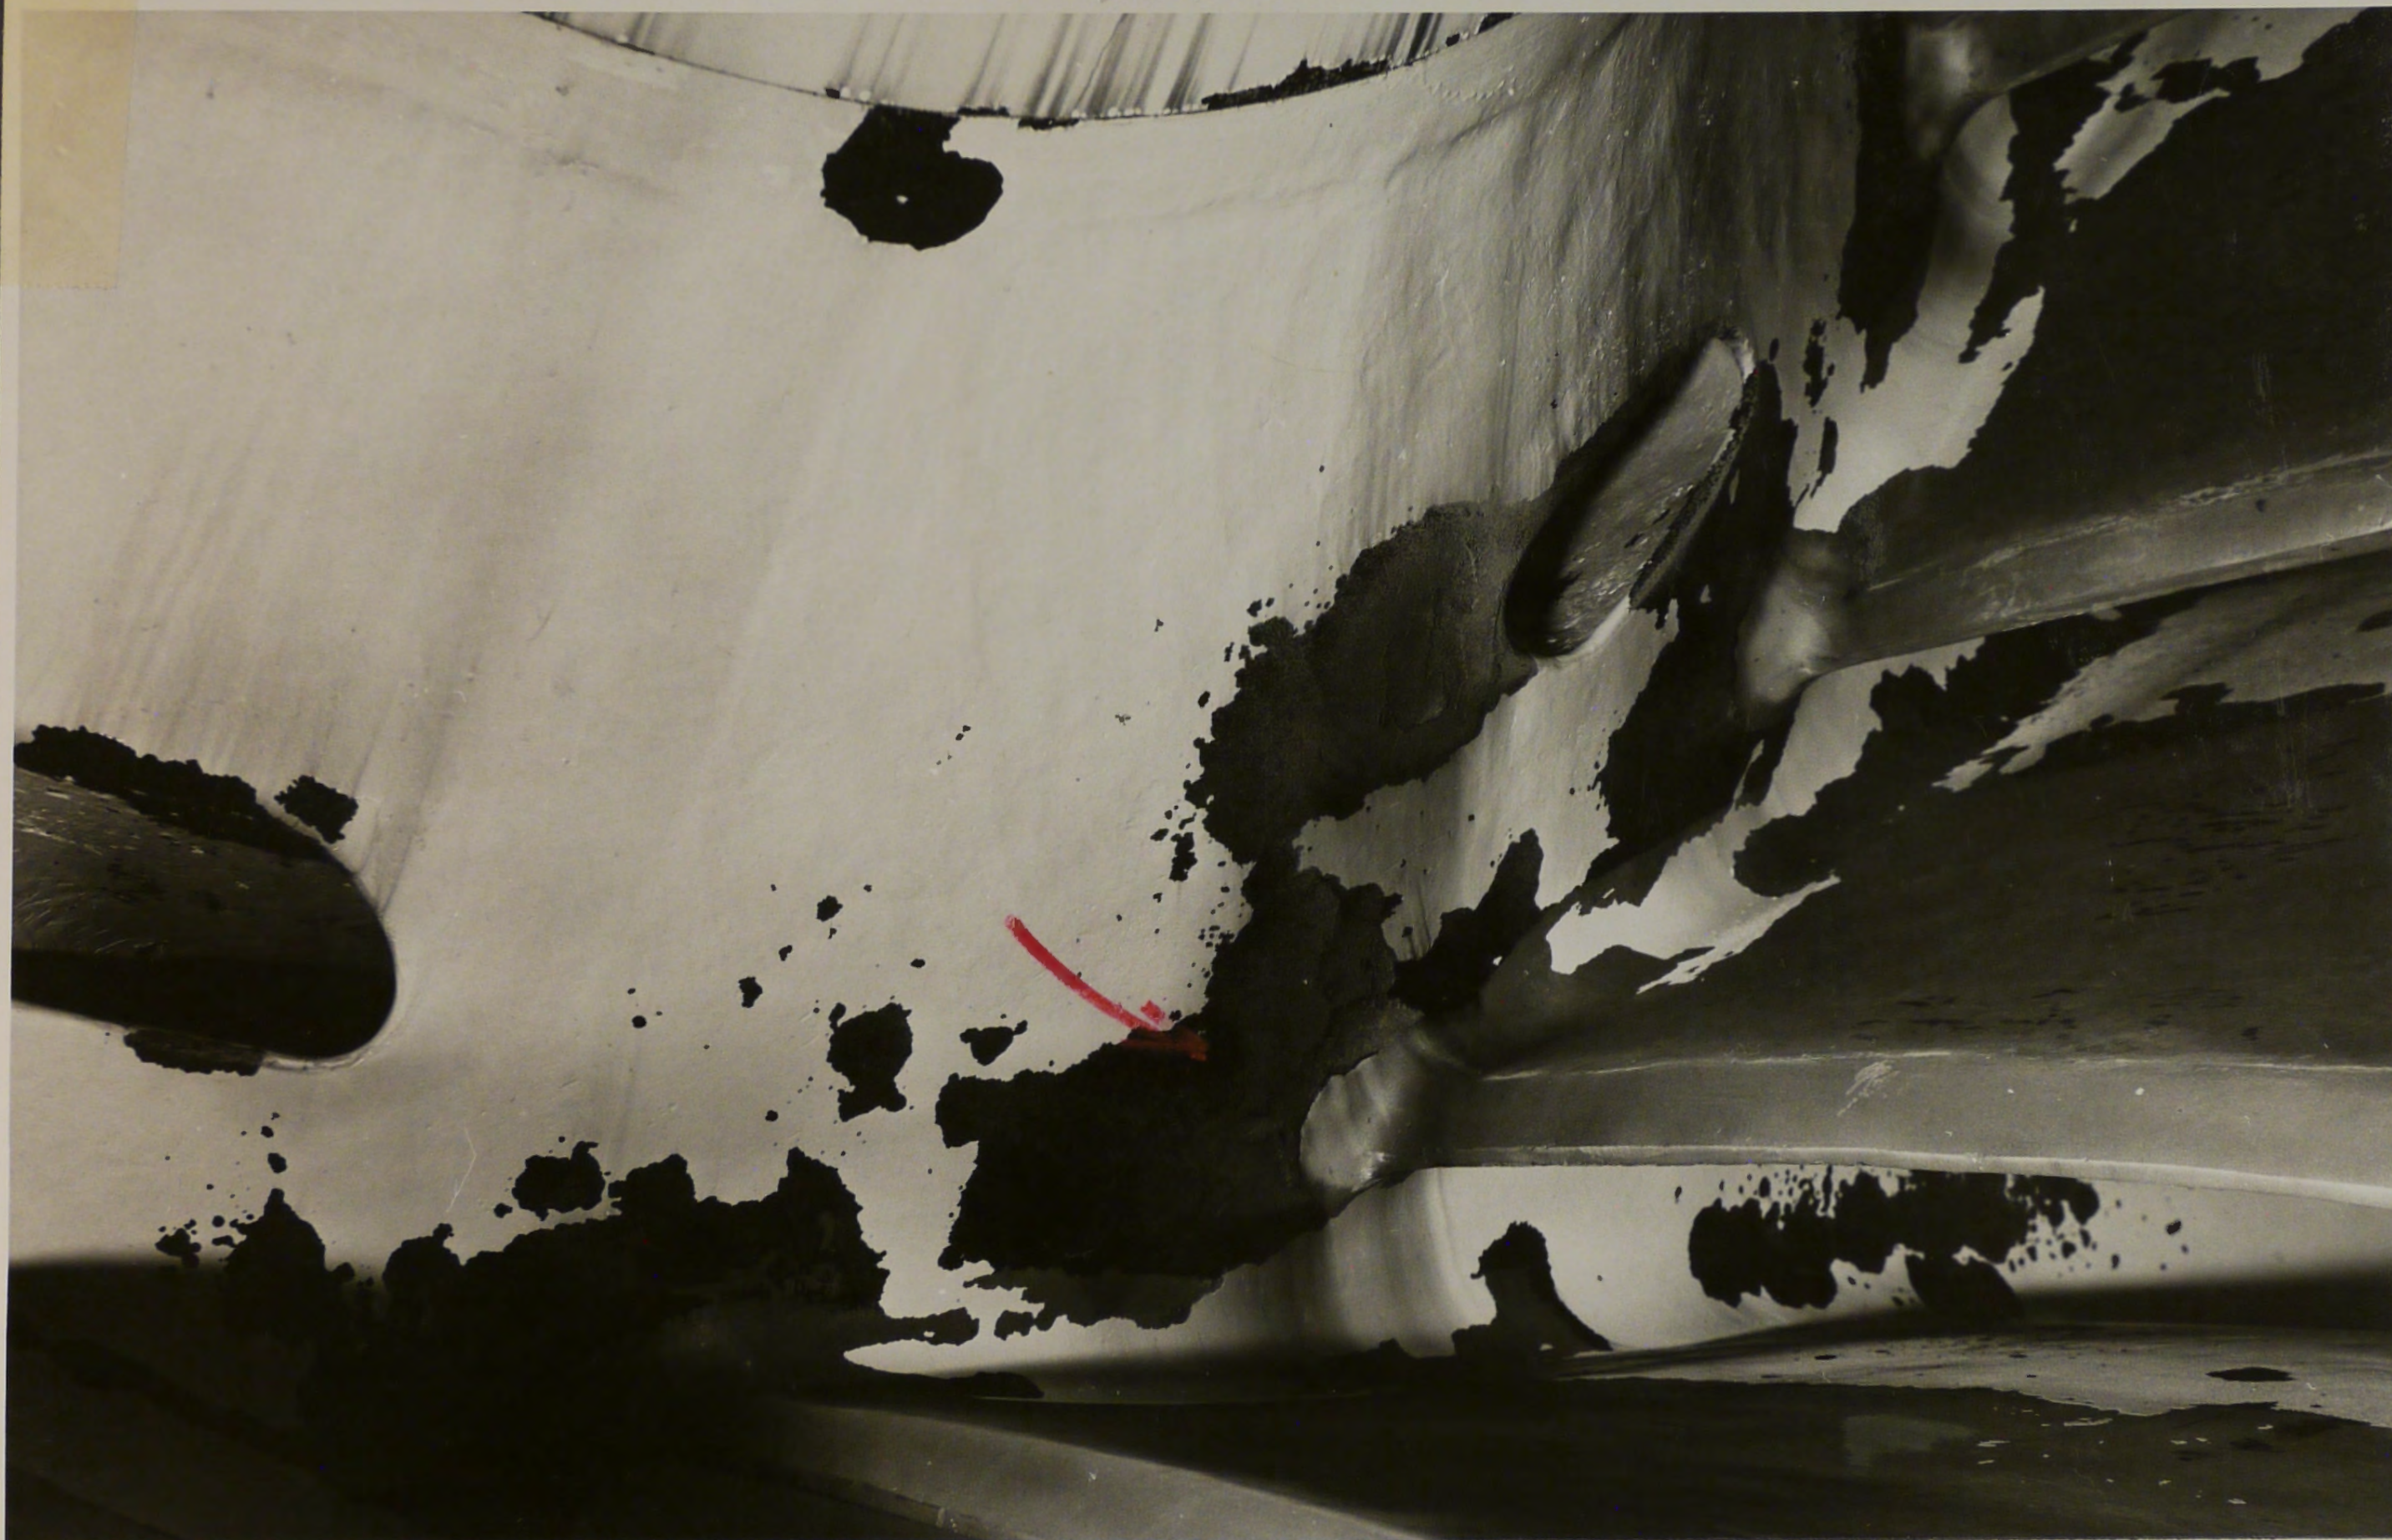
P 557-420-10576  
NA

Unit 2. Looking at the upper end of the trailing edge of 3 of the 15 buckets of the runner. Arrow points to a spot on the crown which had cavitated deeply enough to cause Mr. Claude Tate, the erecting engineer, to have it gouged to 7/8-inch depth and filled with stainless steel electrodes. Contractor: Baldwin-Lima-Hamilton Corp., Contract No. 14-06-D-3506. Invitation No. DS-5234.

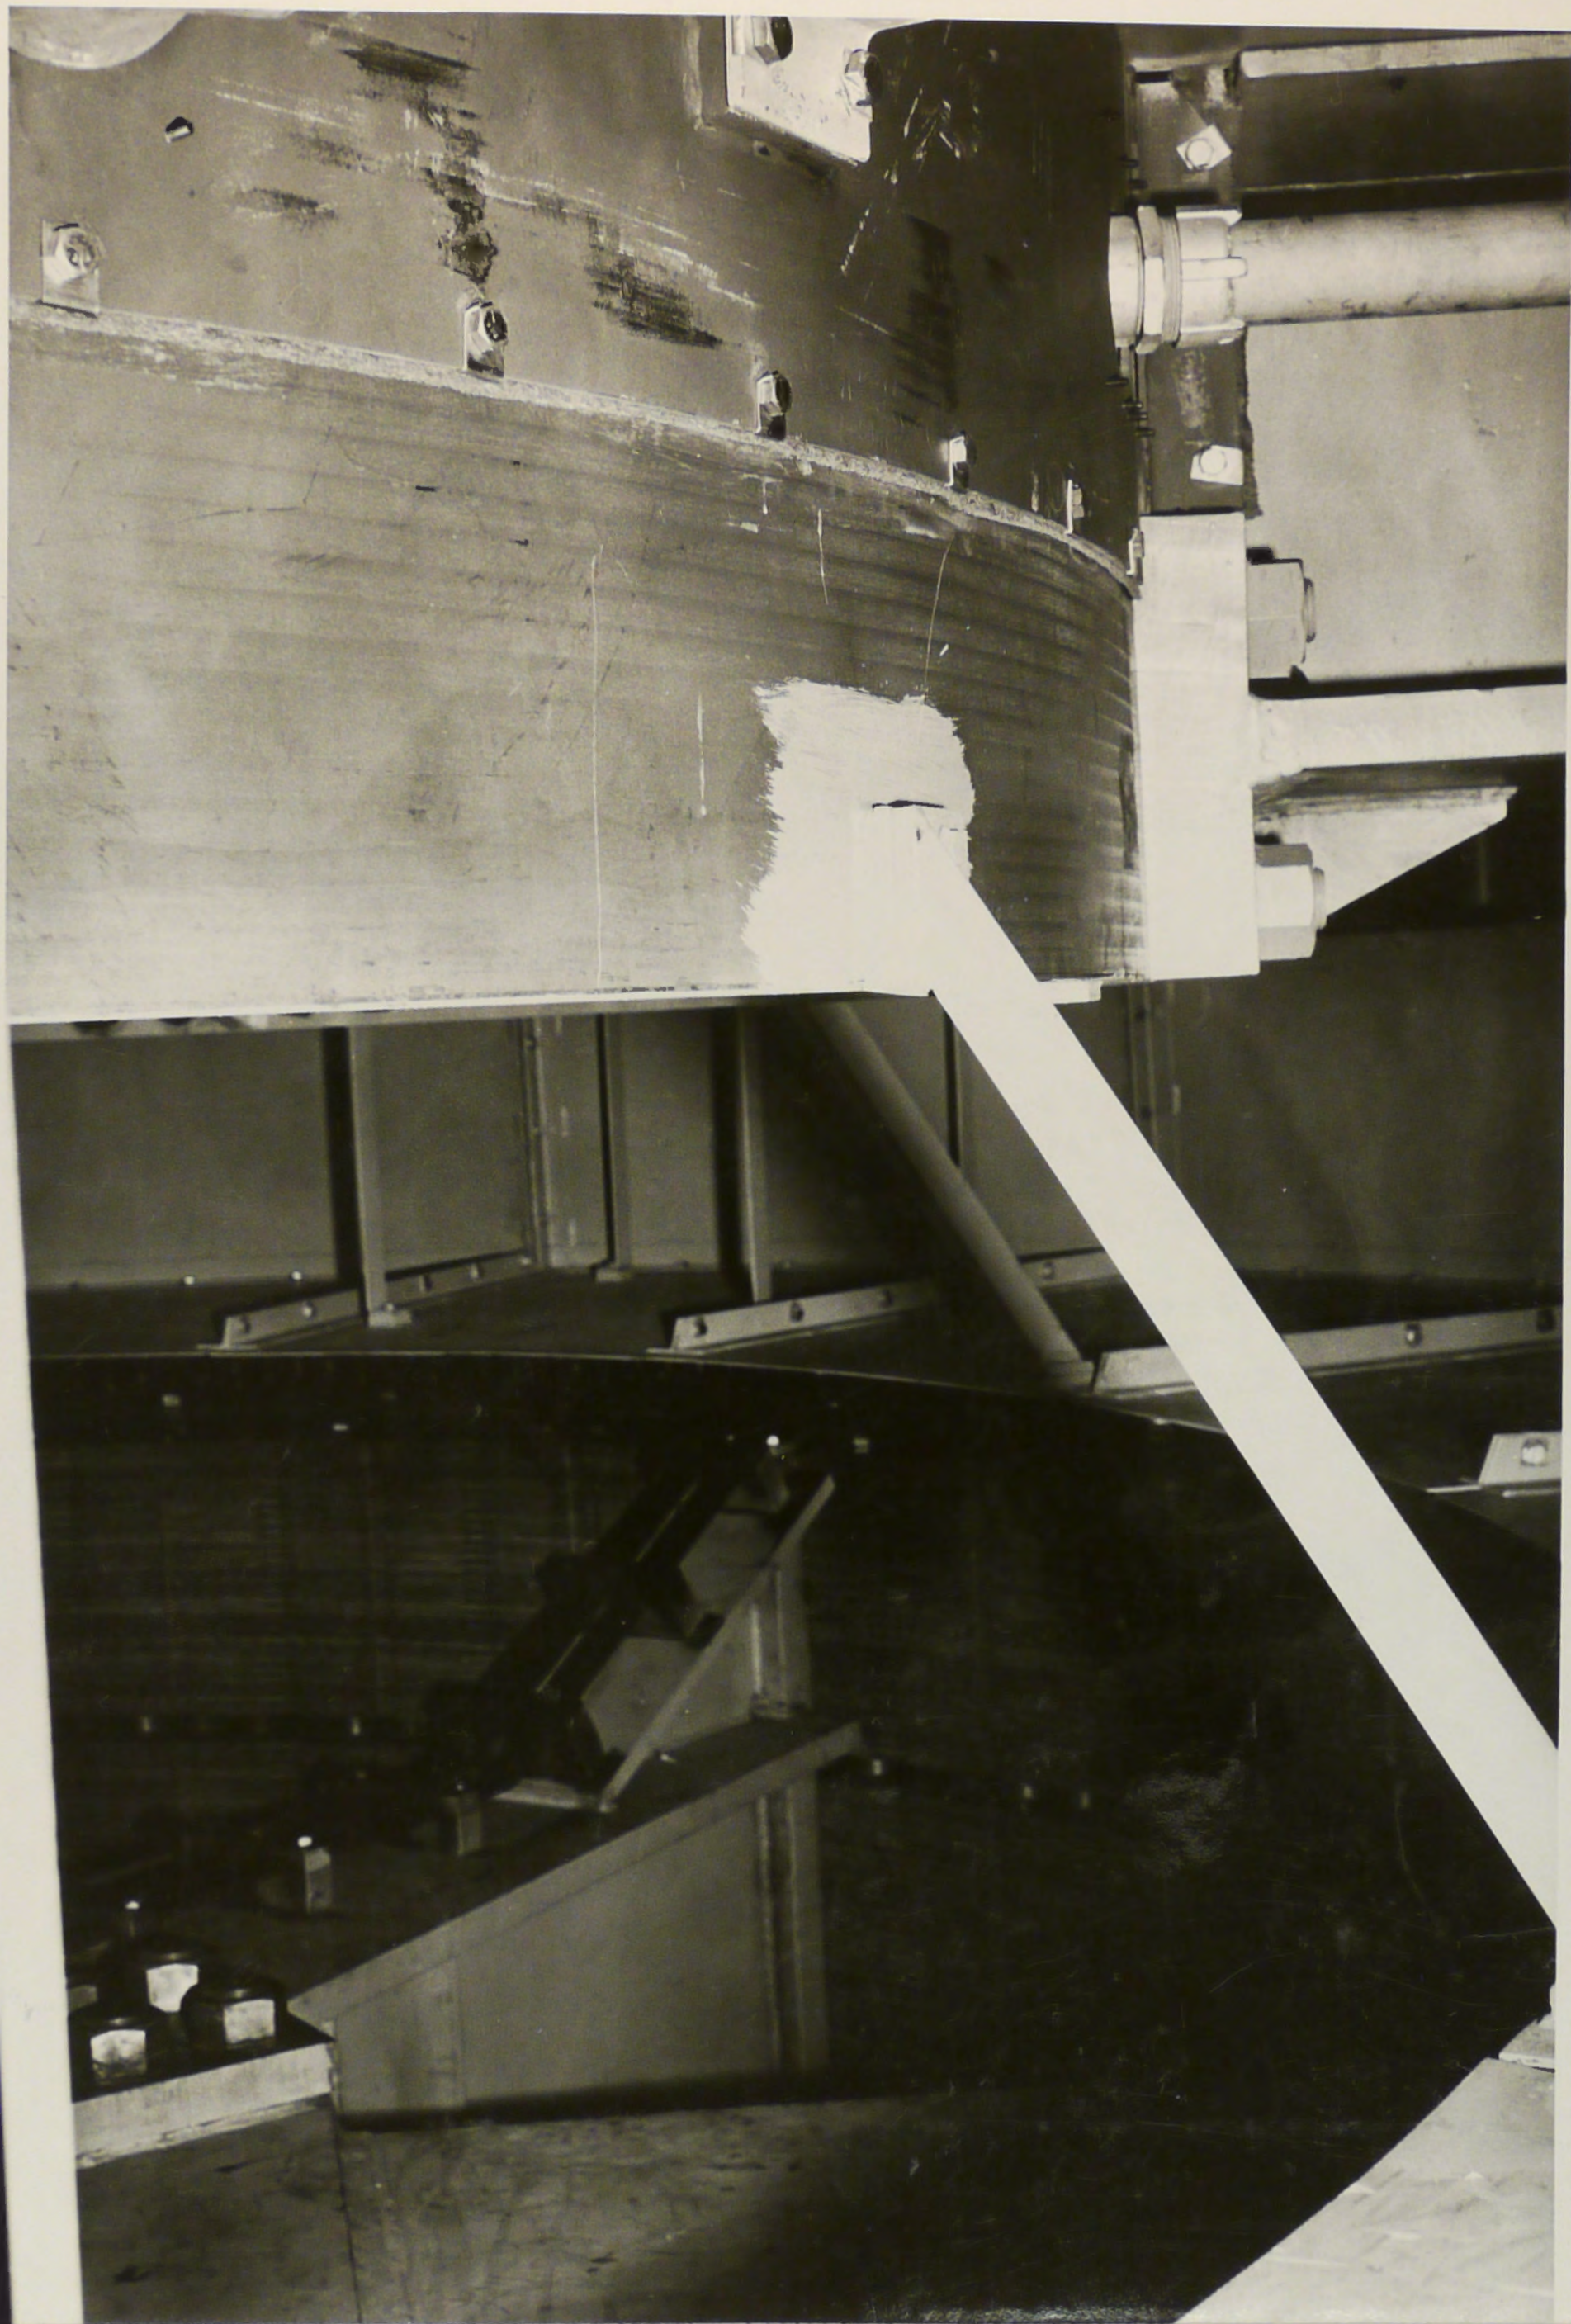
P 557-420-10611 Glen Canyon Unit--C.R.S.P.  
NA One of the additional supports installed on the upper air baffle in Unit 3. Additional supports have been installed in Units 1 through 4 and are necessary because of excessive vibration. Contractor: General Electric Company, Contract No. 14-06-D-3876. Invitation No. DS-5522. 2-23-65 F. Finch

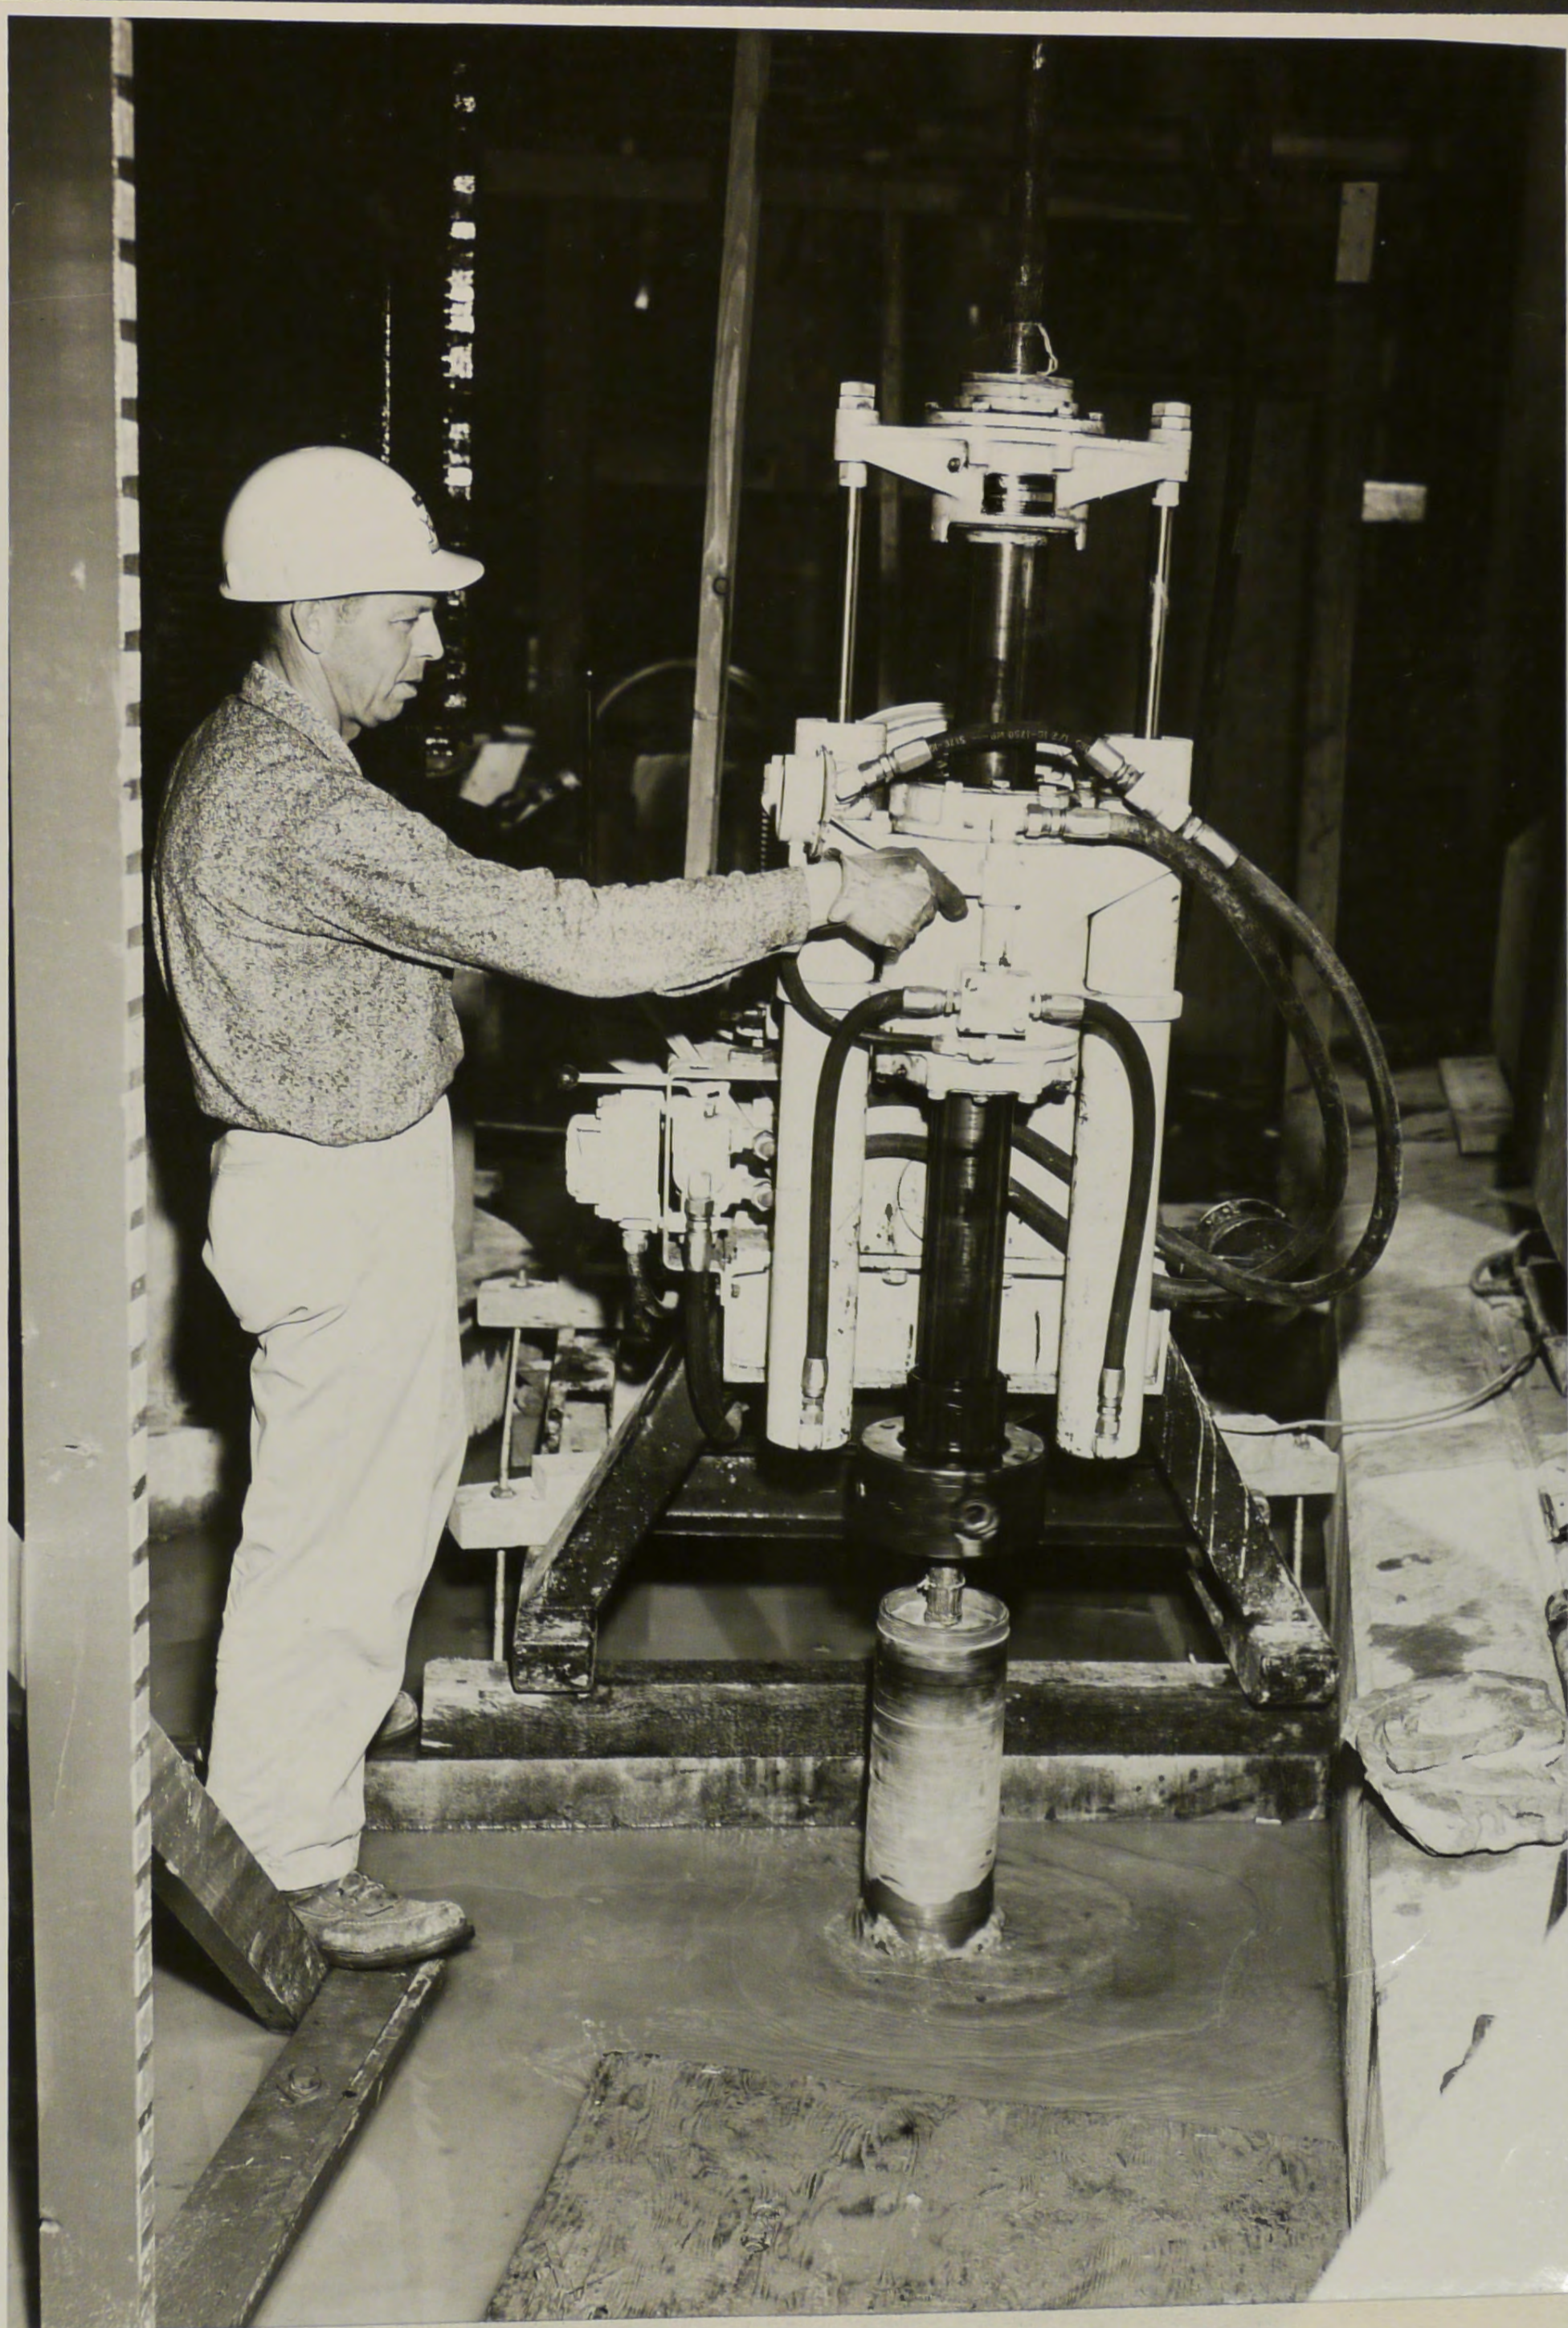
P 557-420-10747- Glen Canyon Unit--C.R.S.P.  
NA Government employee drilling 6-inch concrete core on the transformer  
deck in Unit 8 to check damage to concrete from excessive heat given  
off from reactor bank. No date given. F. Finch

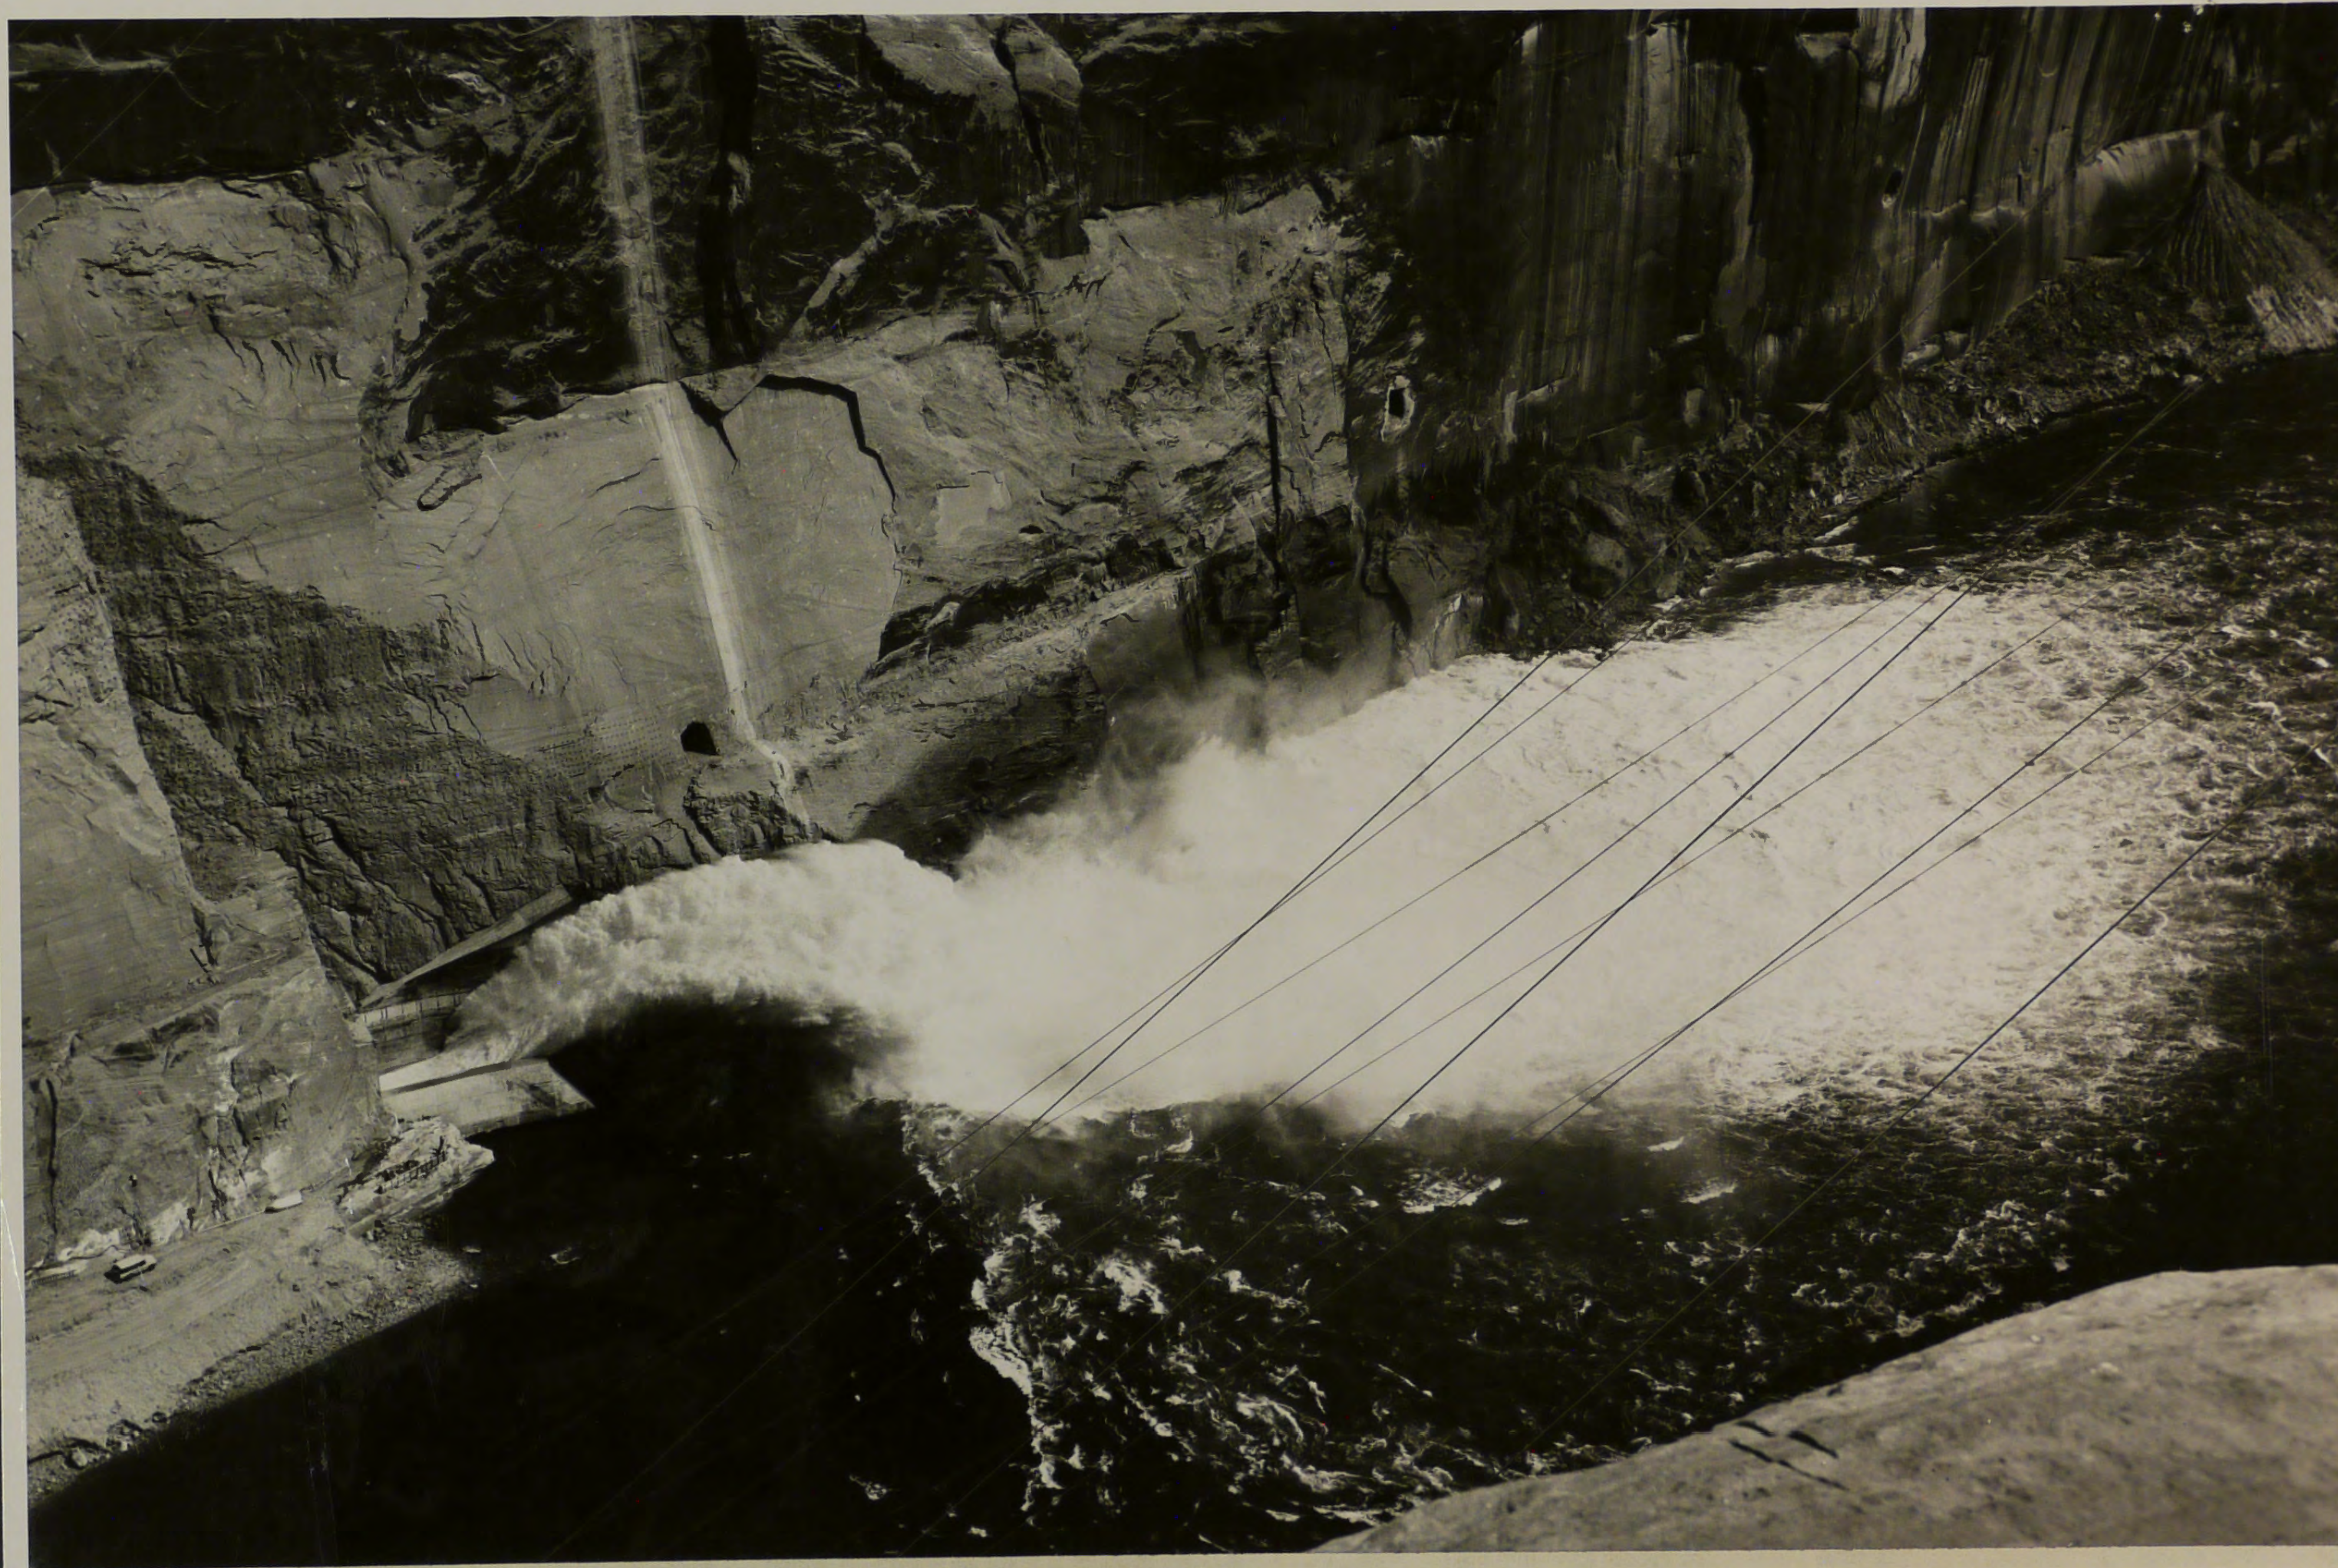
P 557-420-10778  
NA

Glen Canyon Unit--C.R.S.P.  
Release of 18,000 second-feet over the left deflector bucket for purpose of further checking  
erosion damage to left diversion.tunnel. 3-17-65 F. Finch

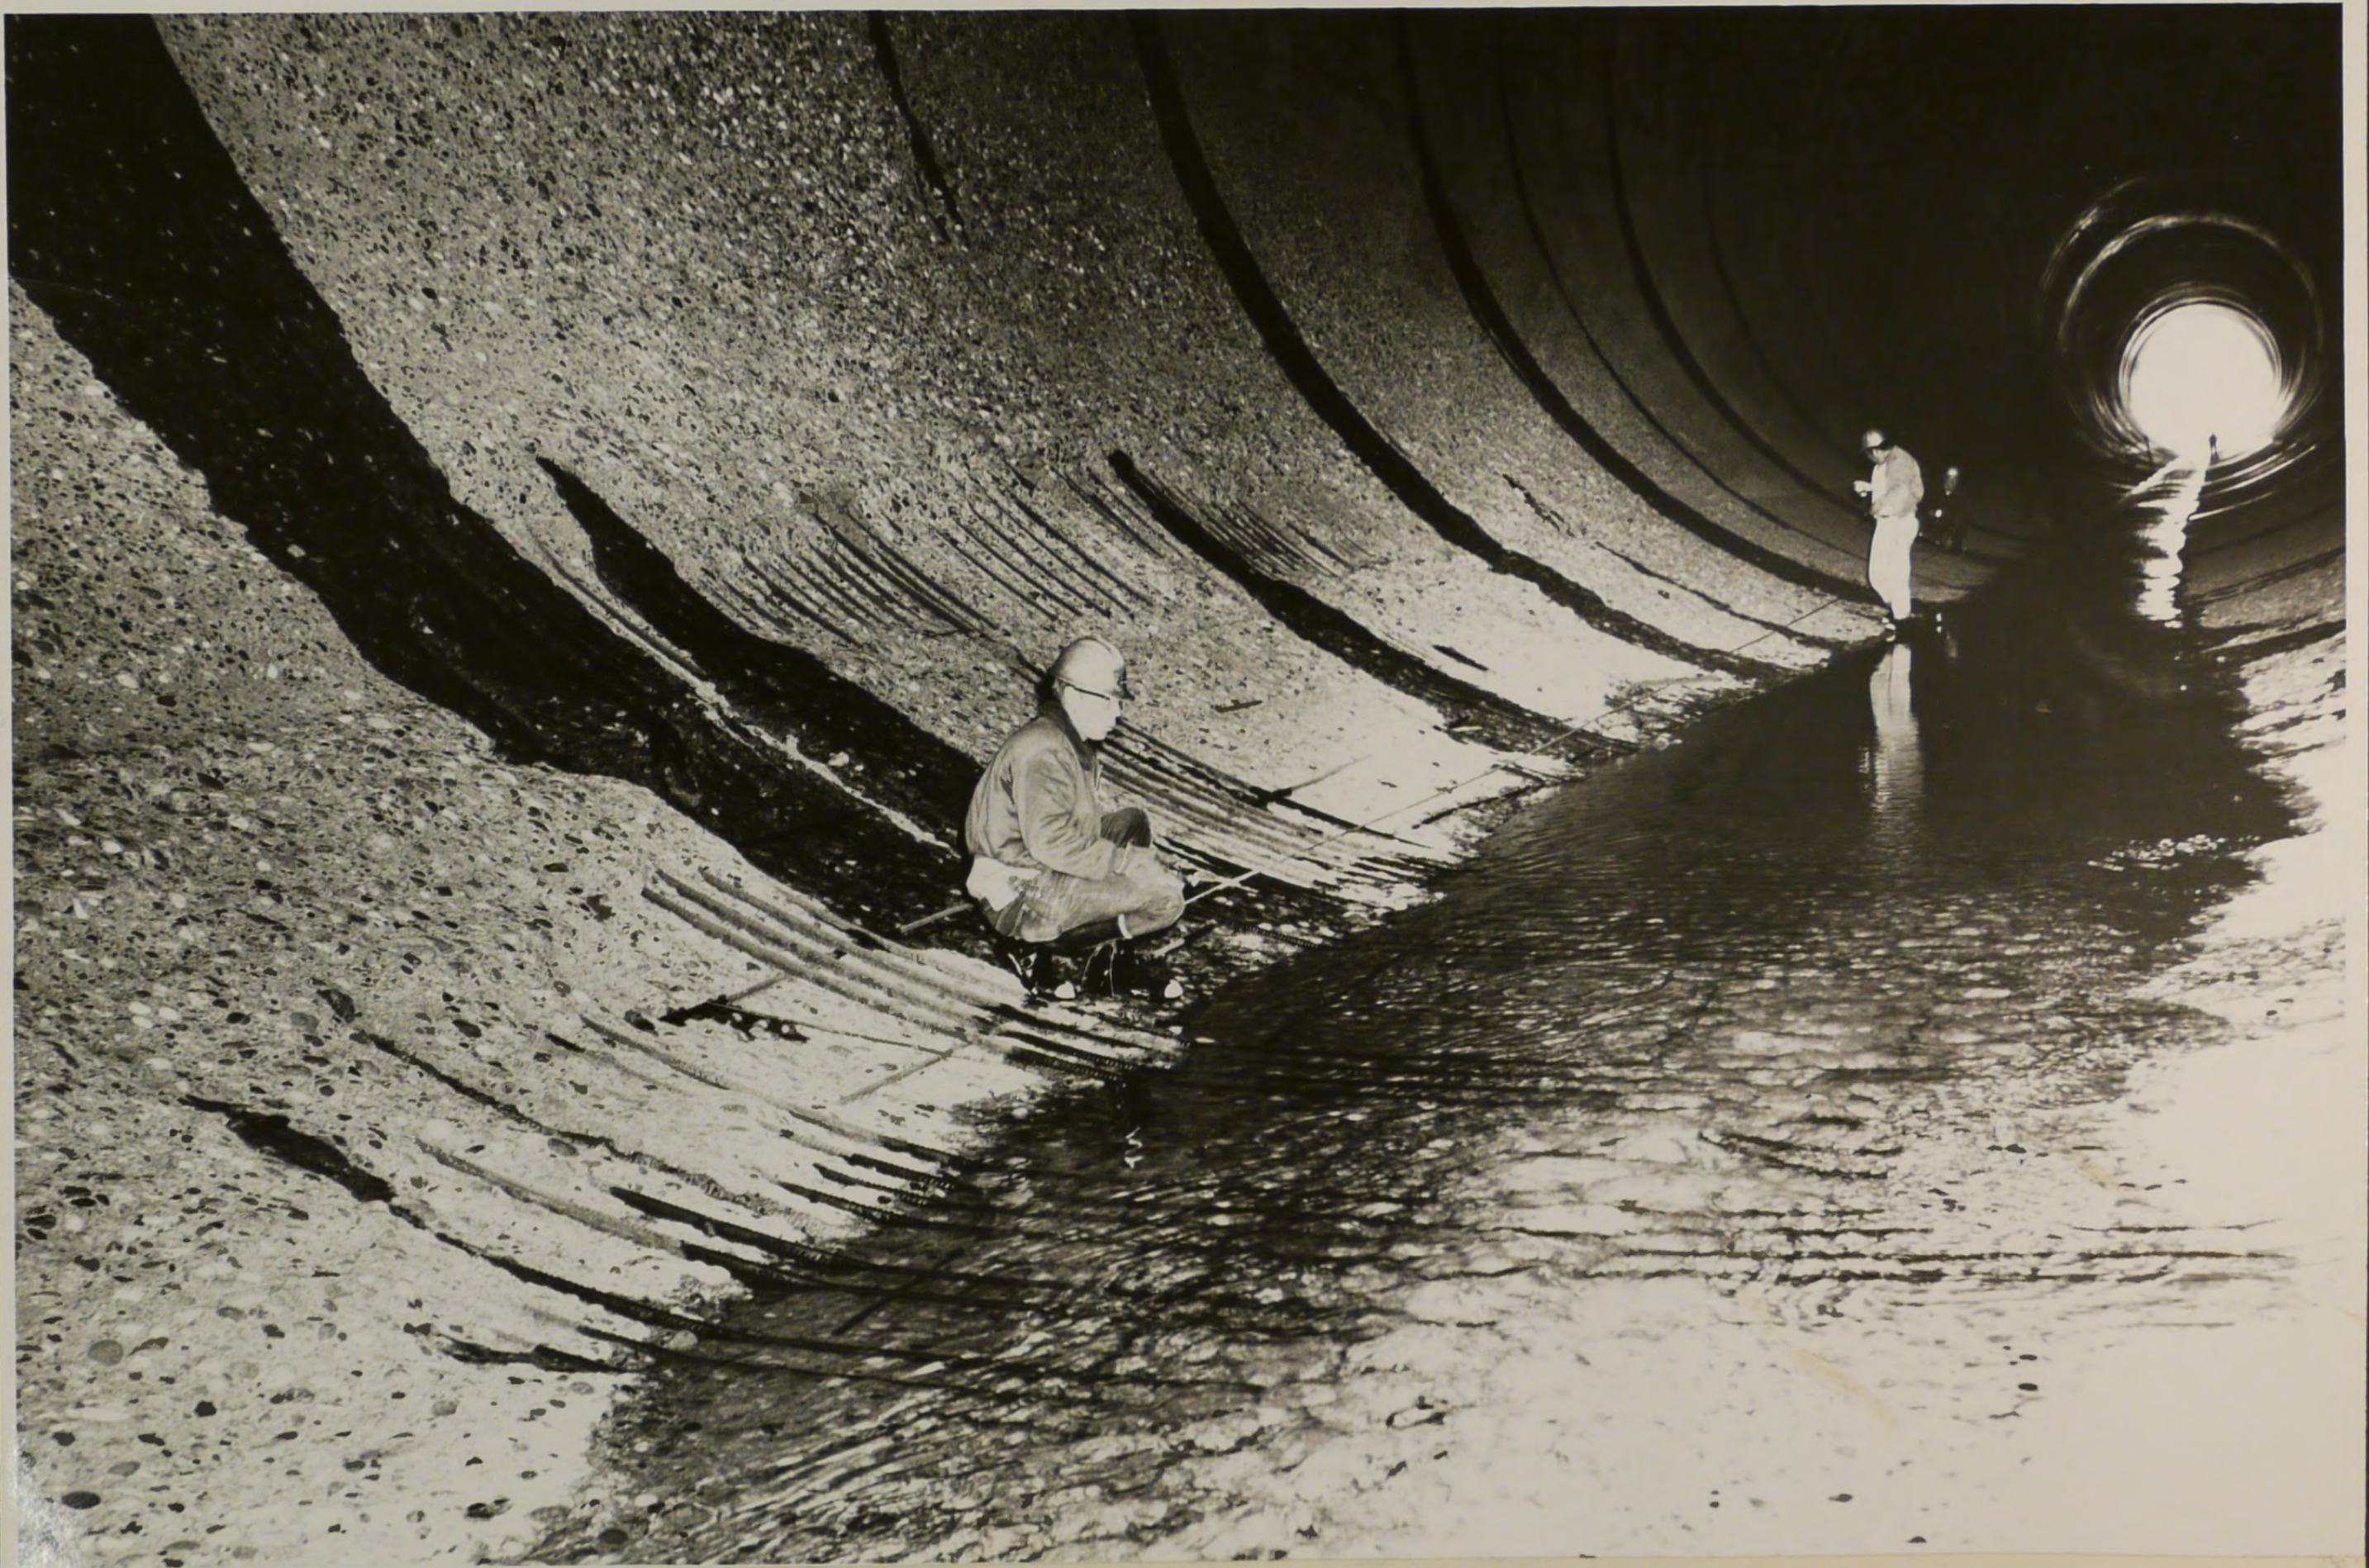
P 557-420-10602 Glen Canyon Unit--C.R.S.P.  
NA View of left spillway tunnel below ; the outlet gates showing erosion caused by heavy discharges.  
Contractor: Merritt-Chapman and Scott Corp., Contract No. 14-06-D-2403. Specs. No. DS-4825.  
2-24-65 F. Finch

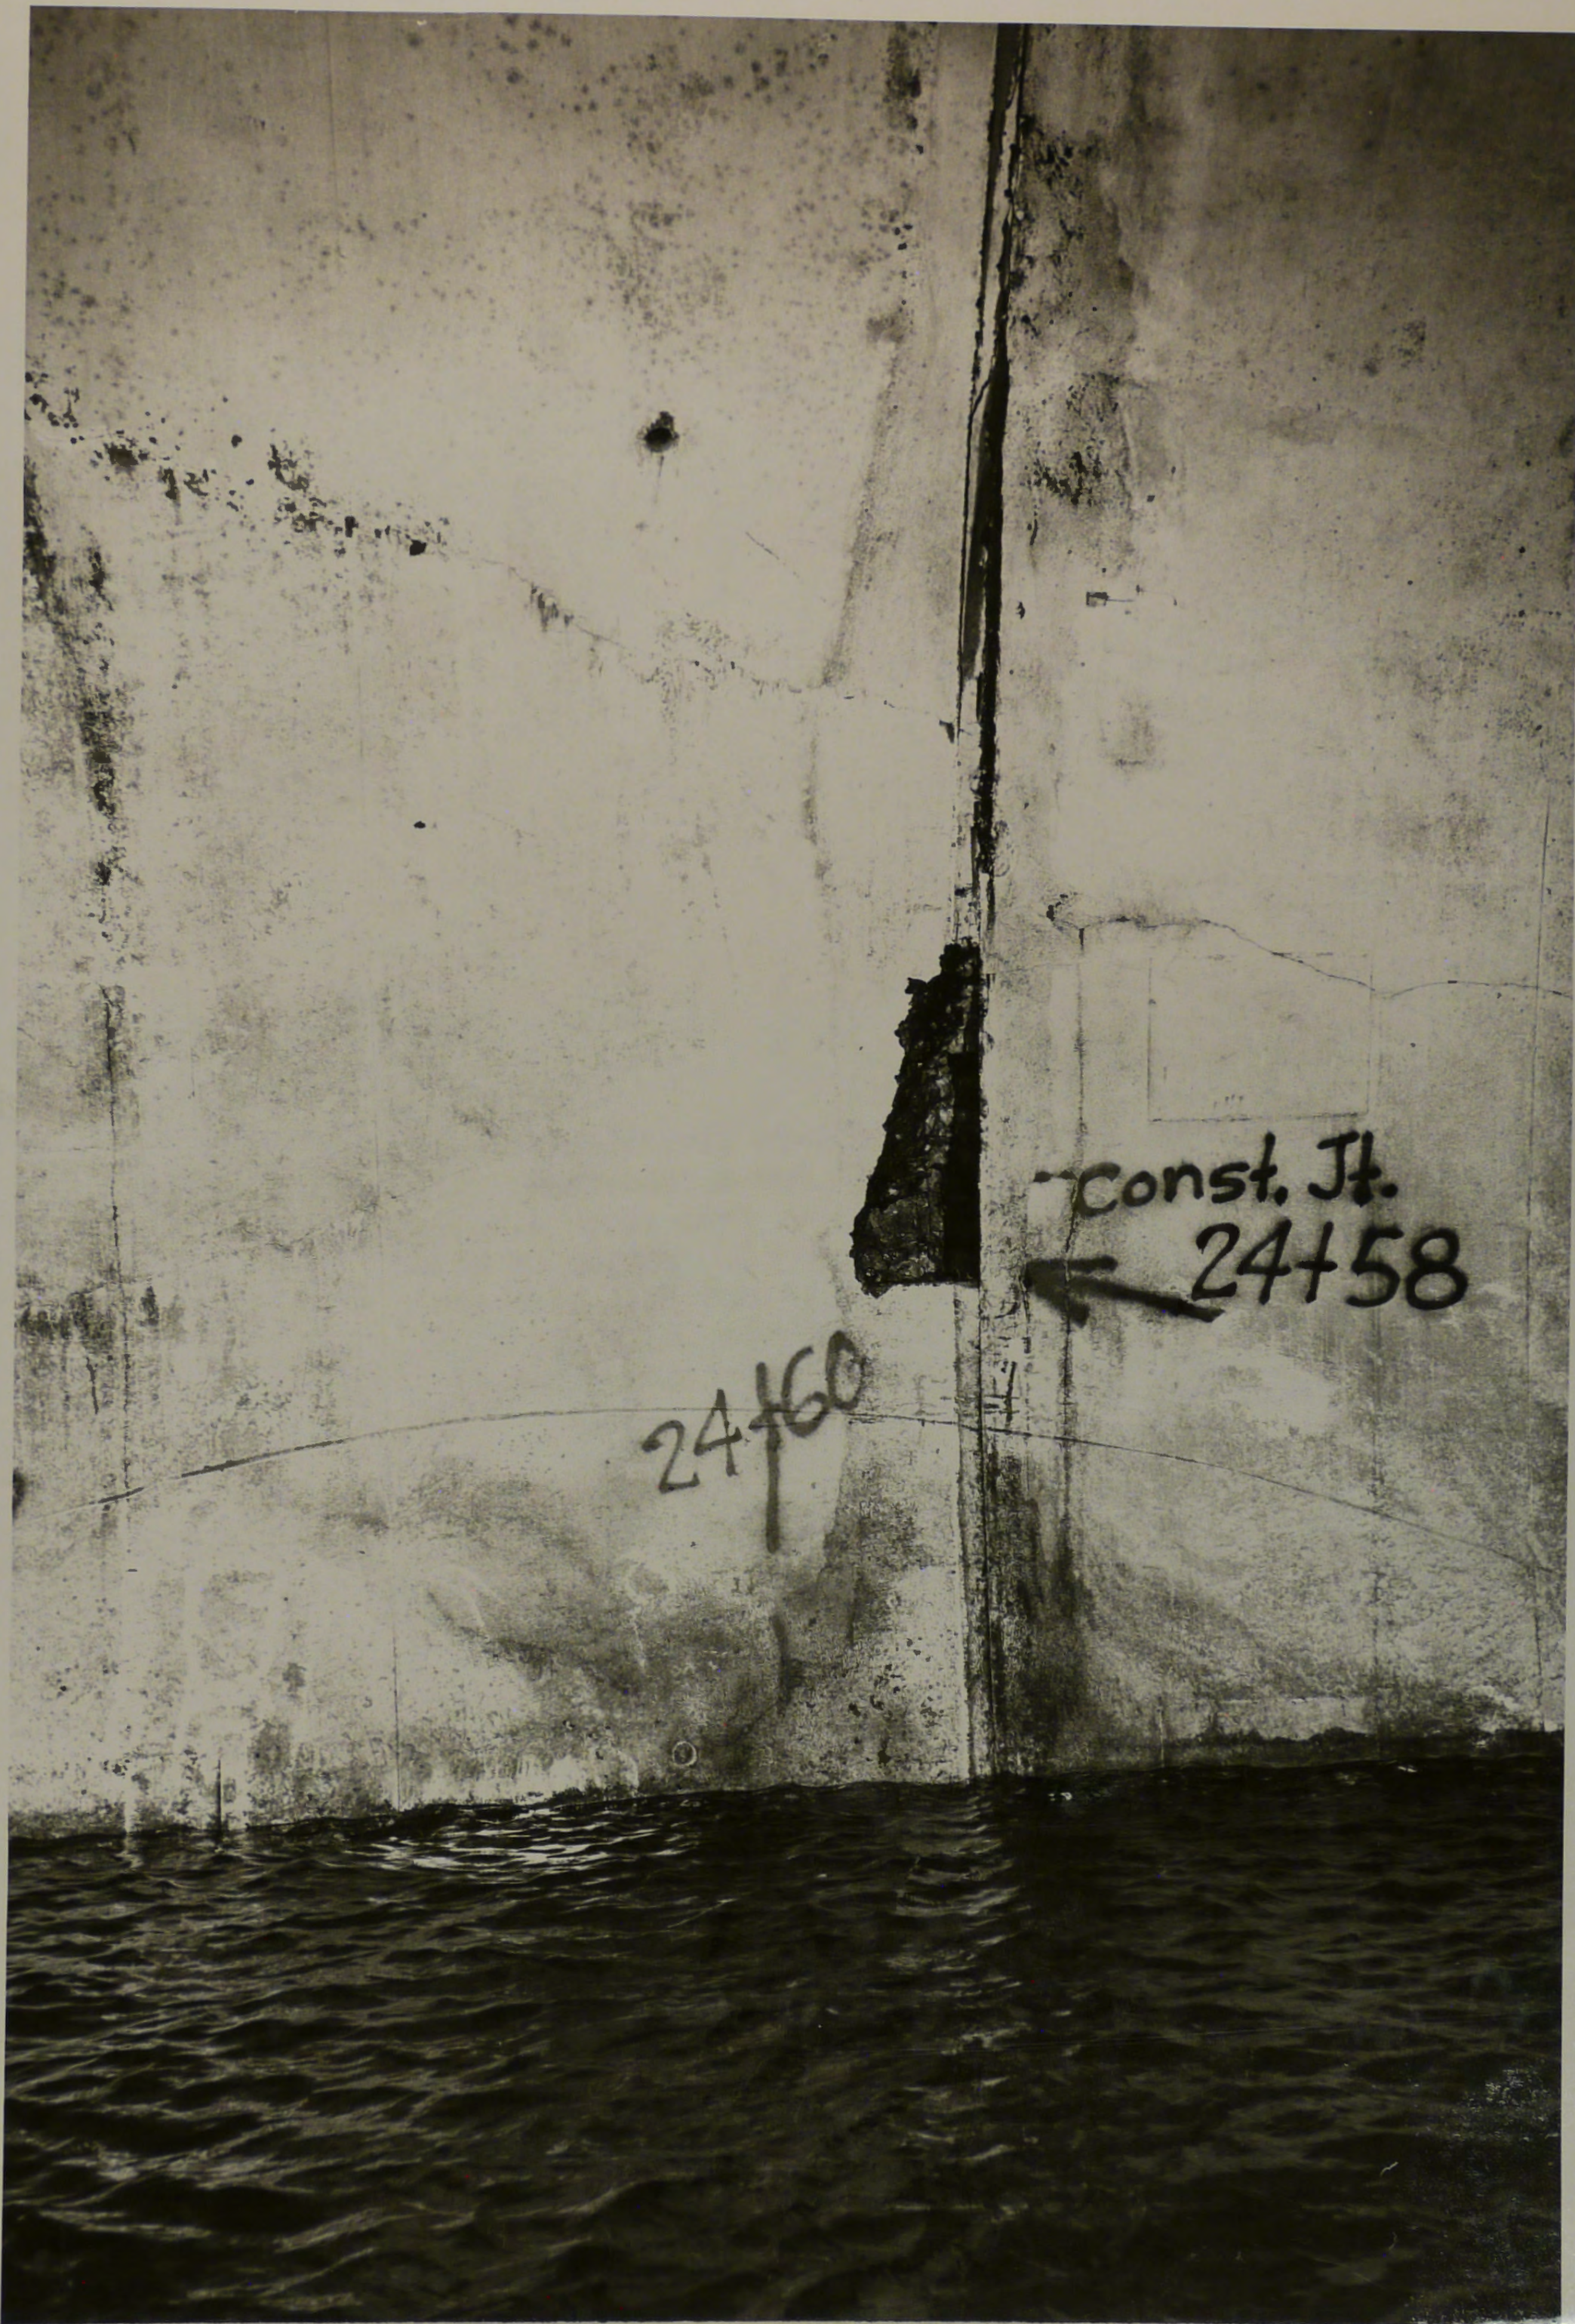
P 557-420-10795 Glen Canyon Unit--C.R.S.P.  
NA Hole in concrete lining of left diversion tunnel  
3-23-65
