P 557-420-10772  
NA

Glen Canyon Unit--C.R.S.P.

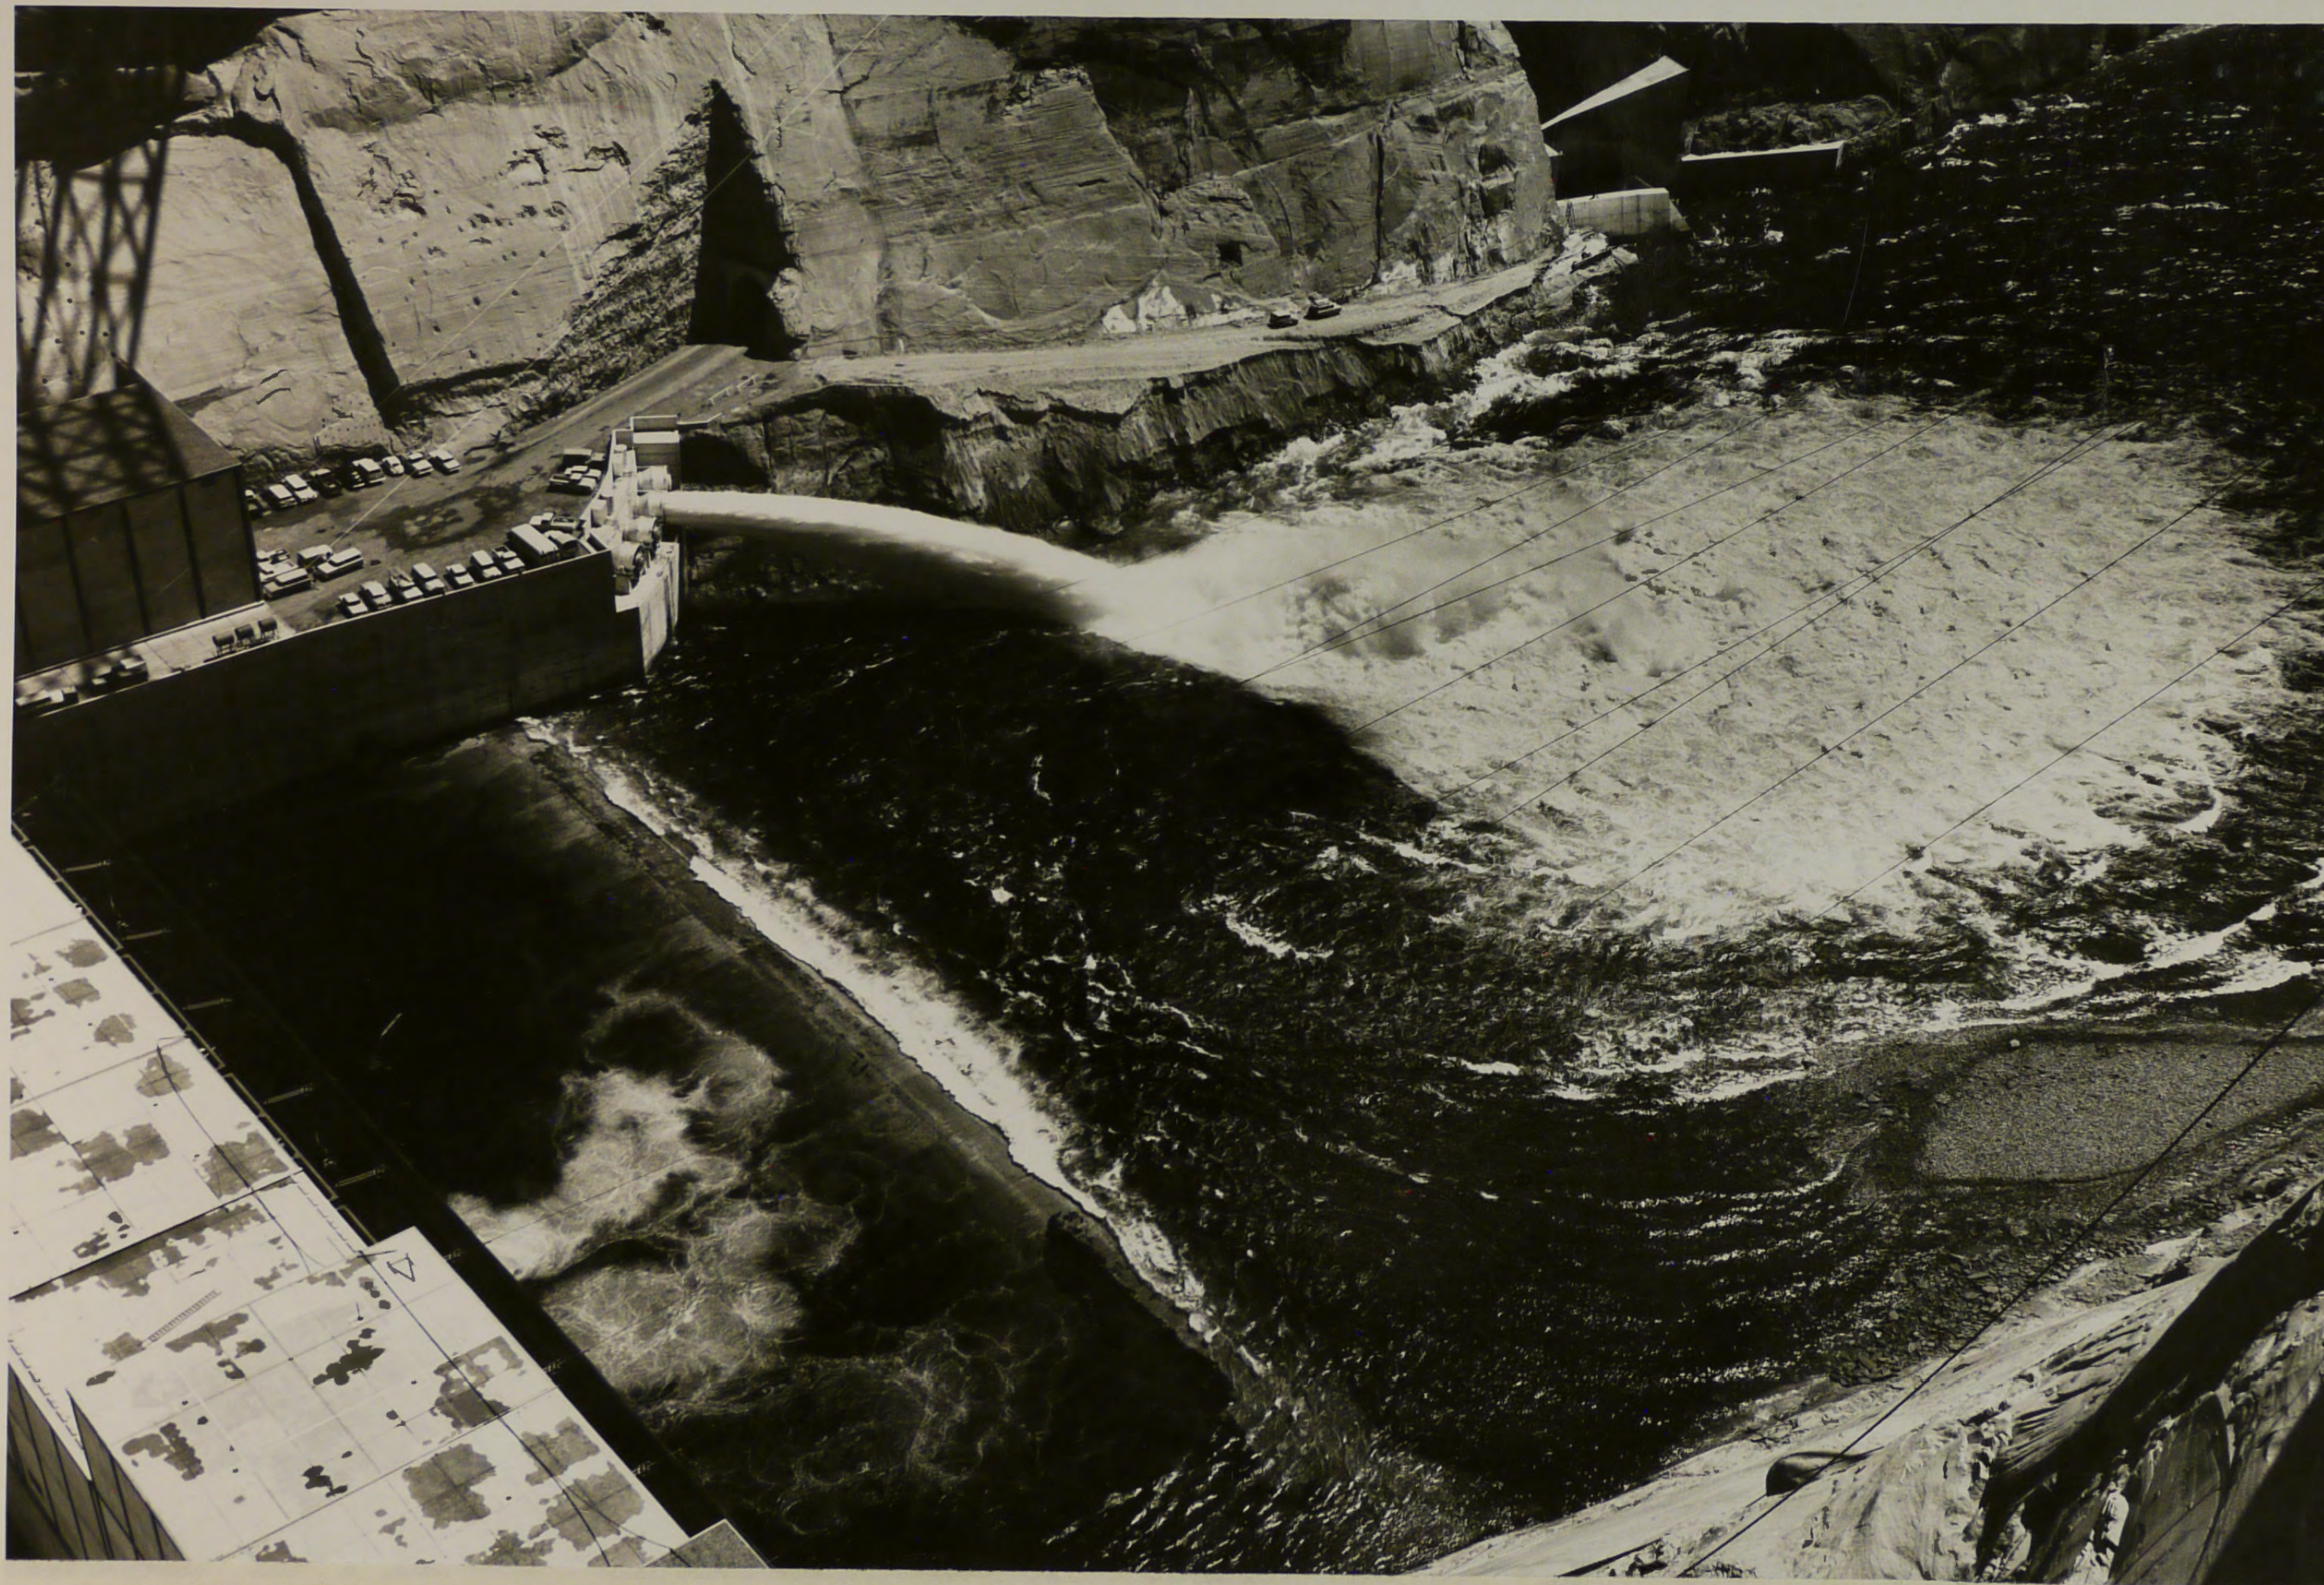
P 557-420-10855 Glen Canyon Unit--C.R.S.P.  
NA Flow through Outlet Gate No. 3, showing eddying at tailrace slab.

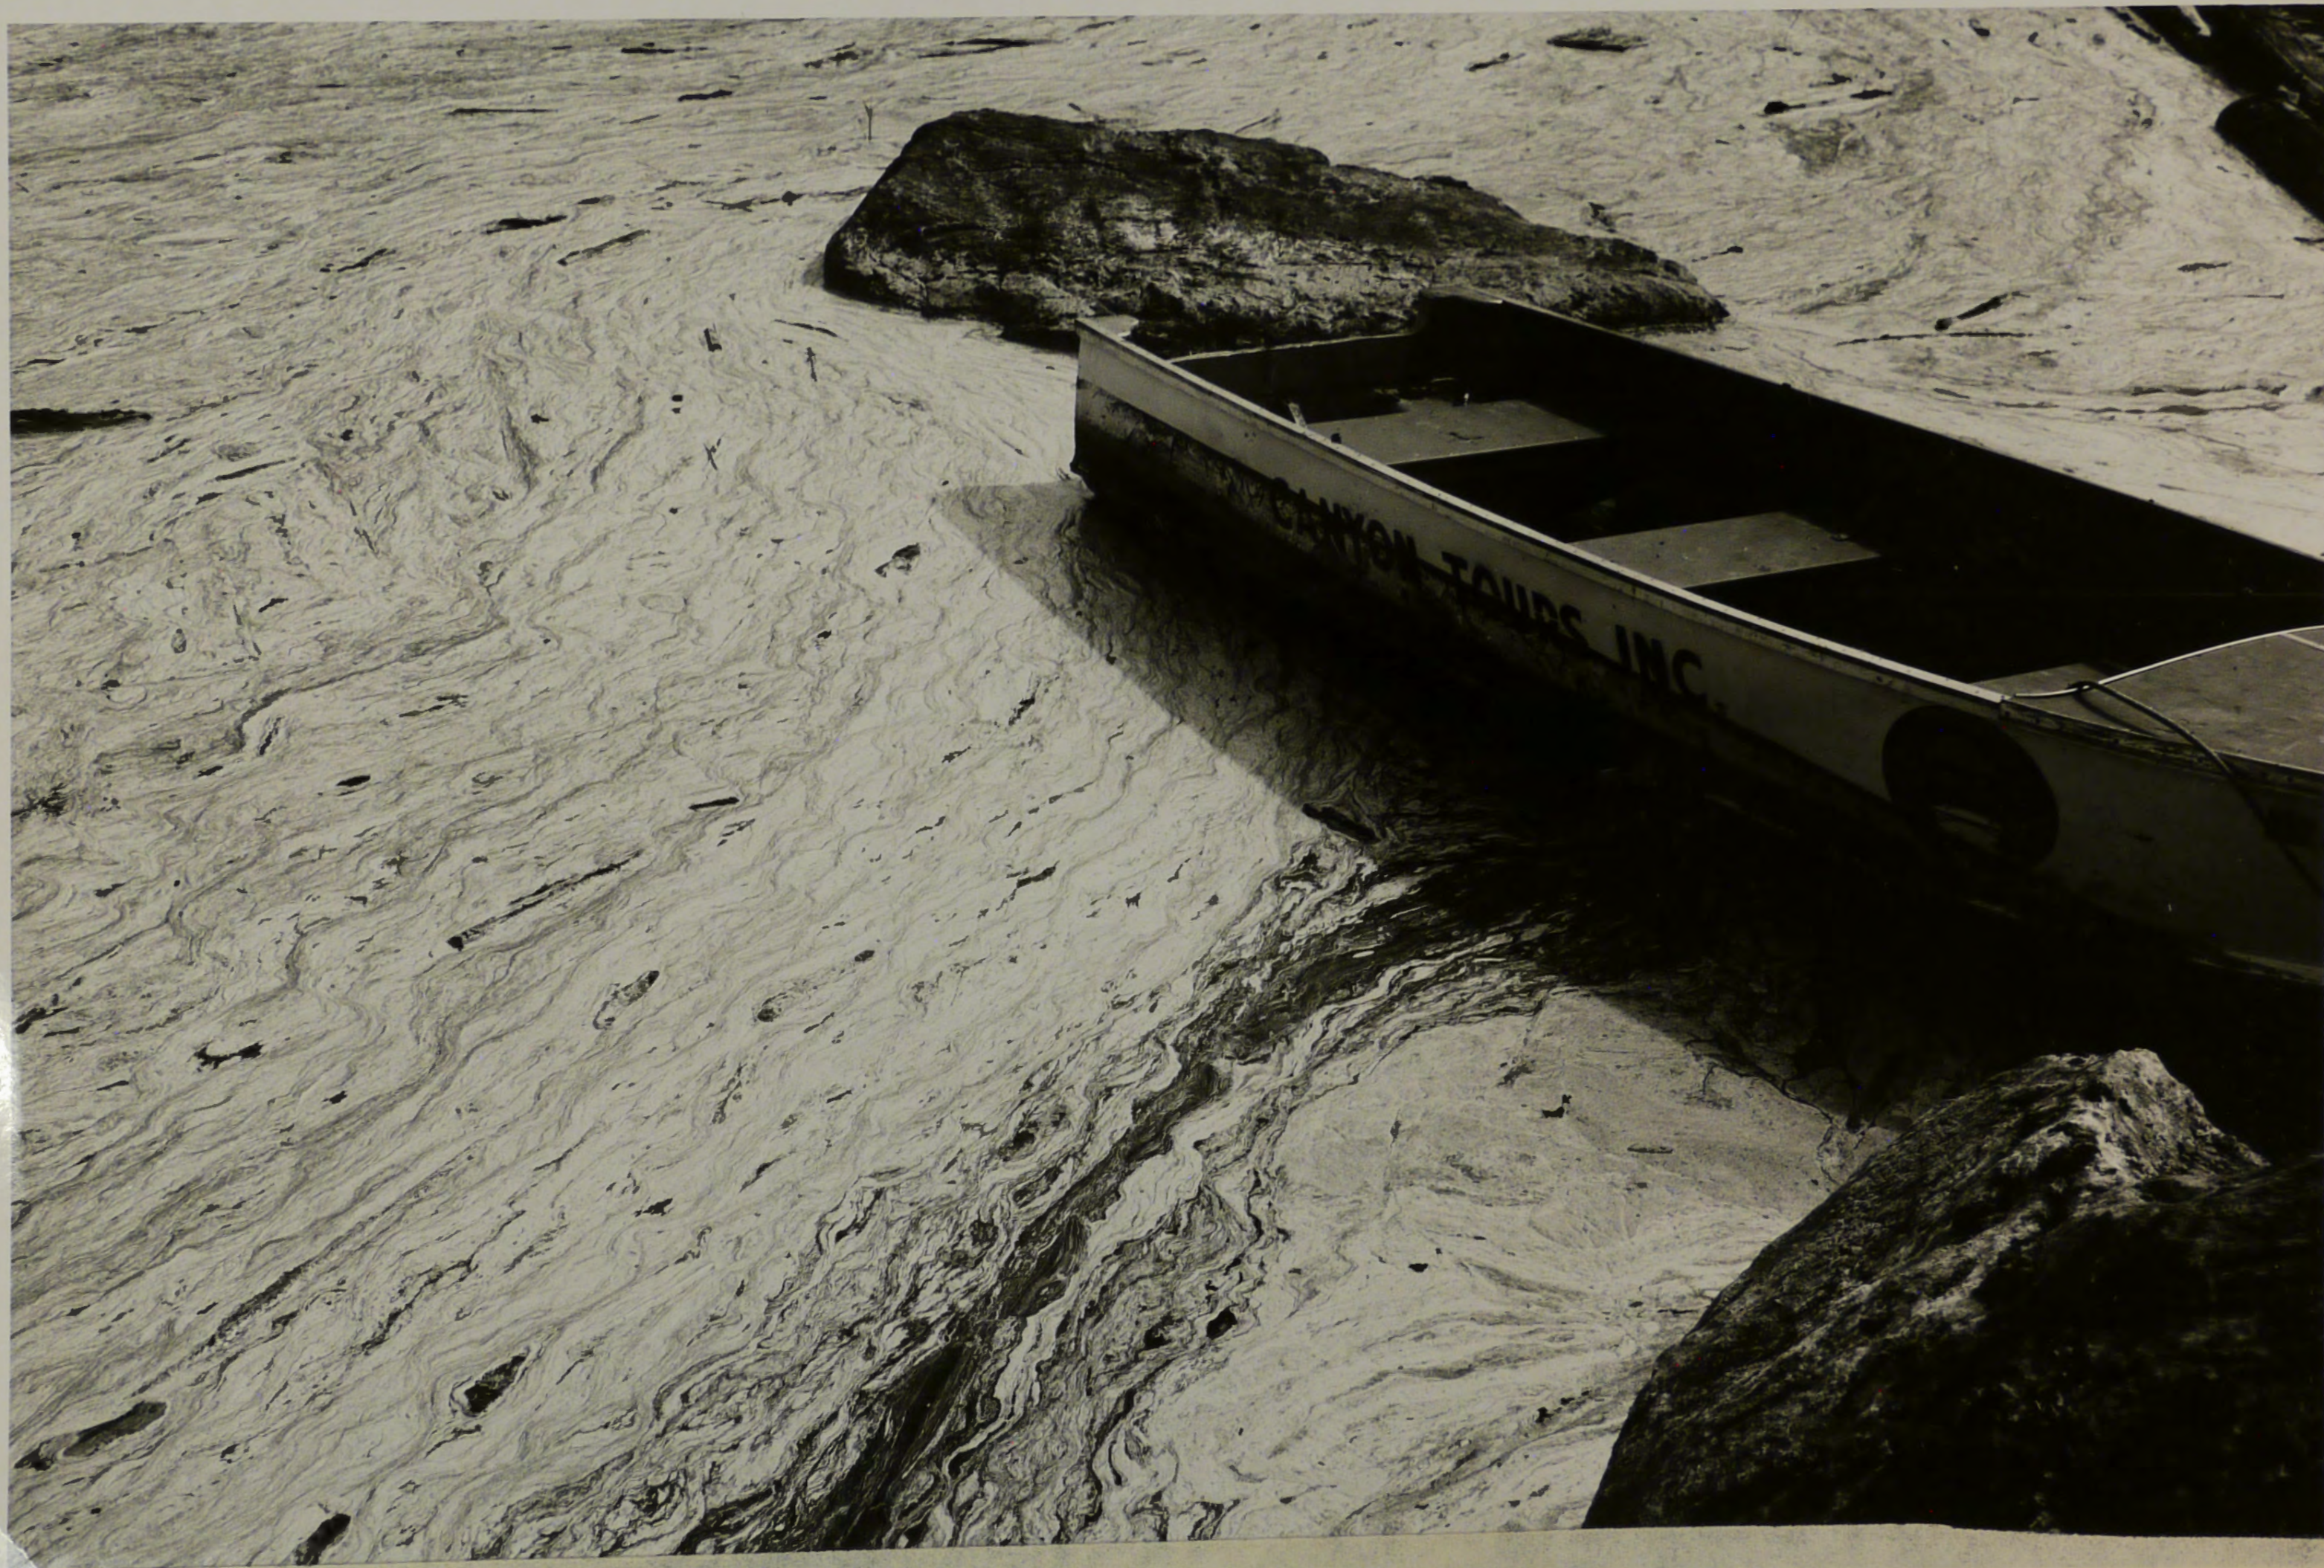
P 557-420-10908  
NA

Close-up view of oil on water surface upstream from the log barrier.
