Studies near the Hite Area

Late winter – Early spring 2023

The perched river, a deteriorating boat ramp,
and a wild sedimented wasteland

Returning Rapids

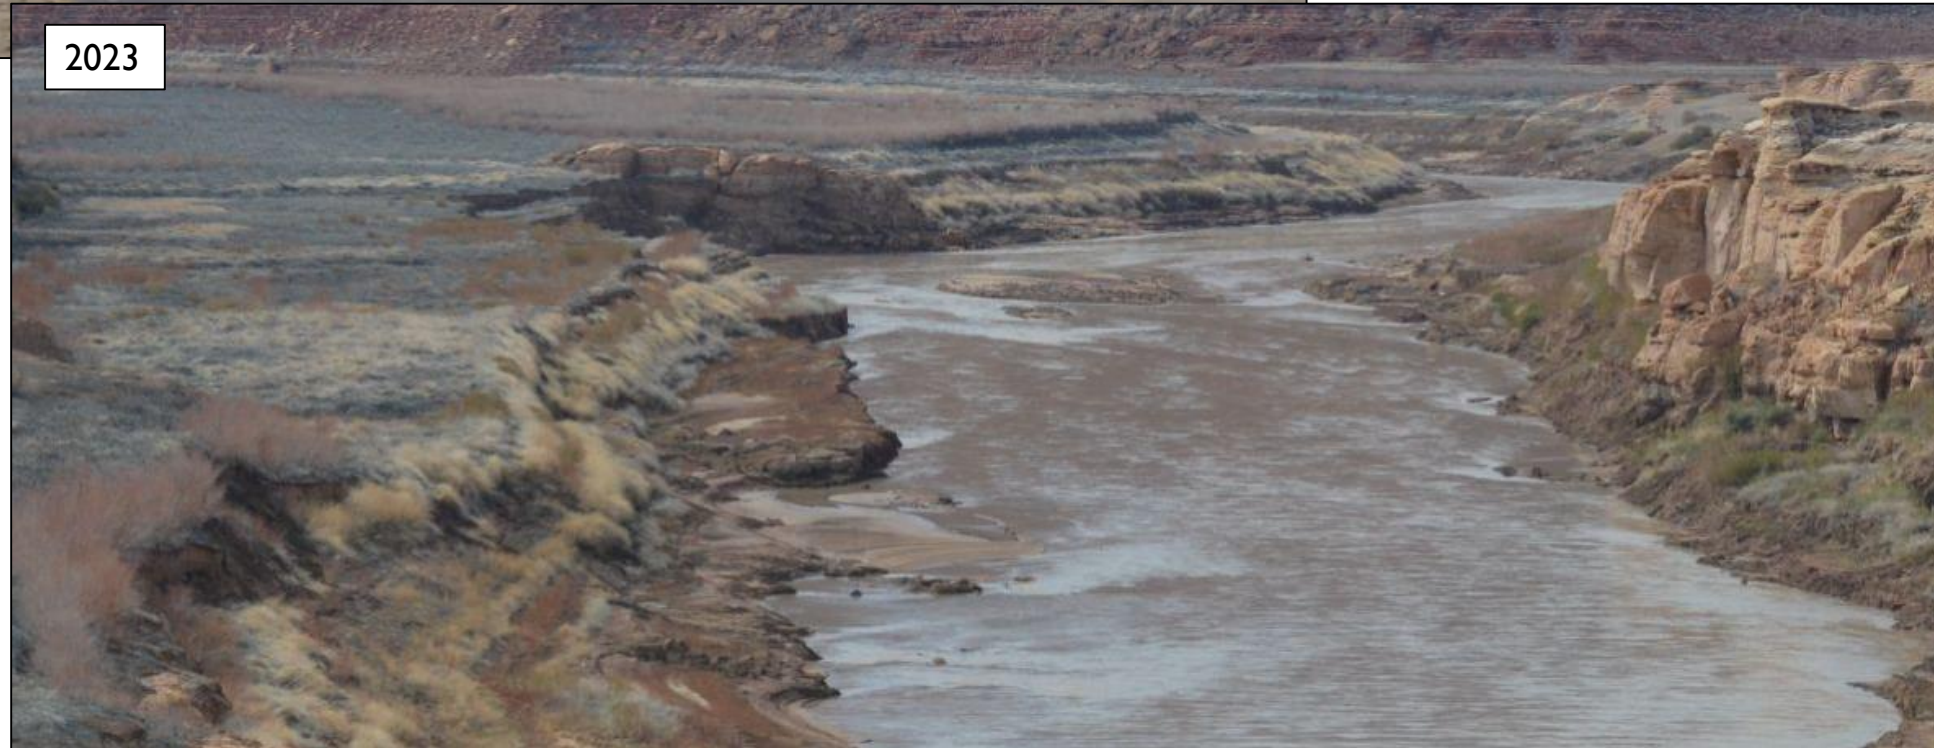
The river surface is 21 feet lower,
deposits from the Dirty Devil
push way further into the channel,
and major amounts of sediment
have eroded from the face of the
headwall.

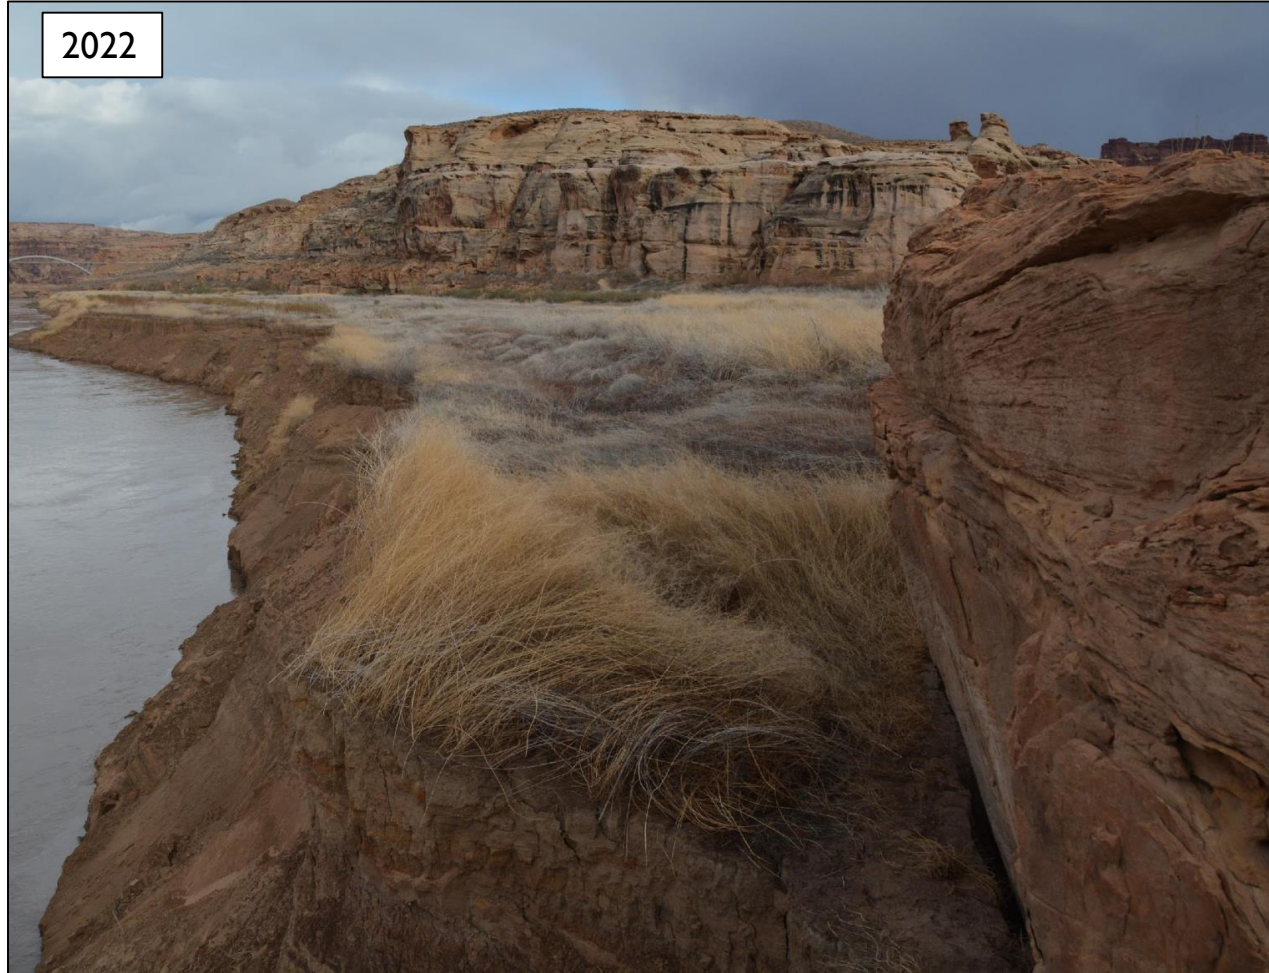
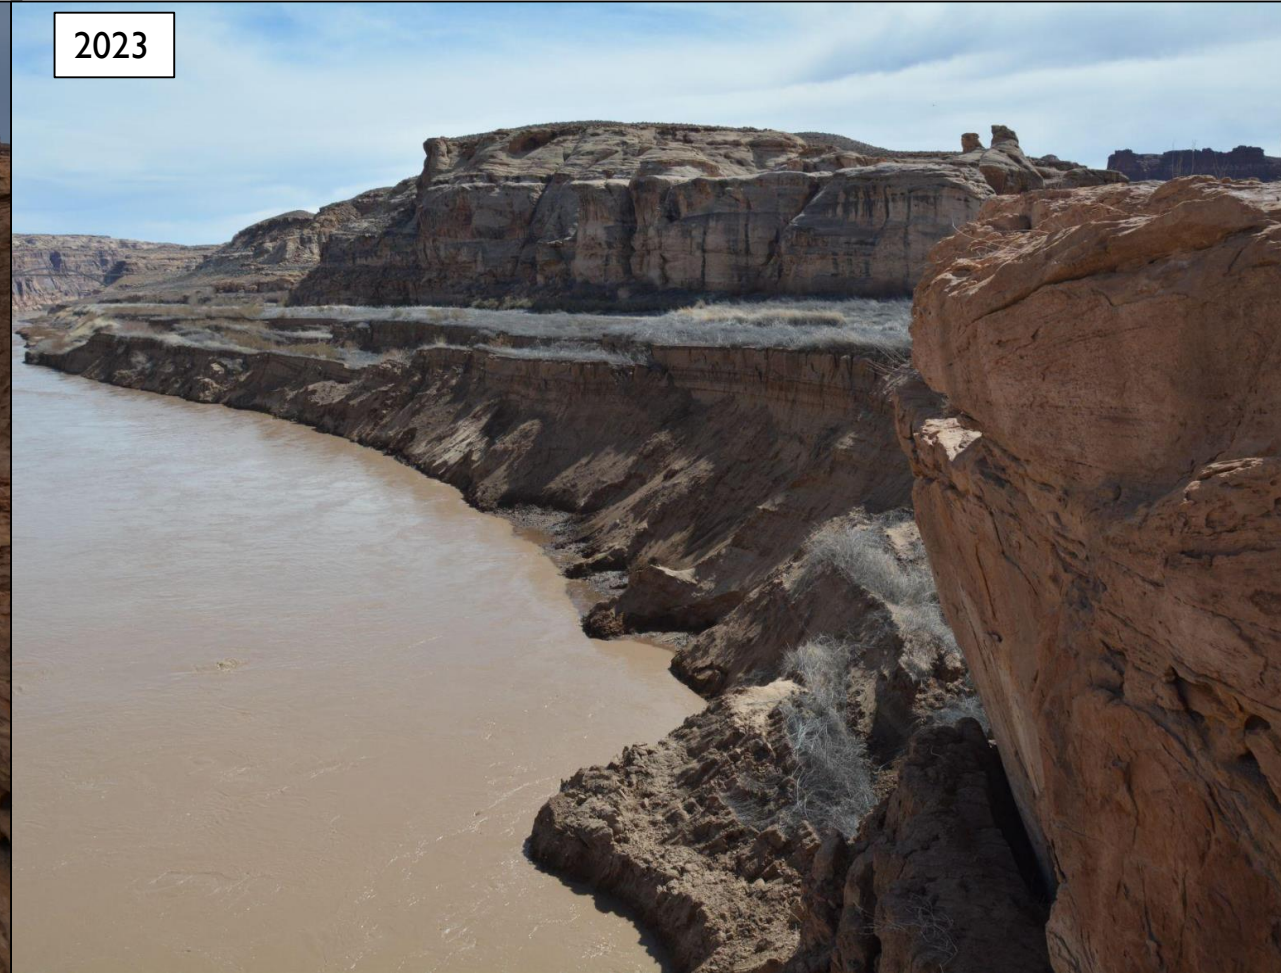
Another View from the Headwall Looking Upstream

A view from the headwall gives you a better vantage point to see how much mud was carved away. Exactly one year to the date. The river really carved back some mud here and is being pushed around by the Dirty Devil.
It will be interesting to see what high water does to this area in this years runoff.

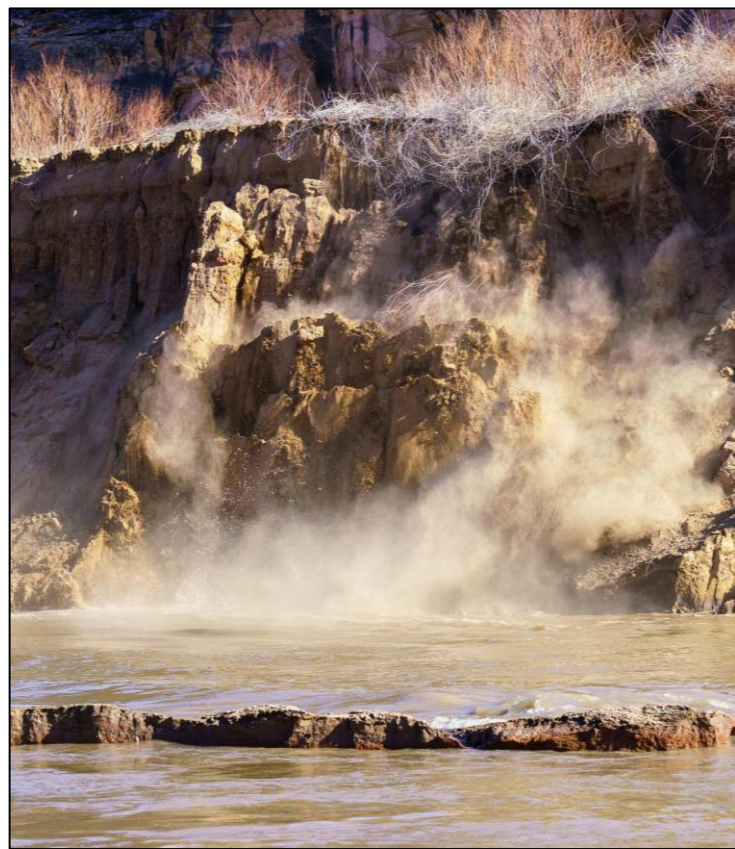
The carving that has taken place at the confluence of the Dirty Devil and Colorado River often occurs in large slumping events.
This photo series captured one of these collapses on film.
Note the skiff is 16 feet in length.

Big Slump at Dirty Devil 3-3-2023
bridge 3579 5400 cfs_Travis Custer

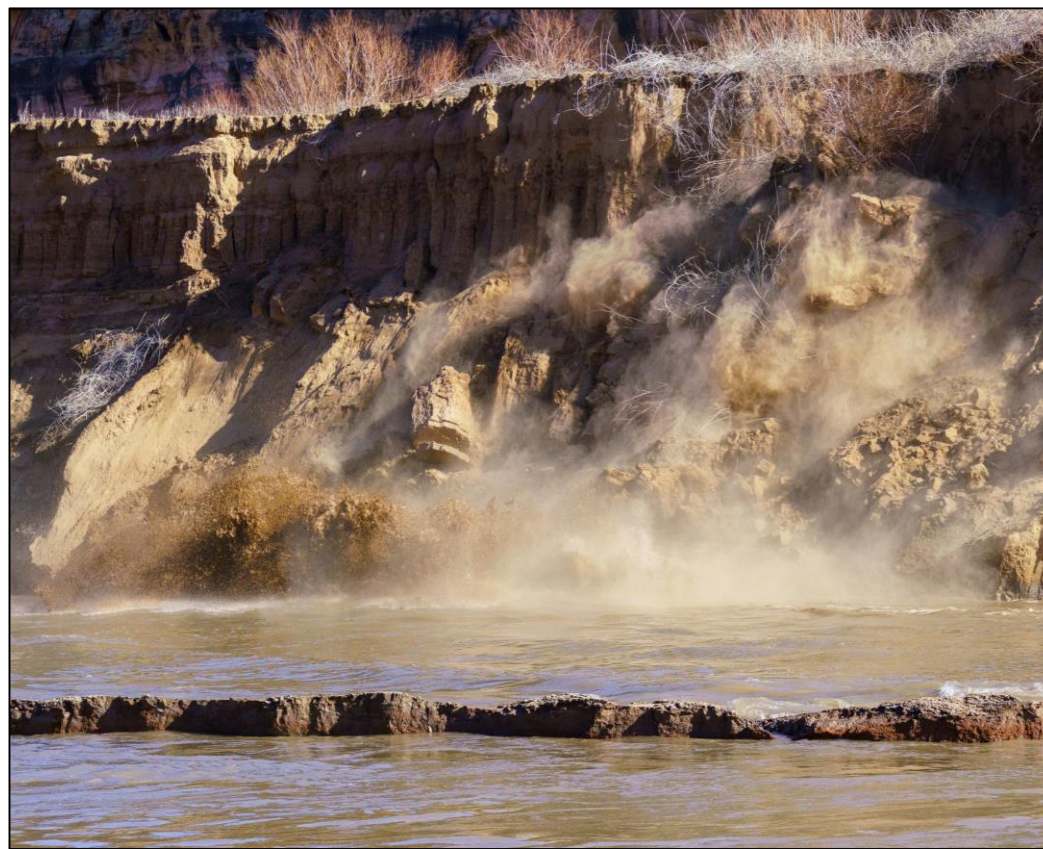
Slump and Wave at Dirty Devil 3-3-2023
bridge 3579 5400 cfs_Travis Custer

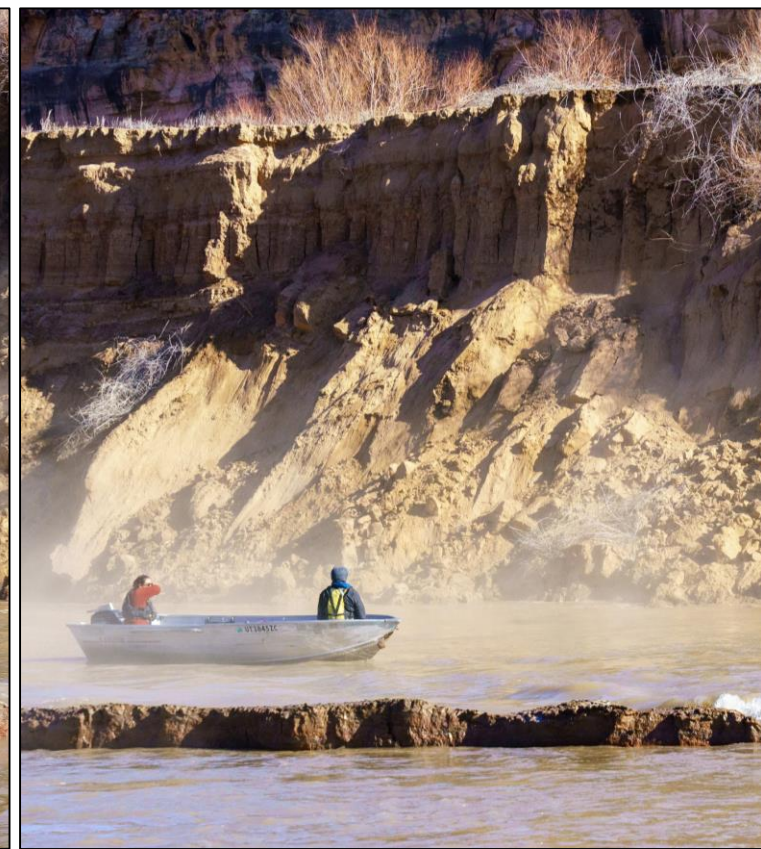
Skiff for scale near Slump 3-3-2023
bridge 3579 5400 cfs_Travis Custer

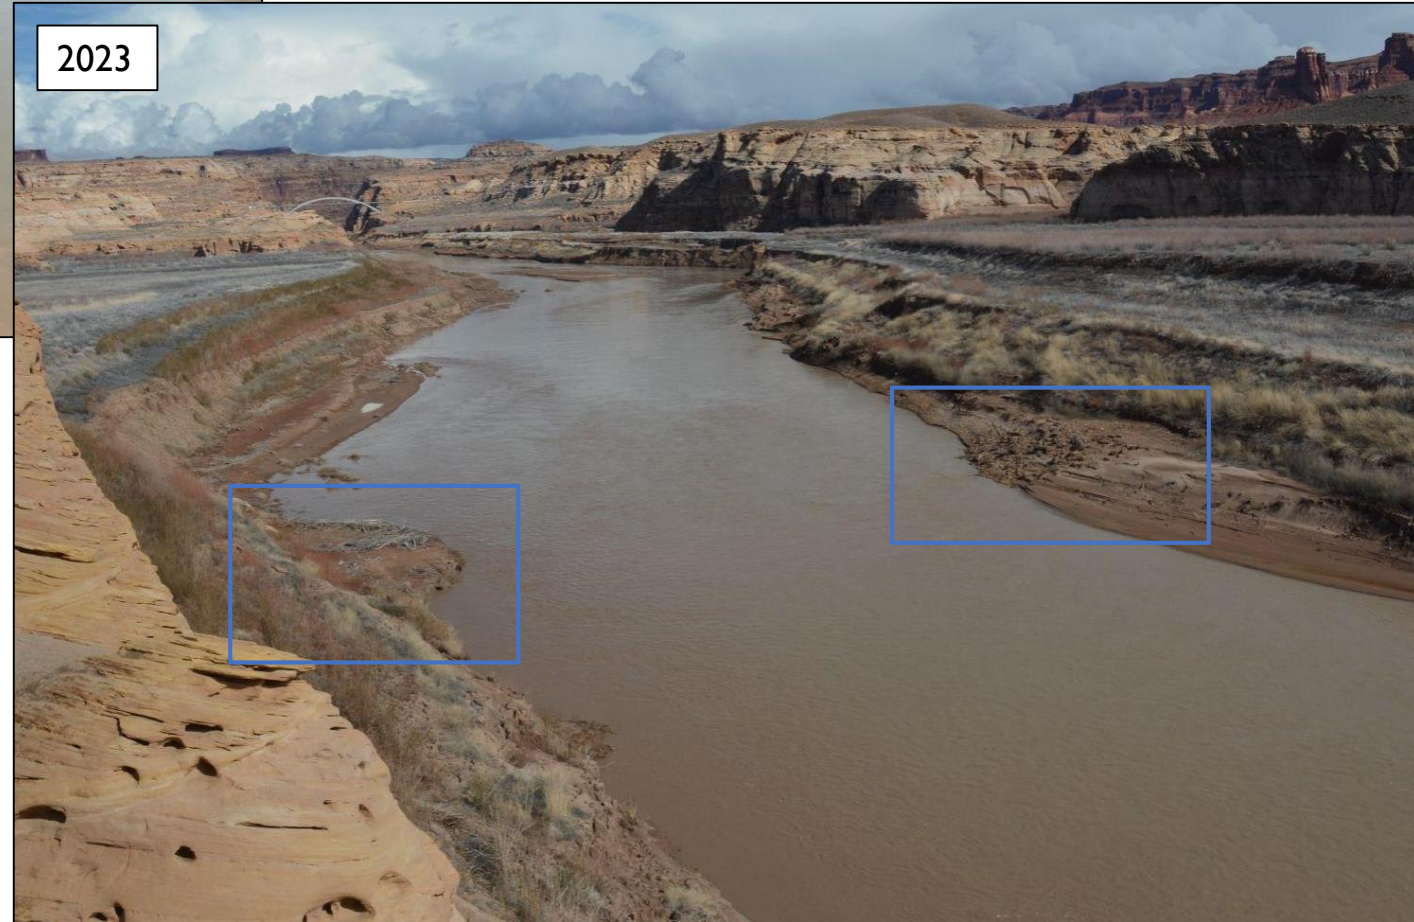
Looking upstream towards the bridge from the takeout area.
The river is out of its original channel here and flowing over cobbles
and bedrock. These cobbles and bedrock are beginning to show on
both sides of the river in the picture to the right.

We worry this could become a riffle or a rapid in the next few
years.

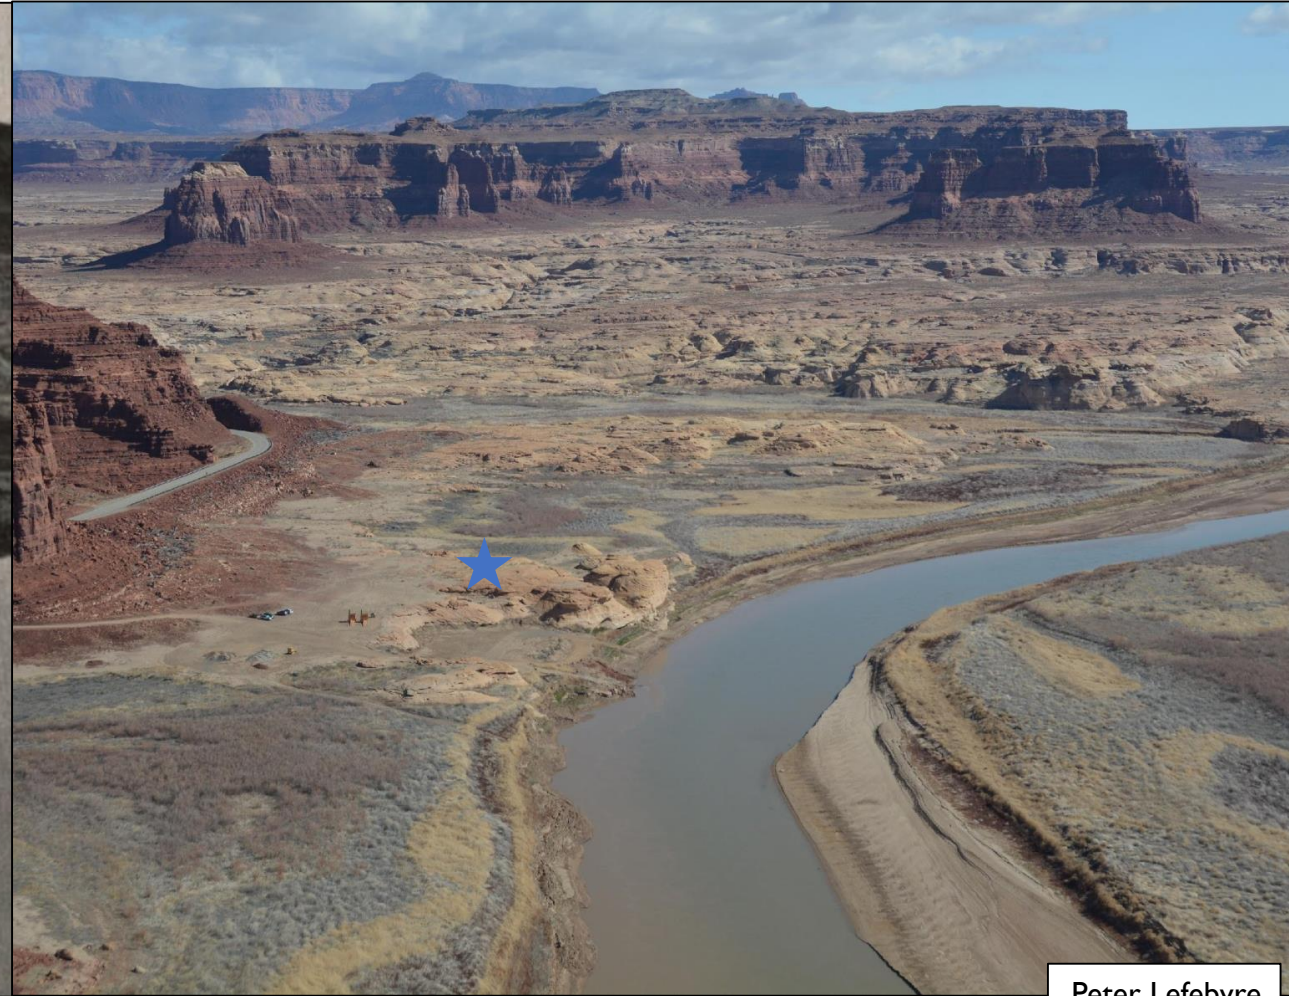
This shows what is going on beneath the surface of the current river and some of the features that it flows over. The blue stars are above the current takeout area. The fingers of land below the star, and the land bridge/saddle right of the star, are capable of creating rapids in the future as the river carves down. Directly upstream and downstream of where we take boats out.

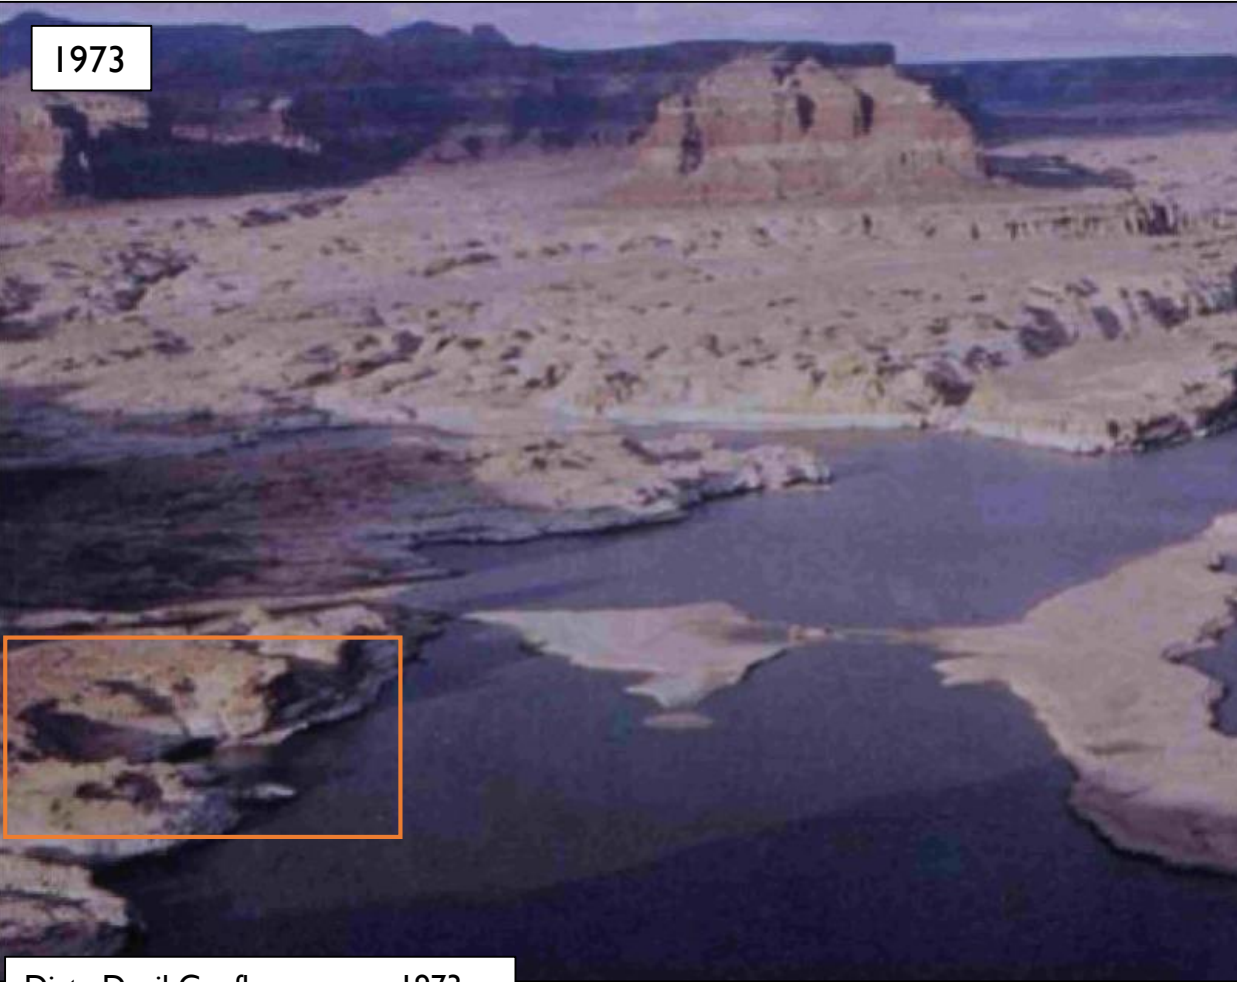
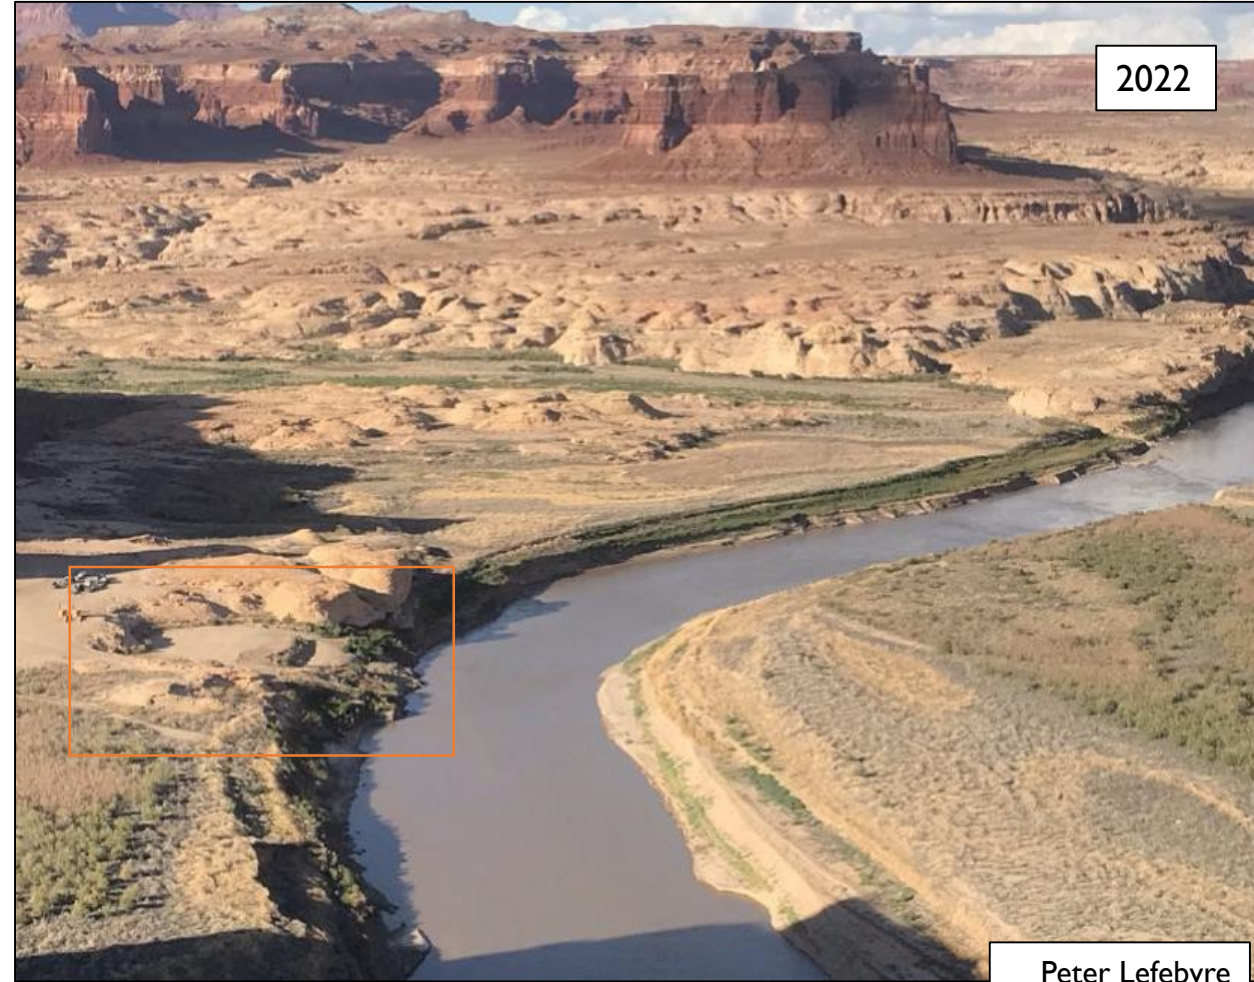
An insightful match. It gives you an idea of where the saddle is upstream of the ramp. Currently there is rock showing on both sides of the river in the exact spot where the saddle is. This match shows how much sediment has been deposited on the landscape and how steep the cliffs are where the current ramp is. Not promising for a smooth transition from ramp to river as the river cuts down.

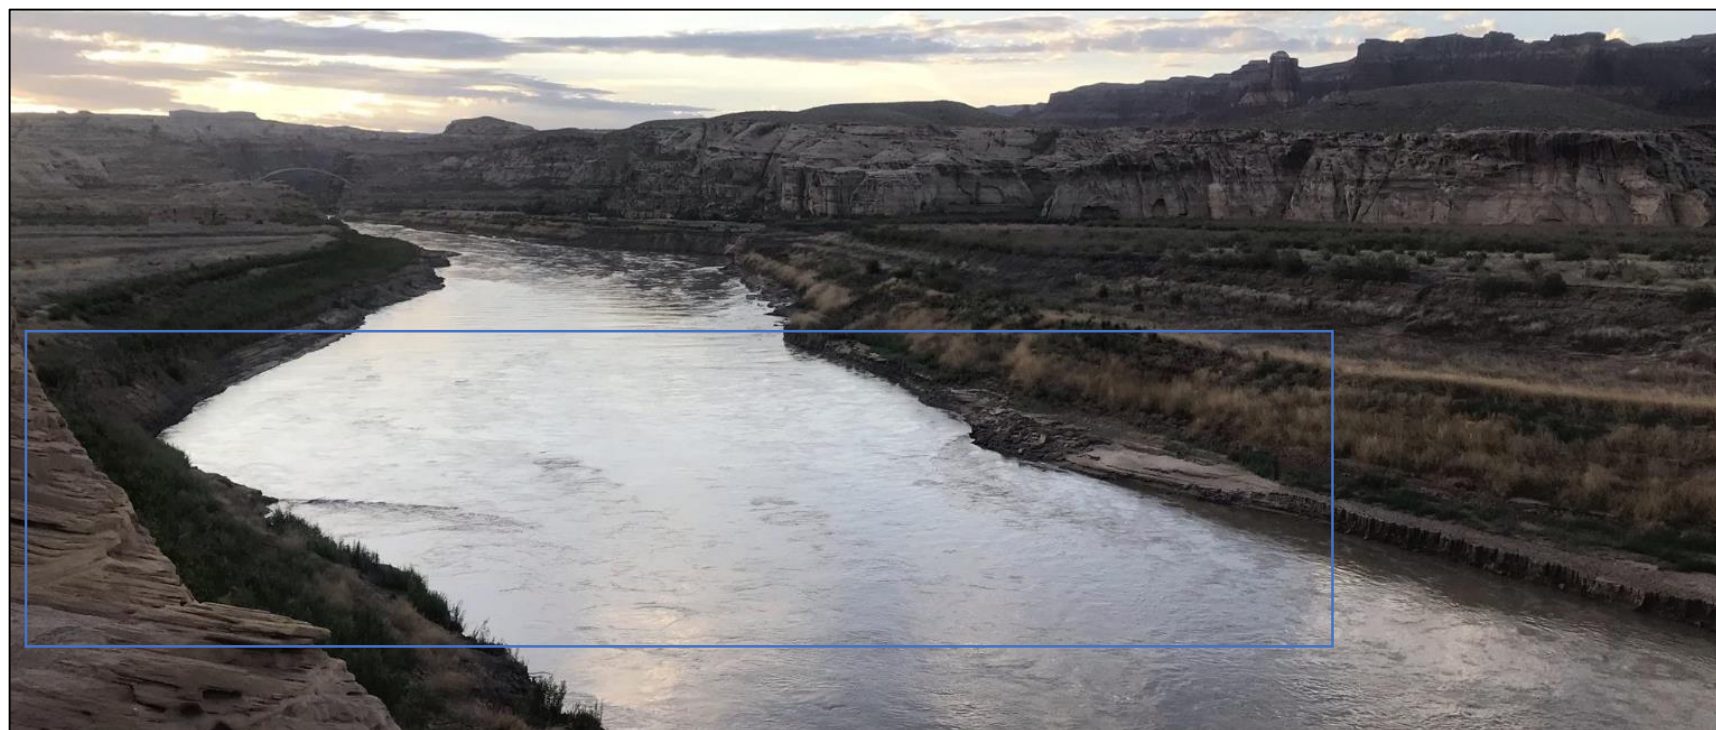
In the blue box you can see rocks sticking out of the mud banks and below the water's surface. This is pinching the river and probably the early signs of a riffle/rapid that may form here. This is the exact location of the saddle shown in the previous slide. In this topo map of the area (pre dam) you can see the elevations of the saddle. With a high point of 3626 and the bridge gauge currently at 3582.6 the river has already carved through 20-40ft of pre dam strata. The saddle was comprised of cobble on top, but at some point, bedrock must be hit.

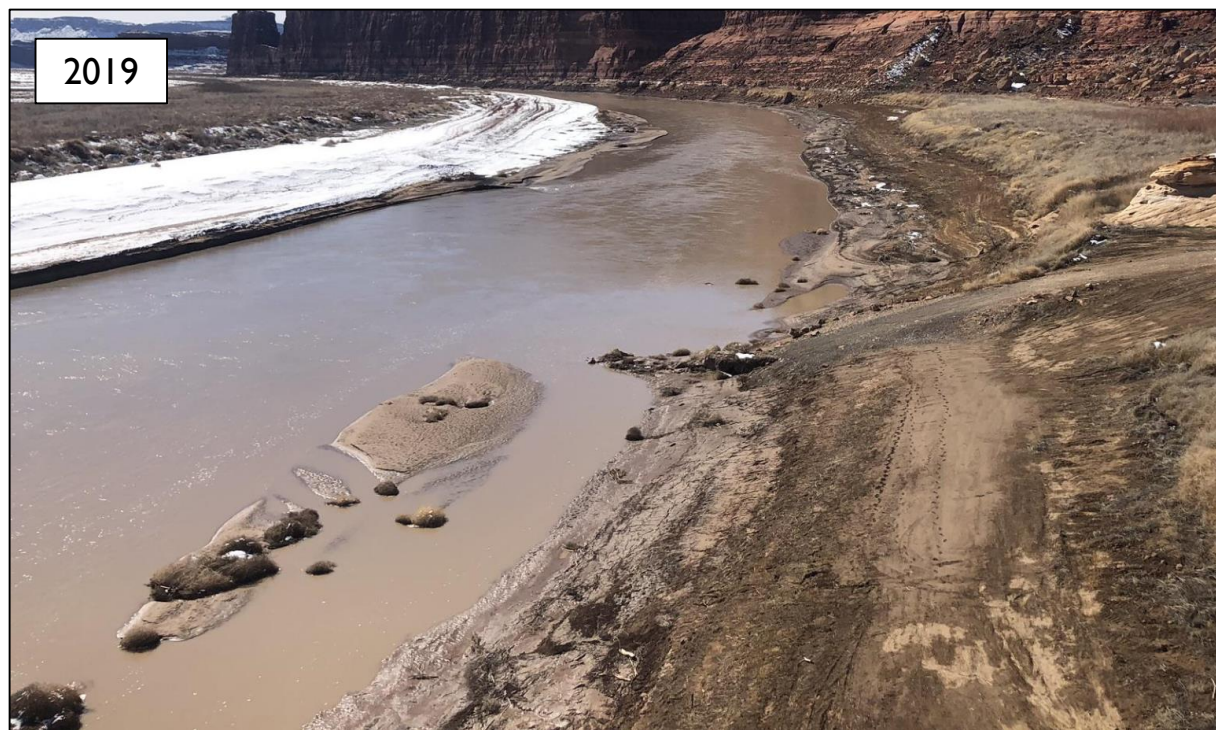
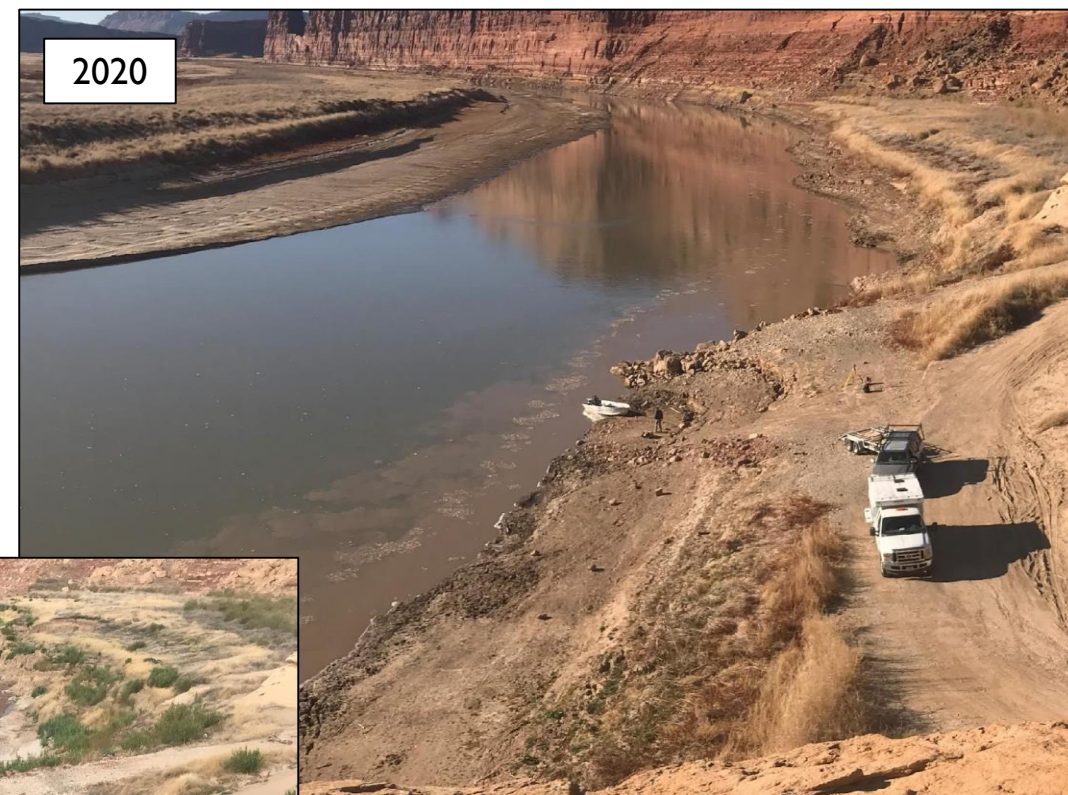
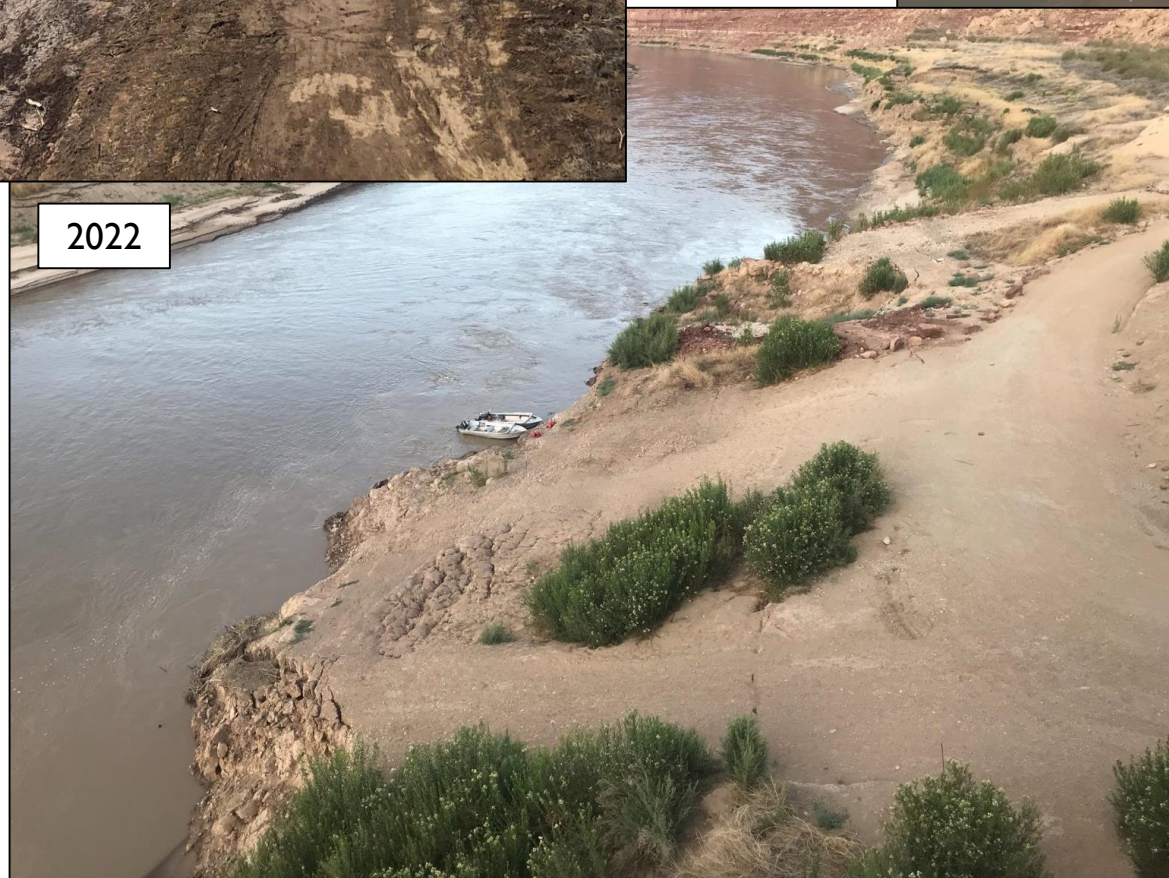
The current evolution of
the "Boat Ramp".
All are varying degrees of barely useable.
The river has carved down over 17' since
2019.
The ramp only gets steeper.
Now there is bedrock showing at river level.

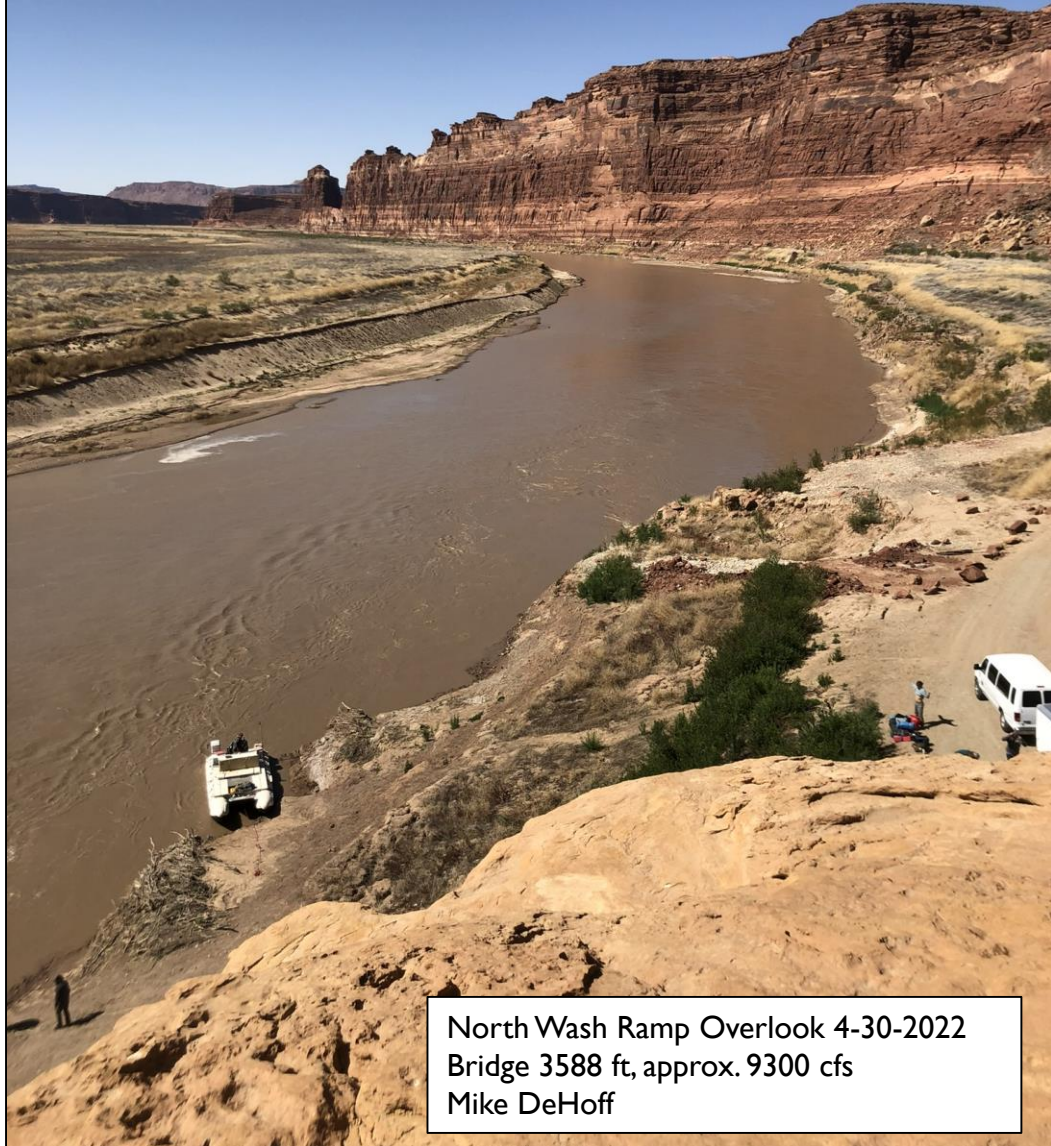
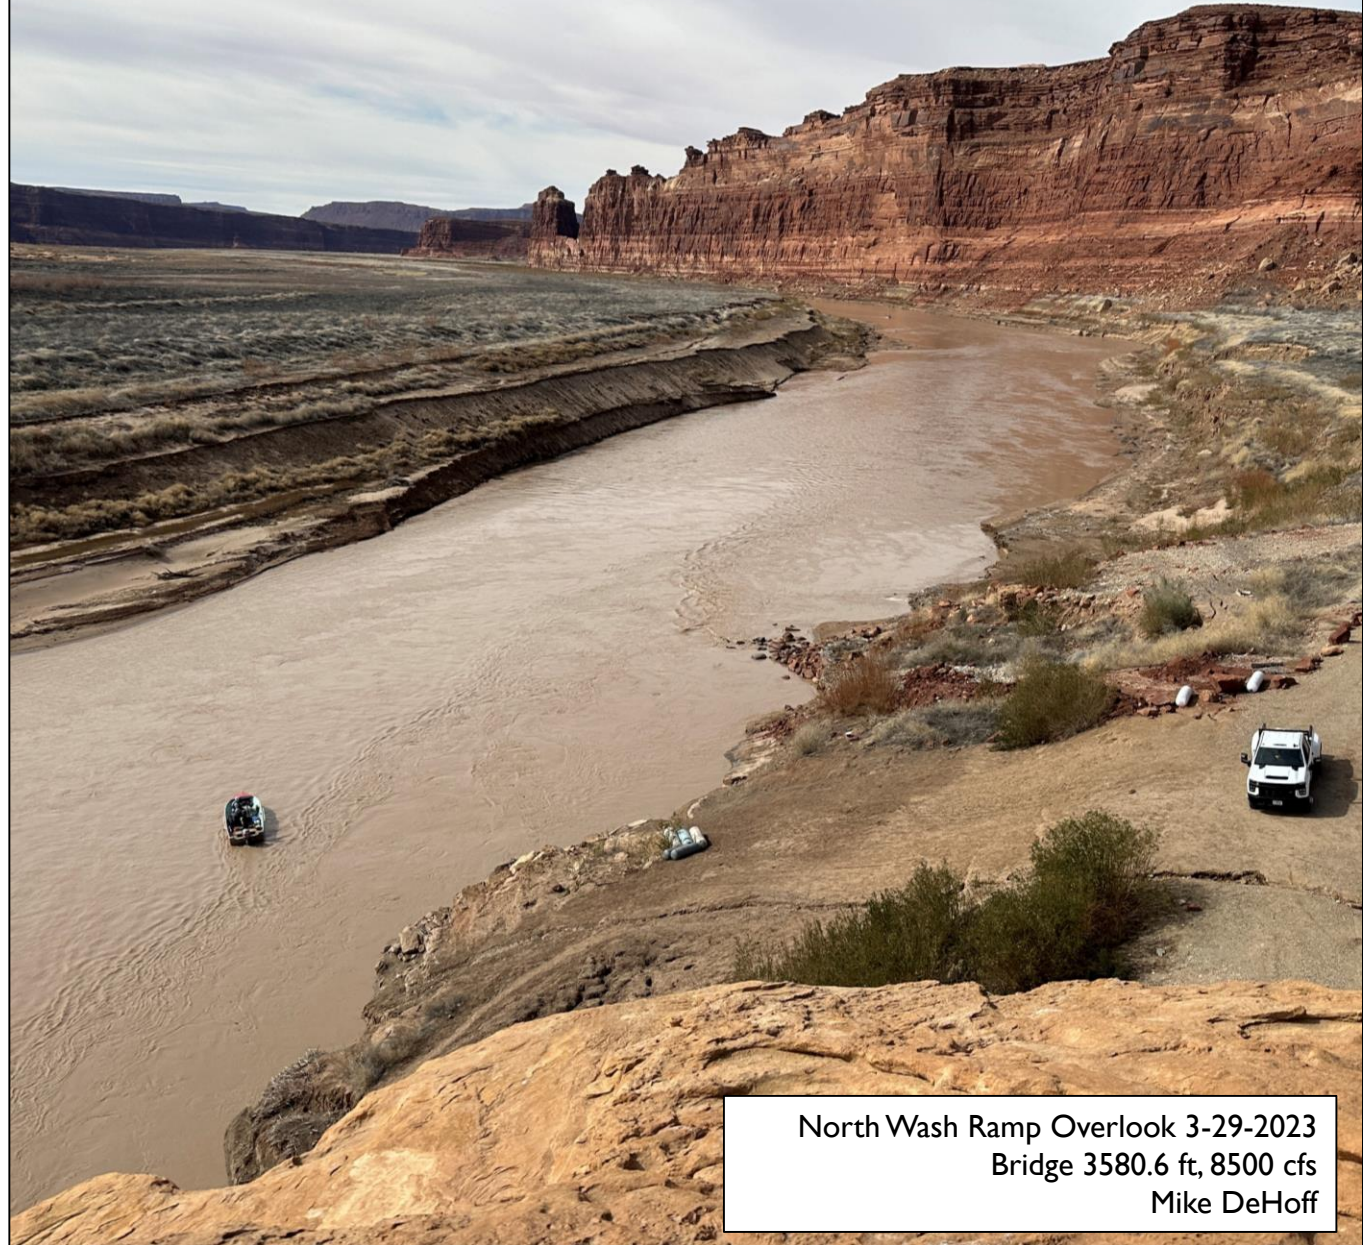
The sediment at the takeout continues to slump away and rock points are showing themselves all over.

As observed in other locations, when bedrock starts to show it supercharges erosion of the mud.

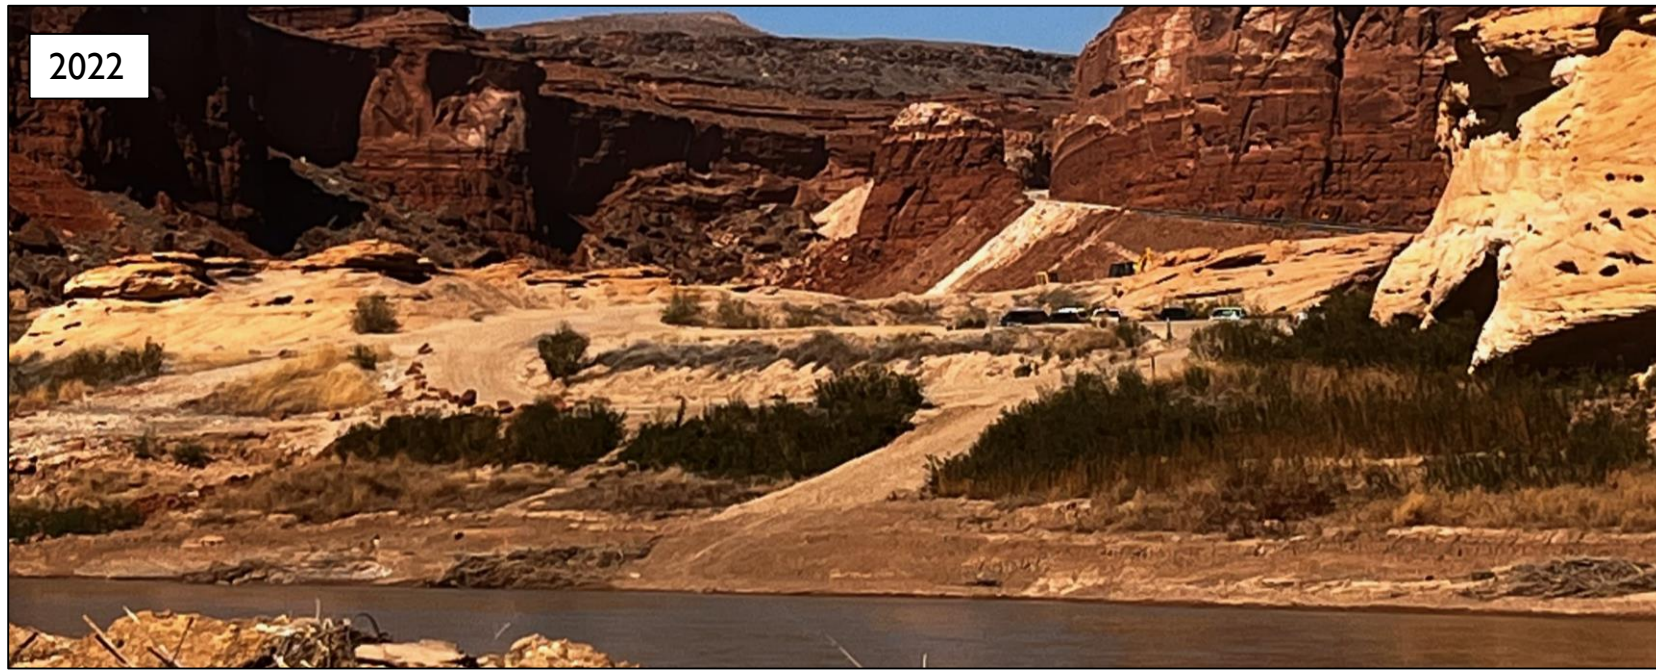
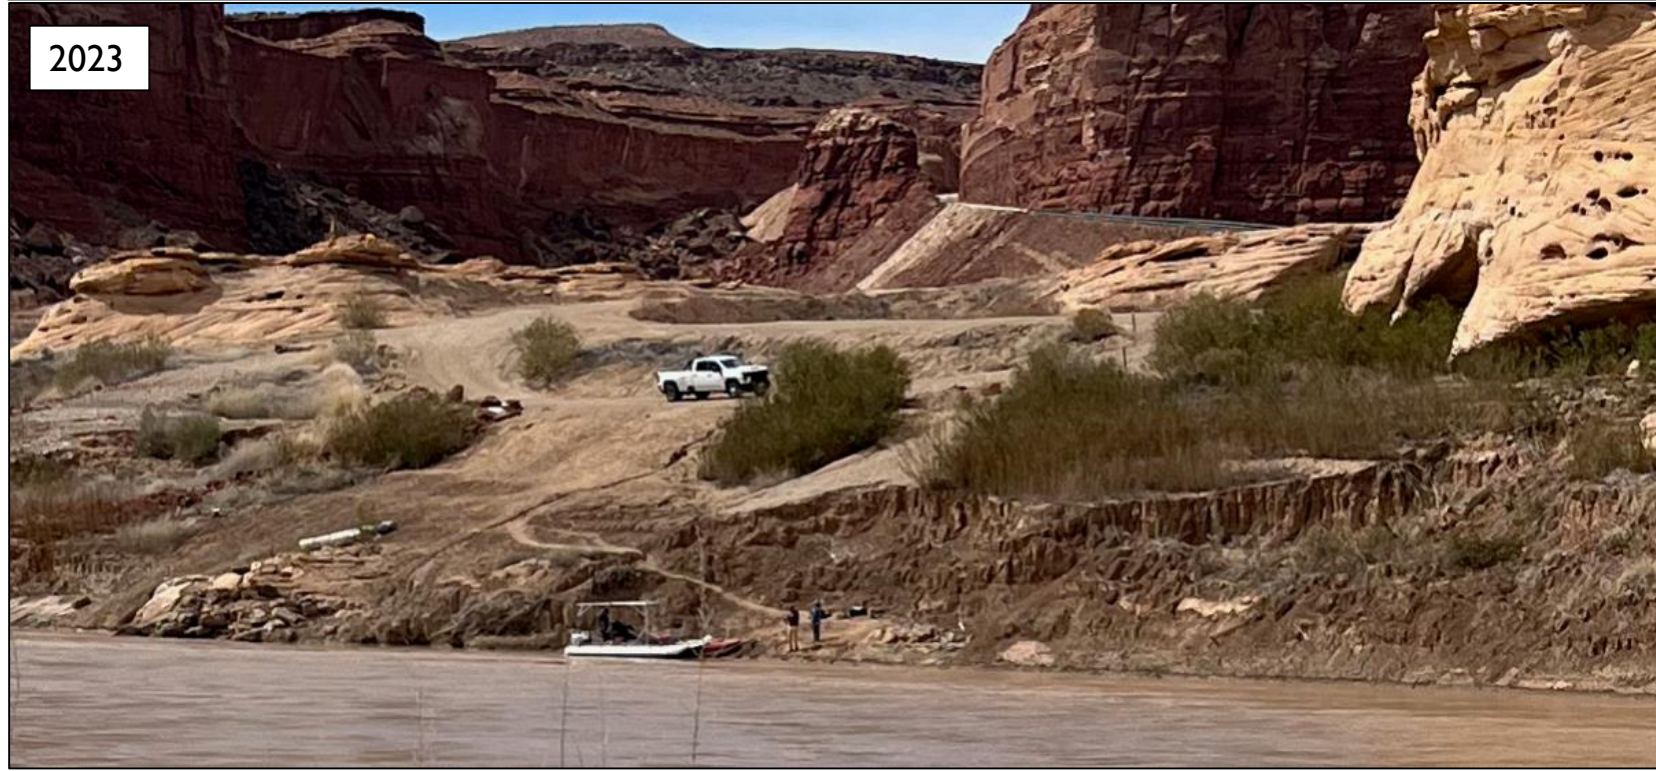
Currently we are observing a rate of change in this area at approximate one foot of downcutting/ carving per month. This rate is astonishing but monthly visits during the spring of 2023 have continued to reinforce this rate.

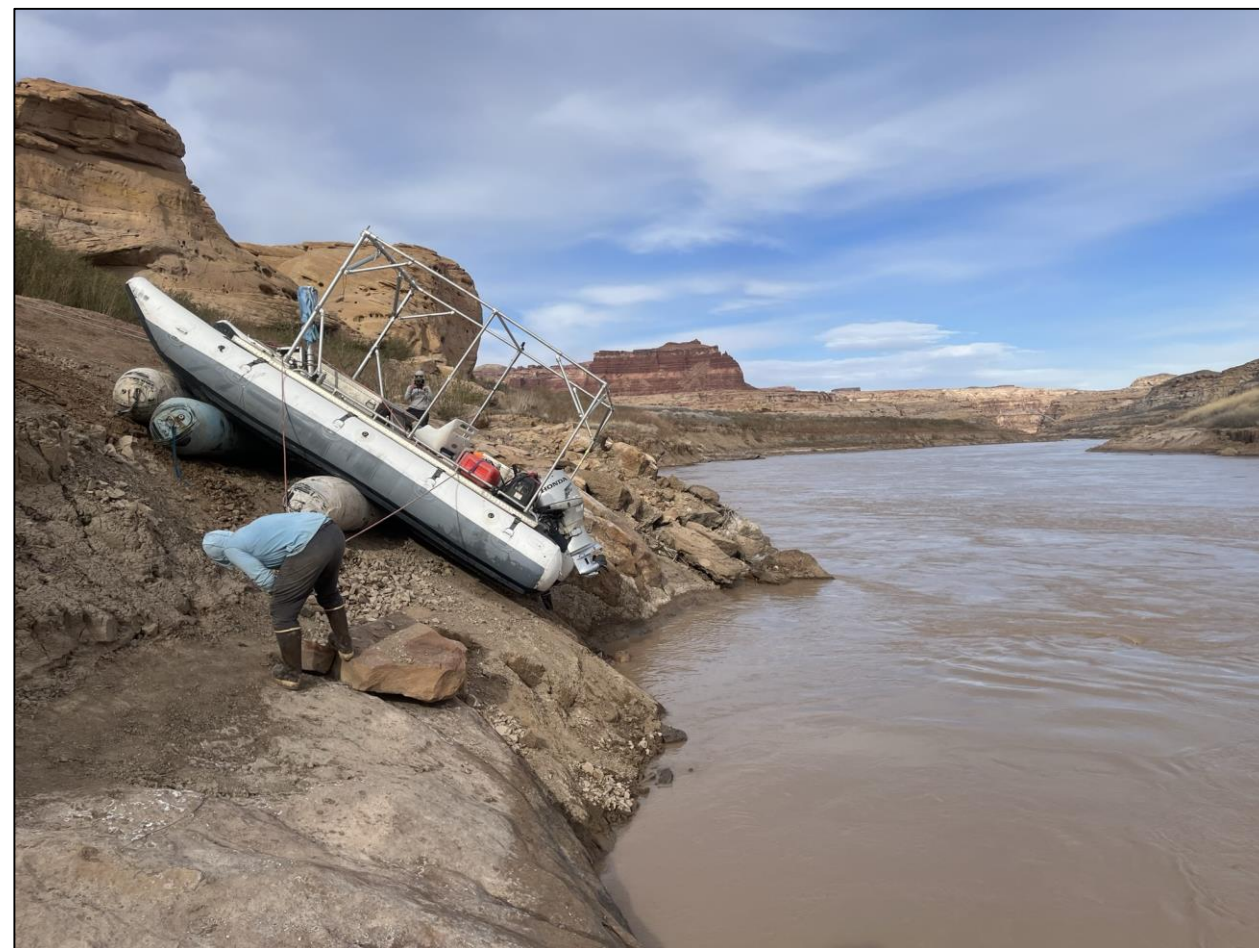
GCMRC snout on tubes coming up the North Wash Ramp
3-29-2023 Peter Lefebvre
Bridge Gauge 3580.6 ft, approx. 8500 cfs

Note the boat got to an angle of 56 degrees at one point coming up the ramp.
