Studies near the Hite Area

Late winter – Early spring 2023

The perched river, a deteriorating boat ramp,
and a wild sedimented wasteland

Returning Rapids

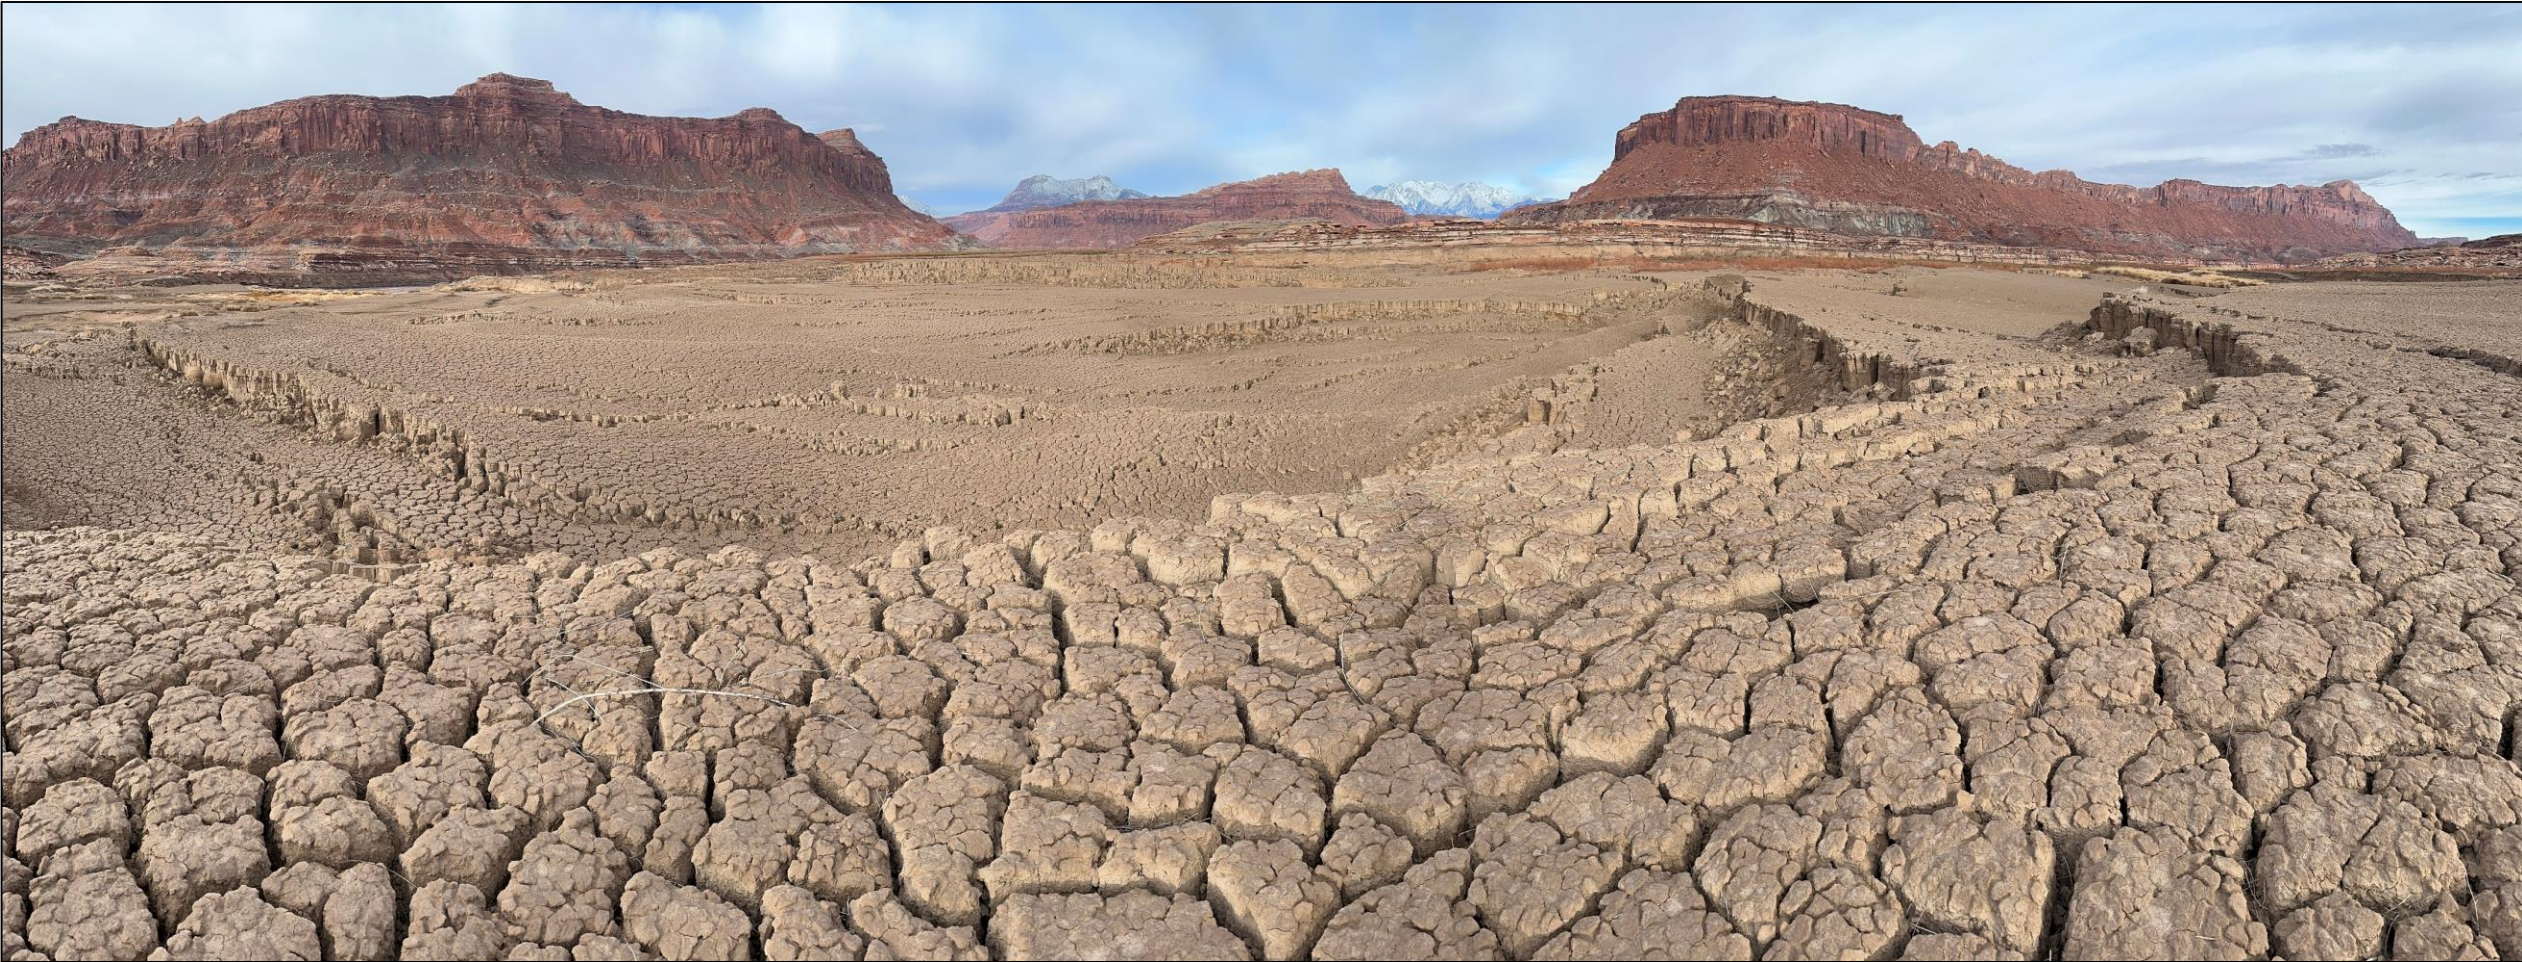
Warping sediment flats near the mouth of White Canyon
3-13-2023
