The 1983 Flood at Glen Canyon

Steve Hannon
Hidden Passage
Volume 2
Summer 1999

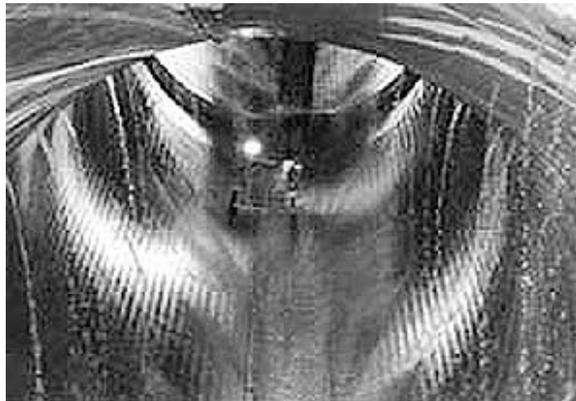
"I Challenge U2", descending left spillway. Air slot is just above cart. Photograph courtesy US Department of Interior, Bureau of Reclamation.

The spillways had only operated for a few days when a slight rumbling and vibration began to be felt in the abutments and the dam itself. Close inspection of the jets emerging from the tunnel portals revealed some debris being ejected in the flow: chunks of concrete, sections of rebar, and, most disturbingly, what looked like pieces of sandstone, arced high above the river. The tunnels had run only briefly at 20,000 cfs and had been throttled back to 10,000 before they were shut down. Since the reservoir was still below the tops of the radial gates, the gates were shut and inspection teams descended into the tunnels in a little cart eased down the 55 degree slopes by a cable. The cart was named the "I Challenge U2."

Right at the curves in both tunnels the three-foot reinforced concrete lining had been eroded away, in a stair-step fashion, and the much softer and porous (20-25% void) Navajo sandstone was exposed. Meanwhile, the reservoir was beginning to rise more quickly as the steady rains and melting snows obeyed the law of gravity. The Bureau had no choice but to reopen the spillways—and increase the flows. The engineers decided to hold the right tunnel somewhat in reserve and pass most of the swelling reservoir down the left tunnel. They were already running as much water as they could through the power turbines and the river outlet works, the former about maxed out at 28,000 cfs and the latter limited to 15,000 due to a design deficiency in its expansion joints. Still the reservoir surface climbed as the rains

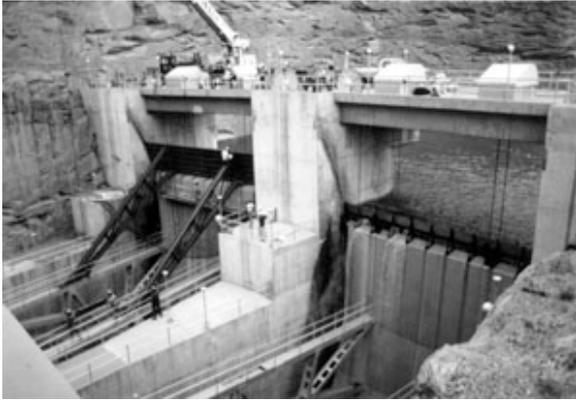
July 7, 1983. Flashboards, Right Spillway; original 4 feet on right, 8 feet on left. Photograph by Tom Fridmann, courtesy US Department of Interior, Bureau of Reclamation.

continued and the snow fields melted. The vibration in the dam and abutments had now become a steady shaking, accompanied by sharp jolts and rumbling sounds. Four-foot-high wooden flashboards were then installed on the tops of the spillway gates—to permit the reservoir to rise higher without having to open the gates further.

In a demonstration of astonishing bureaucratic efficiency, the Bureau designed, built, and attached eight-foot steel flashboards to the tops of the gates in just a few days. Still the reservoir crept toward the crests of the new boards as the rains continued without relief and the snows disappeared with the rain. By the time the left tunnel was running at 32,000 its discharge was turning the whole river below the dam a distinct amber color. Navajo sandstone was being excavated from within the dam abutment like soil before a placer miner’s hydraulic nozzle. Down in the employee dining room, located at the base of the dam adjacent to the left abutment, a worker later said that it sounded like the artillery barrages he had experienced in Viet Nam. Everyone was “pretty nervous and on edge” he said.

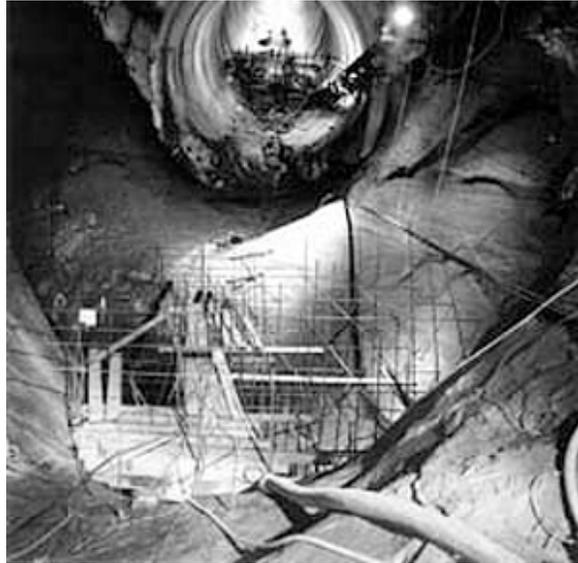
September 21, 1983. Left spillway; view upstream across "Big Hole". Photograph by Tom Fridmann, courtesy US Department of Interior, Bureau of Reclamation.

The total discharge from Glen Canyon peaked at 92,000 cfs and the reservoir topped out on July 15, lapping less than a foot below the tops of the steel flashboards and only six feet below the crest of the dam. Inspection of the left tunnel revealed a hole carved into the sandstone at the tunnel plug nearly 50 feet deep and 135 feet long. A ten by fifteen foot boulder was found halfway down the tunnel beyond the hole. The right tunnel had similar but less severe damage. One-inch rebar had been pulled out of the concrete like bones from a cooked fish.

A year after the flood, the Bureau firmly declared that the "cavitation" that had started the damage, that soon turned into rapidly increasing mechanical erosion, had been dealt with. After the damage was repaired (2,300 cubic yards of concrete), the fix consisted of cutting an annular slot, four feet by four feet, around three-quarters of the bore in each tunnel, located halfway down the inclined section. The cavitation had started because there was no air in the water. Minute vacuum bubbles downstream of bumps and ridges in the tunnel linings had imploded, starting the cavitation that, in turn, led to cratering. Air will now be entrained in the flow as it goes over the slot and this will provide a "cushion" to prevent cavitation from starting. Okay, but what if the tunnels have to run so full that much of the air will be cut off? That cannot happen, say the keepers of the dam.
