MITIGATION, MONITORING, AND GEOMORPHOLOGY
RELATED TO GULLY EROSION OF CULTURAL SITES
IN GRAND CANYON

Joel L. Pederson¹, Paul A. Petersen^{1,2}, William W. Macfarlane²,
Mark F. Gonzales³, Keith Kohl³

November 2003

Report in fulfillment of cooperative agreement 01WRAG0074 and modifications
between Utah State University and the U.S. Geological Survey,
Grand Canyon Monitoring and Research Center

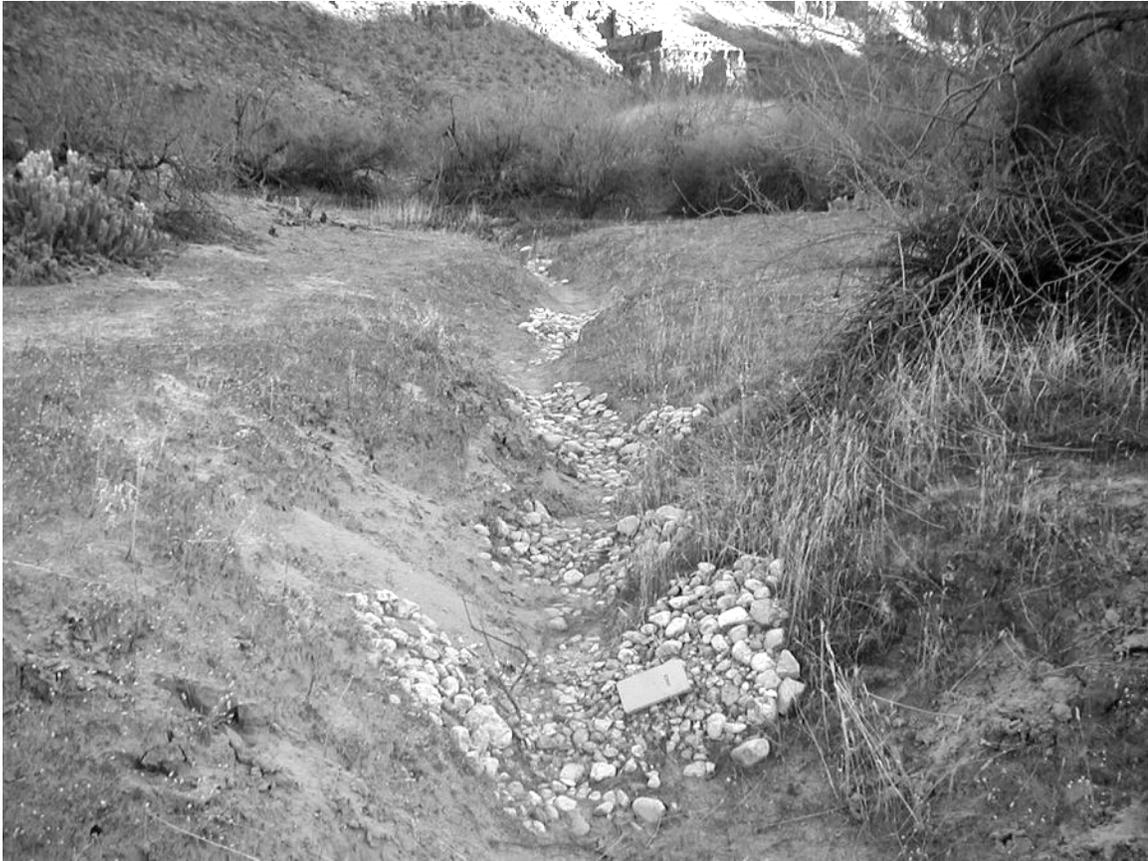
Figure 1.2. Rock lining erosion-control structures typical of treatments in Grand Canyon.

Some of the erosion-control structures in Grand Canyon are wood or stone checkdams, but the majority are low-profile rock linings. Many of these rock linings were originally constructed as larger rock and rock-and-brush checkdams, but were reduced by maintenance to the linings in order to prevent future breaching (Dierker et al., 2002). These rock linings serve to armor the channel and increase roughness, hopefully preventing loss of channel and bank material. Fischenich (2001) noted that such armoring can cause local scour where flow is constricted and of higher velocity between clasts. Also, the effects of armoring are not expected to influence the area beyond the structure itself. Unfortunately, little evaluation of rock linings in gullies has been performed, since brush and stone checkdams are more common, especially in larger gullies and arroyos.

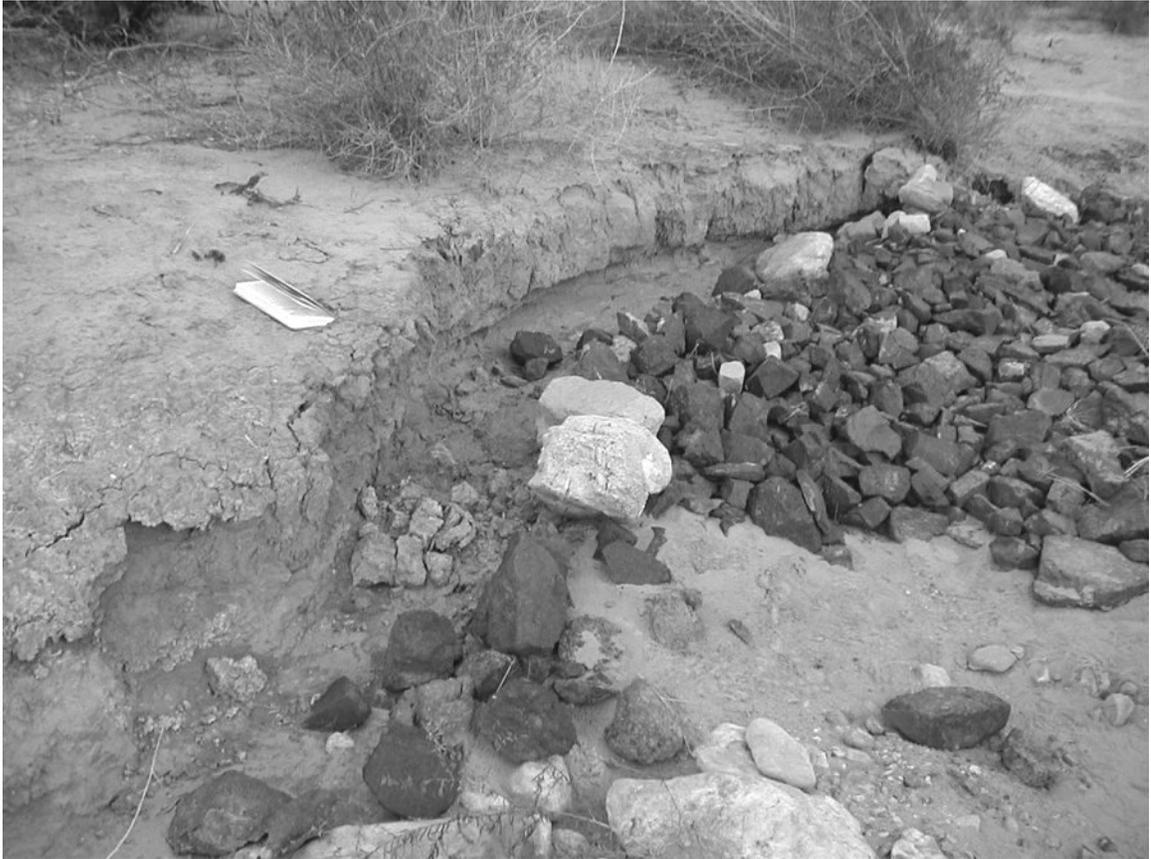
Figure 1.3. Example of a flanked rock lining at Palisades site.

Of the 116 erosion-control structures assessed, 51 (45%) were damaged by erosion at the time of the second data collection in October of 2002. Based on all sites but Palisades (incomplete data), 23% of these damaged structures were intact at the beginning of the research in February of 2002 (Appendix D). Most of those that were already damaged at the beginning of this research underwent further erosion during the study. Of the damaged erosion-control structures, 47% were flanked (eroded at its side; Fig. 1.3), 22% were breached (damaged in the middle; Fig. 1.4), and 31% were both flanked and breached.

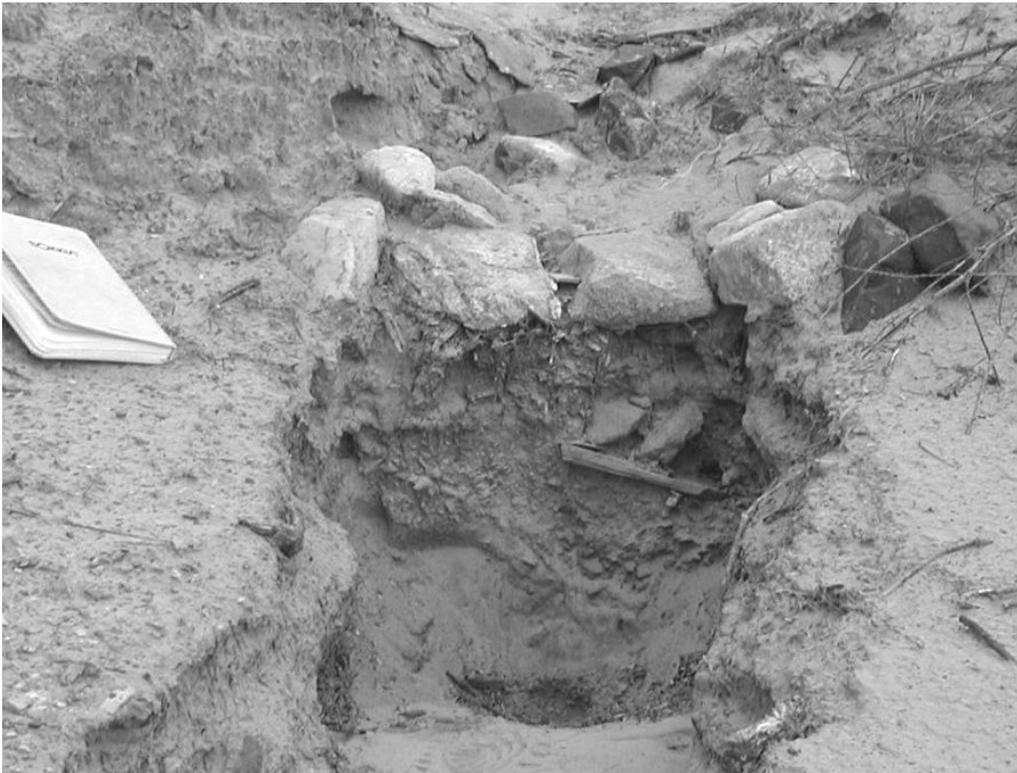
Figure 1.4. Rock lining at Basalt Cliffs sites undercut by knickpoint and close to being fully breached. A) February, at the start of research; B) October, at end of study period.

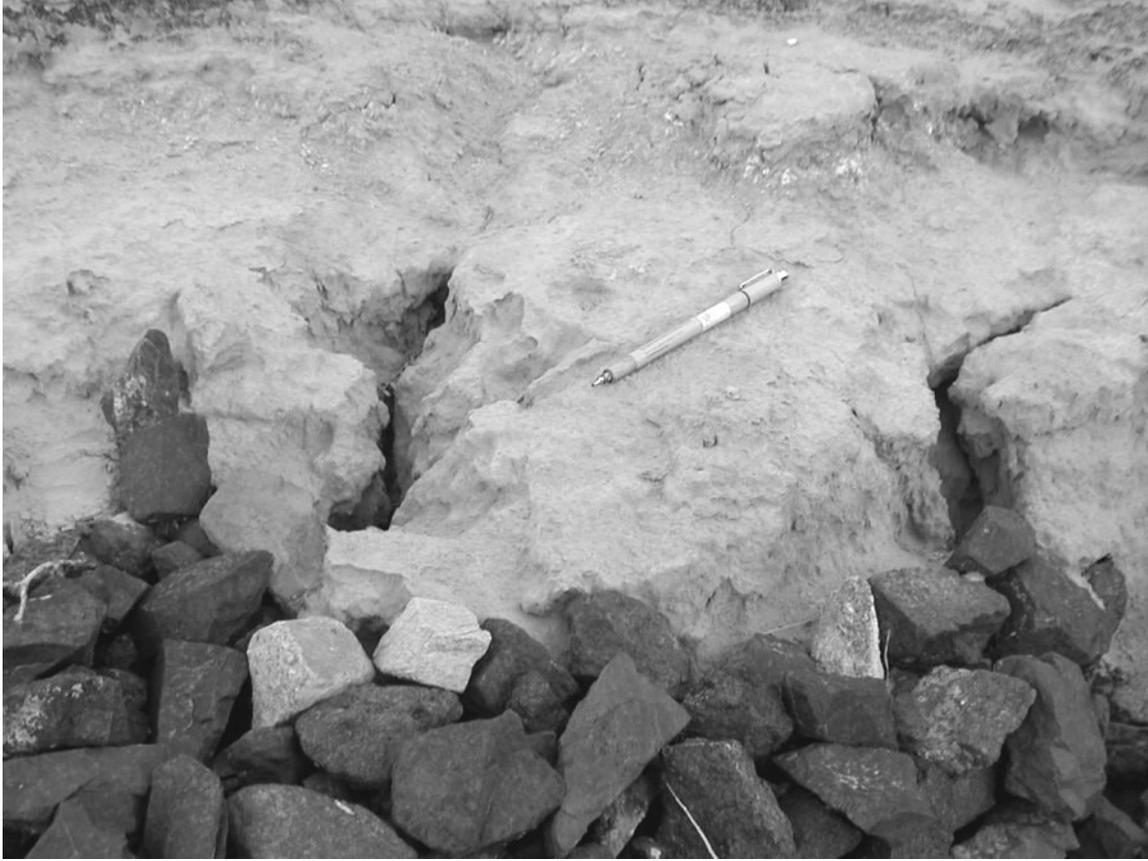
Figure 1.5. Piping along channel side with rock lining at Palisades.

The majority of this erosion and damage is interpreted as caused by infiltration-excess overland flow discharging through gully channels. Piping caused measurable headcutting and channel widening over the study period at only the Palisades study site, where it undermined structures and caused bank collapse (Fig. 1.5). A salt pan comprising much of the upper catchment of the Palisades gully system generates high runoff due to its unusually low infiltration capacity (Appendix E), and also encourages piping due to its sodium-rich (dispersive), silty sediment and the macroporosity provided by its desiccation-cracked surface (Appendix B).

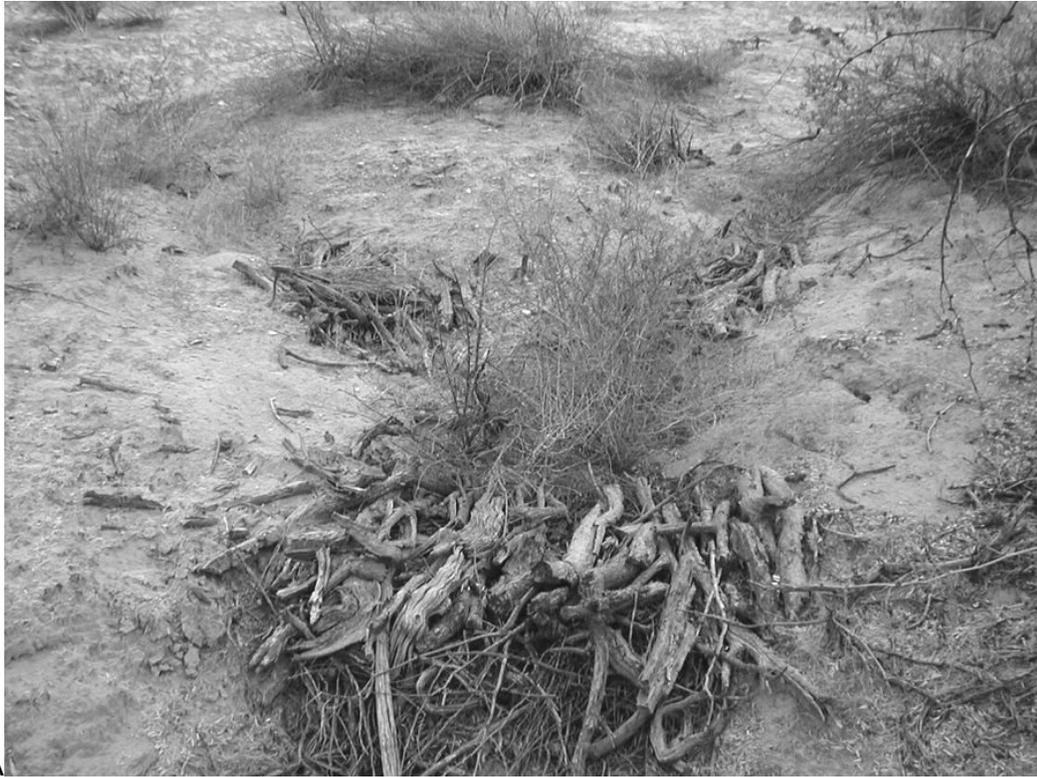
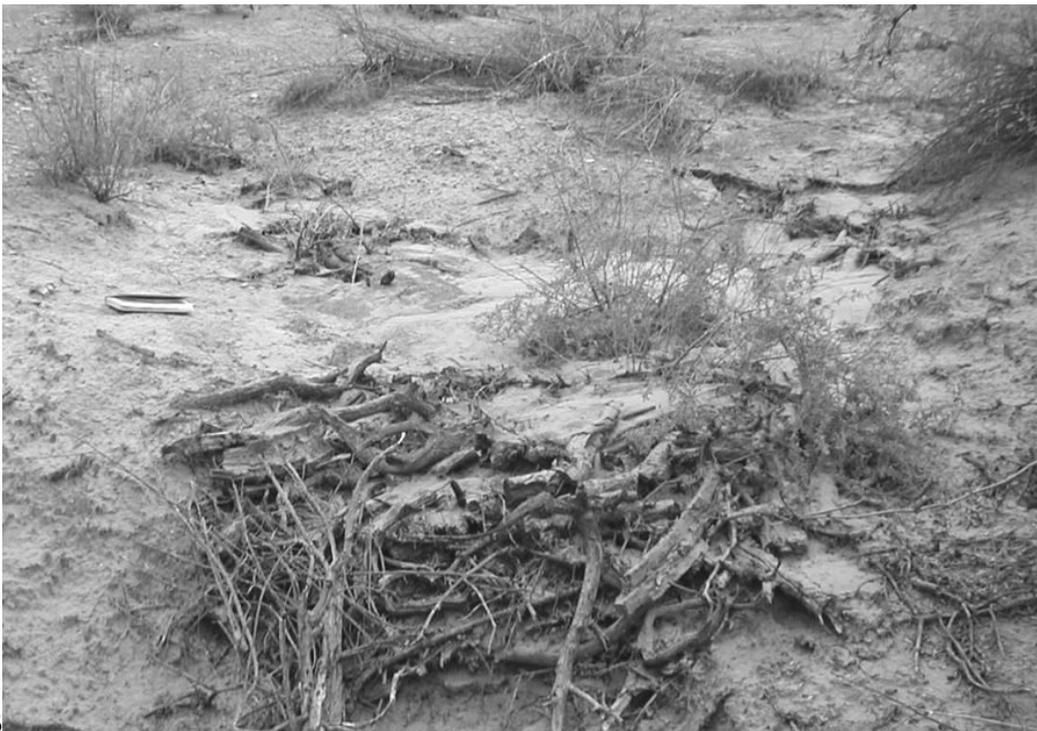
Figure 1.14. Repeat photographs of brush checkdams at the Basalt Cliffs site. A) February, 2002; B) October, 2002, filled in with sediment. Notebook for scale.

All four gullies at the Basalt Cliffs site have similar gradients and drainage areas, but differ in erosion treatment. Brush checkdams at the Basalt Cliffs site were relatively effective at staying intact and in trapping sediment (Figs. 1.12C,D and see Fig. 1.14). The benefits of these structures are localized, however, and most denudation was associated with knickpoints formed between and downstream of the checkdams, especially rock linings. The rock linings that remained intact were successful to a lesser degree in stabilizing the channel (Figs. 1.12A,B), but were not associated with deposition as much as the brush checkdams were (Fig. 1.12C,D). Like the 60-mile and Palisades sites, the treated parts of the Basalt Cliffs gullies fared better than the untreated segments. For example, a gully with only one checkdam aggraded an average of 3 cm upstream of the structure, but eroded an average of 4 cm on the untreated reach downstream of the dam (Fig. 1.12D).

The Basalt Cliffs site has five erosion-control structures made of woody debris along with stone structures and untreated areas, all in a setting with uniform geomorphic characteristics, which allows for comparison of treatment types. Brush dams fared better than the neighboring rock linings in terms of both damage and erosion control. Repeat observations indicated that all of the brush structures stayed intact and were not associated with local scour (Fig. 1.14). Over half of the rock structures in similar gullies at the same site were destroyed by runoff during the study period (Appendix D). Logically, the more-uniform permeability of brush checkdams slow flow but still let water through without concentrating it, causing deposition and creating a more resilient dam. Our initial observations indicate that, unlike a stone structure, brush structures that are damaged tend to stay somewhat intact or remain effective roughness elements after washing some distance down the channel.

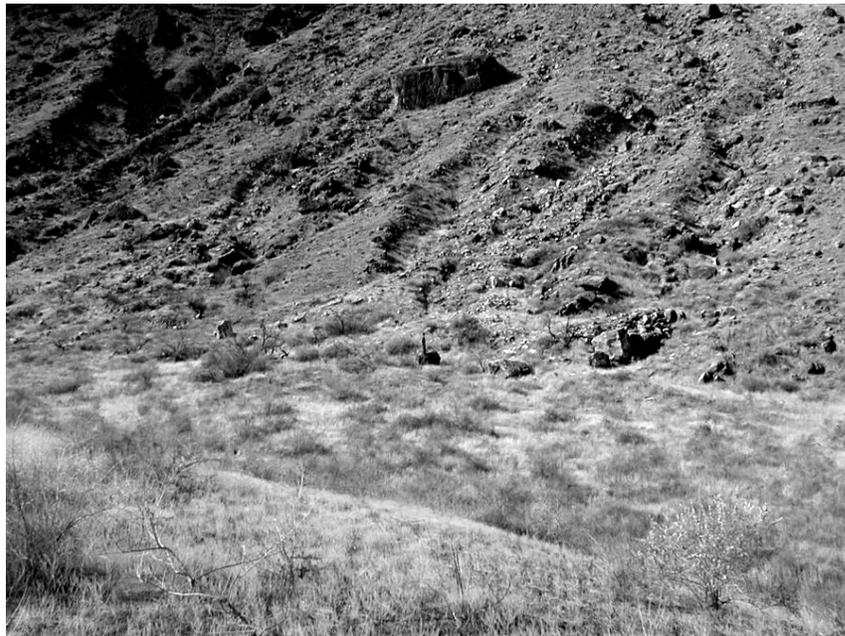
Kwagunt serves as an erosion-control site; there is no active gully erosion endangering archaeological features. There are two very small gully channels, neither of which features any knickpoints. The catchment is very small (~0.03 ha) and the channel gradients are ~12%. Both channels appear to be old and inactive, and are probably experiencing infilling. The northern channel experienced runoff during the study period, but did not show signs of channel incision or widening. The upper catchment faces the northeast and is set in talus boulders derived from Redwall limestone, Muav limestone, and Bright Angel shale. The small gully features exist at the toe of the talus, where there is still relatively steep gradient, and drains within the ap terrace. A major trail trends parallel to the hillslope near the site. The archaeological site itself lies between the talus toe and a large foredune to the east. All dunes and eolian activity exist to the east of the study site. Vegetation is dominated by cryptobiotic crust, grass and forbs, brittle brush, salt brush, and mesquite. The abundance of grass and forbs and organic detritus relative to other sites is notable.

Figure B.1. Overview of Kwagunt site. Photograph taken on dune, facing southwest. Person standing on boulder for scale.

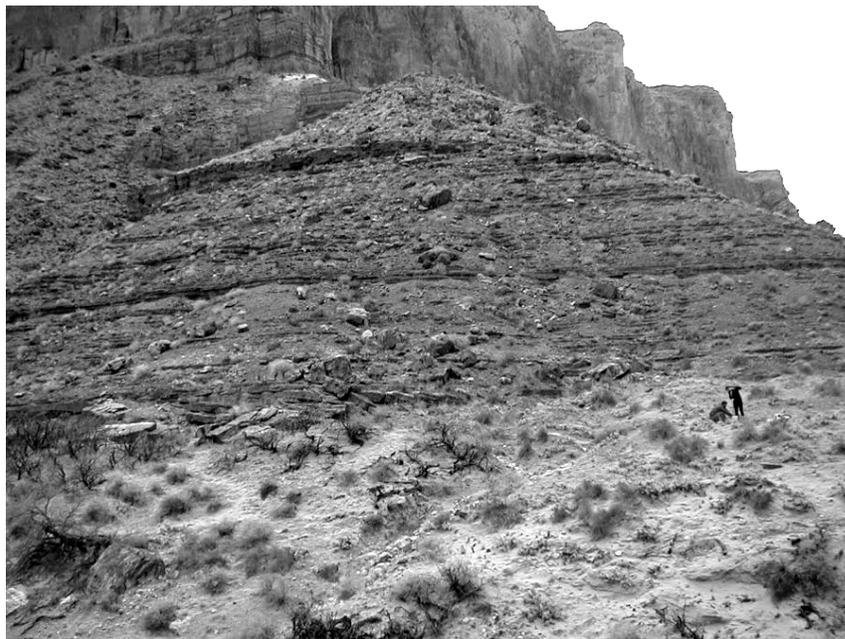
The 60-mile site features one active gully with four notable tributary branches; archaeological sites are endangered and are actively being destroyed. The catchment is small (0.12 ha) and the main gully drops nearly 11 m over the length of 46 m (24% slope). All of the gully channels feature many abrupt, steep knickpoints, and most contain stone erosion-control structures. Channels widened and incised during the summer of 2002, and the east-most tributary is entirely new. The upper catchment is south-facing and is composed of Bright Angel shale bedrock. The gullies begin in the bedrock, and incise through a dune-dominated ap terrace, and drain to a tributary to the Colorado River. The site has experienced trailing on the dune near the gullies, but this path is becoming less visible due to Park Service efforts. Eolian activity is high and the site is very sensitive to impacts due to its dune setting. Vegetation is dominated by cryptobiotic crust, grass and forbs, mesquite, cholla, prickly pear, saltbrush, and fedra. Raindrop erosion and crusts are readily visible. Infiltration-excess overland flow dominates the runoff regime, creating knickpoints and plunge-pools.

Figure B.2. Overview of 60-mile catchment. Photo taken facing north. Main gully trends through lower middle portion of photo.

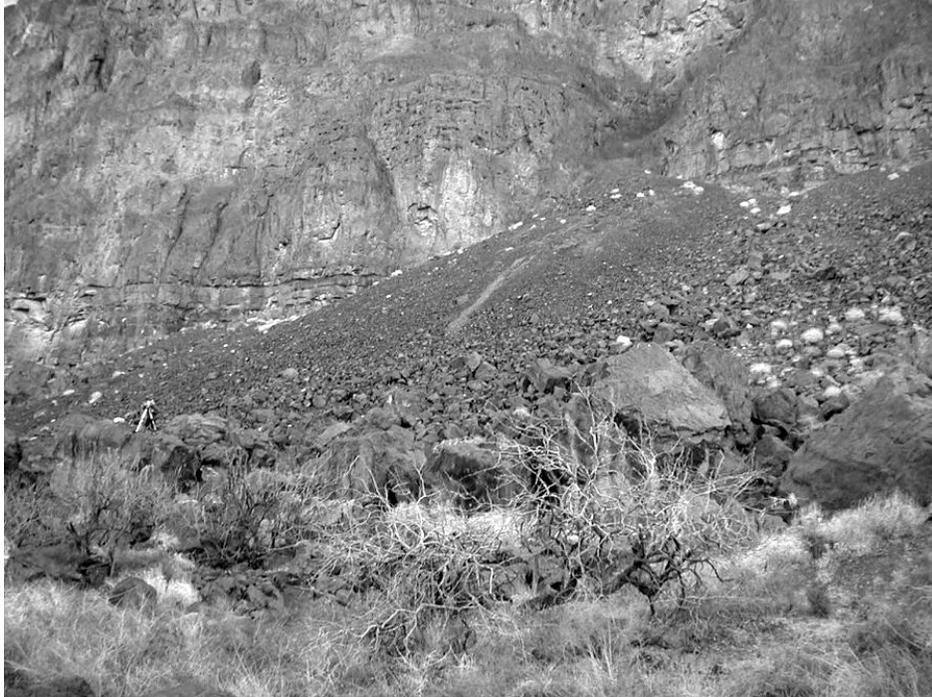
Figure B.3. Talus upper catchment

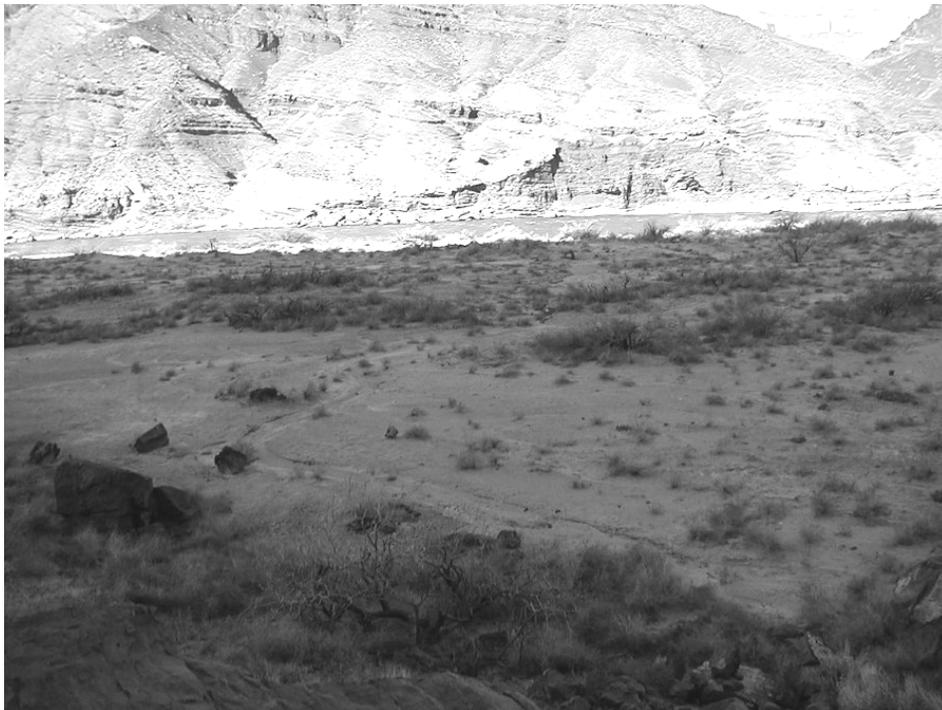
The Palisades site features two very large active gullies, each with a high density of tributaries; archaeological sites are endangered and are actively being destroyed. The catchments are large (~2 ha) and the two gullies drop 5 and 7 m over the length of 185 and 180 m (4 and 5% slope), respectively. All of the gully channels feature many abrupt, steep knickpoints, and most contain stone erosion-control structures. Channels widened and incised during the summer of 2002. The upper catchment faces the west and is composed of Dox sandstone and Cardenas basalt bedrock and talus. The middle catchment consists of a virtually impermeable, flat, cracked, salt-crustured "playa." The gullies begin in this playa area, and incise through an expansive mainstem alluvial ap terrace, draining in or near the Colorado River. The site has experienced trailing on both upper and lower sections. Eolian activity is present. Vegetation is dominated by cryptobiotic crust, grass and forbs, mesquite, prickly pear, saltbrush, and arrowweed. Salt crusts are prevalent on the upper gully reaches. Piping causes substantial channel initiation, widening, and headward retreat in the upper reaches, and bank caving caused by lateral scour promotes further channel widening. Pipe collapse into small tributary rills is common in the upper reaches. Drainage density decreases in the lower reaches, as the influence of piping diminishes, sediment is more permeable, and vegetation increases. Overall the site can be divided into three gully reaches: 1) upper: unvegetated playa catchment with high drainage density; 2) middle: piping zone with moderate vegetation and hard soil crust; 3) lower: relatively vegetated incised zone with eolian influence.

Figure B.4. Overview of entire site, looking west from talus slope. Playa in foreground.

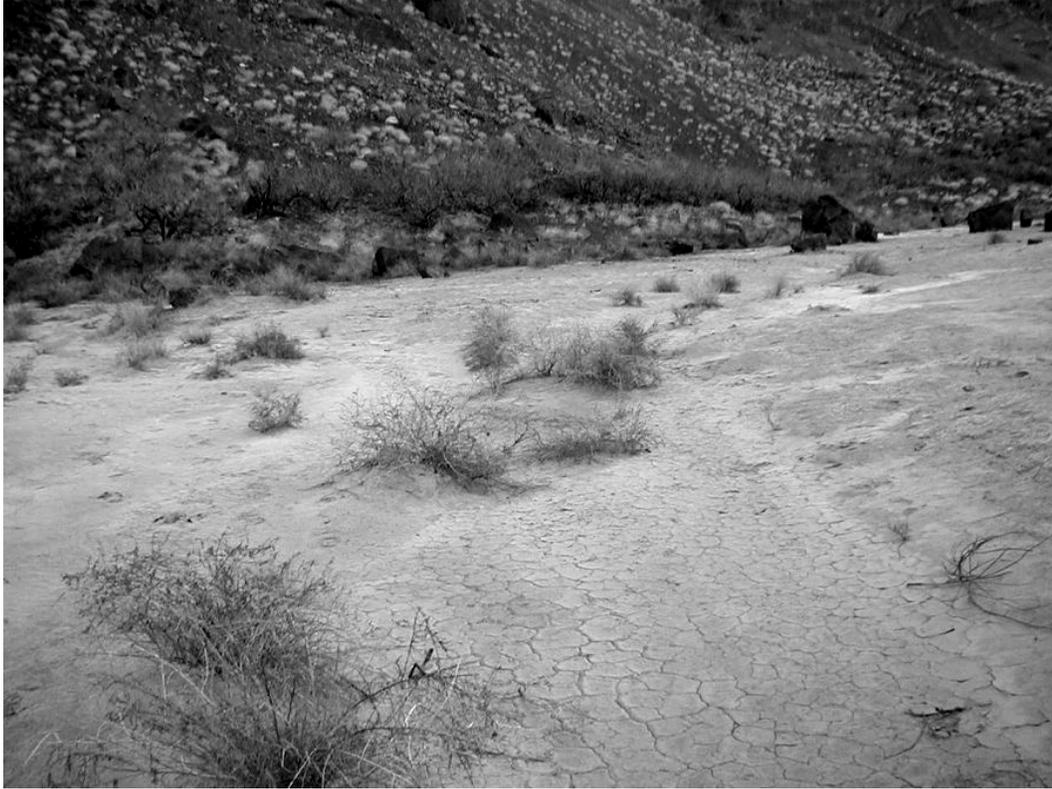
Figure B.5. Playa. Note mudcracks and sparse vegetation.

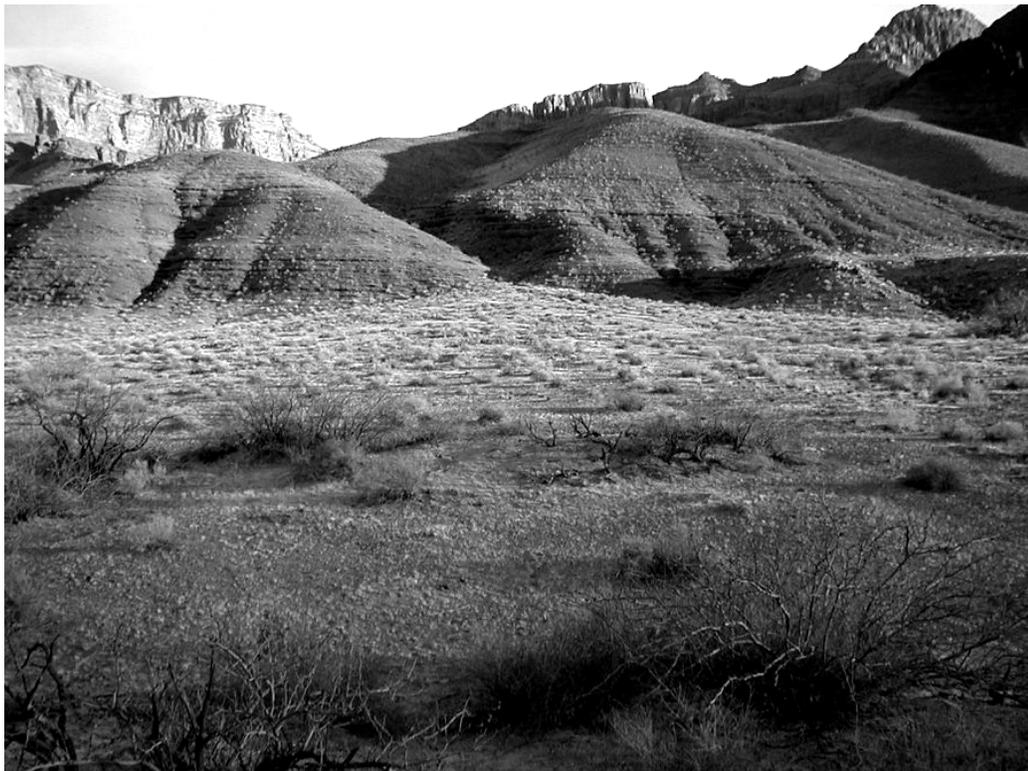
Figure B.6. Alluvial fan catchment. Photo taken facing south.

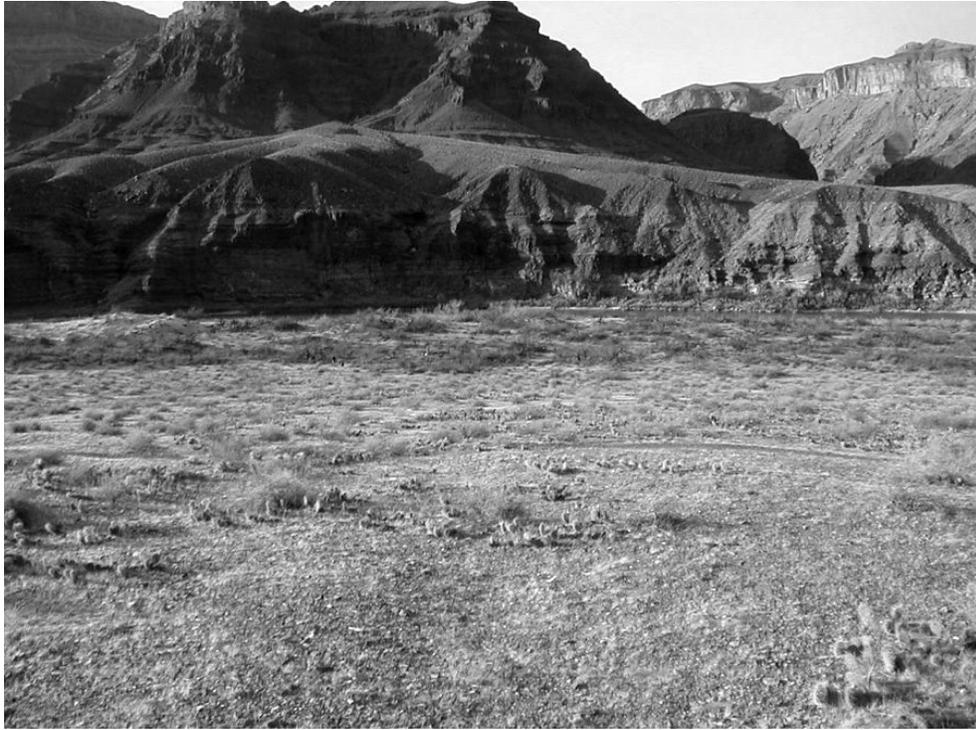
Figure B.7. North-facing view from mid-fan.

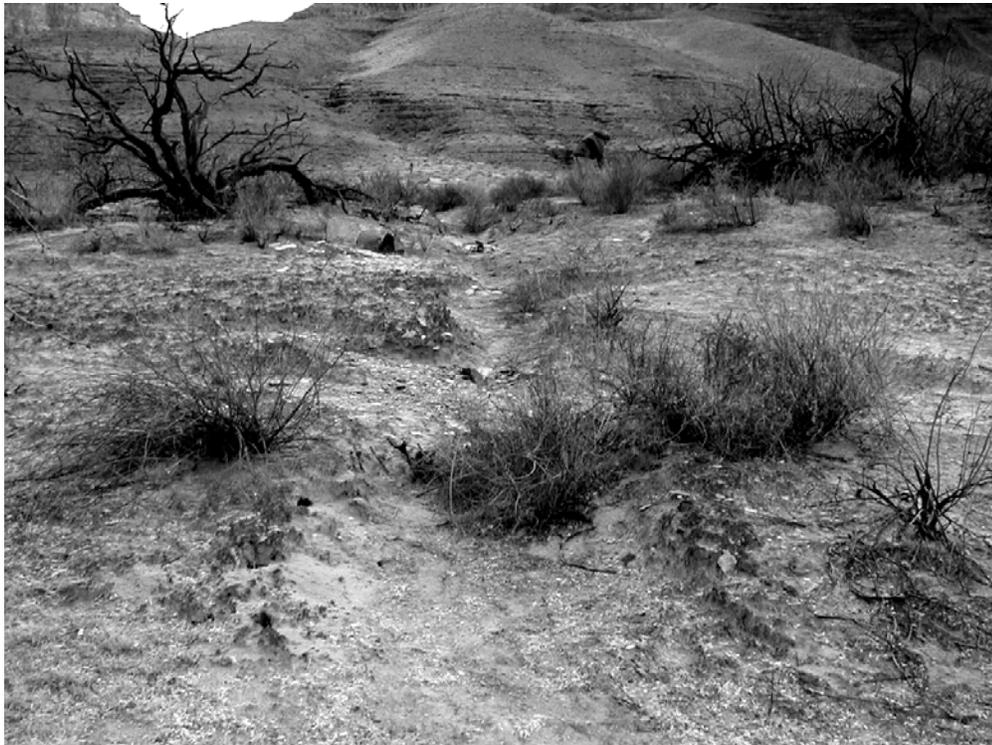
Figure B.8. Gully incising through toe of fan. Photographer standing at baselevel.
Parashant

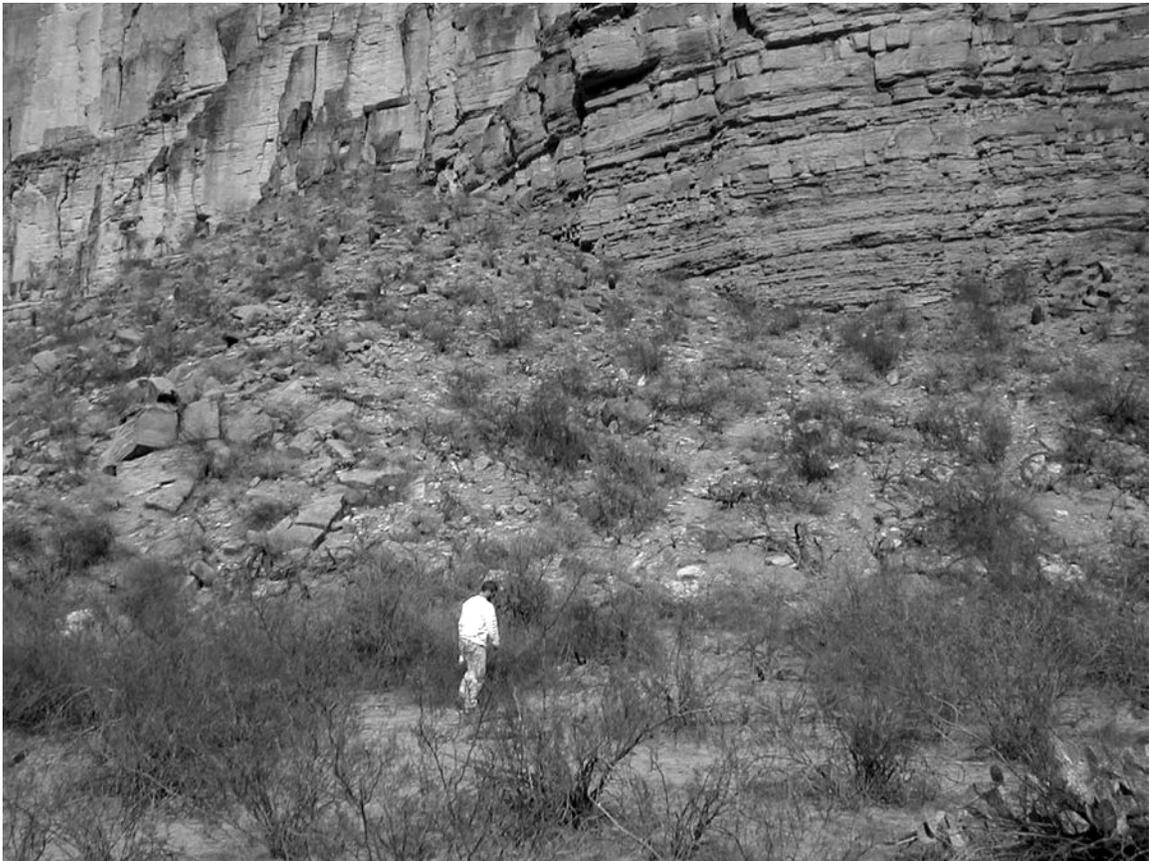
Figure B.9. Talus catchment, Muav source. Photo taken facing northeast.

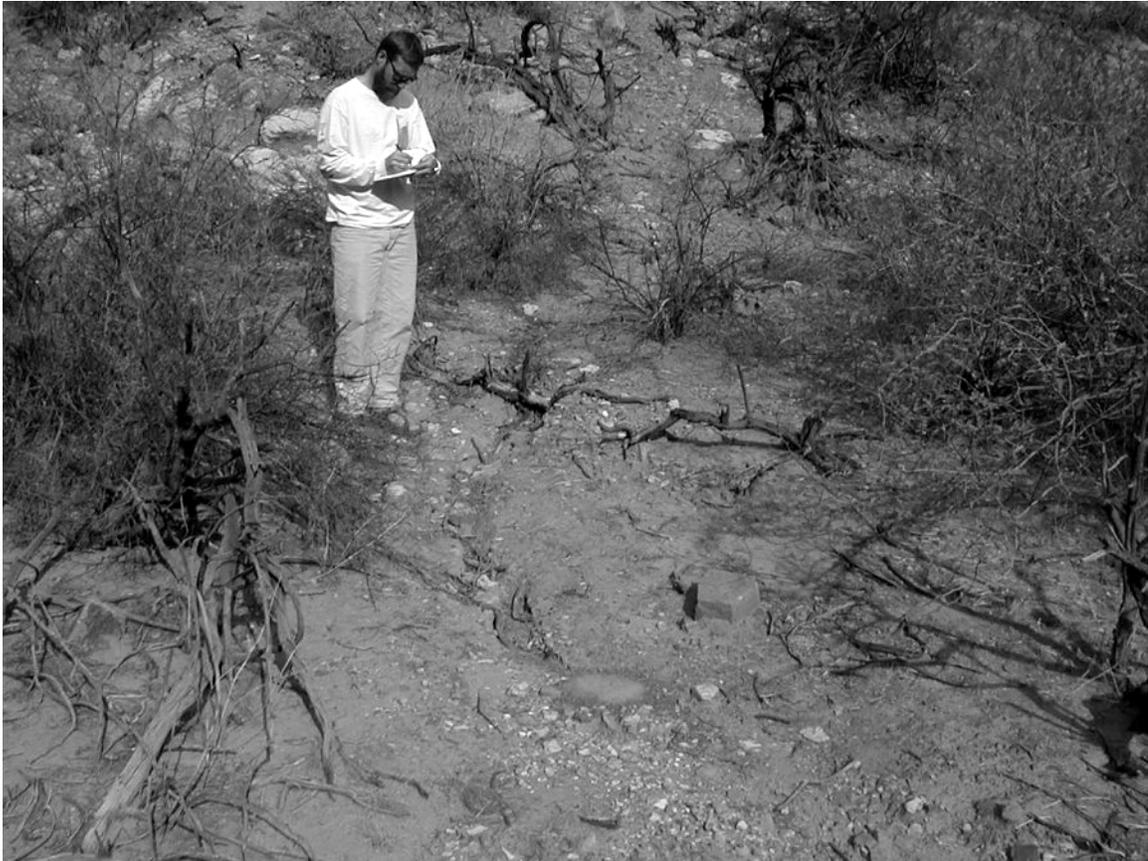
Figure B.10. Small gully. Knickpoint exists near root across channel.

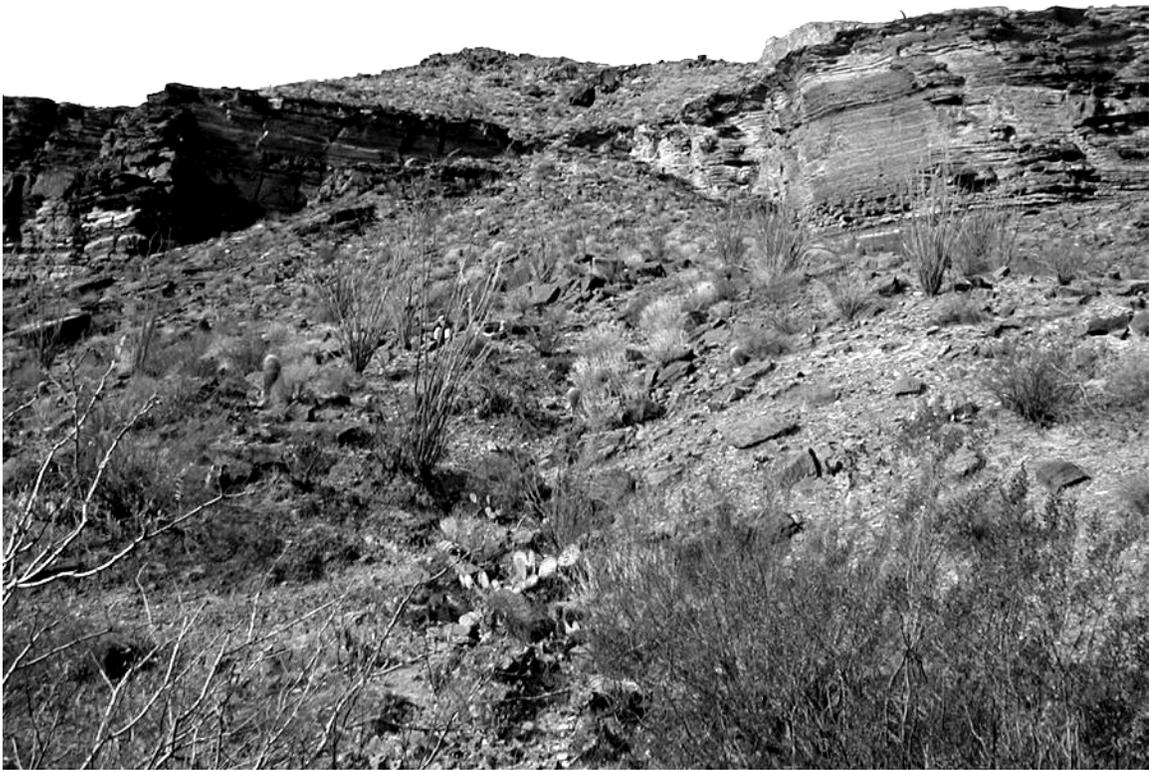
Figure B.11. Talus upper catchment. Photo taken facing west.

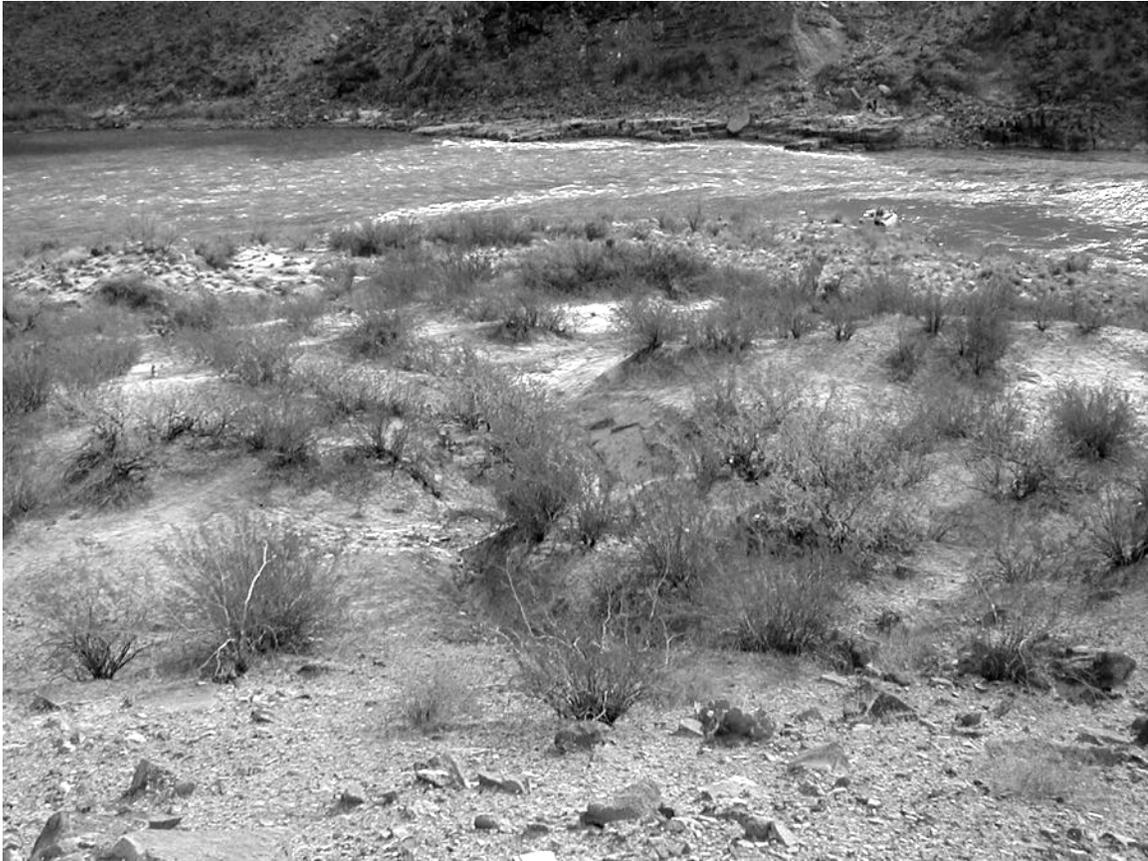
The Indian Canyon site features one large active gully, along with several small, rill-like tributaries and small, discontinuous gullies; archaeological sites are actively being destroyed. The catchment is medium-sized (~0.05 ha) and the main gully drops 26 m over the length of 140 m (19% slope). The gully channel has many abrupt, steep knickpoints, and contains several failed stone erosion-control structures. The channel widened and incised slightly in the upper reach during the summer of 2002. The upper catchment faces the east and consists of talus derived from Bright Angel shale and Muav limestone. The gully begins in the lower talus, incises deeply immediately upon entering the softer, coppice dune-dominated ap terrace, especially through two steep terrace risers, and becomes discontinuous near the bottom before it terminates on 1983 flood sand near the river. The site experiences little visitation, but study impacts and trampling were

Figure B.12. View of site from talus slope. Gully is in middle of photo.

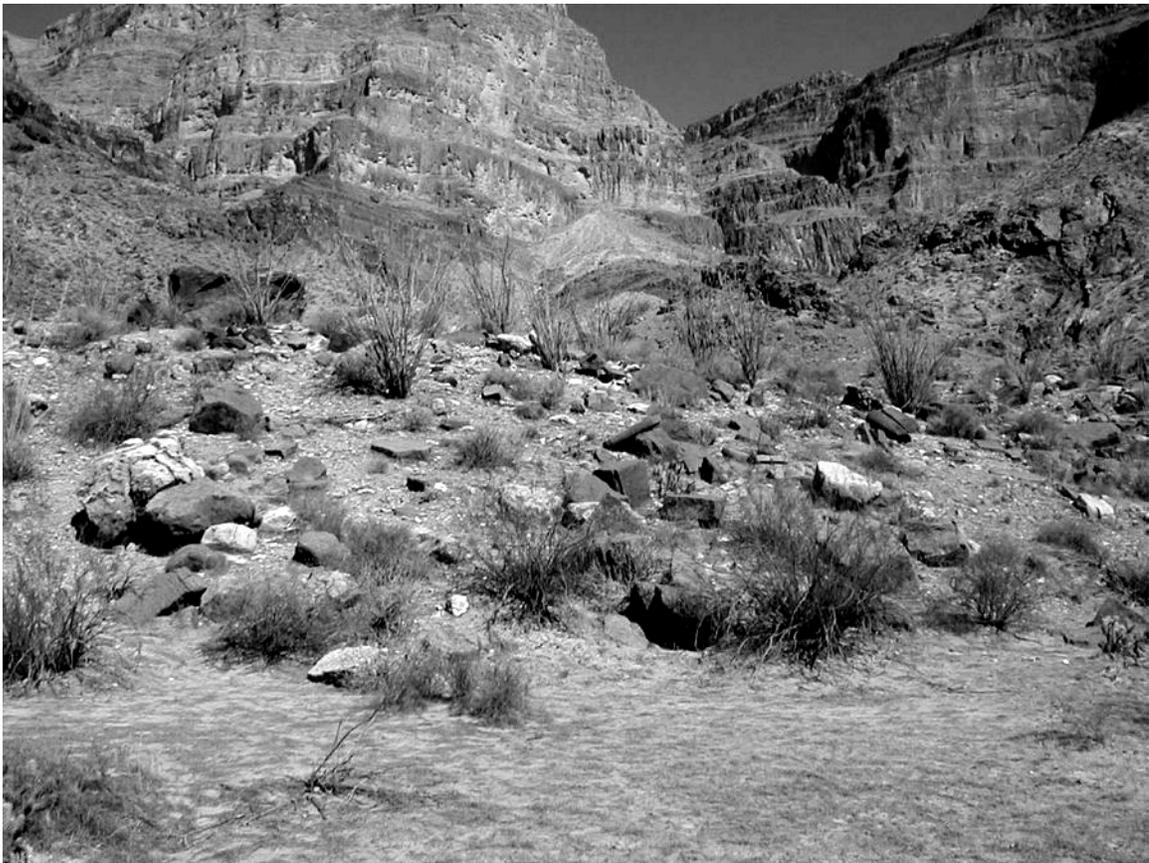
Figure B.13. Quaternary debris flow upper catchment, with ap terrace top in foreground. Photo facing the northeast.

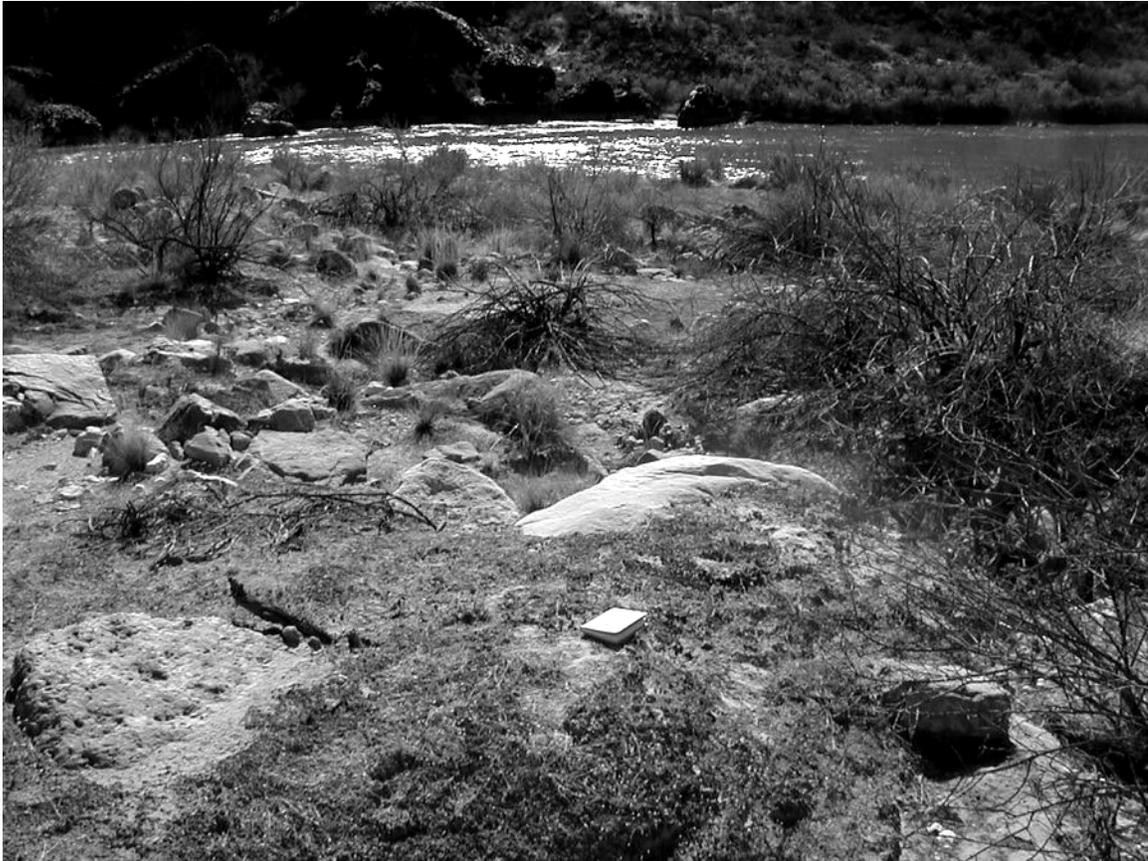
Figure B.14. Modern debris-flow deposit to which large main gully (right foreground) drains.

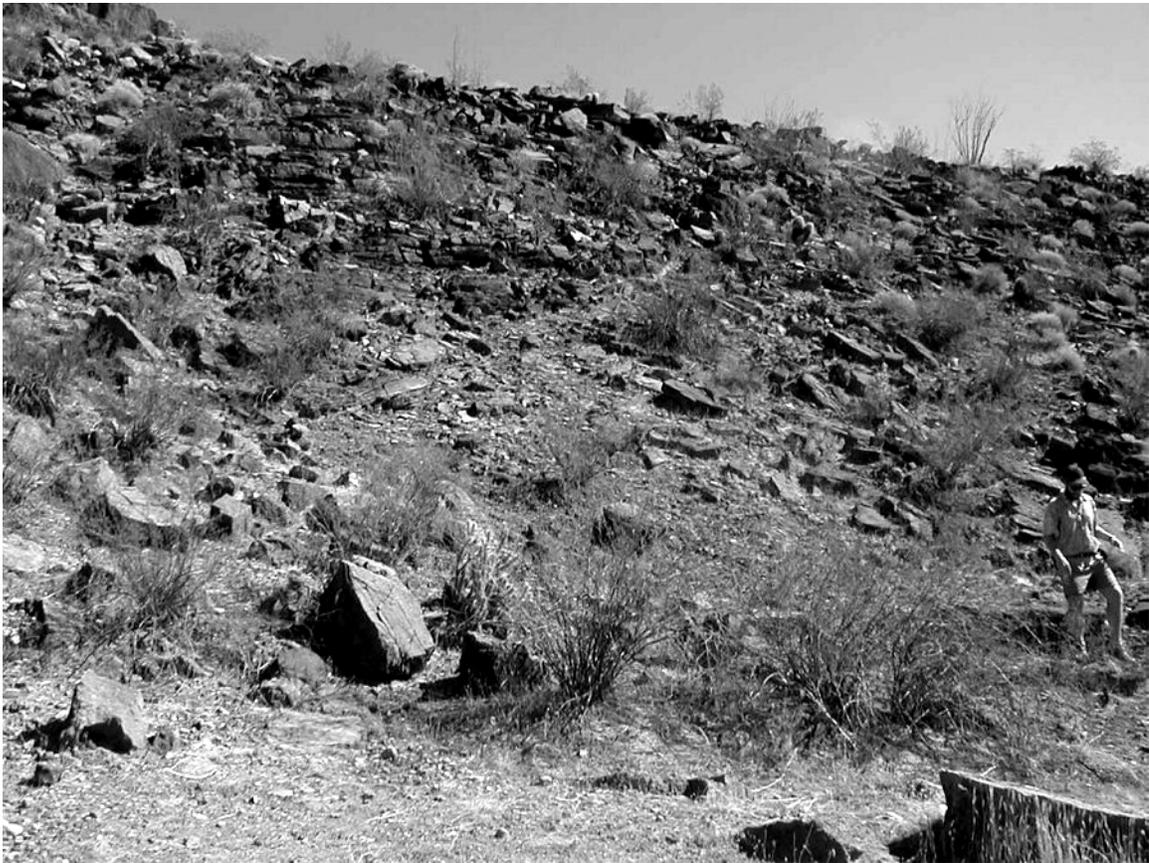
Figure B.15. Upper catchment: talus and bedrock. Photo taken facing east.

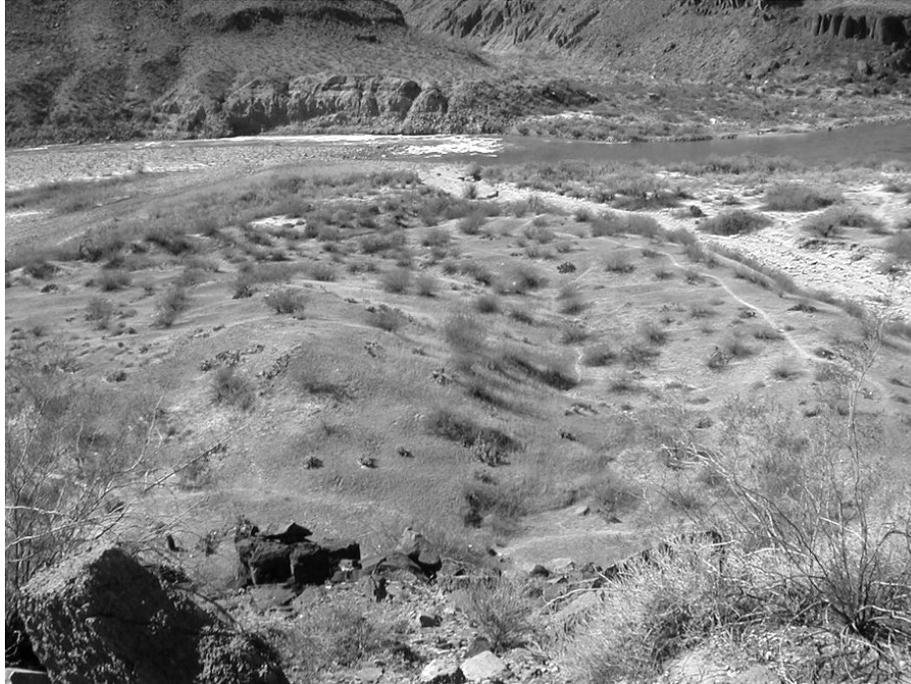
The north-facing slope is dominated by grass and shrubs and has no erosional features, while the south-facing slope features only cryptobiotic crust, sparse shrubs, and bare ground, and has several small, erosive tributaries draining to the main gully. The gully dissipates at the boundary between the ap terrace and a bouldery modern tributary debris-flow deposit, about 100 m from the mainstem Colorado River. The site has experienced trailing on the far-east side, perpendicular to the gully head, and on the crest of the south-facing hillslope, parallel to the main gully. Dunes are present throughout the ap terrace, and an eolian mantle lies over the most of the terrace. Vegetation is dominated by cryptobiotic crust, grass, creosote, brittle brush, prickly pear, barrel cactus, ocotillo, and some mesquite. Piping plays a small role on the crusted, south-facing hillslope of the catchment, but overland flow dominates as the main process.

Figure B.16. View of entire site from talus/bedrock slope. Note vegetated N-facing slope (on left) and bare S-facing slope (right). Trails trend both perpendicular and parallel to gully.

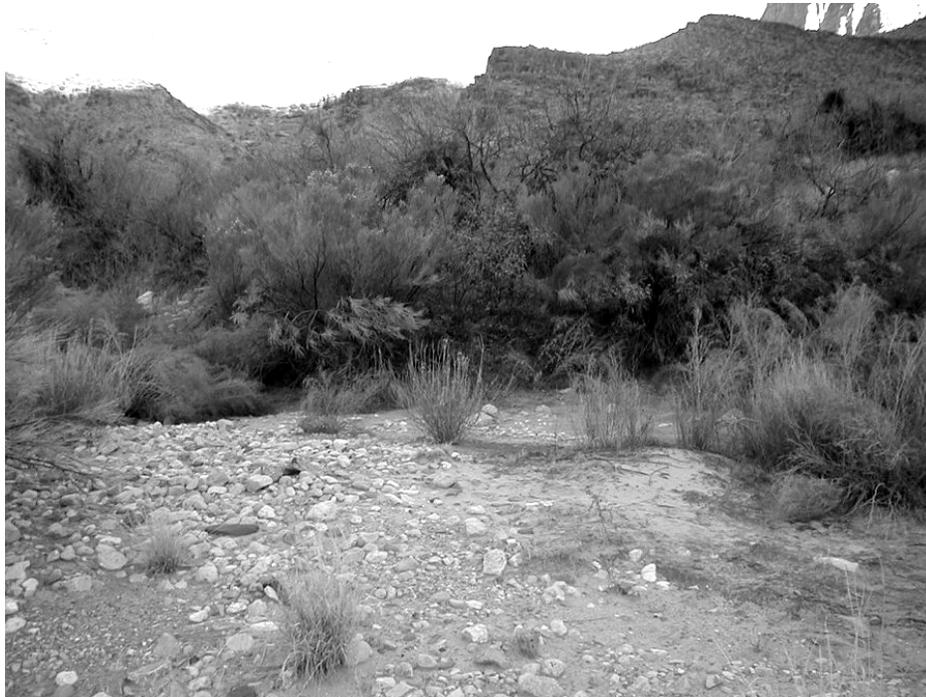
Figure B.17. Thick vegetation where gully terminates. Photo taken from debris-flow deposit, facing east (upcatchment).

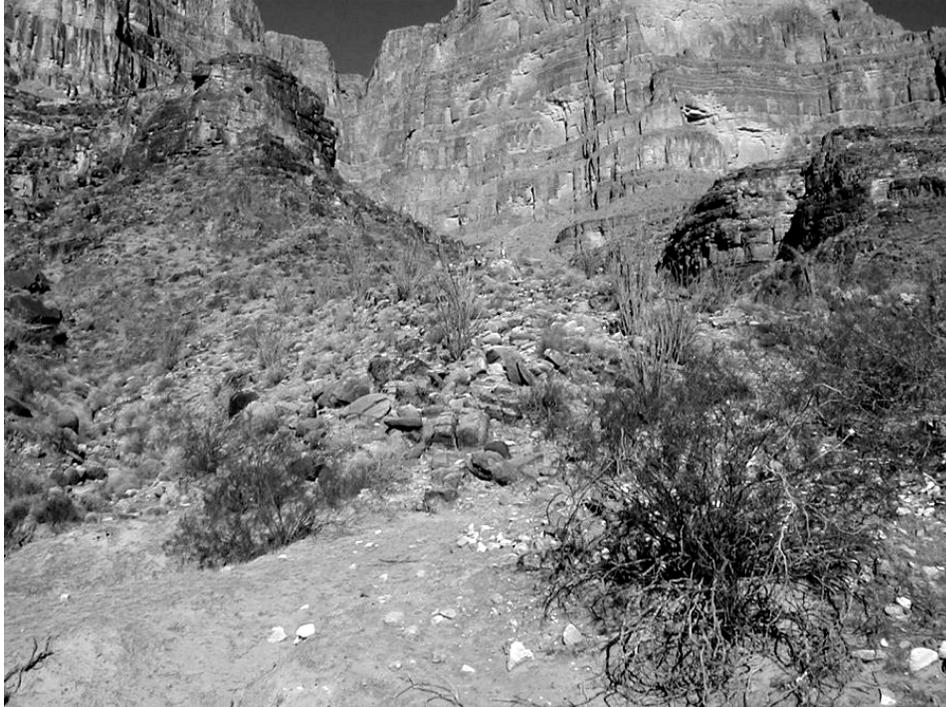
Figure B.18. Debris-flow upper catchment for western gullies. Photo taken facing north.
