MITIGATION, MONITORING, AND GEOMORPHOLOGY
RELATED TO GULLY EROSION OF CULTURAL SITES
IN GRAND CANYON

Joel L. Pederson¹, Paul A. Petersen^{1,2}, William W. Macfarlane²,
Mark F. Gonzales³, Keith Kohl³

November 2003

Report in fulfillment of cooperative agreement 01WRAG0074 and modifications
between Utah State University and the U.S. Geological Survey,
Grand Canyon Monitoring and Research Center

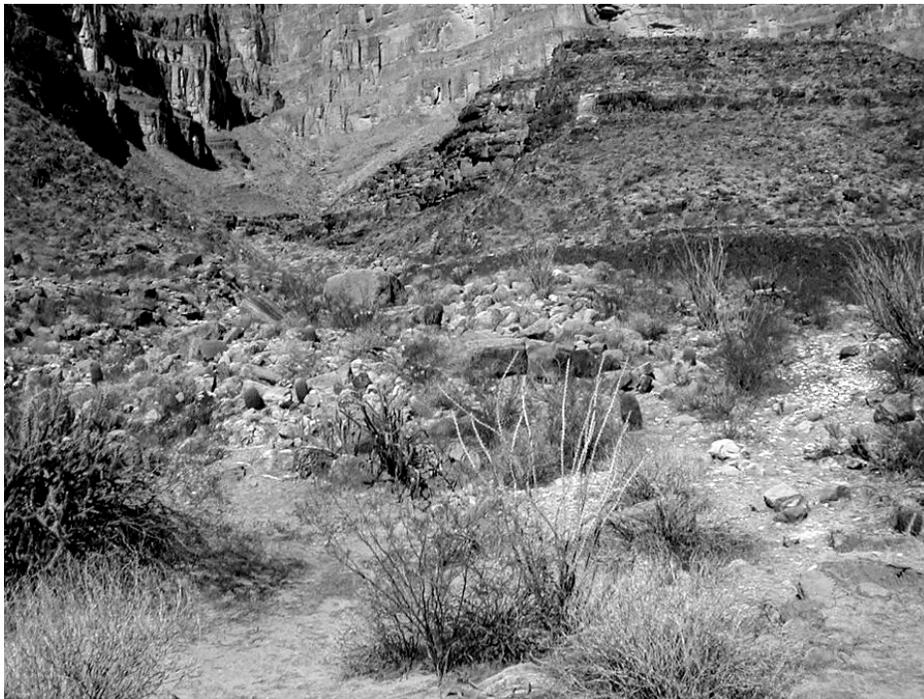
Figure B.19. Debris-flow upper catchment for east-most gully. Photo taken facing north.

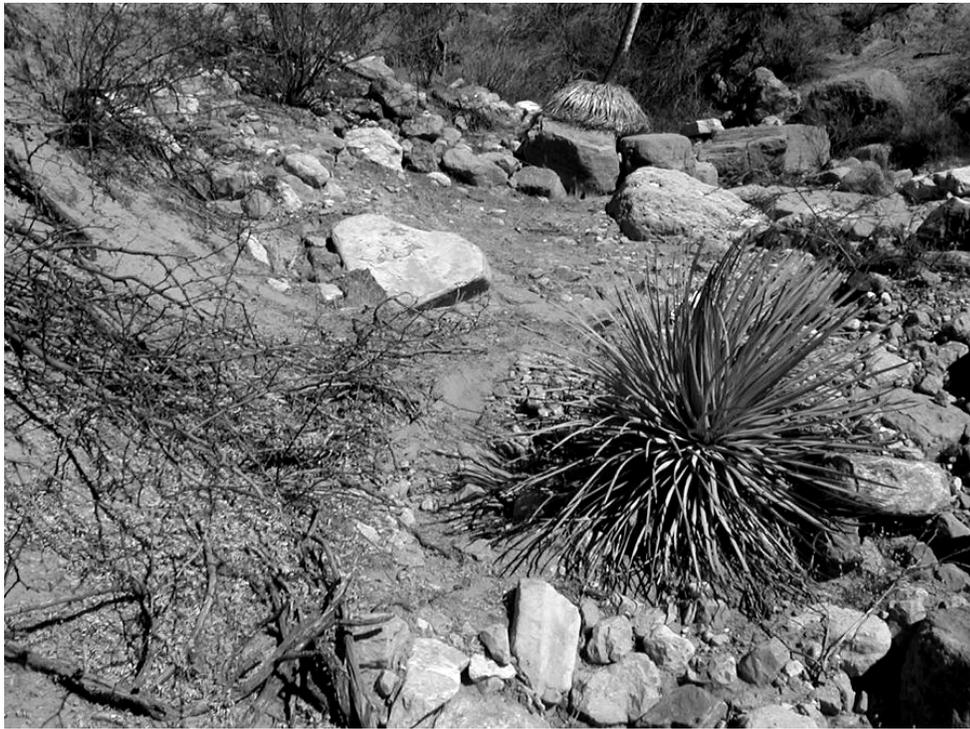
Figure B.20. Ephemeral wash to which western gullies drain. Photo taken facing east.

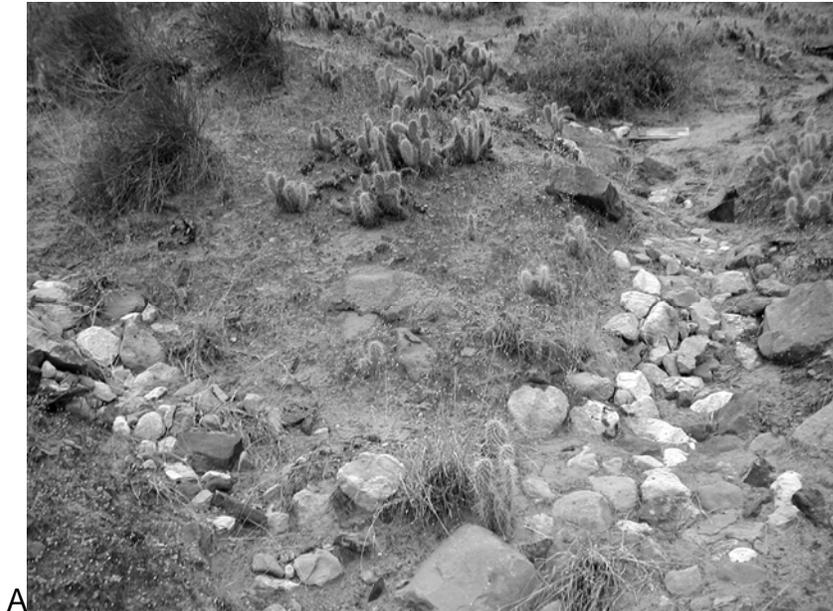
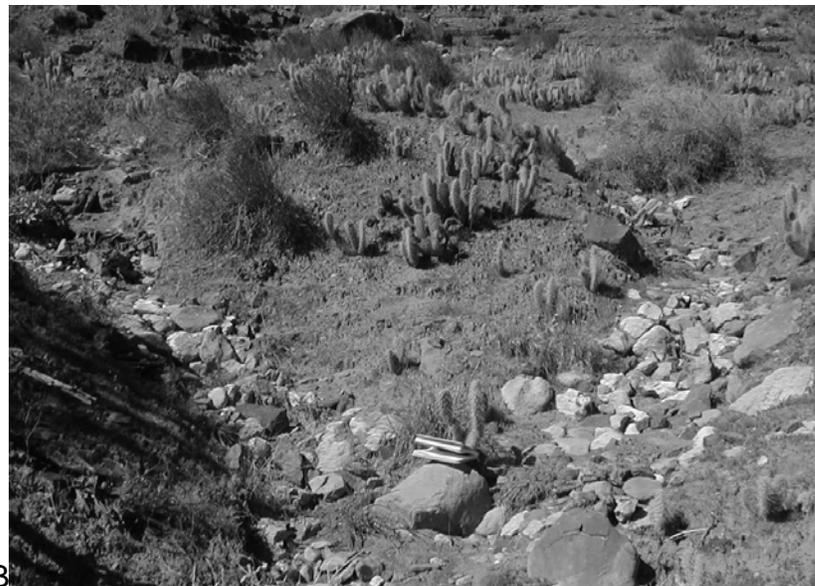
Figure G.1. 60-mile structures #2 (left) and #3 (right), at confluence in main channel. February (A) #3 is intact, but #2 needs repair due to minor flanking, scour, and undercutting; October (B) very little change overall.

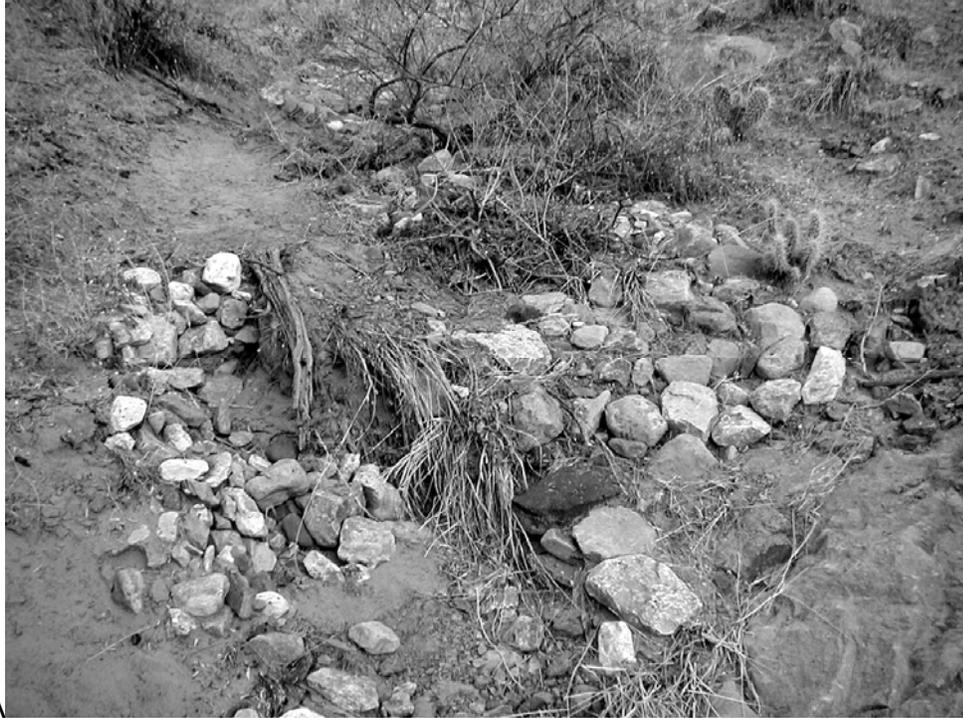
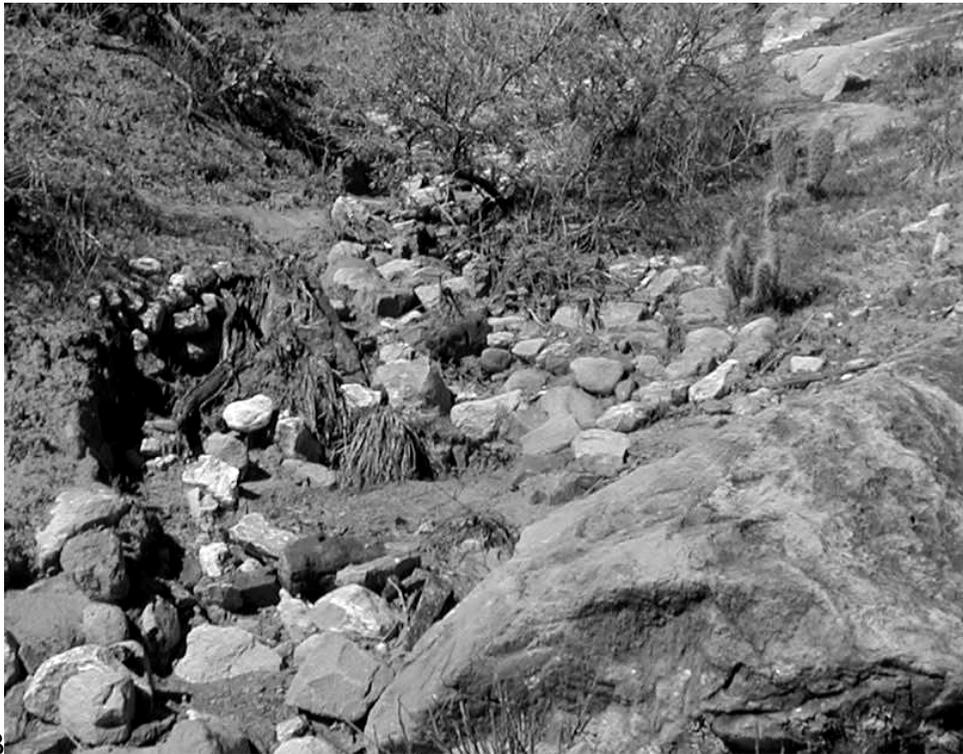
Figure G.2. 60-mile structure #6. February (A) right side is intact; left side features minor breaching at knickpoint; October (B) right side still intact, but left side flanked such that structure cobbles removed.

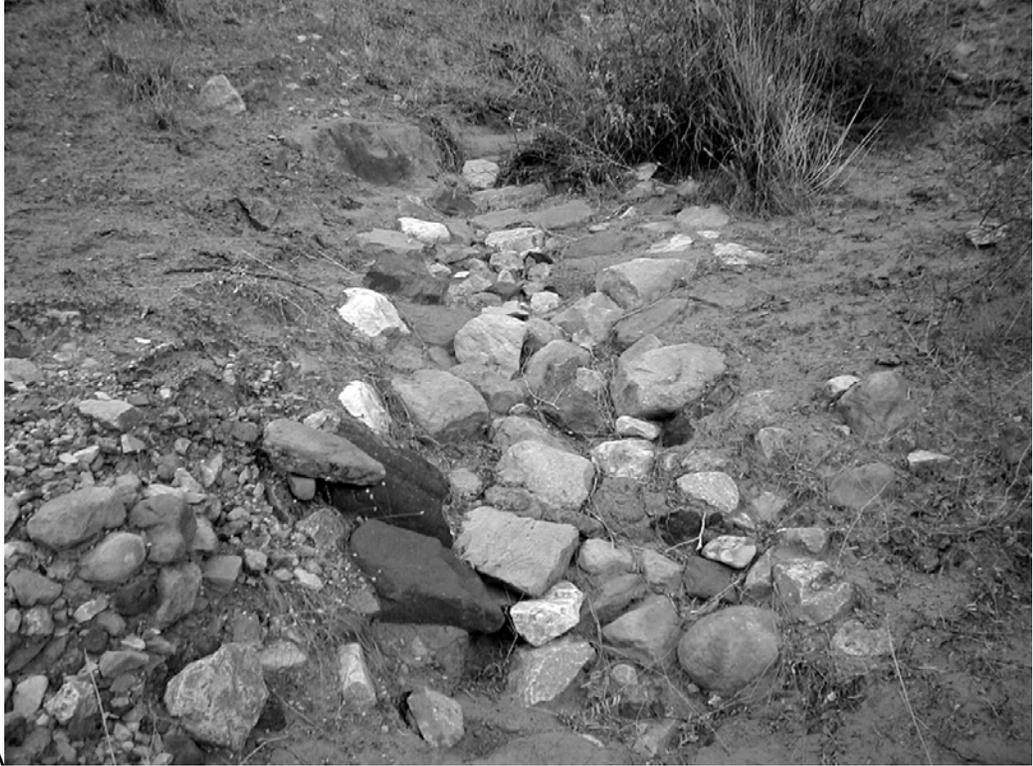
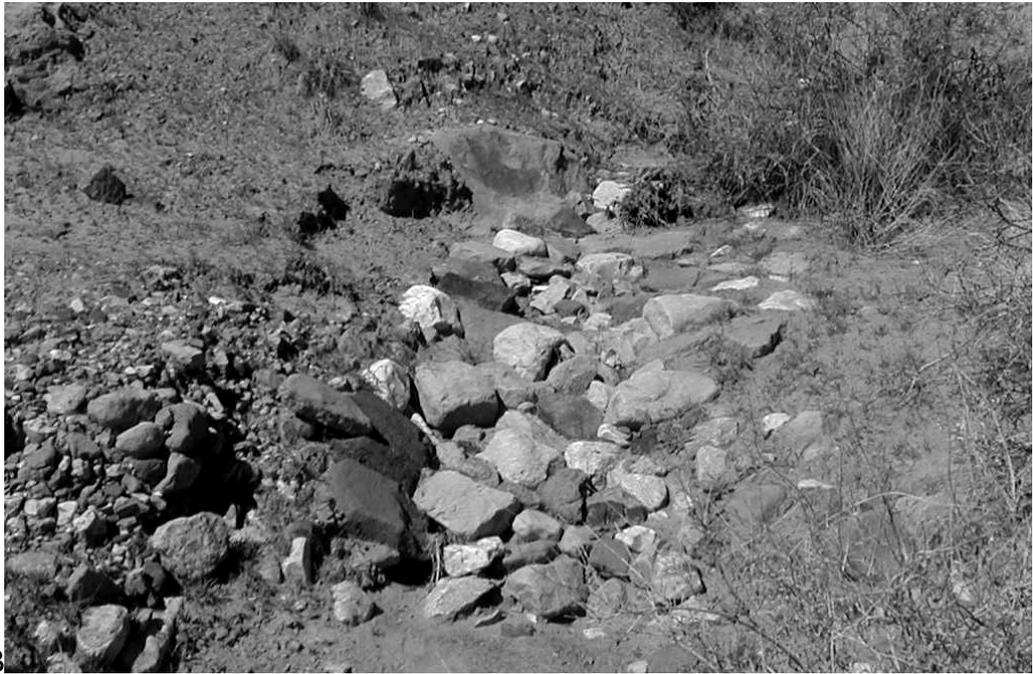
Figure G.3. 60-mile structure #8. February (A) completely intact; October (B) completely intact.

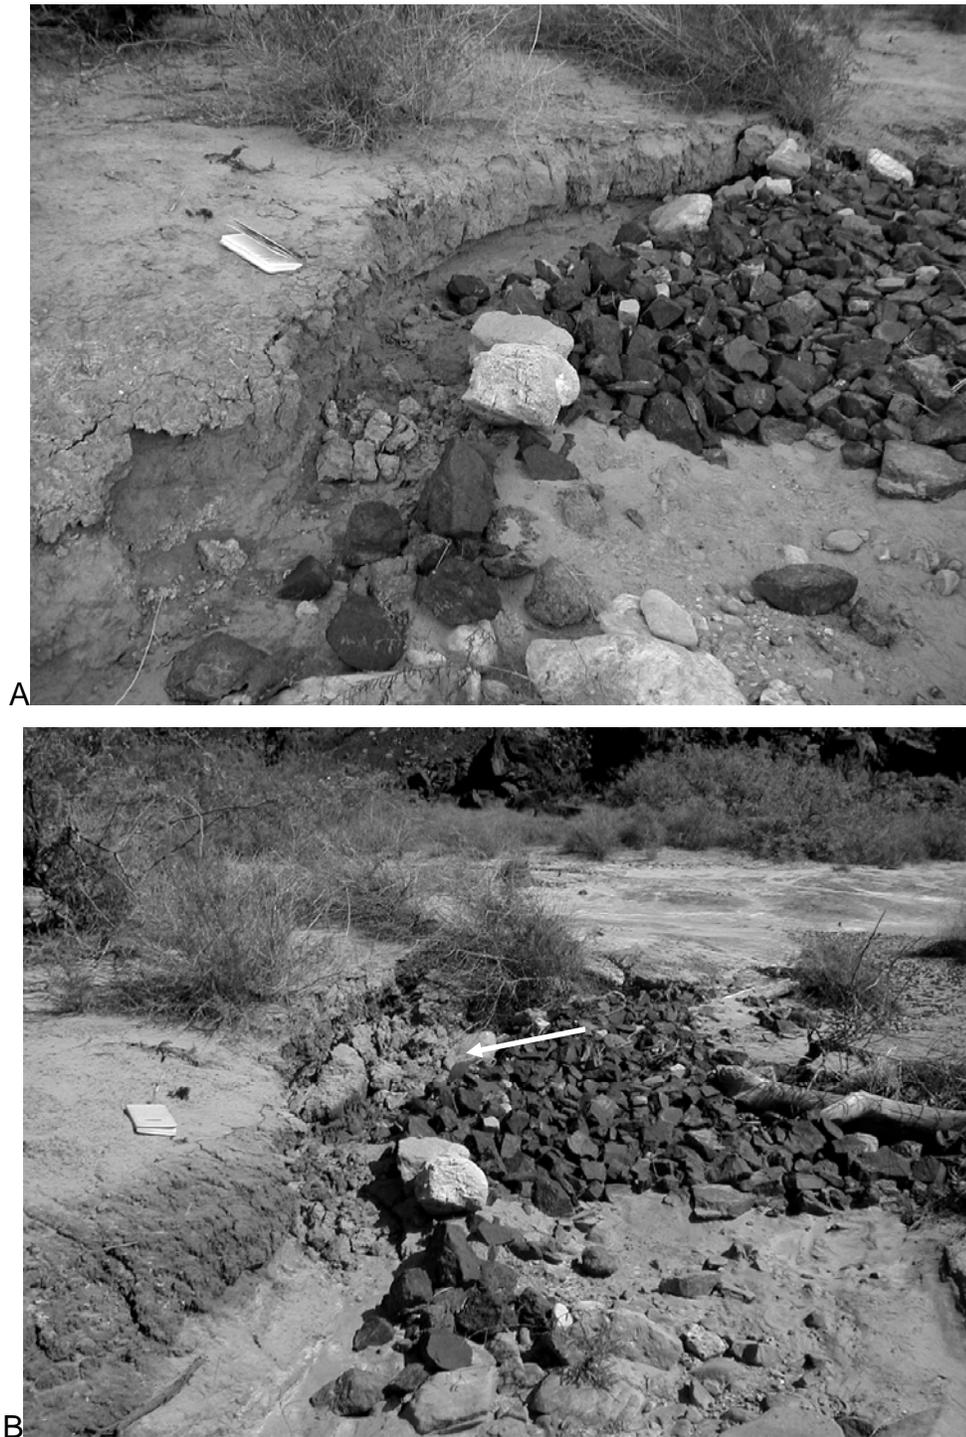
Figure G.4. Palisades structure #42. February (A) flanked; October (B) up to 60 cm of lateral erosion (by arrow).

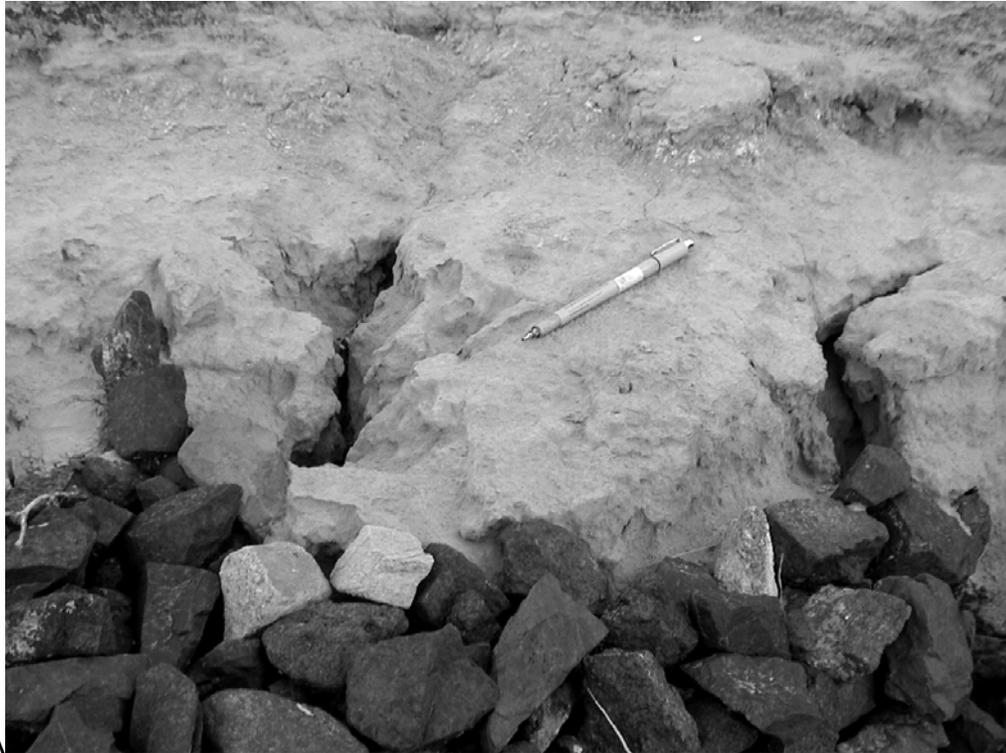
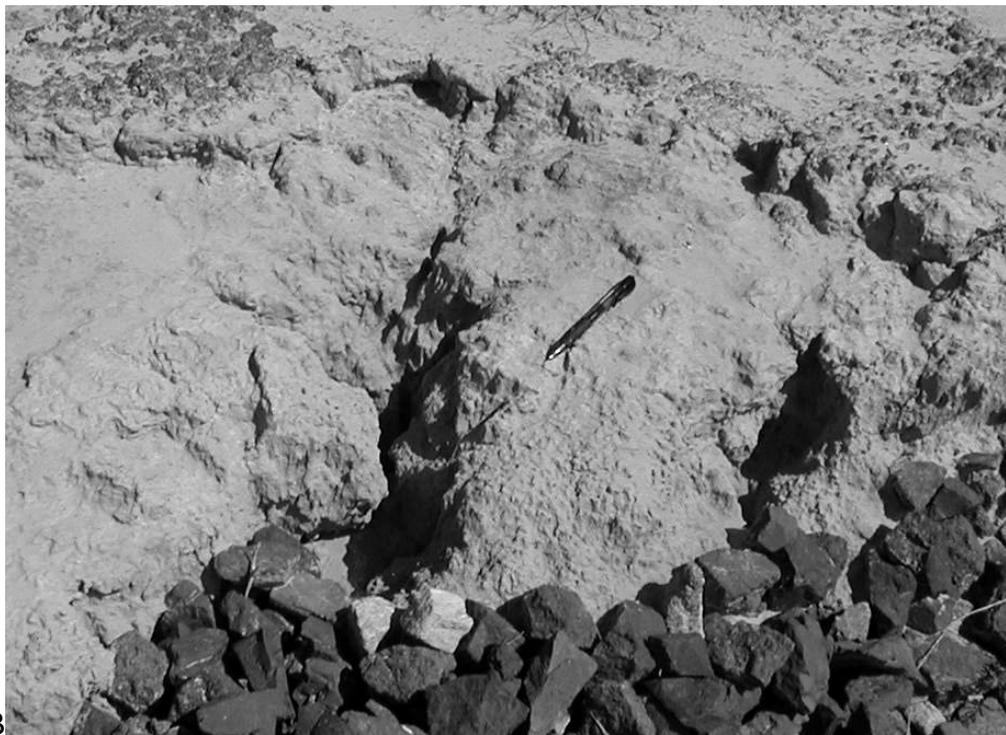
Figure G.5. Palisades structure #41. February (A) piping in channel bank; October (B) some deepening, widening, and retreat of erosion features in channel bank.

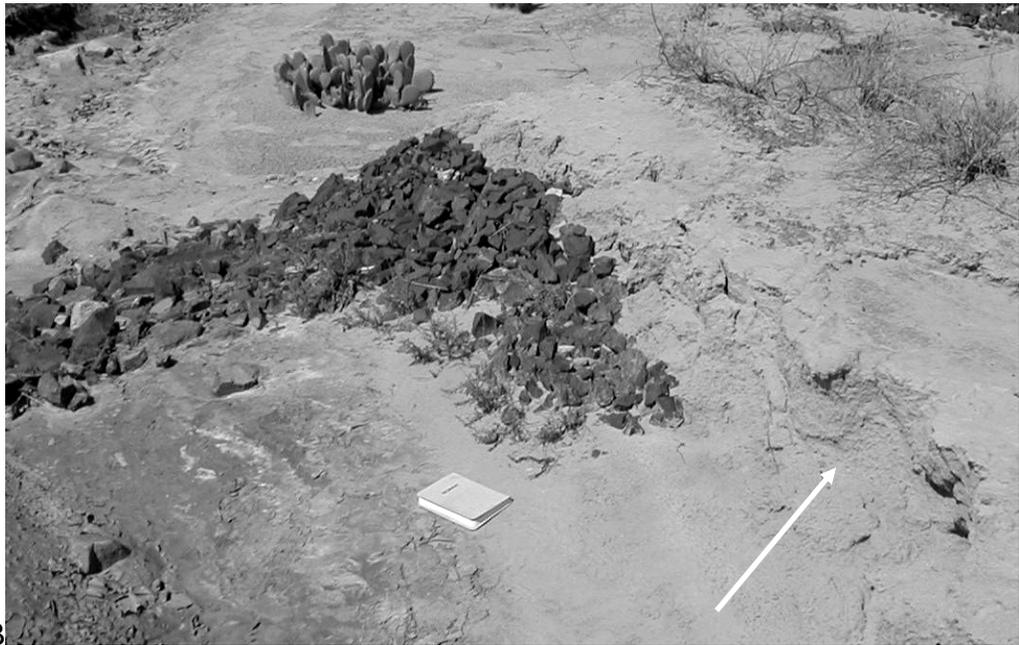
Figure G.6. Palisades structure #41. View downstream. February (A) note fracturing of bank (arrow); October (B) blocks in (A) have collapsed.

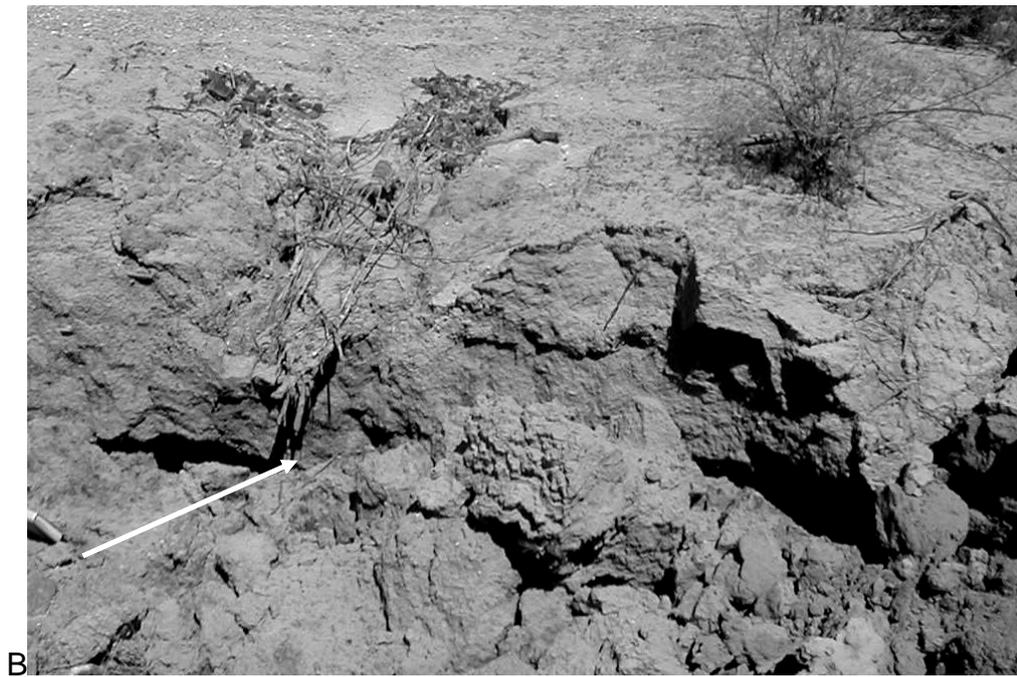
Figure G.7. Palisades small, unnamed structures. February (A) in high drainage density region with many rills nearby; October (B) 30-cm tall block of sediment below was undercut and failed (arrow), structures at top were flanked.

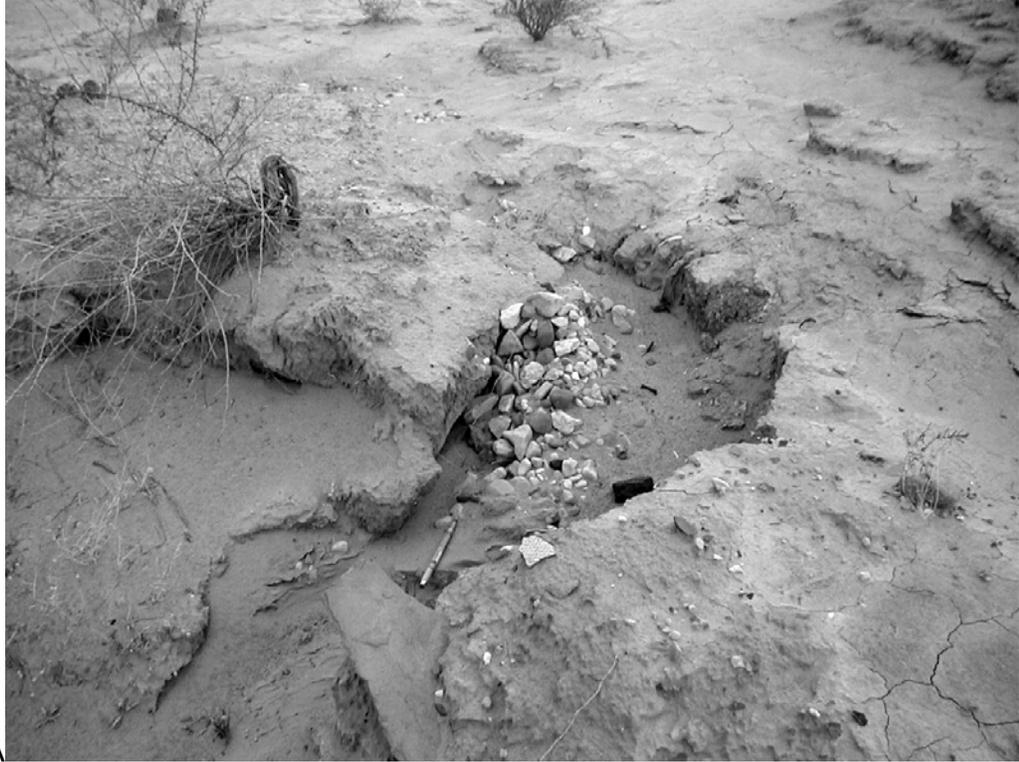
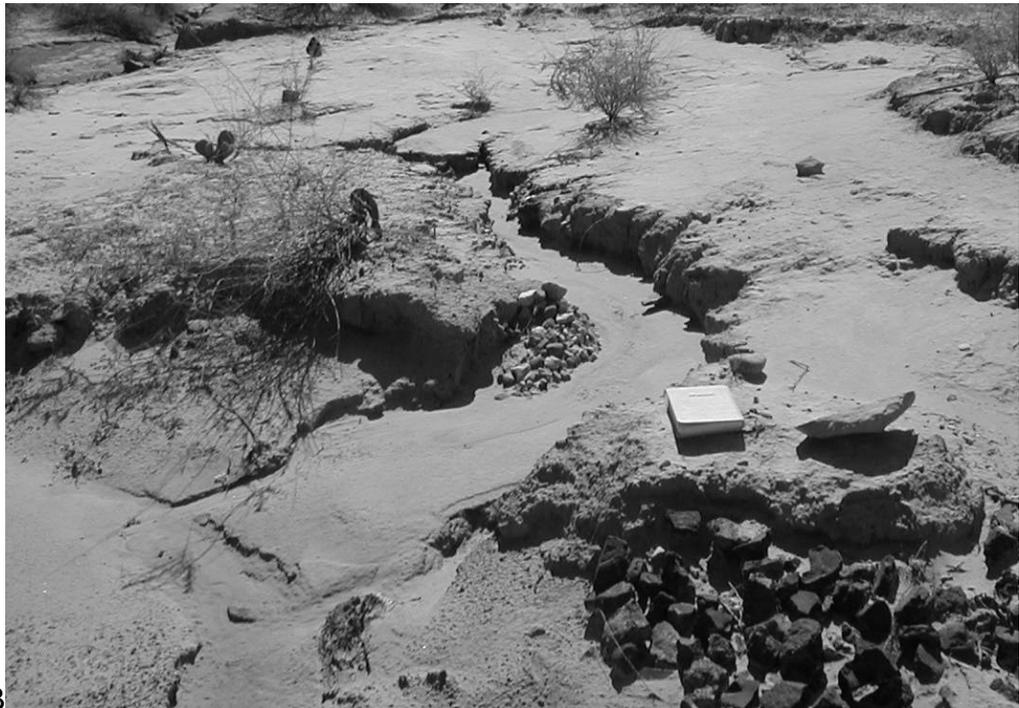
Figure G.8. Palisades small, unnamed structure in tributary gully. February (A) completely flanked; October (B) major channel widening and headcut retreat.

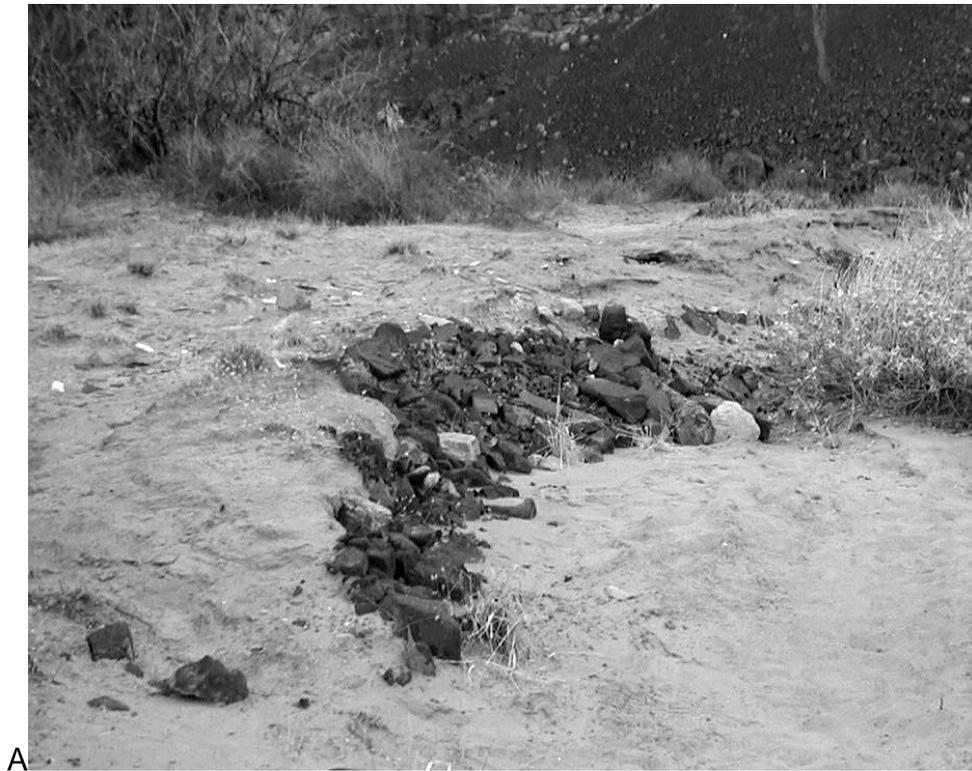
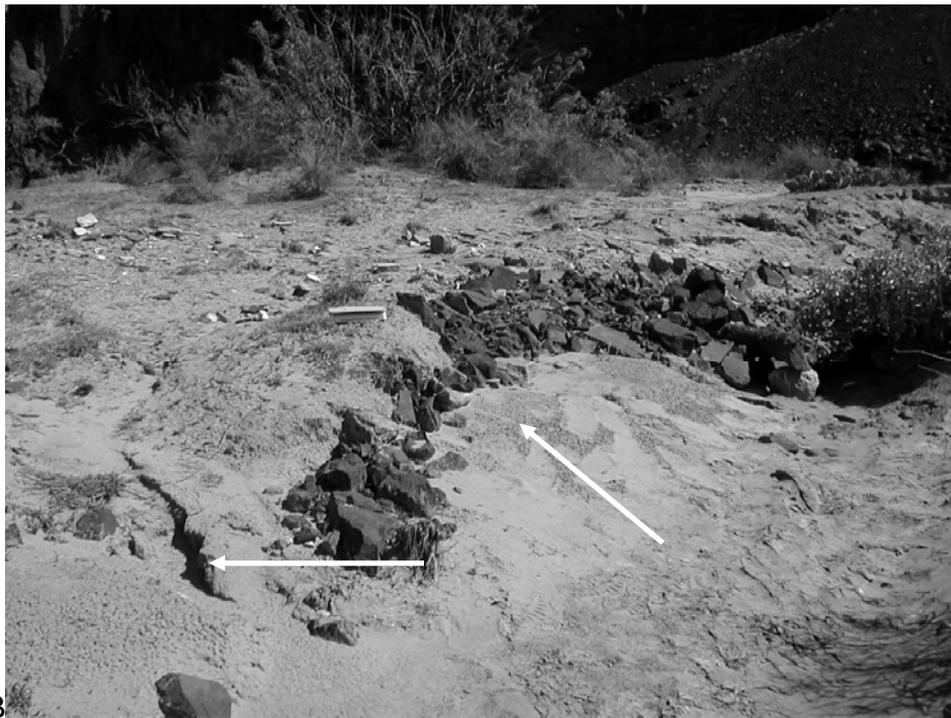
Figure G.9. Palisades structure #35N. February (A): completely intact. October (B): still fairly stable. Possible deposition to side of structure (arrow). Channel in foreground is new (arrow).

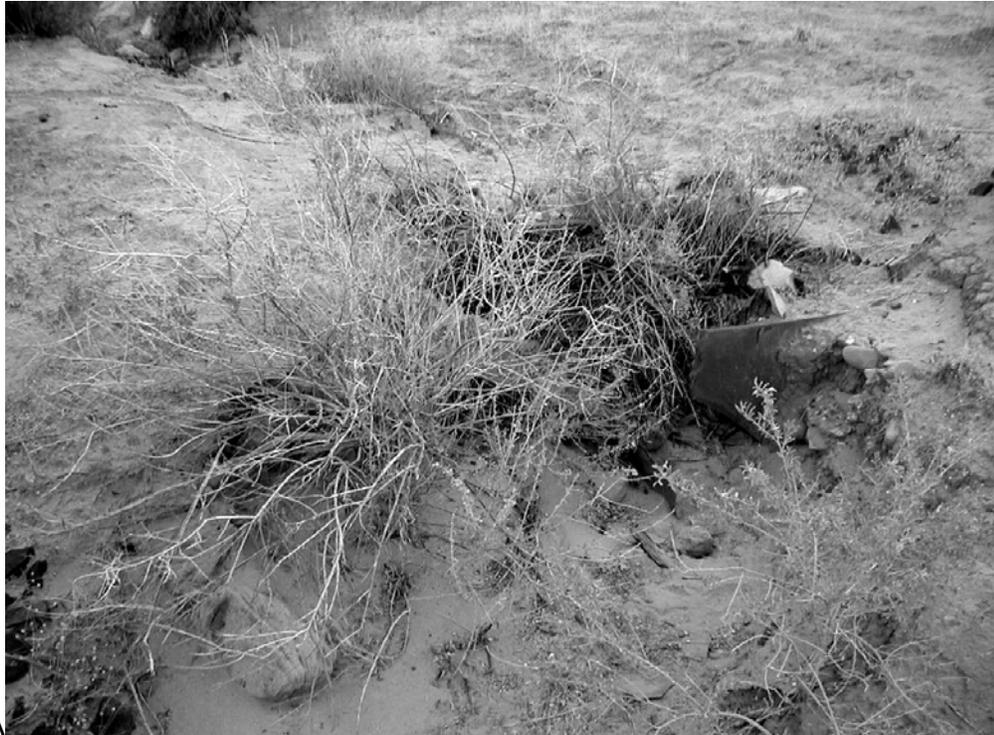
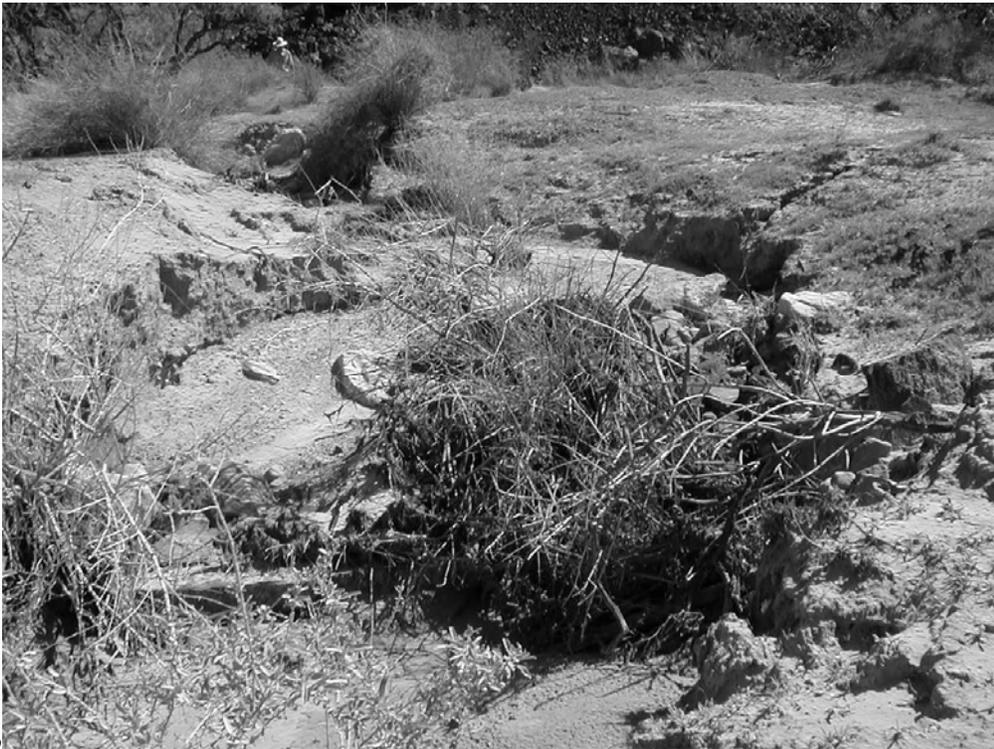
Figure G.10. Palisades structure #21, F7. February (A) woody debris has been incorporated into this structure through erosion. Flanked and scoured; October (B) left side of channel has been scoured out, nearly doubling channel width.

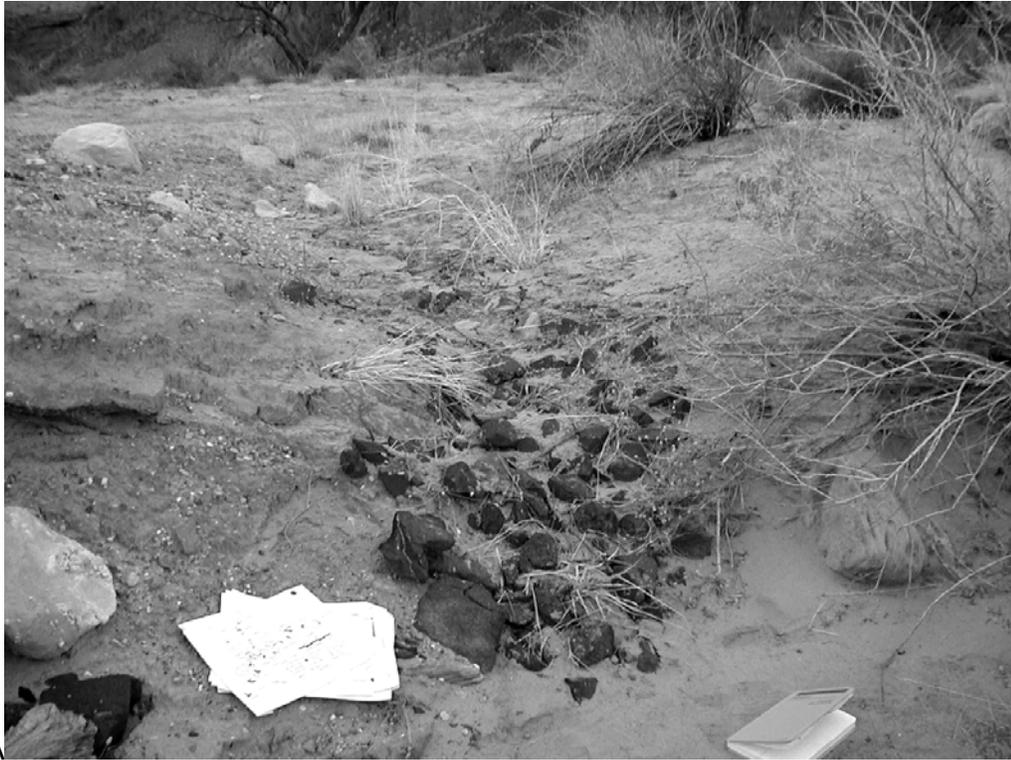
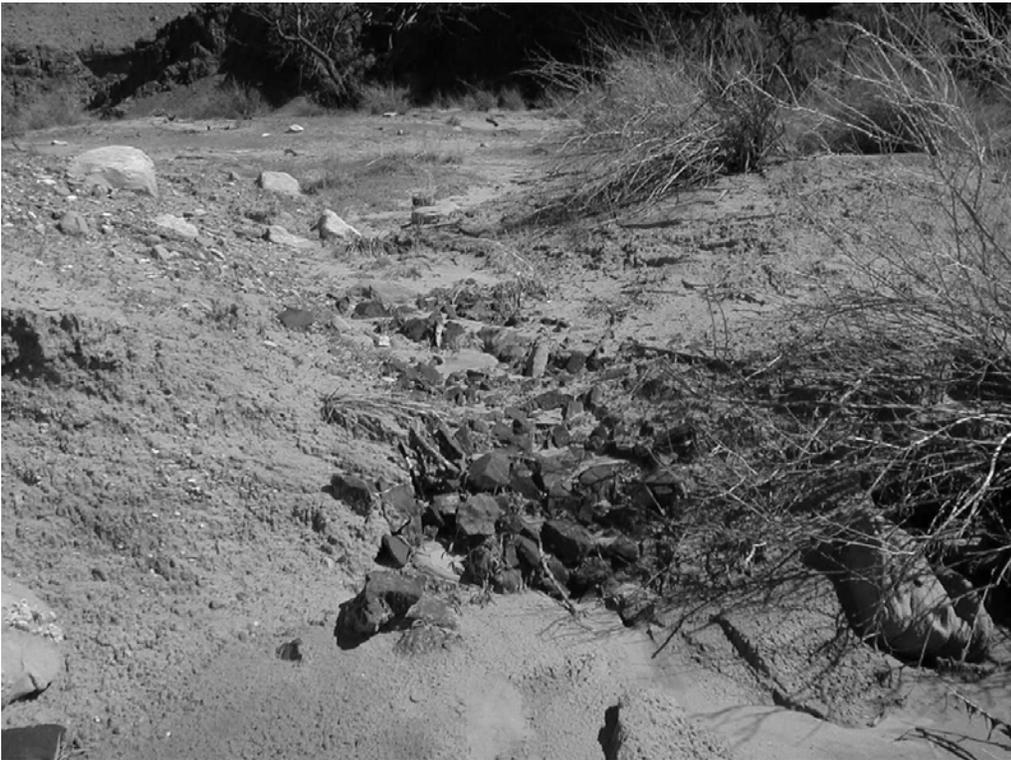
Figure G.11. Palisades structure #17N (?). February (A) intact, gully healed; October (B) still stable, except for slight scour near pen on left-central side.

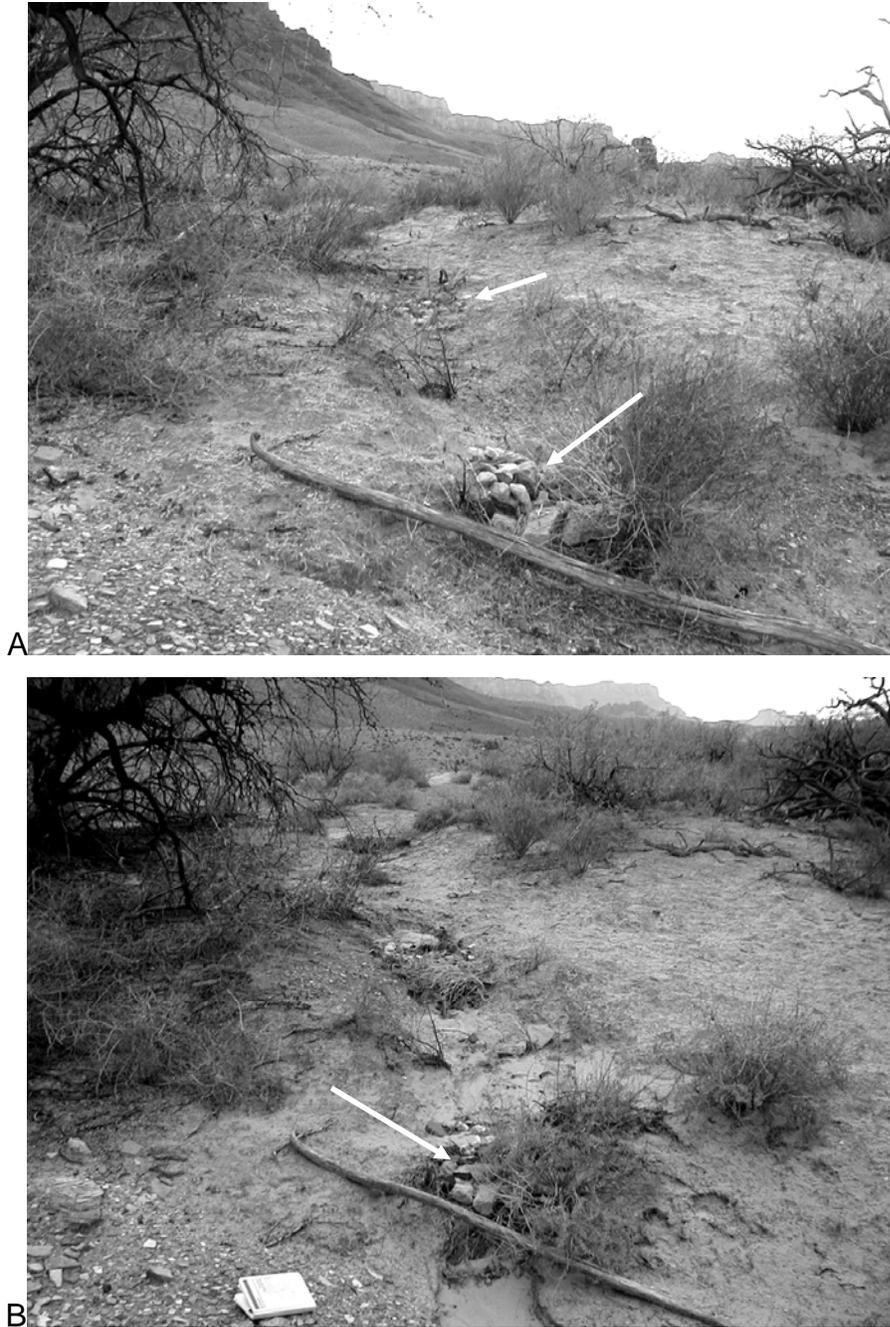
Figure G.12. Basalt Cliffs eastern gully with two structures (see arrows, #9 in foreground). February (A) all structures are intact; October gullies flowed, channels widened, knickpoint formed in front of structure #9. Some infilling within structure #9 (arrow).

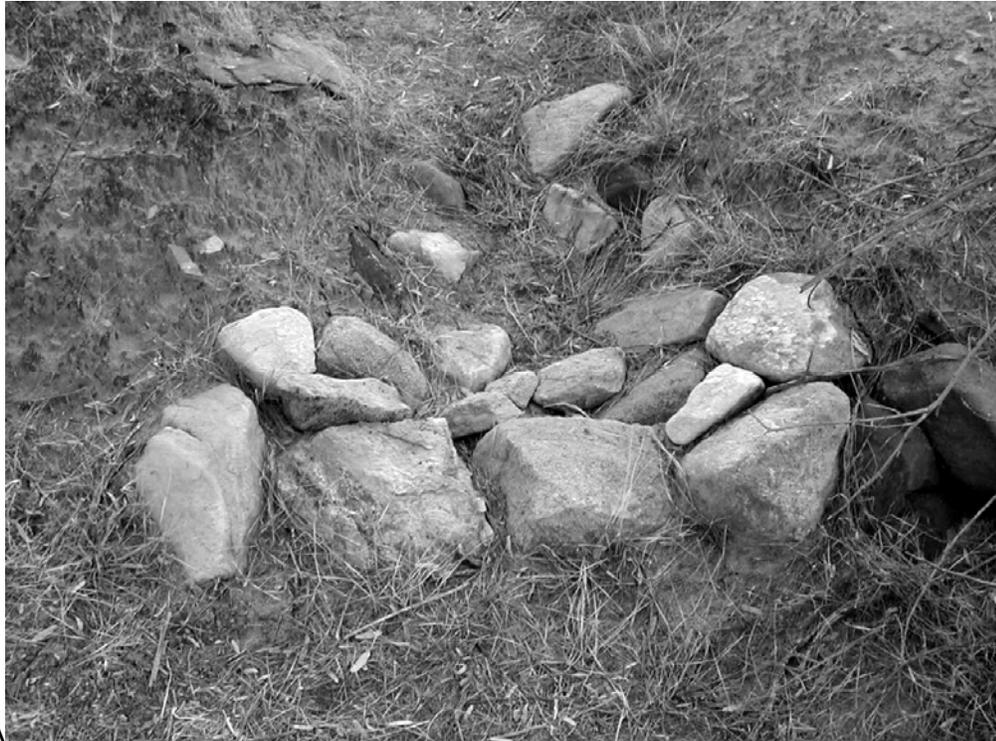
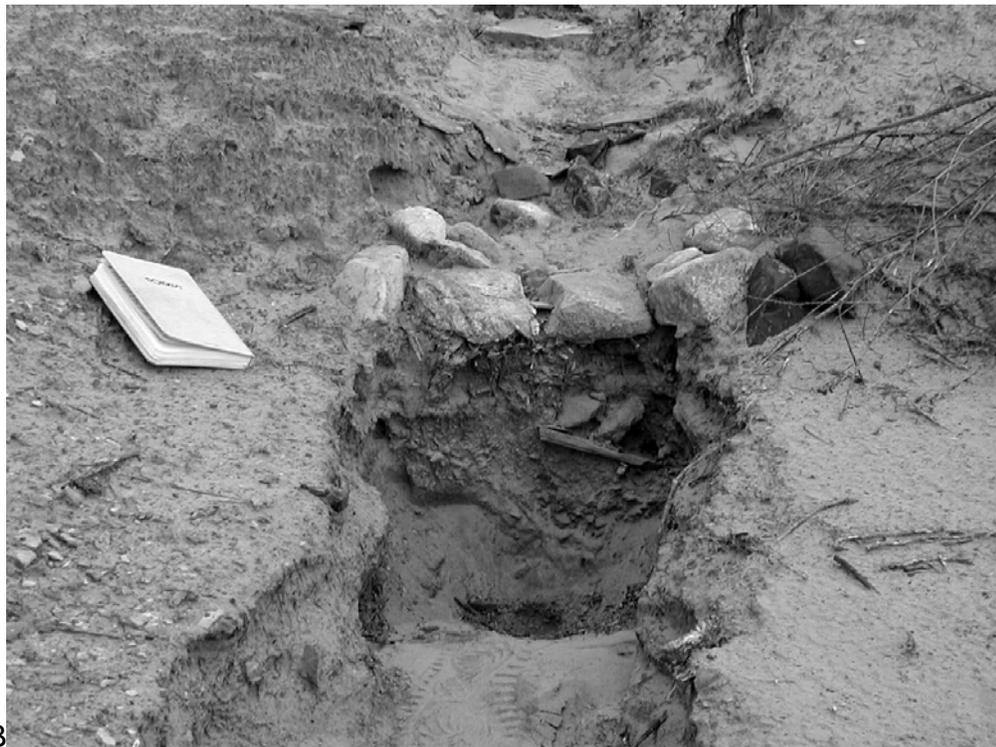
Figure G.13. Basalt Cliffs structure in western gully. February (A) intact; October (B) knickpoint just below structure, some channel widening, sediment deposition in middle part of structure, some rocks removed.

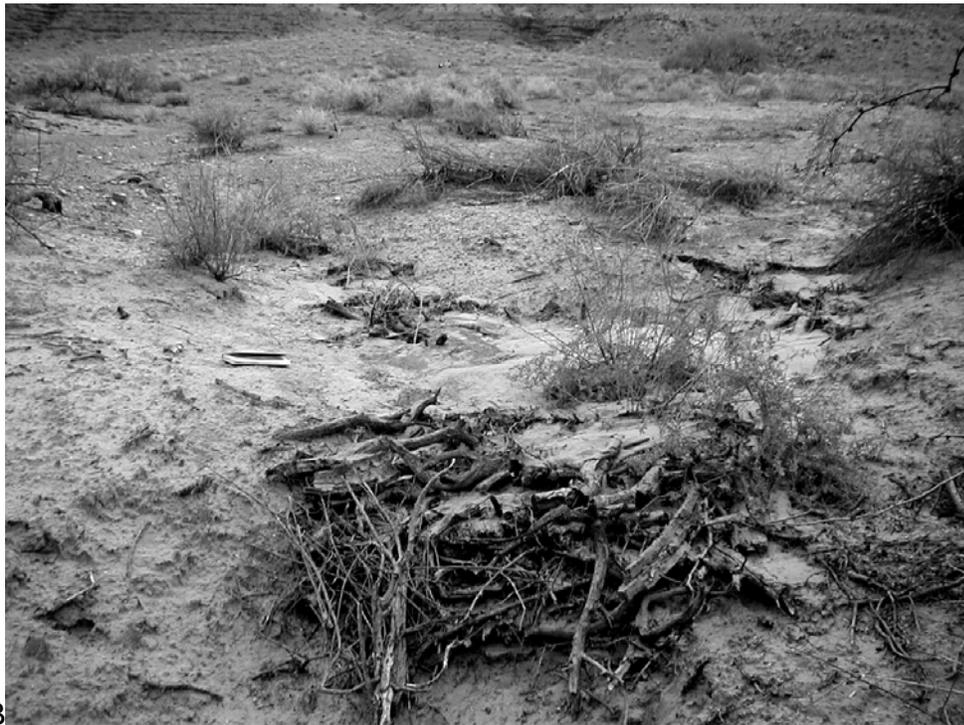
B

Figure G.14. Basalt Cliffs wooden checkdam structures #2 (background) and #3 (foreground) in west gully in C:13:348. February (A) intact; October (B) not much change in #2, but #3 has filled in with sediment.

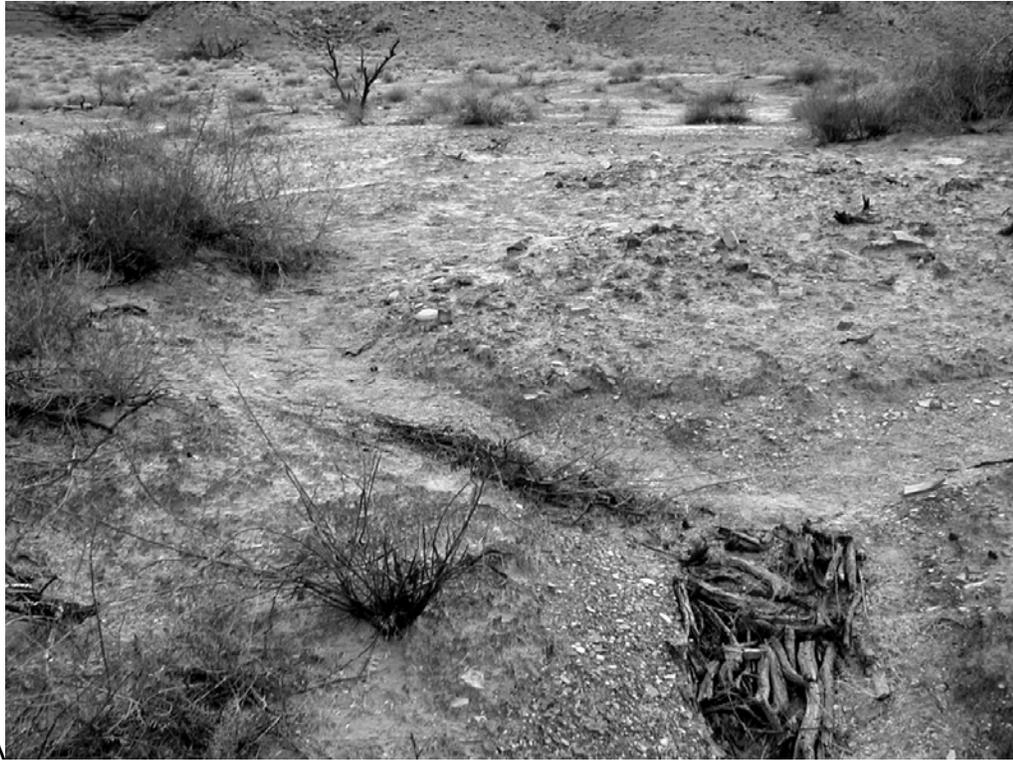
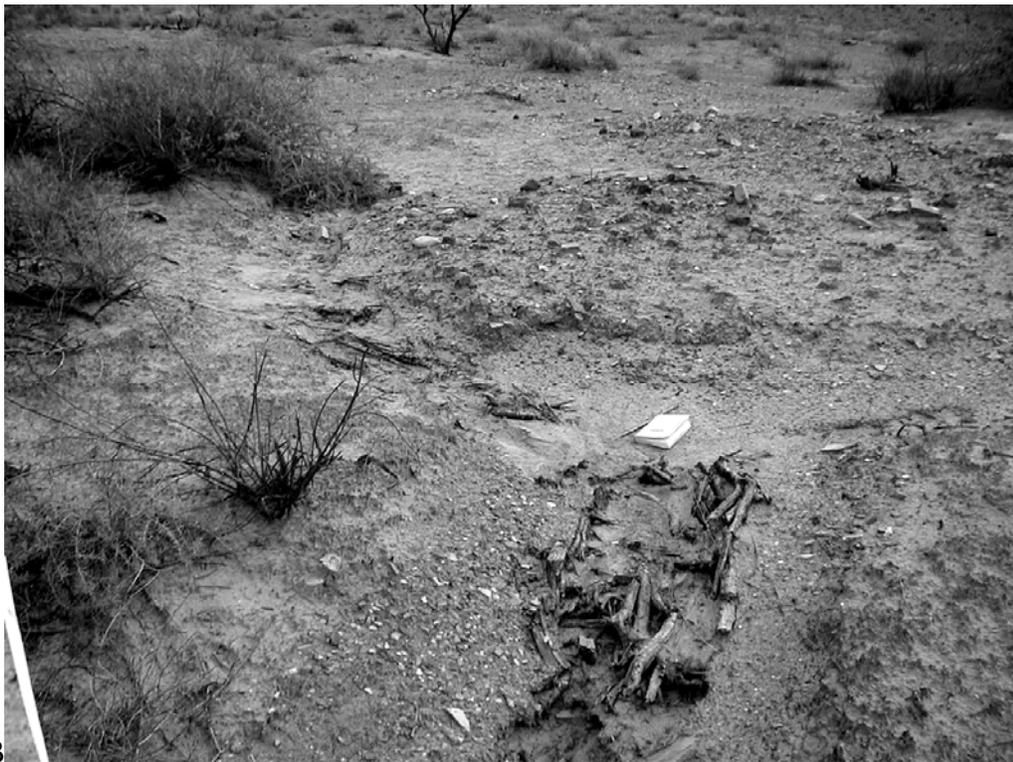
Figure G.15. Basalt Cliffs unnamed, wooden checkdam structure in east gully. February (A) intact; October (B) sediment deposition, still intact.

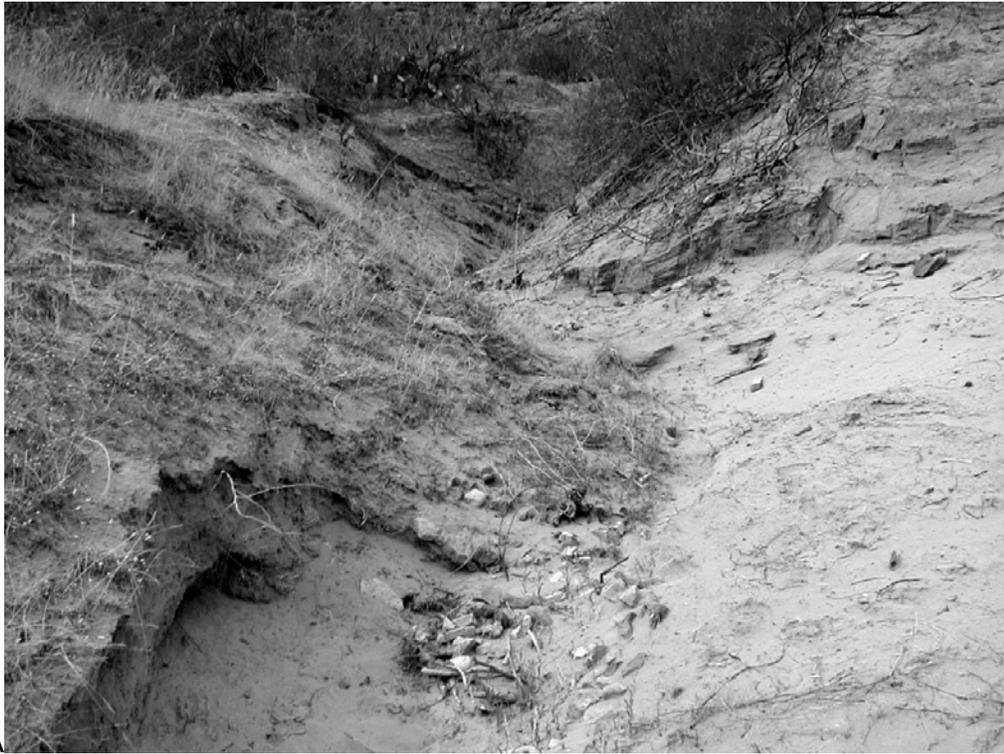
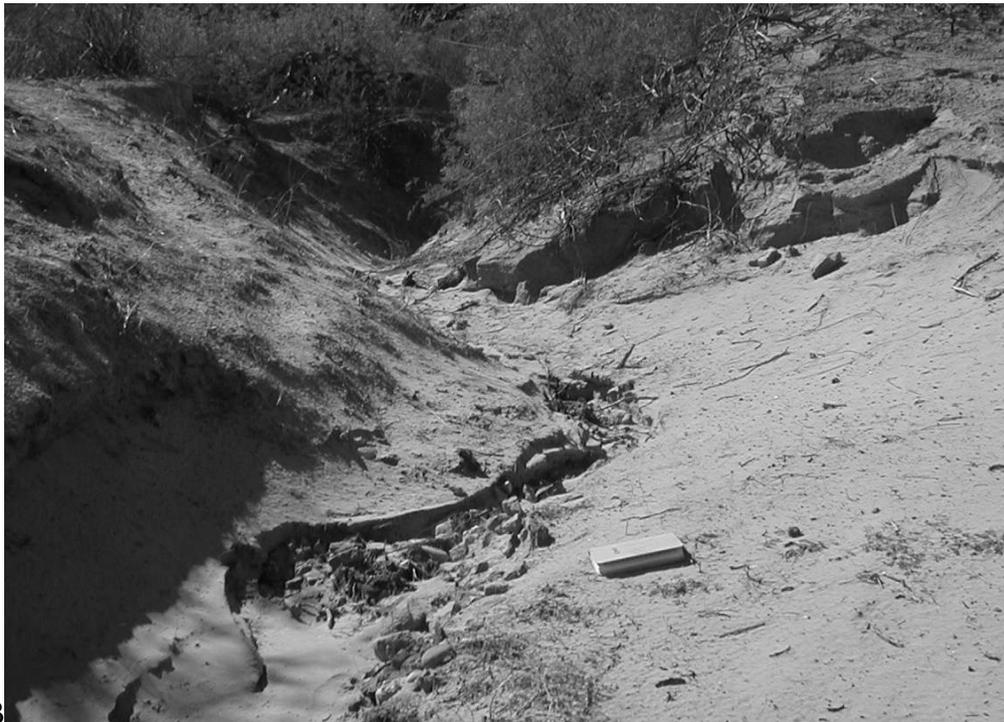
Figure G.17. Indian Canyon structure #5. February (A) breached; October (B) incision and widening of smaller, rejuvenated thalweg cut evident.
