MITIGATION, MONITORING, AND GEOMORPHOLOGY
RELATED TO GULLY EROSION OF CULTURAL SITES
IN GRAND CANYON

Joel L. Pederson¹, Paul A. Petersen^{1,2}, William W. Macfarlane²,
Mark F. Gonzales³, Keith Kohl³

November 2003

Report in fulfillment of cooperative agreement 01WRAG0074 and modifications
between Utah State University and the U.S. Geological Survey,
Grand Canyon Monitoring and Research Center

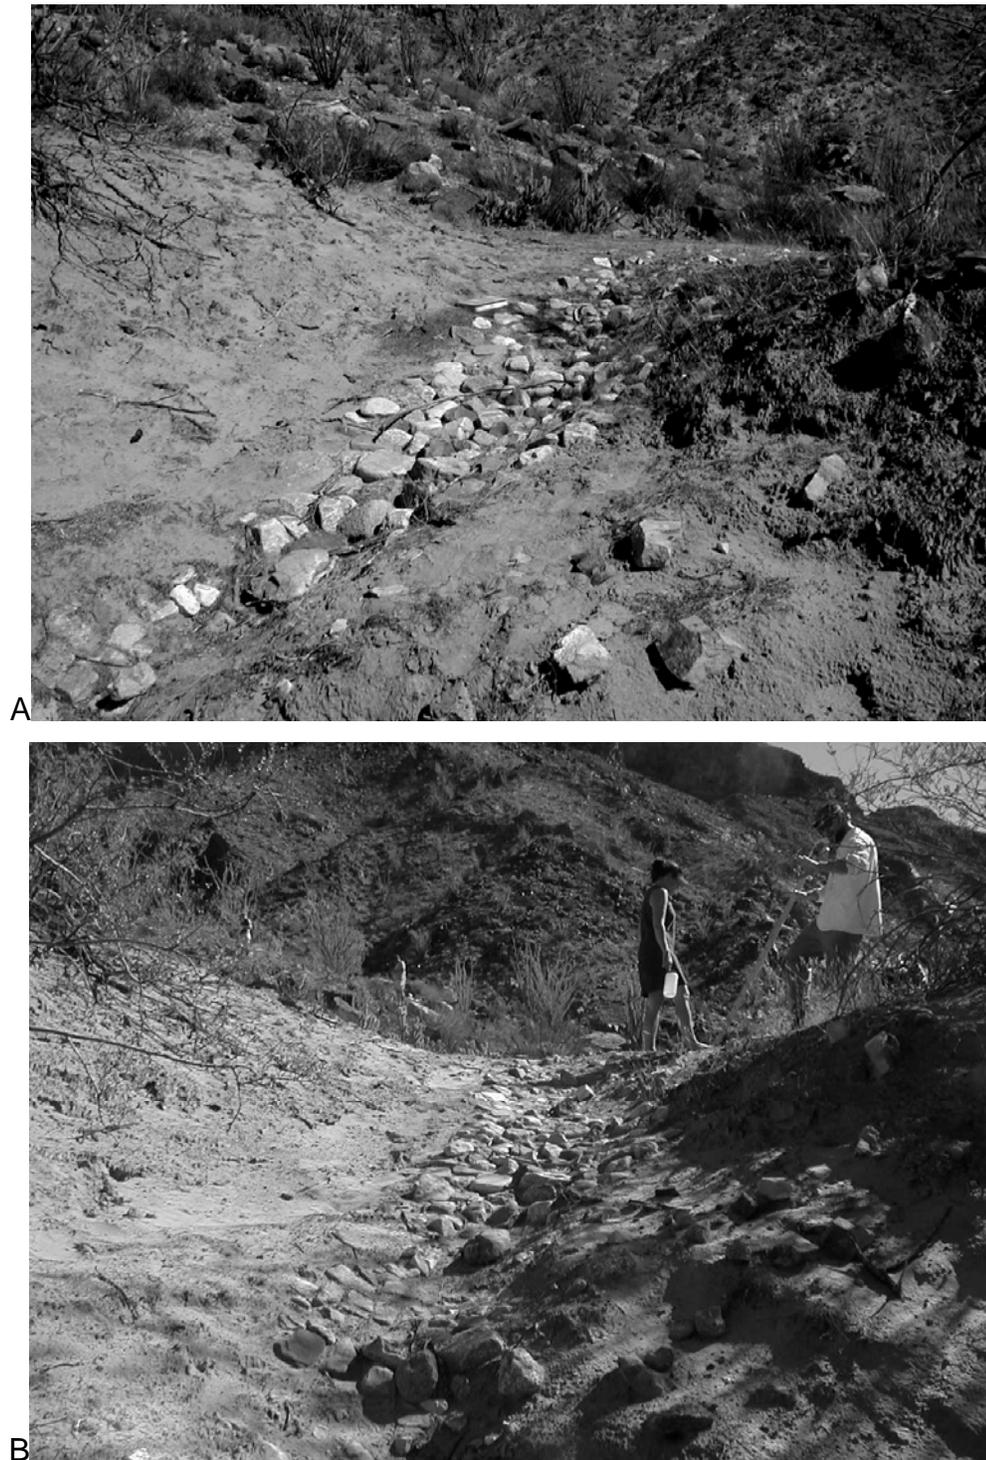
Figure G.18. Arroyo Grande structure #2. February (A) intact; October (B) no change.

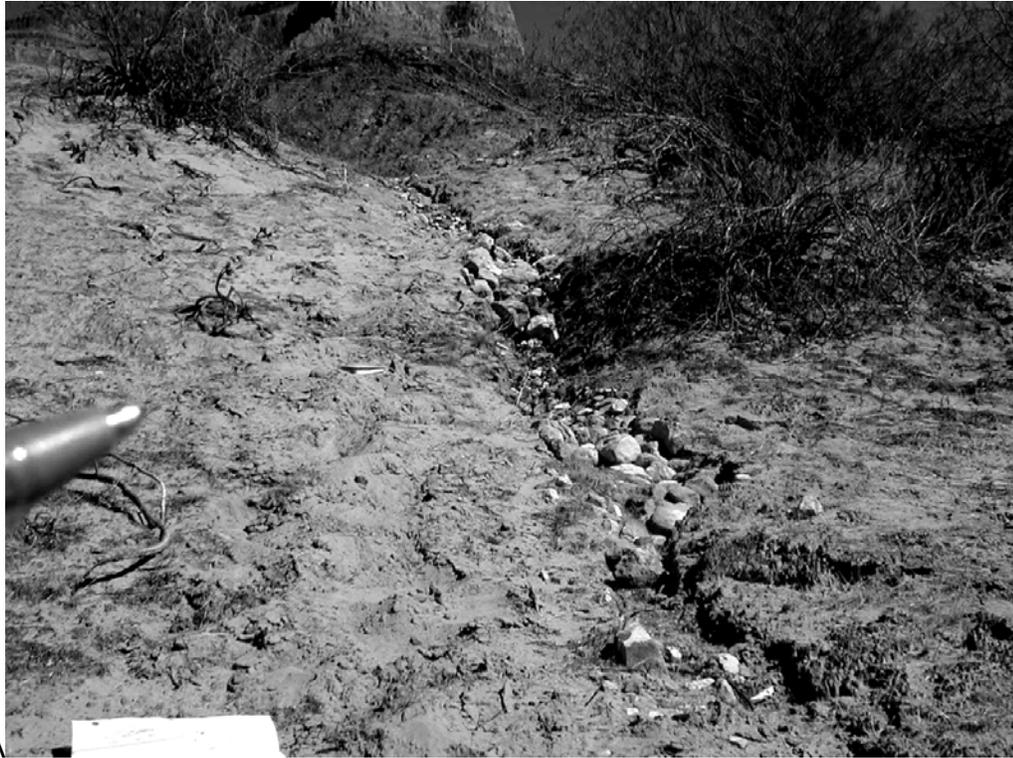
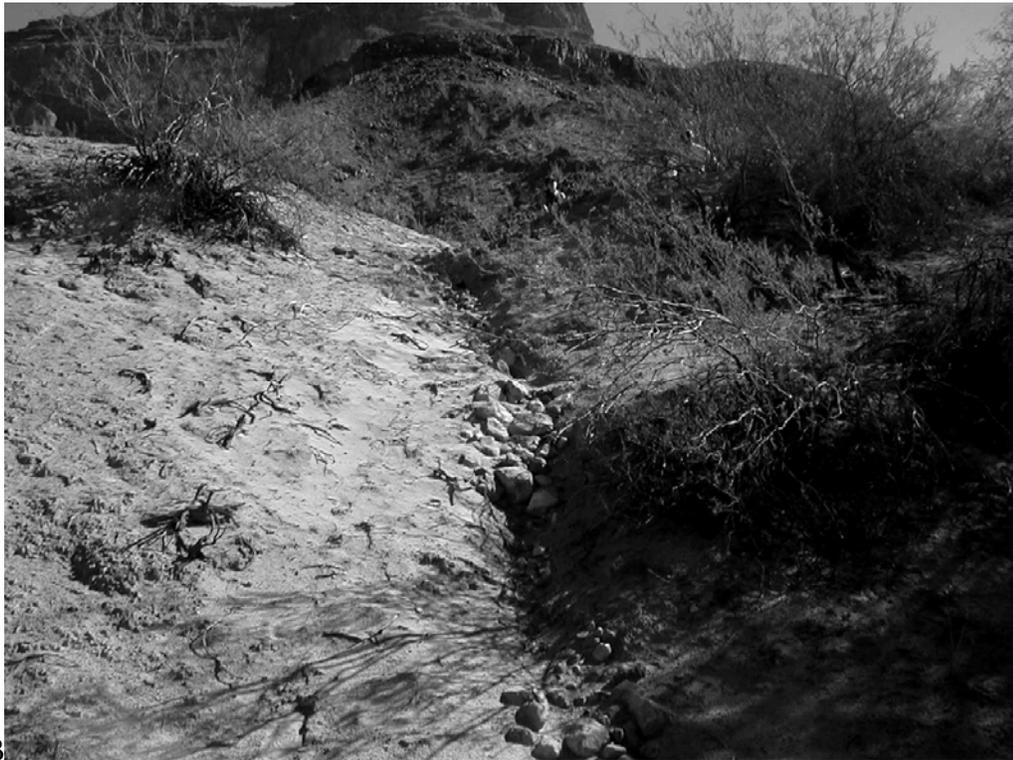
Figure G.19. Arroyo Grande structures in western gully. February (A) most structures are flanked; October (B) partially filled with eolian sediment.

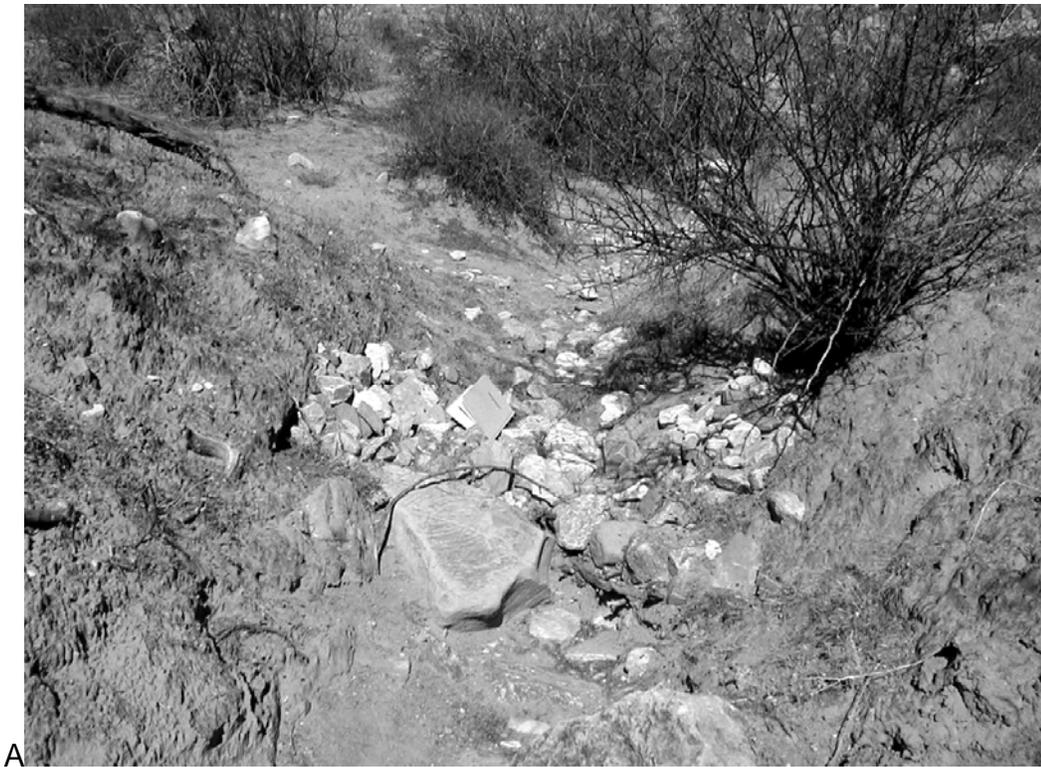
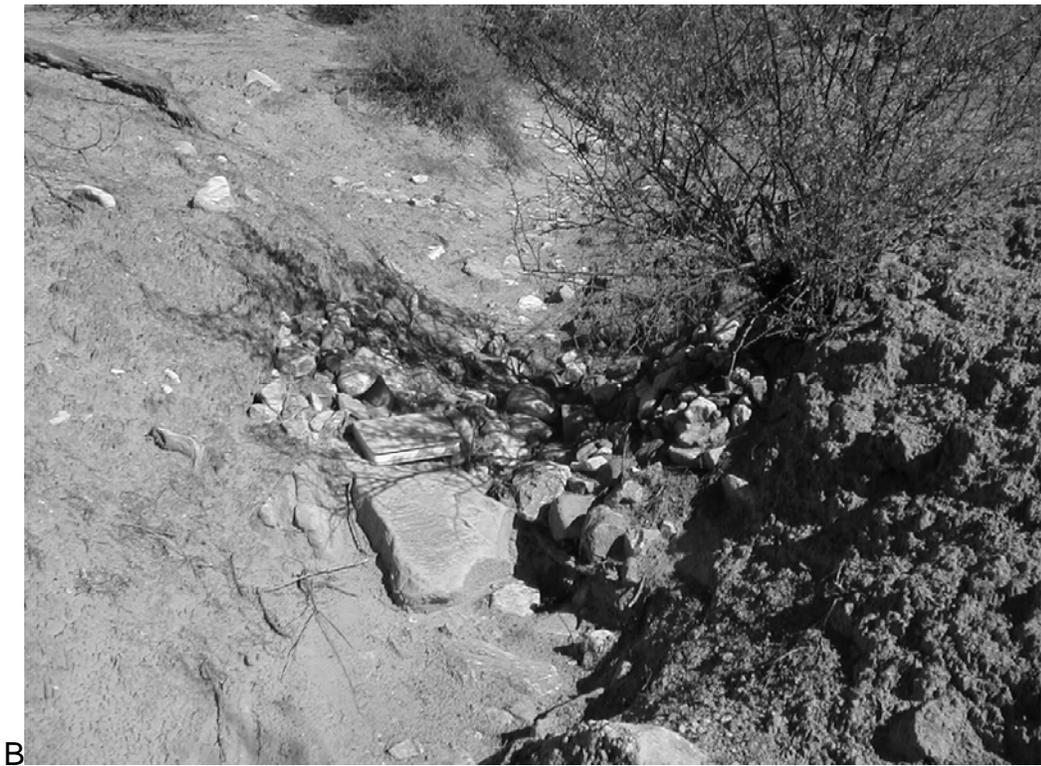
Figure G.20. Arroyo Grande structure #1. February (A) intact; October (B) no change.

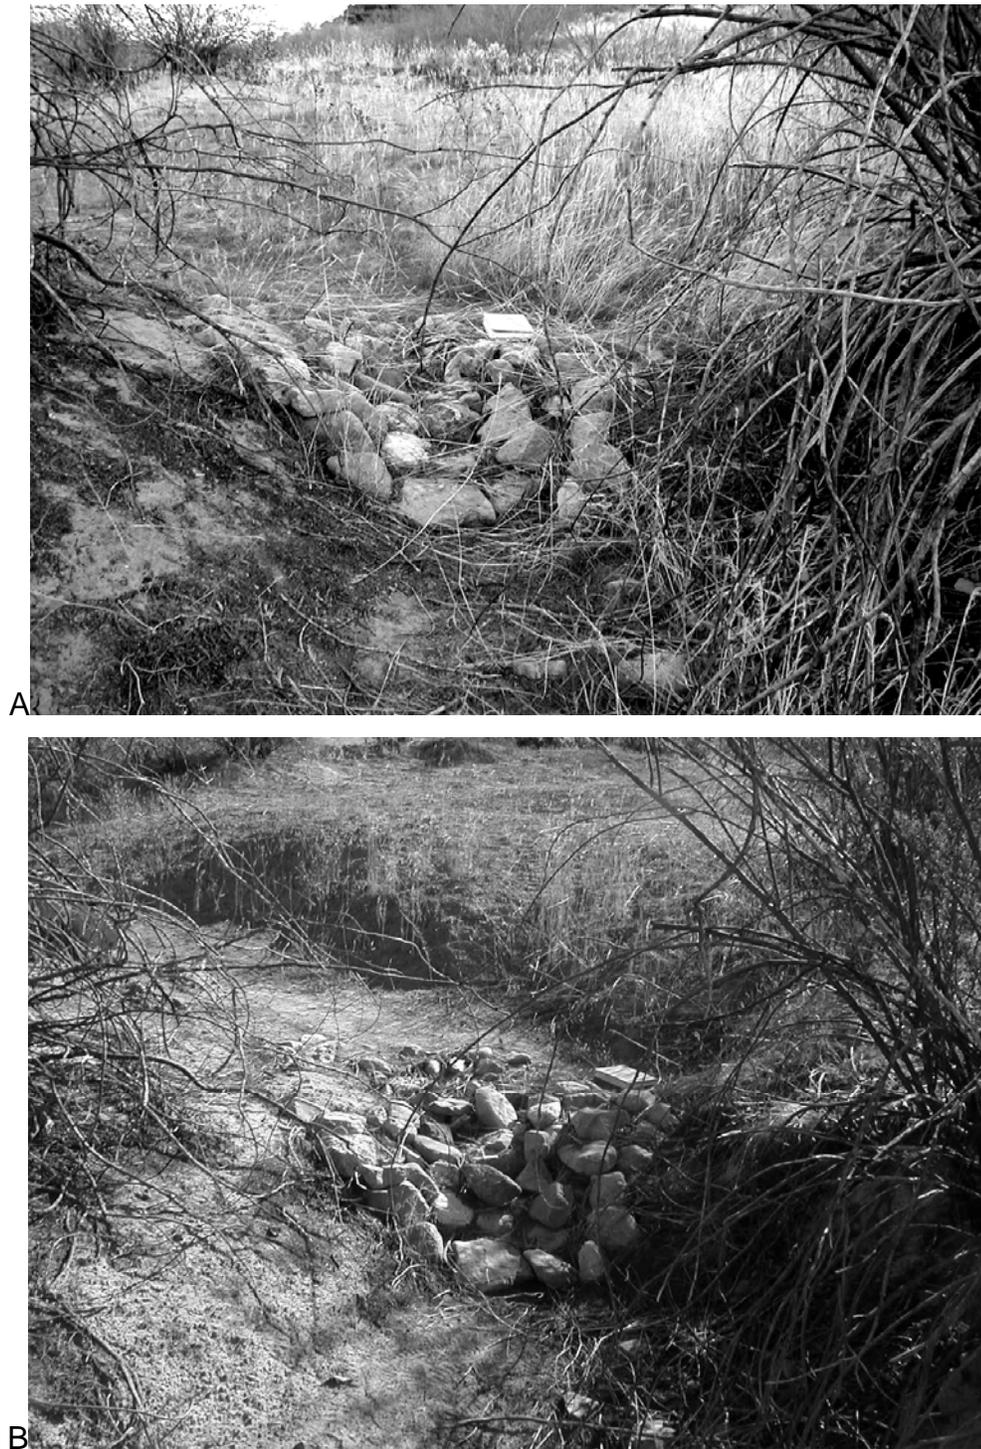
Figure G.21. Granite Park structure #3. February (A) intact; October (B) no change.

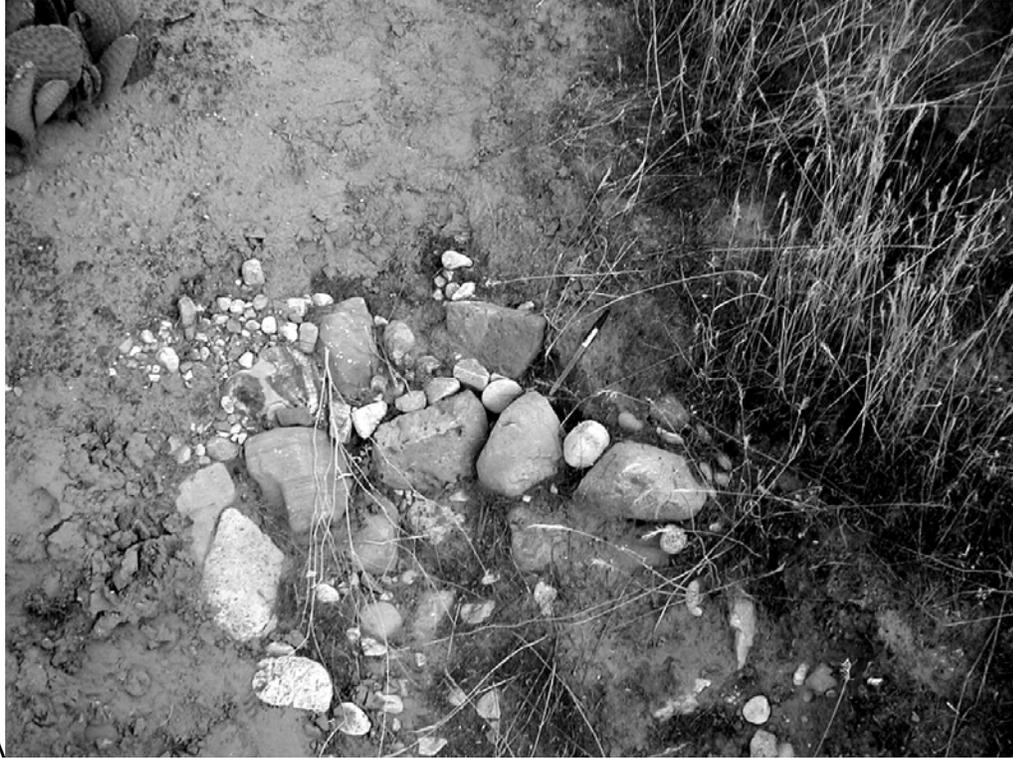
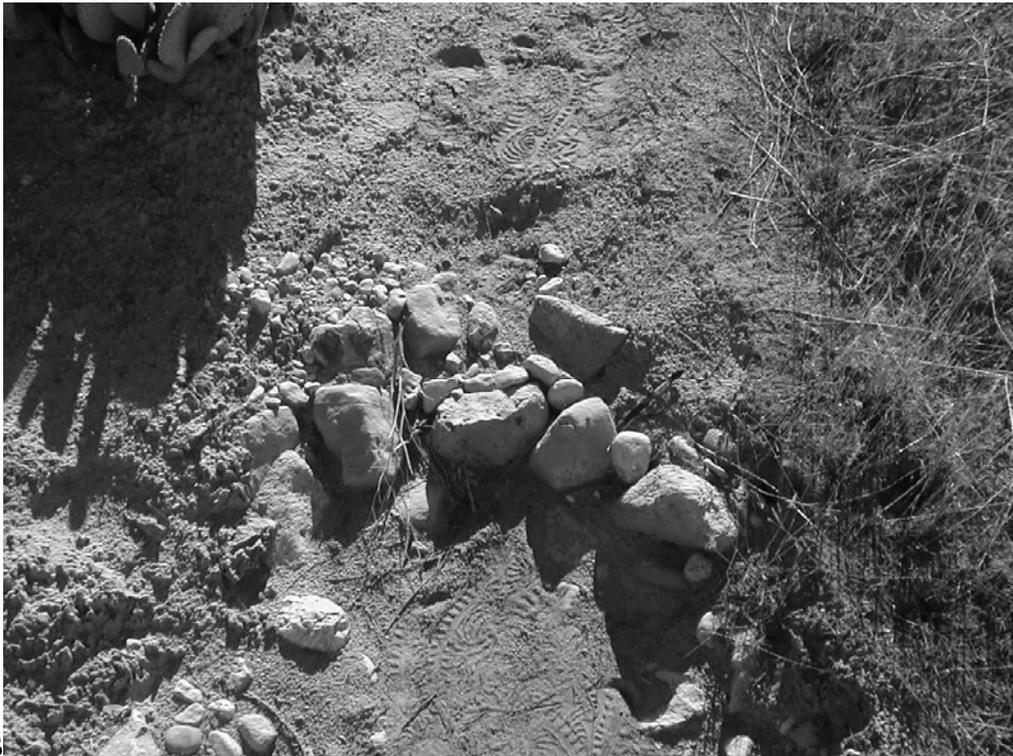
Figure G.22. Granite Park structure #2. February (A) intact, although minor erosion near pen; October (B) minor erosion near pen filled in through rainsplash creep.

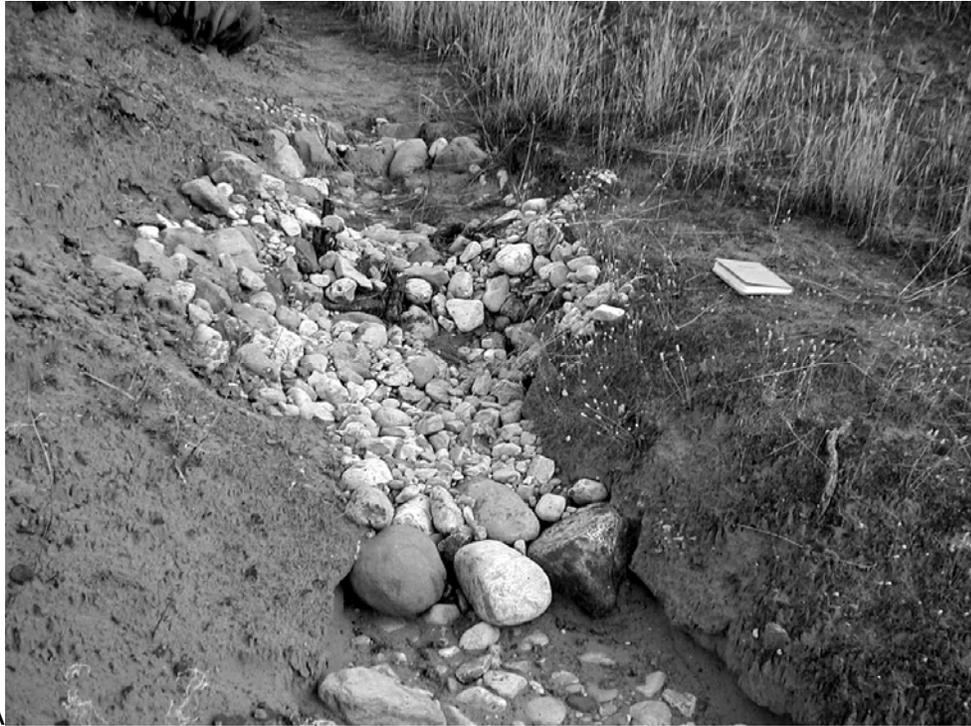
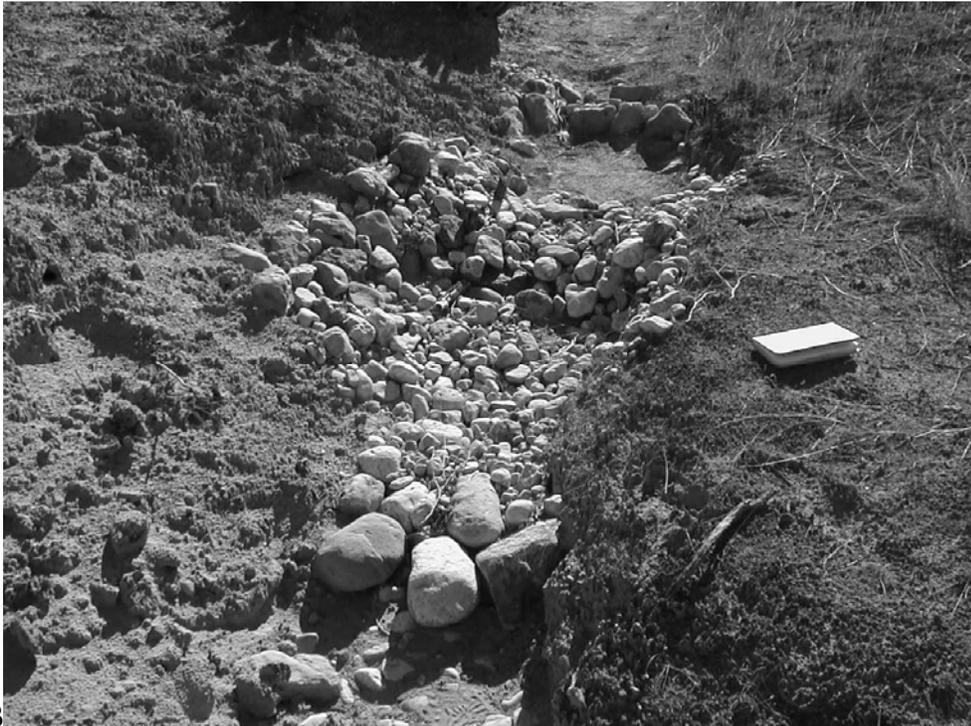
Figure G.23. Granite Park unnamed structures in foreground, structure #2 in background. February (A) intact, minor flanking around foreground boulders; October (B) little change.

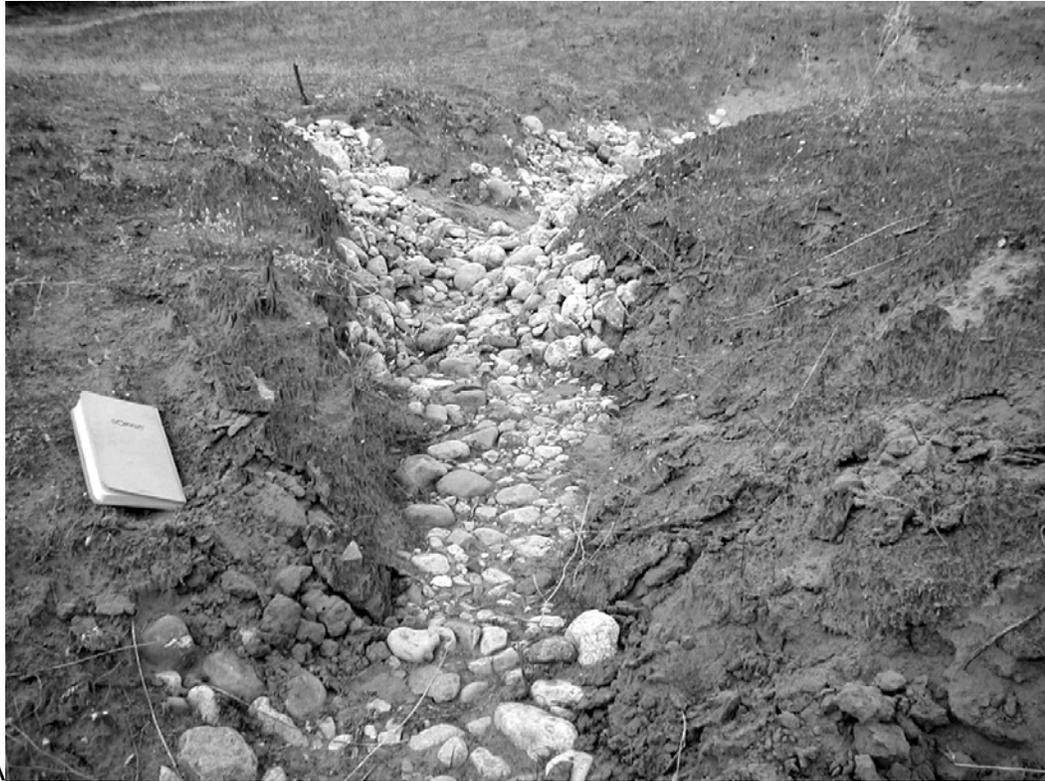
A

Figure G.24. Unnamed structures. February (A): intact. October (B): sediment filling at bottom and top of photograph (arrows).

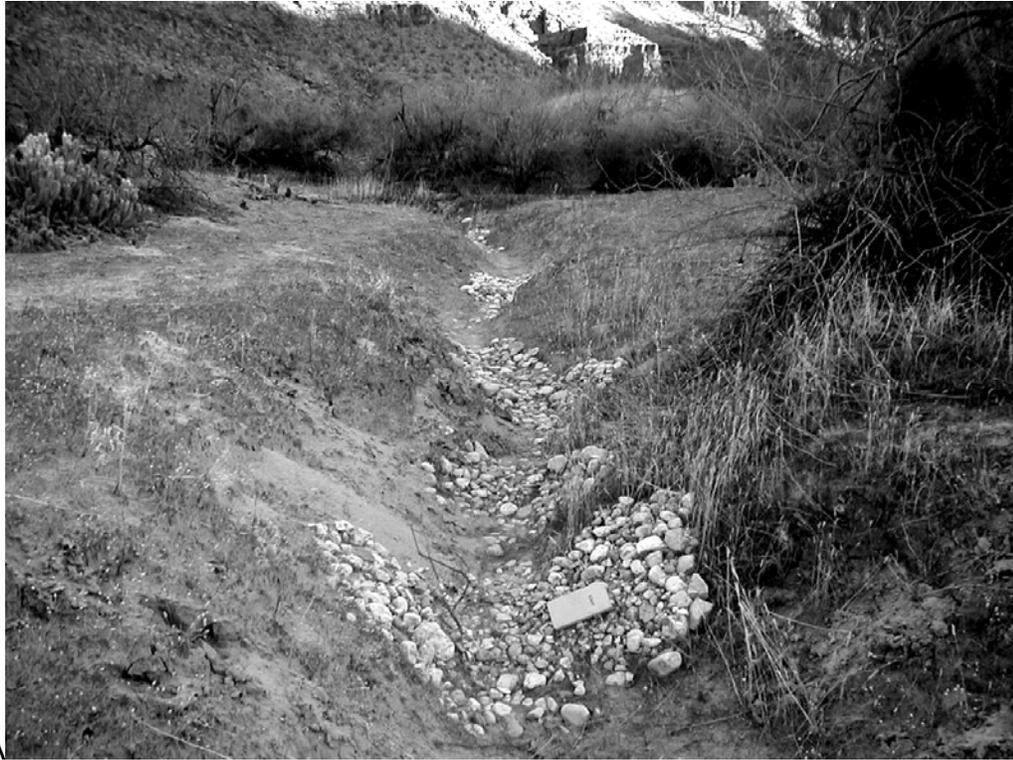
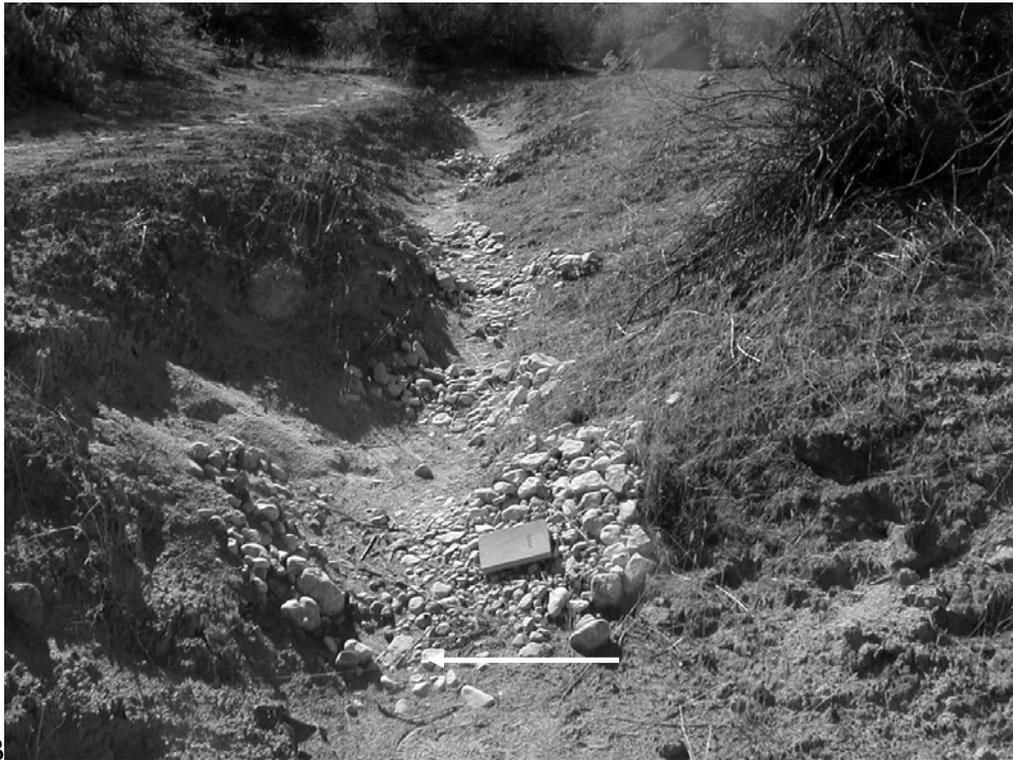
Figure G.25. Granite Park series of unnamed structures. February intact; October sediment infilling in front checkdam (arrow).

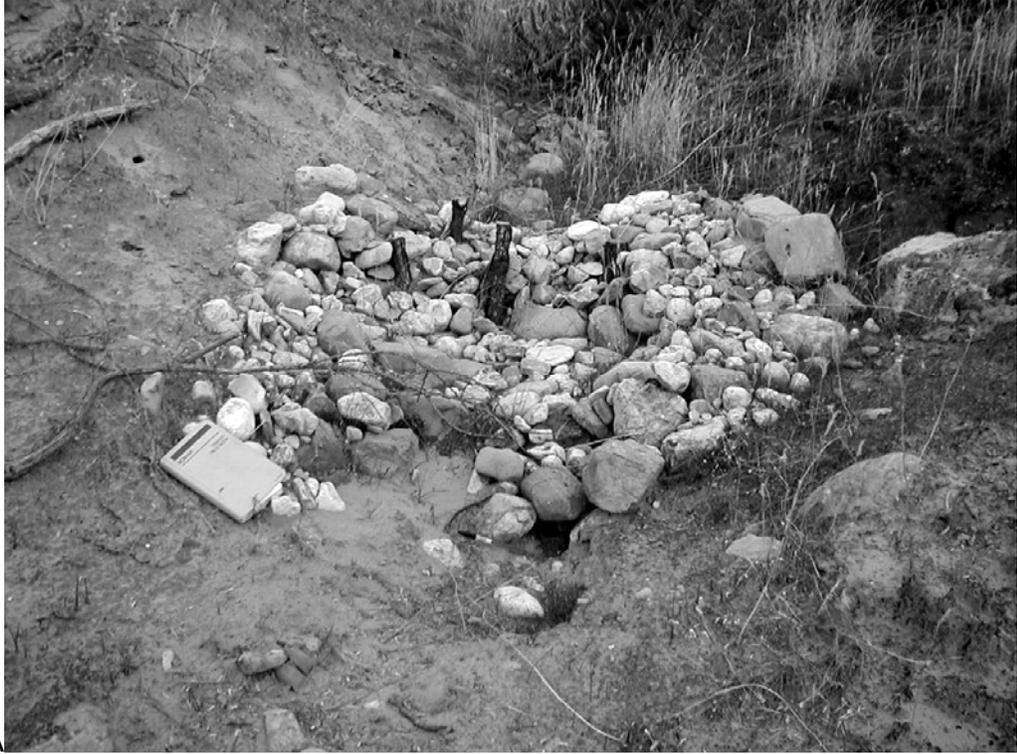
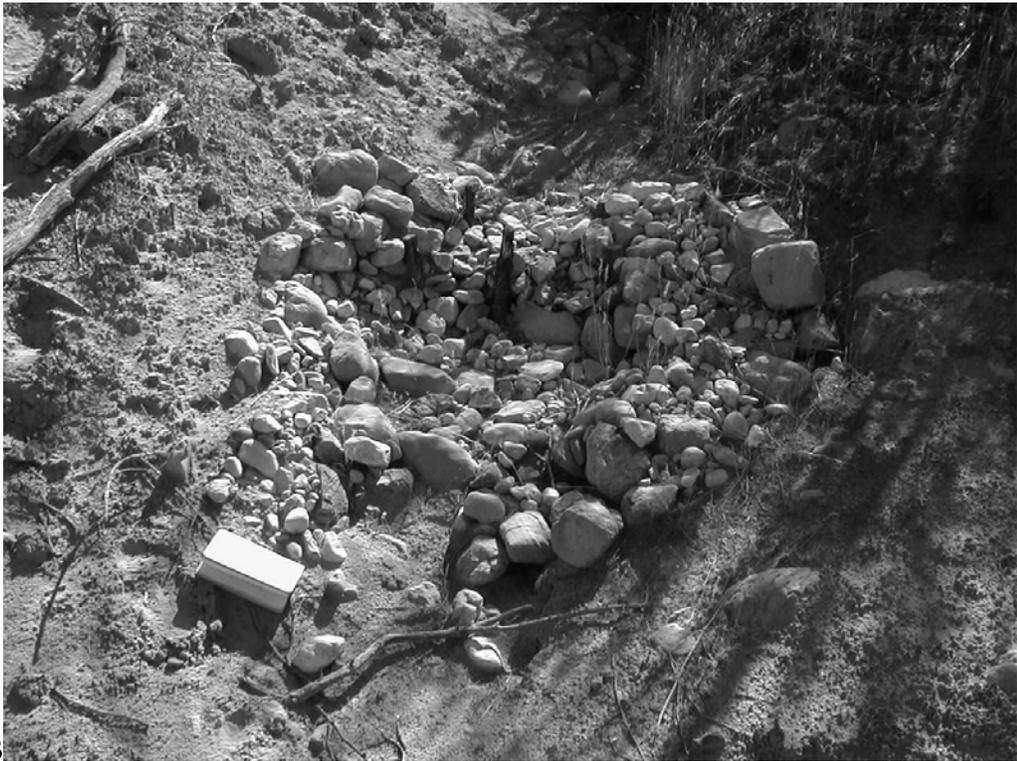
Figure G.26. Granite Park structure #1. February (A) intact; October (B) no change.

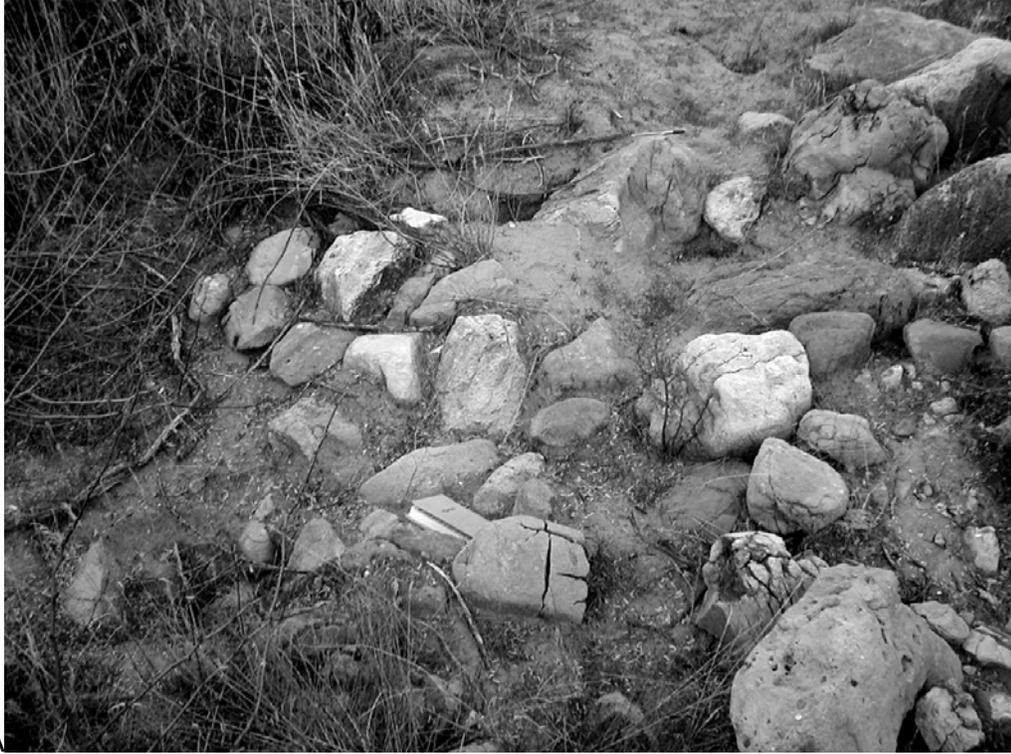
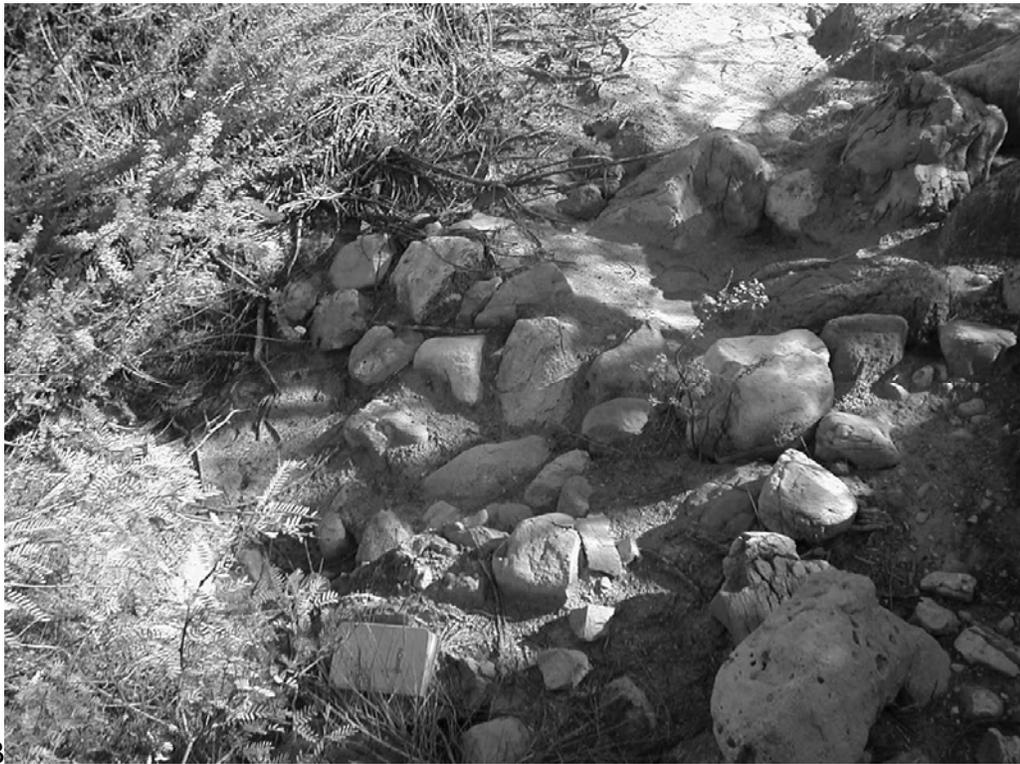
Figure G.27. Granite Park structure #4. February (A) intact; October (B) no change.

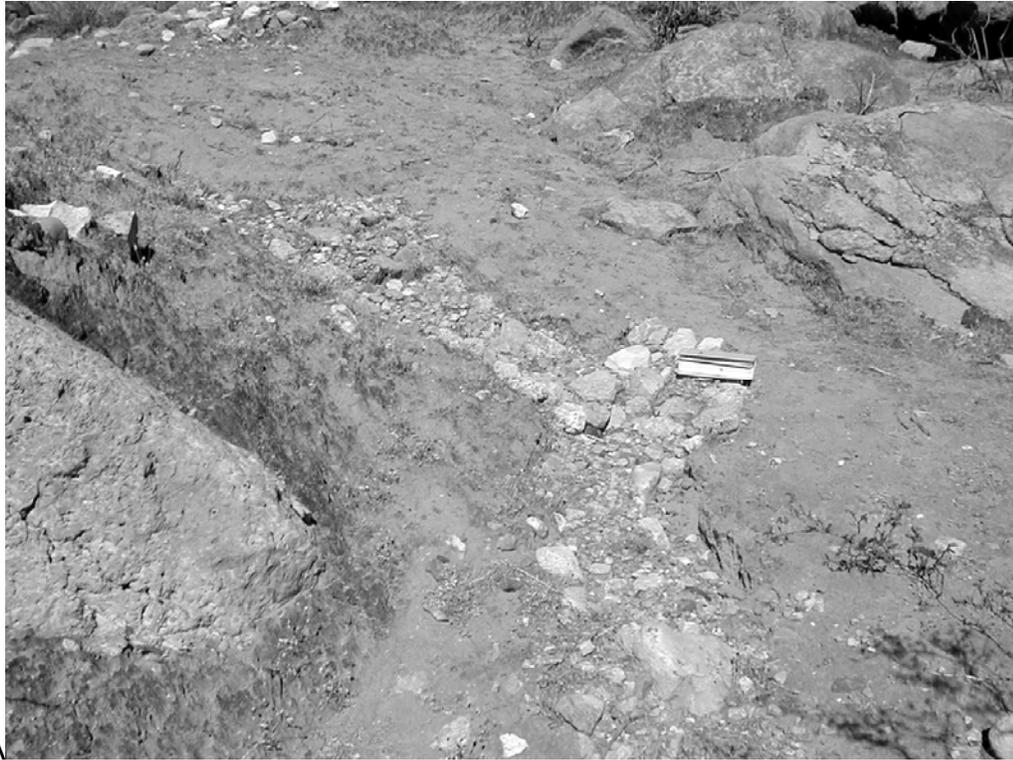
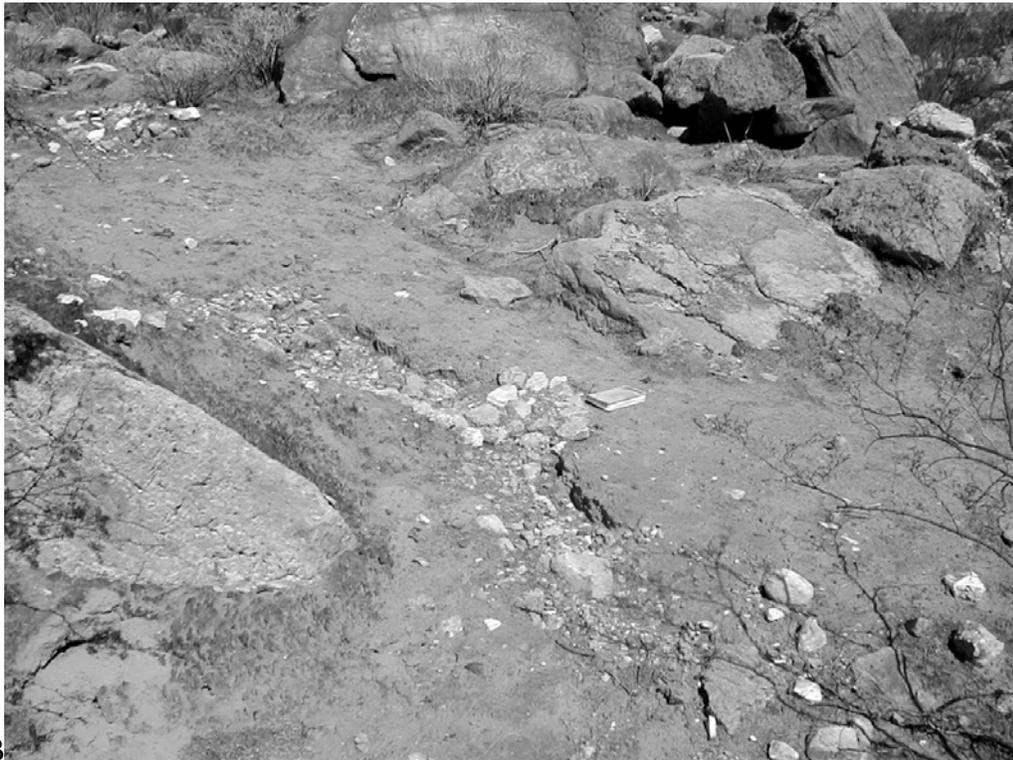
Figure G.29. 223-mile structure #10. February (A) some flanking; October (B) no change.

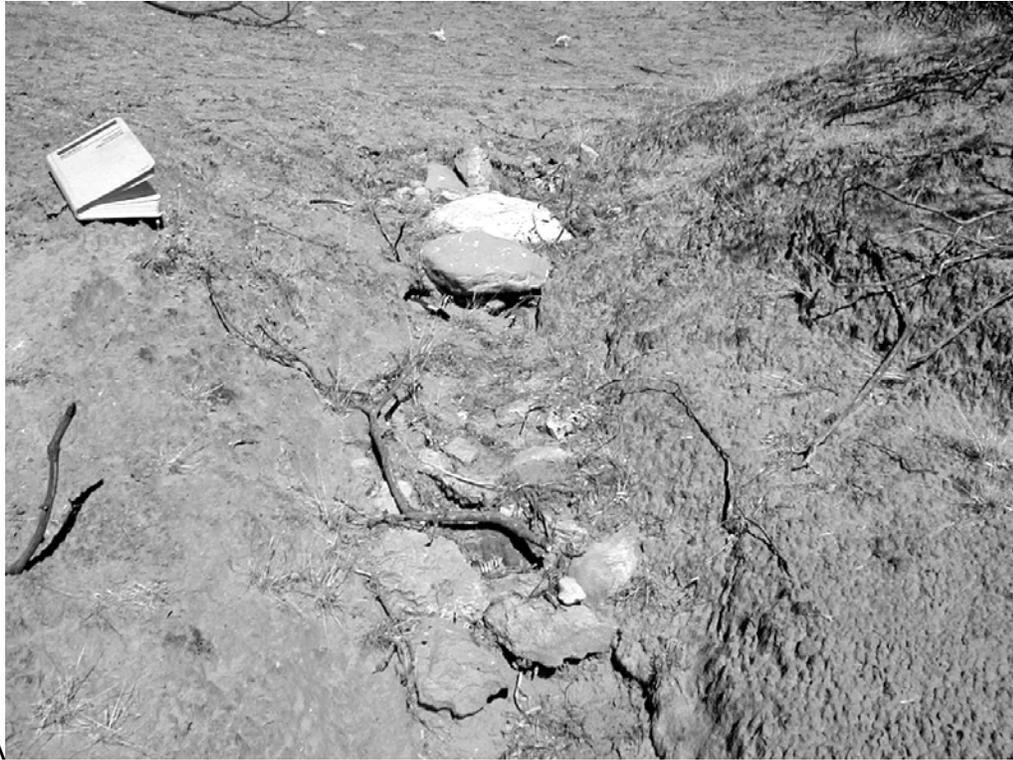
A

Figure G.30. 223-mile structure #5. February (A) minor breaching, but mostly intact; October (B) no change.

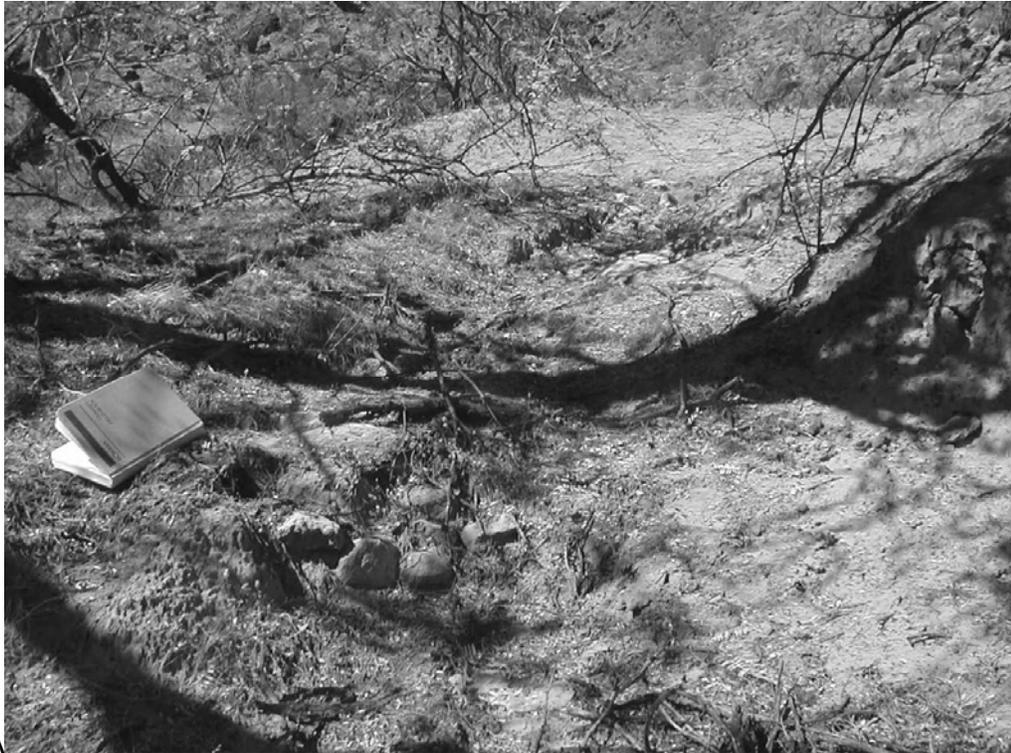
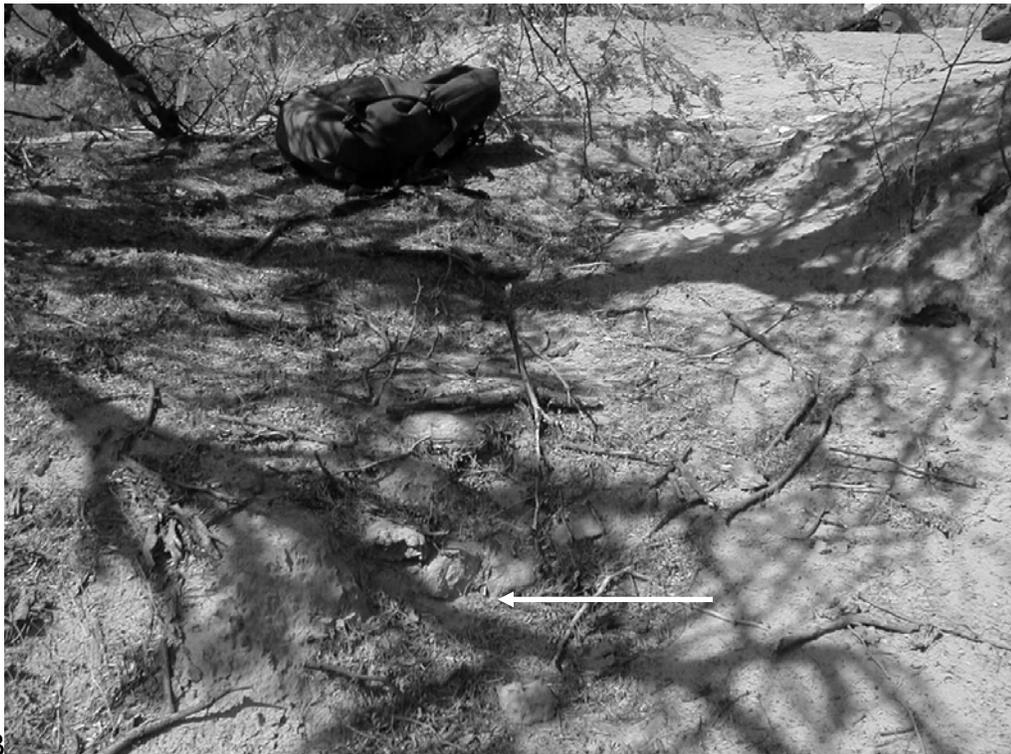
Figure G.31. 223-mile structures #7 (foreground) and #6 (background). February (A) both are intact; October (B) some deposition within structure #7 (arrow).

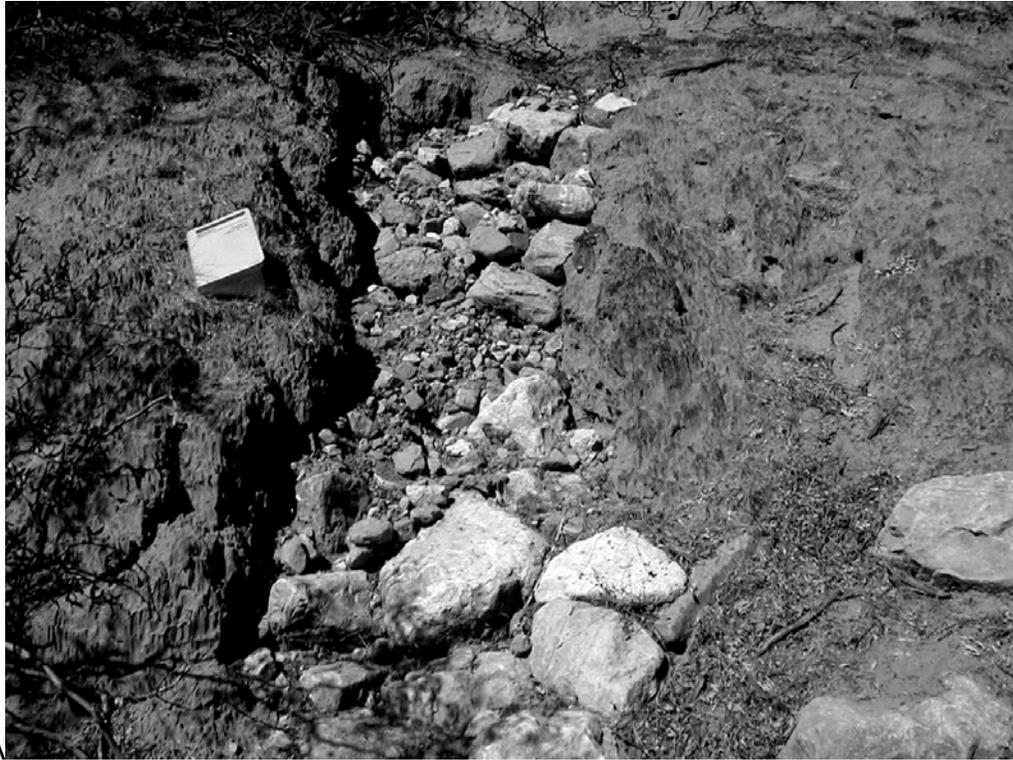
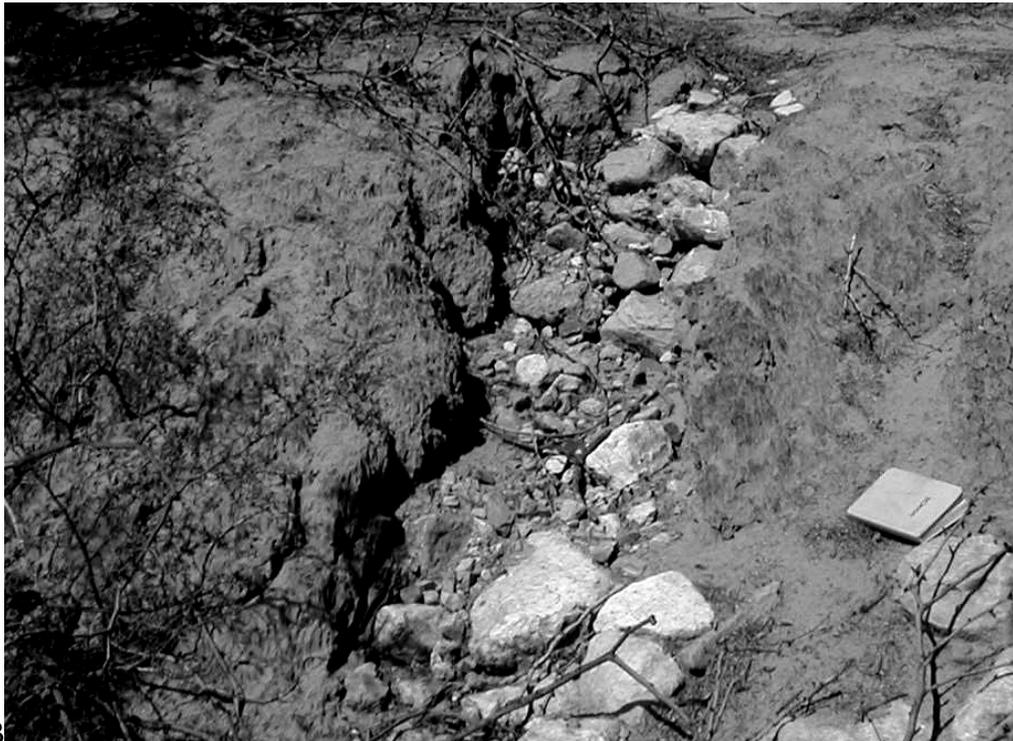
Figure G.32. 223-mile structure #16. February (A) flanked and breached; October (B) no change.

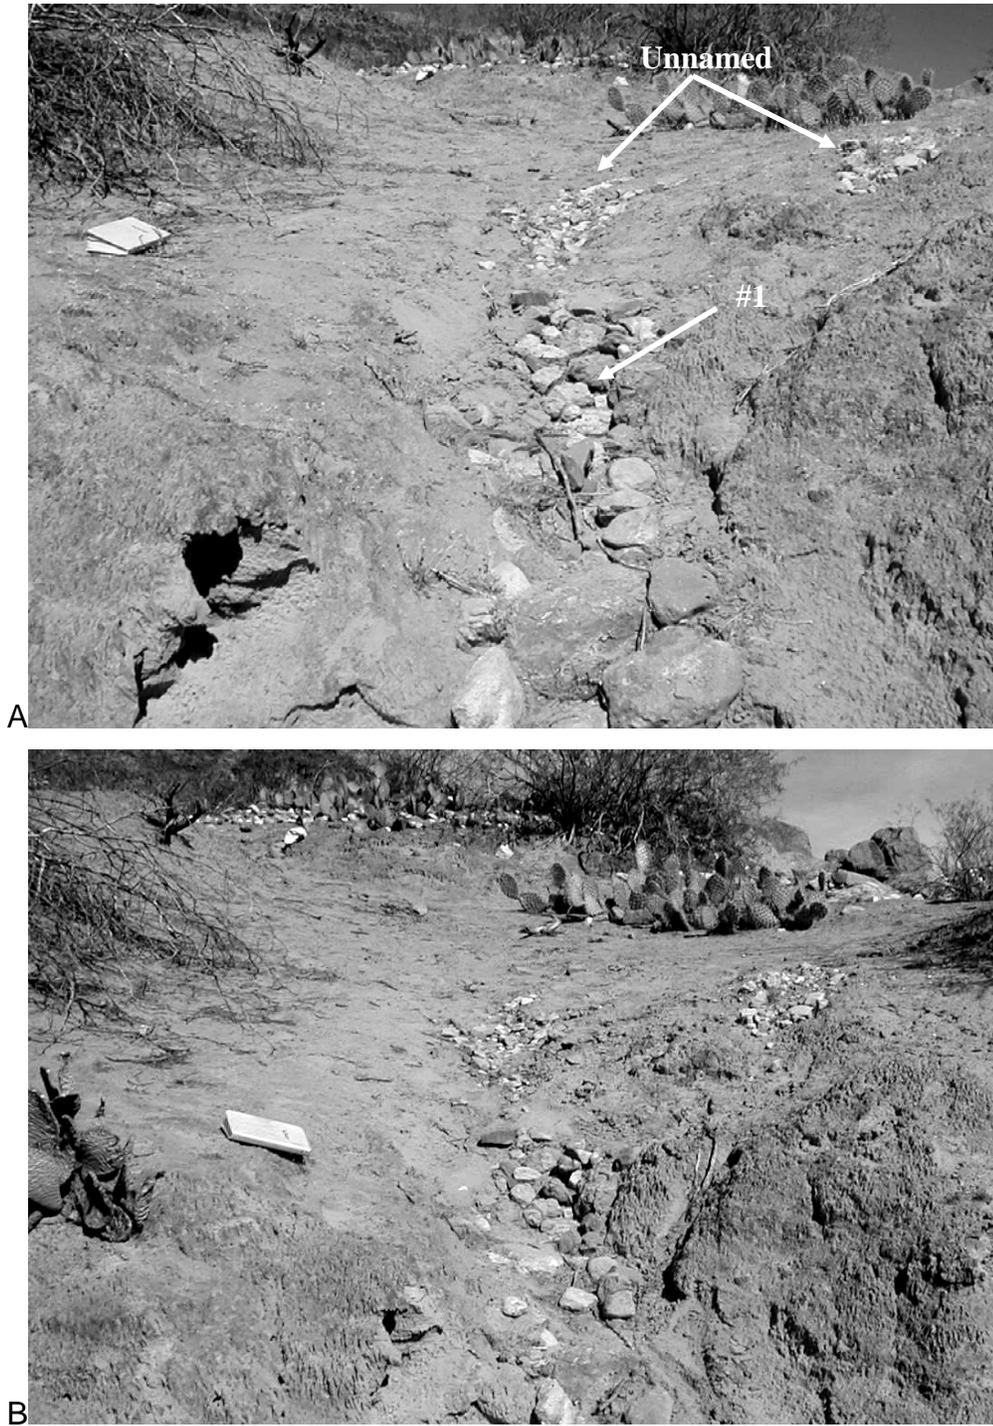
Figure G.33. 223-mile structure #1 (bottom), unnamed structures (top). February (A) #1 has minor breaching and flanking; unnamed structures intact; October (B) no change.

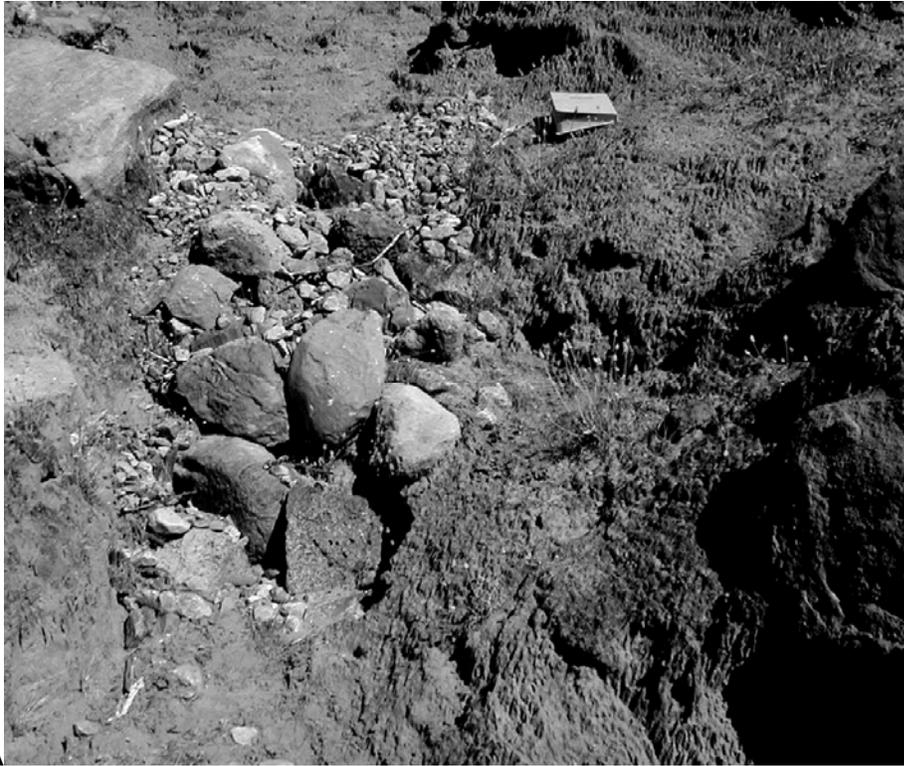
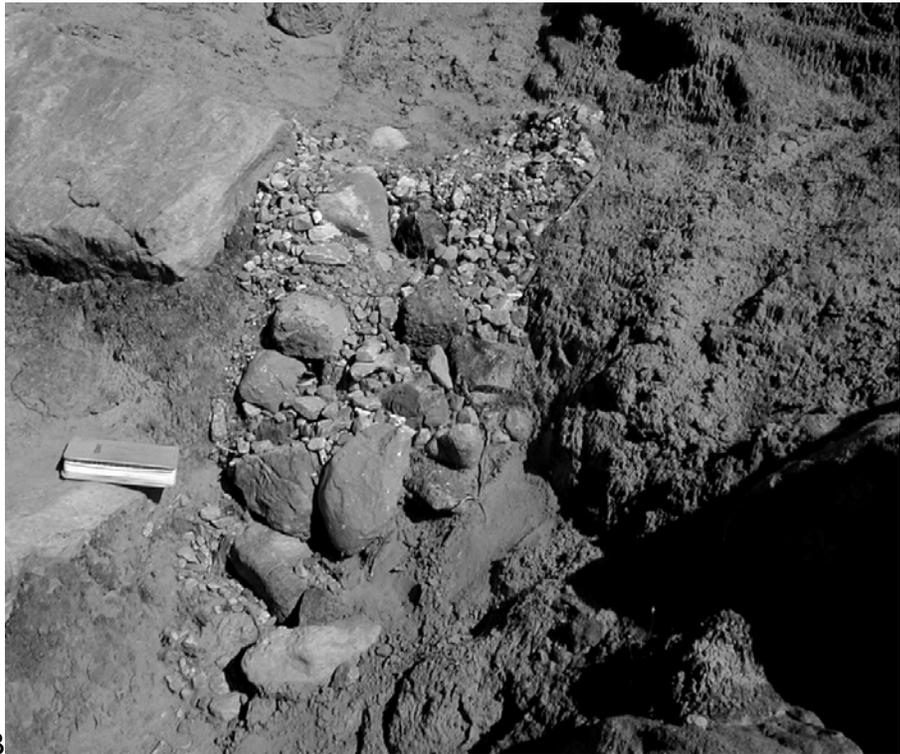
Figure G.34. 223-mile structure #2. February (A) minor breaching, rock displacement; October (B) little change.
