MITIGATION, MONITORING, AND GEOMORPHOLOGY
RELATED TO GULLY EROSION OF CULTURAL SITES
IN GRAND CANYON

Joel L. Pederson¹, Paul A. Petersen^{1,2}, William W. Macfarlane²,
Mark F. Gonzales³, Keith Kohl³

November 2003

Report in fulfillment of cooperative agreement 01WRAG0074 and modifications
between Utah State University and the U.S. Geological Survey,
Grand Canyon Monitoring and Research Center

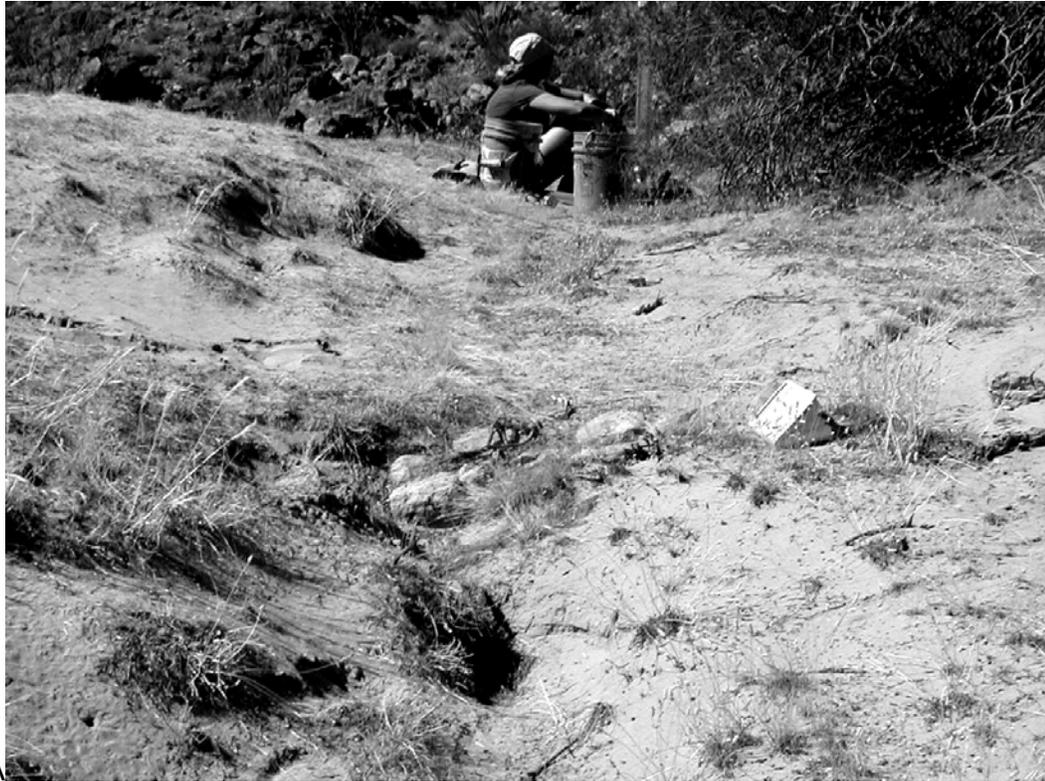
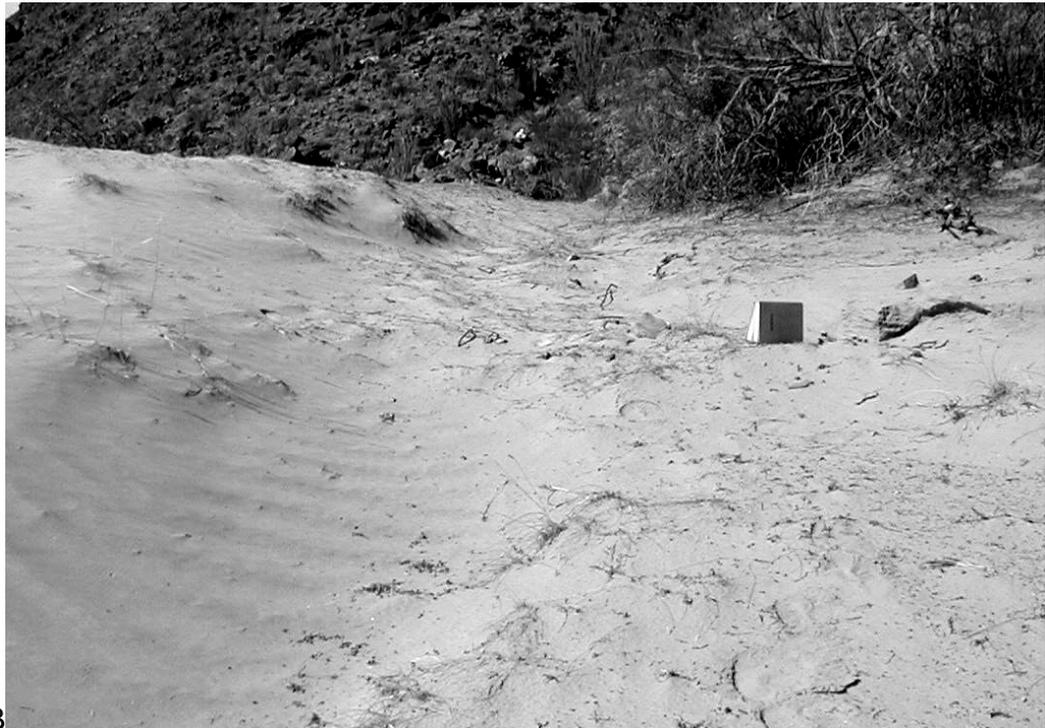
Figure G.35. 223-mile structure #11. February (A) intact; October (B) infilled by eolian sand.

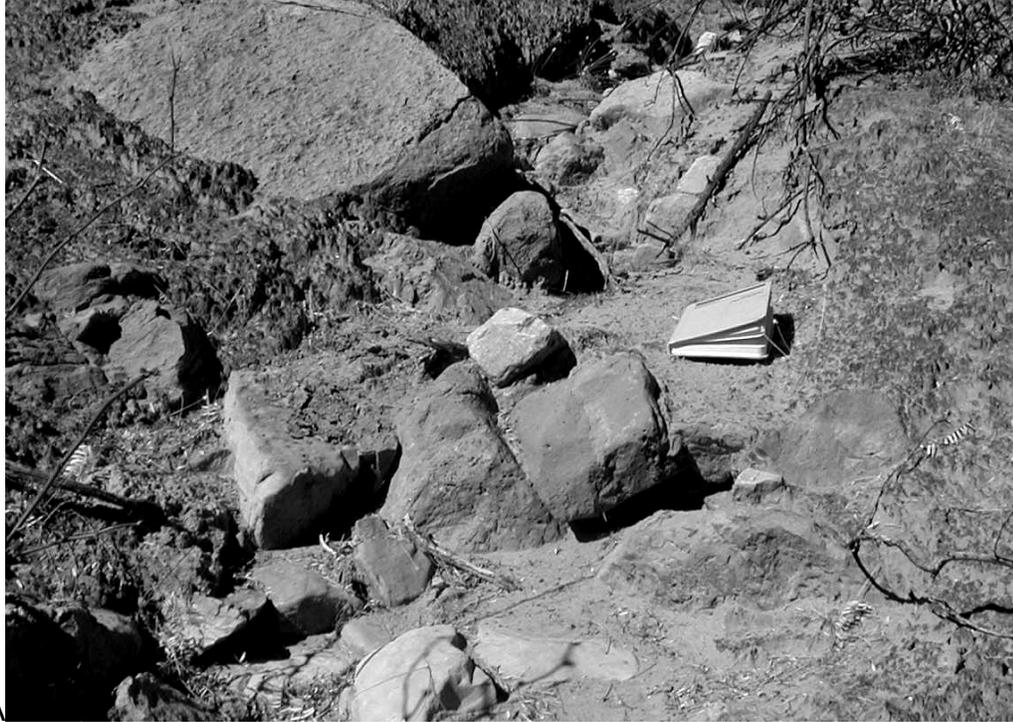
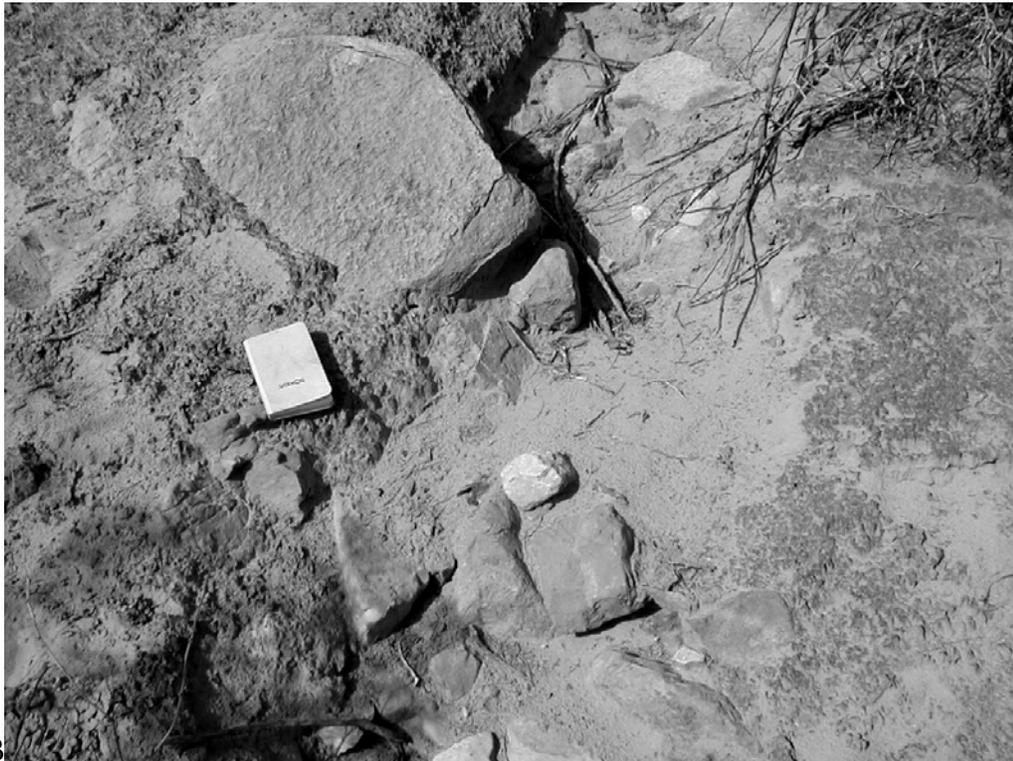
Figure G.36. 223-mile structure #14. February (B) minor breaching and flanking; October (B) no change.
