HYDROLOGY AND SEDIMENTOLOGY OF THE COLORADO RIVER
IN GRAND CANYON

Technical Report No. 13

Final Report

Department of Civil Engineering
University of Arizona
Tucson, Arizona 85721

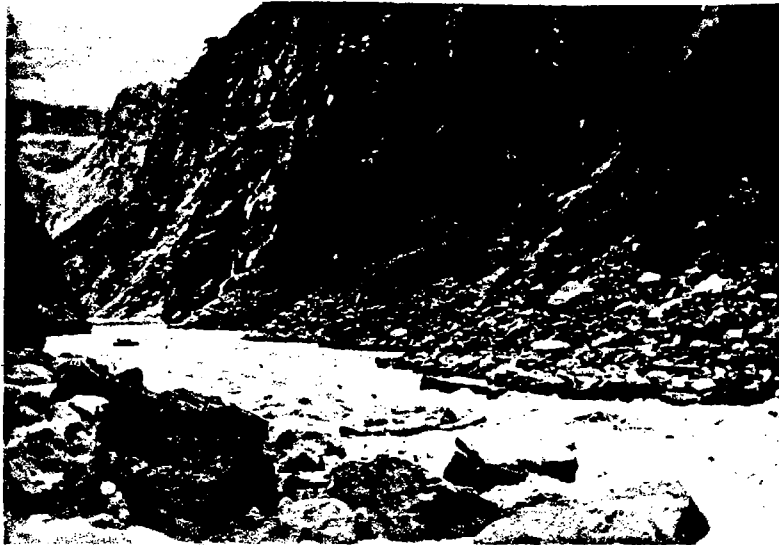
Figure 2. Boulder mass at a rapids of the Colorado River

These same characteristics in the same order are found in the flow pattern over the boulder mass that forms a rapids; however, the flow is now three dimensional and not at all smooth and simple. Each boulder, especially the large ones, is a geometric boundary element that the flow must go over and around. In going over a boulder the flow must go uphill and will slow down, only to speed up again when past the top. In going around a boulder the flow may be constricted and increase in velocity, or it may be deflected past a low-velocity, deadwater cup, or it may go into a superelevated curve. At different flow rates the water surface will be higher or lower in respect to the boulders and the flow patterns can change dramatically. The boulder mass will not be symmetrical right and left, but will be roughly a flat V (or U) shape. Sometimes there will be two channels separated by a boulder island which may or may not be covered at high flows. At low flow rates, only the bottom of the V is covered with water. At higher flow rates, the depth and the velocity over the bottom of the V is greater, and the sides of the V becomes covered with water. The dynamic fluid forces on the boulders in the bottom of the V increase from some modest value to a larger value; the forces on the boulders on the sides of the V increase from zero when they are out of the flow to some moderate value. In general at low flow rates the forces on any boulder are smaller than at high flow rates; however, because the flow pattern can switch around with changes in flow rates, for a few special boulders the opposite trend may be possible.

In the past a few, or many, boulders, large and small, were added to the rapids on infrequent occasions. These added boulders were acted upon by the dynamic fluid forces of the flow and either resisted the forces and stayed in place or were moved to a new position where they were able to resist the fluid forces. At the extreme, this new position would be in the downstream pool beyond the toe of the rapids. Before closure and regulation by Glen Canyon Dam, the flood flow each year was quite large and occasionally was very, very large. These large, and

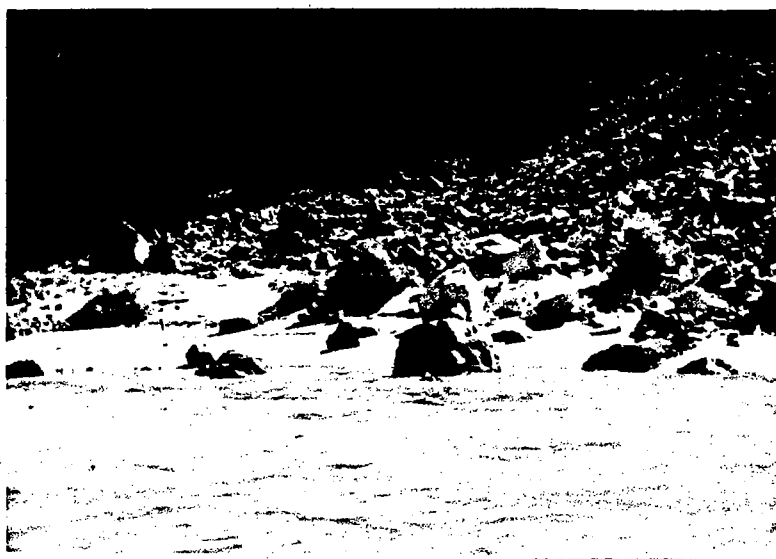
Figure 4. Beach at the base of a talus slope along the Colorado River

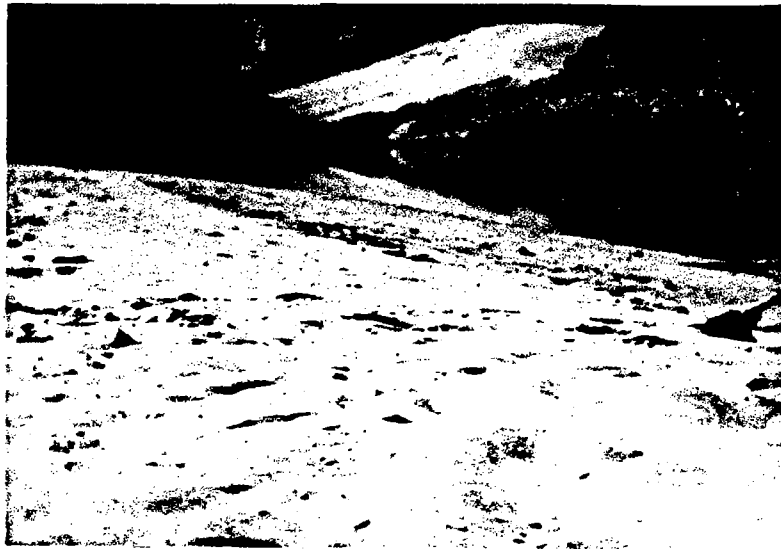
Figure 5. Ripples formed at high water and exposed at low water

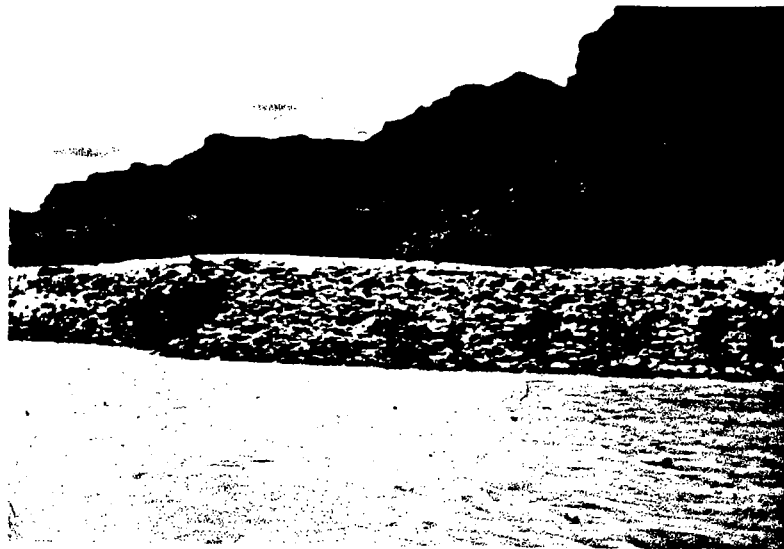
Figure 6. Naturally riprapped beach along the Colorado River

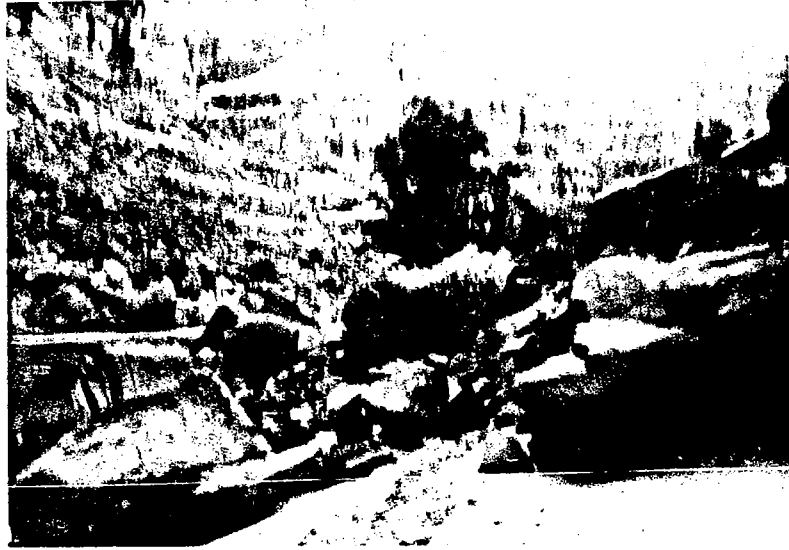
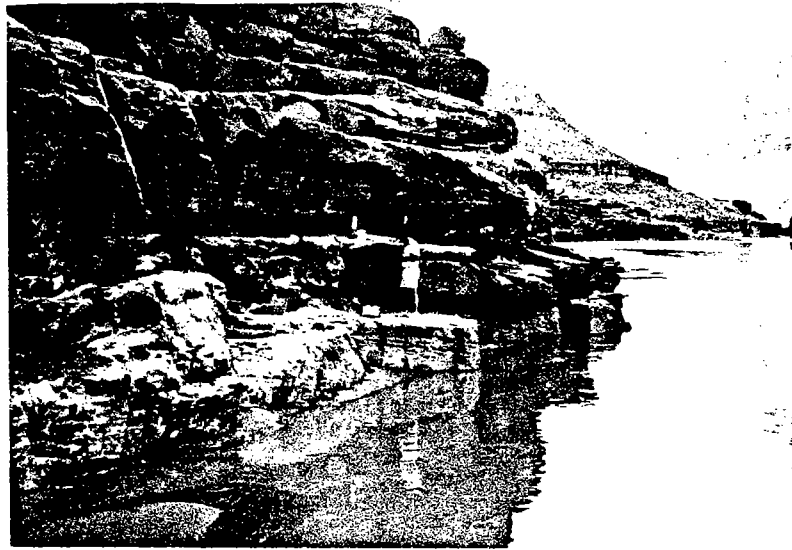
Figure 7. Typical camera station locations

a. Boulder Location

b. Ledge Location

In locating the camera stations an attempt was made to either outline a cross-sectional profile of the beach or to include large rocks (too large to be likely to be moved). If the beach erodes, the profile should move back from the river or down, and the sand line on the large rock should be lowered. These are the changes that can be looked for in successive photos. In the beginning qualitative changes will be sufficient evidence of what is happening. Is the beach eroding or not? If it is eroding, is it eroding a lot or just a little bit? If more quantitative values are necessary in the future, measurement of the distance between rocks, or of rock dimensions, or photos with sticks of known dimensions, strategically placed, should suffice. Figures 7, 8 and 9 show a boulder and a ledge chosen for stations, the pebbles glued on to form stations, and the photos taken from these stations.

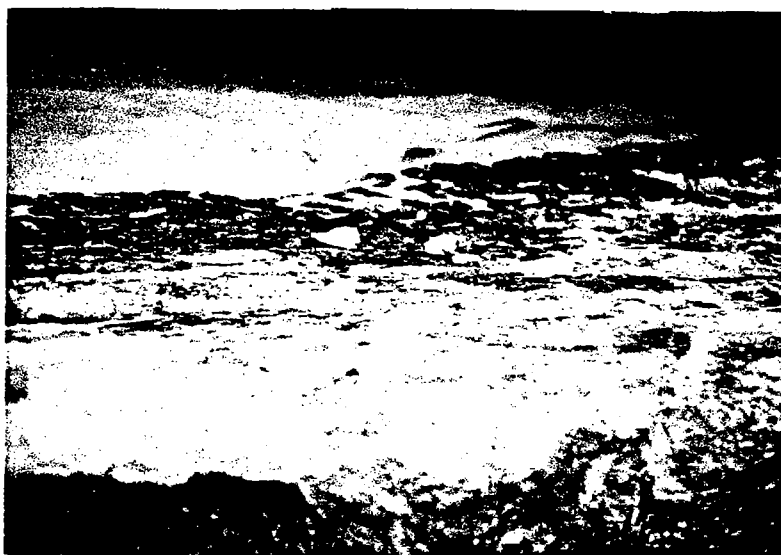
Figure 8. Pebbles glued on rock to form camera stations

a. Camera station on boulder

b. Camera station on ledge

It was quickly discovered that the thin, liquid epoxy glue worked much better and easier when sand was mixed with it, resulting in a paste that would stay in any space between the pebbles forming the camera station and the large boulder or parent rock which was the base of the station. The epoxy was thin enough to make a good contact with smooth rock or even penetrate porous rock; the mix was thick enough to stay in place and remained workable long enough to set several stations. On a second trip a few months later, it was observed that at some of these early stations the paste had run enough to be a little messy. However, the paste blended well enough with the rocks that the stations were hardly noticeable except under close inspection.

The camera stations were made by attaching pebbles to the flat top of a large boulder or a ledge of rock to fit a RICOH Model 500G 35mm camera with a 40mm lens. A very small clearance was left between the pebbles and the camera body so almost exactly the same picture should be taken over and over. Both of the cameras used will be made available for the continuing monitoring program to insure obtaining photos that can be directly compared. In taking the first set of photos the automatic setting on the camera was used. This proved to be a mistake because the beach sometimes was the brightest part of the picture, sometimes the darkest. The pictures should be taken with camera settings for the beach without regard for the rest of the picture. Therefore, some type of light meter should be used to get spot light readings when possible. There should always be enough detail in the rest of the picture to serve as reference points. Color slide film (Kodachrome 25) was used.

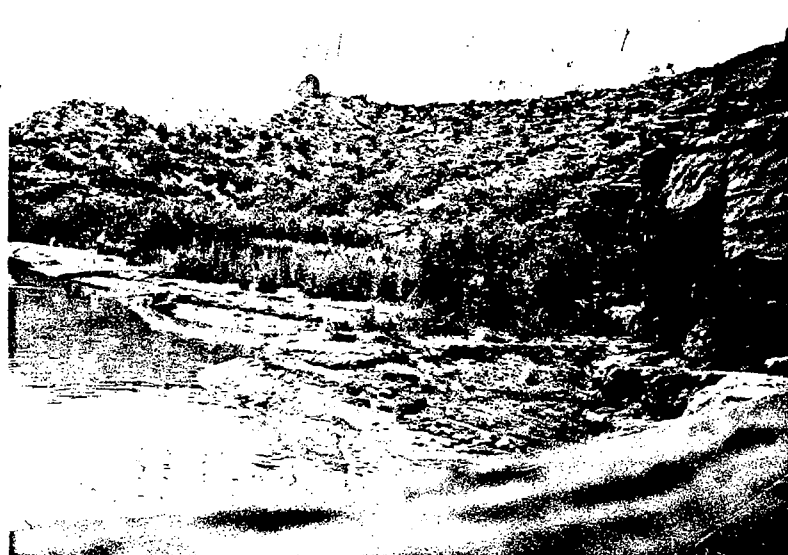
Figure 9. Typical views taken from camera stations

a. Large rocks on beach

b. Profiles of beach

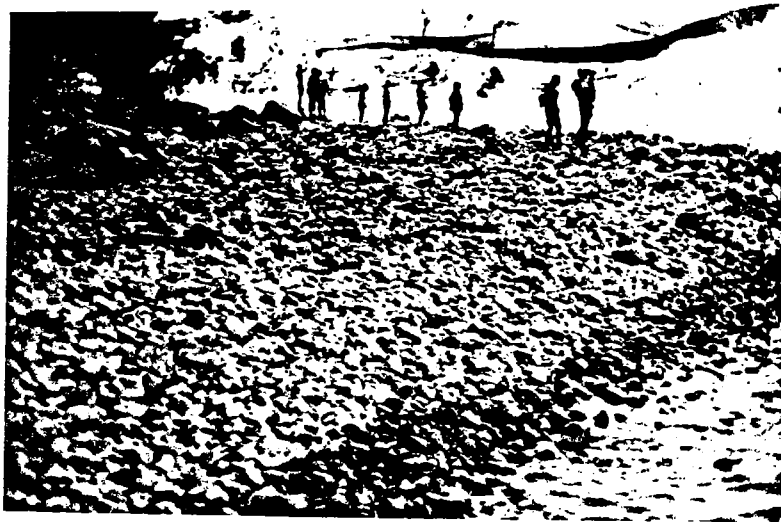
Figure 11. Typical appearance of riprapped beach

a. Riprapped beach

b. Closeup of riprap

At many rapids and many beaches, it could be observed that the flow boundary had been naturally armoured with riprap - and that often this riprap was only a few inches in diameter. Examples are shown in Figure 11. Considerable time and effort would be needed to expand this simple observation to decide just what size is needed to armour a surface for a given flow in a given rapid geometry. On the other hand,

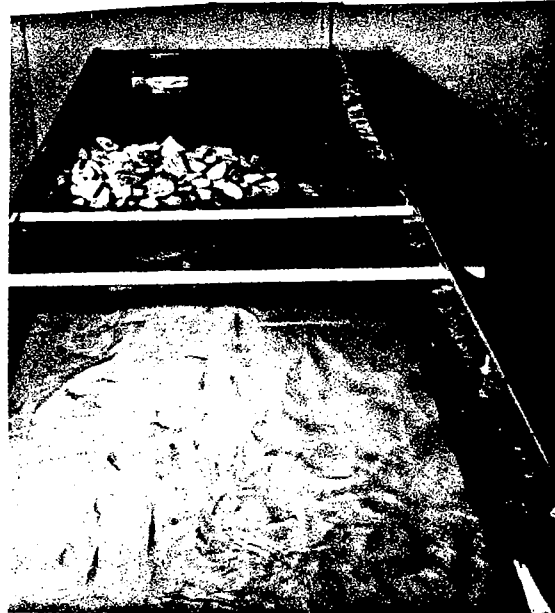
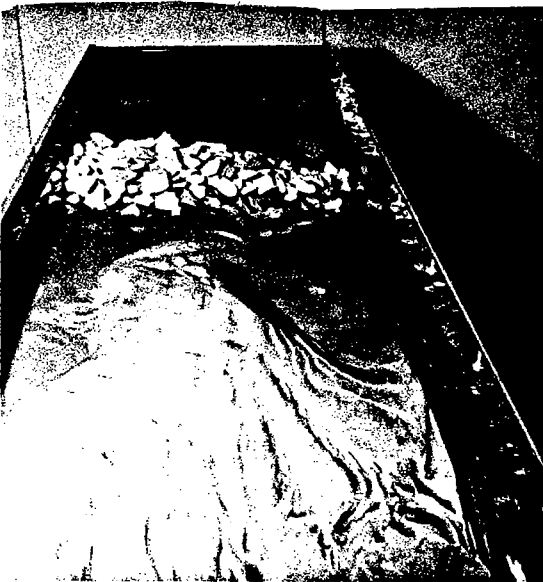
Figure 12. Formation and erosion of beach in the laboratory

a. Beginning of run

b. Formation of bar (beach)

c. Emergence of beach

d. Eroding beach

The rapids formed in the small laboratory flume could only be suggestive of real Colorado River rapids. They seemed to be typical in their action. The rapids constricted the flow, there was a critical control and supercritical flow down the face of the rapids. This high velocity, supercritical jet dug a scour hole below the rapids. The jet in the scour hole spread laterally in a 180° fan with some of the flow coming out laterally. The lateral flow carried with it a bed load which moved outward and upward and was deposited as an underwater bar. When the flow rate and the water surface elevation was decreased, this bar (or deposit) was above water and had formed a typical Colorado River beach below a rapids (Figure 12).

As long as sediment was supplied to the head of the flume above the rapids, the bar or beach was stable once it had been formed. The supply of sediment to the beach and the capacity to move sediment along and off the beach was balanced. When the supply ceased, the capacity to transport was no longer balanced by the supply and the beach started to erode. The erosion continued for a time with essentially the same flow pattern as with a sediment supply, but when the beach eroded too much, the main flow would separate from the boundary (the beach) and an eddy would be interposed between the main flow and the beach. The eddy would move sediment upstream along the beach and off the beach into the main flow from whence it would be moved on downstream. The erosion of the beach seemed to go on and on forever, although the rate of erosion got slower and slower. This geometric, asymptotic progression is the usual form of clear-water scour phenomena.

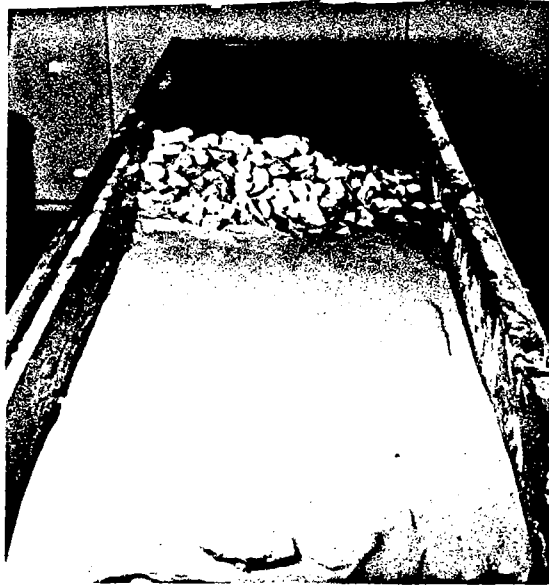
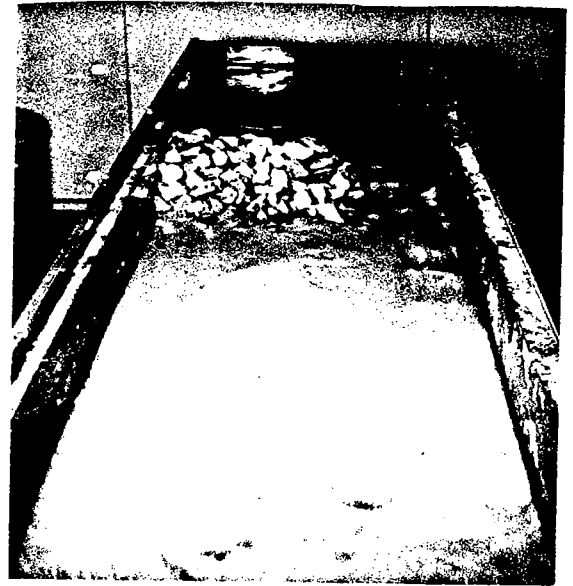
Figure 13. Beach formation and erosion affected by large rock in rapids

a. Beginning of run

b. Formation of bar (beach)

c. Emergence of beach

d. Eroding beach

During the active phase of scour hole formation and beach building, a greater supply of sediment would result in a shallower scour hole and more rapid beach building. If the rapid contained a large rock, the flow could go over the rock during high flow and be diverted during low flow - not completely, but more or less. A steep rapid could result in a short scour hole; a flat rapid in a long scour hole. A small, intense eddy could form directly at the end of rapid before the geometry of the scour hole induced the spread of the jet into a fan shape; a strategically placed rock could cause enough lateral flow to break up this eddy. Different rocks placed differently resulted in different bed and beach configurations but all were very similar and qualitatively alike (Figure 13).

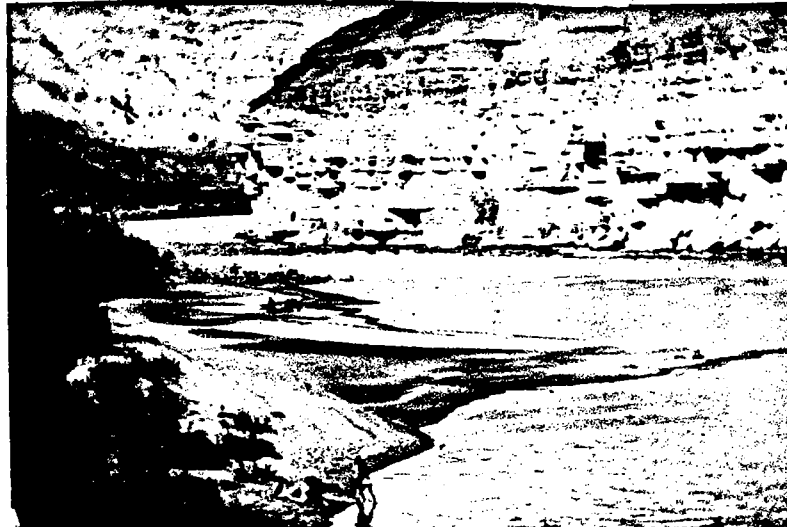
Figure 14. Typical beach below a rapids on the Colorado River

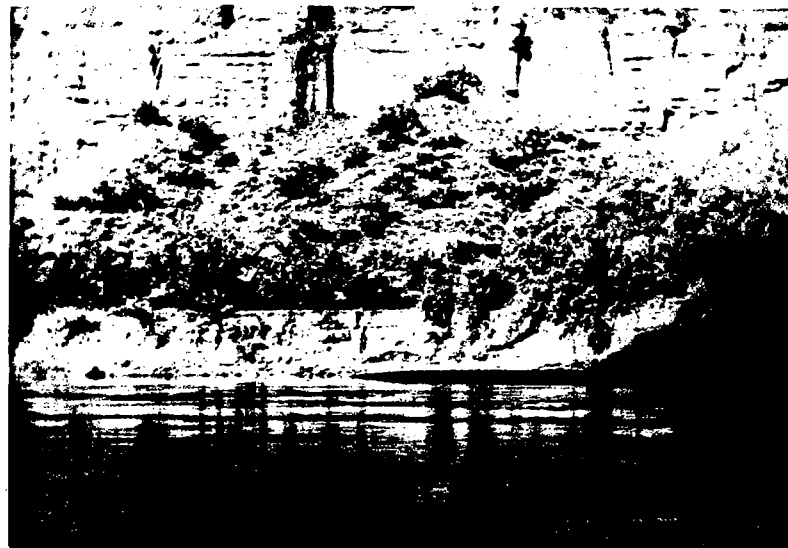
Figure 15. Eroding beach along the Colorado River

There may be some tendency towards erosion wearing away the beaches at moderate and low flows (Figure 15). Scour and fill often tend to be cyclic; points in a stream which scour during high flow fill during low flow and vice versa. Since the beaches are cast up in floods, the possibility of erosion during low flows should not be entirely discounted. However, because low flows have low capacities for transport, the scour or fill processes during low water tends to be slow.

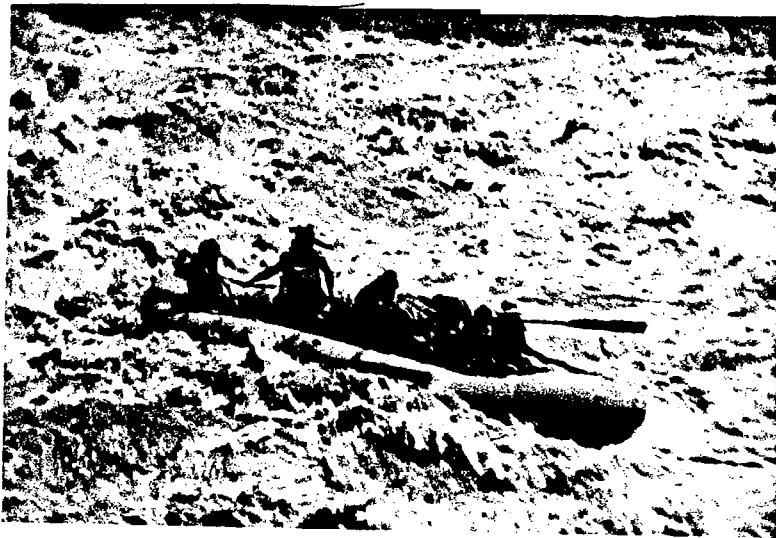
Figure 17. Running a rapids of the Colorado River

The rapids of the Colorado River are there because unusual storms on tributaries resulted in floods of sufficient magnitude to bring down boulders, large and small, in such a quantity as to create rock dams across the river which subsequent river floods have not been able to wash away. Rock falls, residual boulders and exposed bedrock can contribute to these rock dams which can be built up through a series of events. There are boulder masses which merely constrict the river without creating a rapids; whether because the mass was never large enough to create a dam or because the river has been able to wear it away is difficult, if not impossible, to say. A small rock dam may only create a riffle rather than a rapids; the difference being one of degree from a scientific viewpoint, but of considerable consequence from a practical viewpoint. Running the rapids is a large part of the fun of a Colorado River boat trip (Figure 17).

The essential hydraulic characteristic of rapids is that the constriction of the flow by the rise in the river bed and the pinching in of the walls results in a critical control, i.e., the flow goes through critical (minimum energy for a given discharge) with subcritical, tranquil, low velocity flow in the pool above, critical depth and velocity at the crest, and supercritical, high velocity flow on the steep rocky downstream slope of the boulder mass. At the toe of the rapids, the transition back to the tranquil flow condition in the next pool takes place either by jet dispersion in a deep hole downstream of the rapids or among a jumble of large rocks downstream of the toe.
