# Glen Canyon Dam in Arizona – an interesting rockfall problem

## Glen Canyon Dam

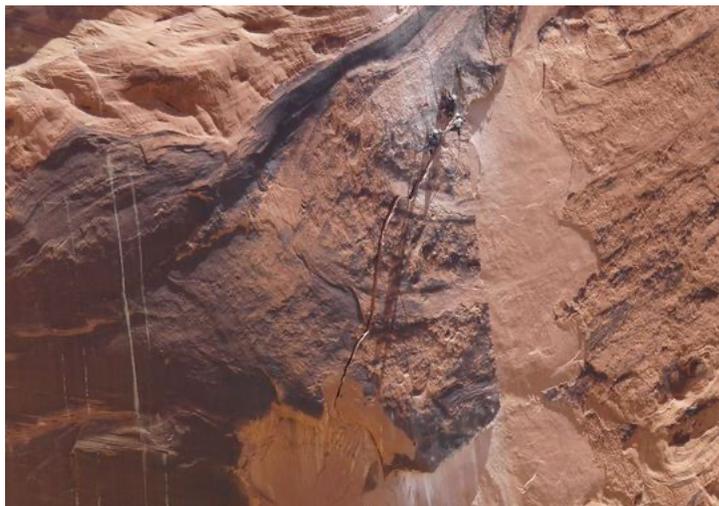
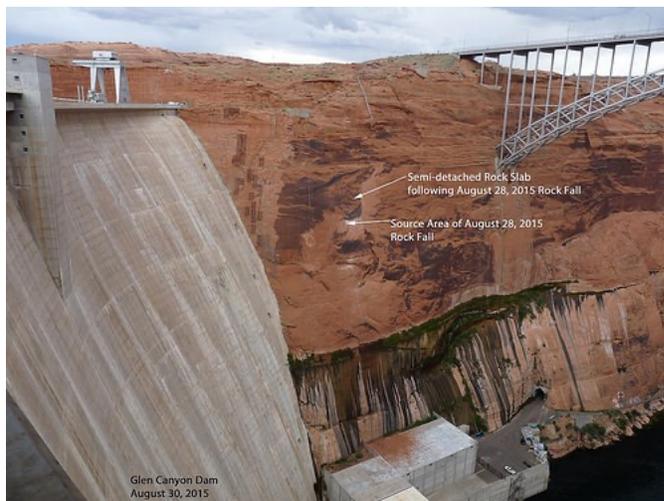
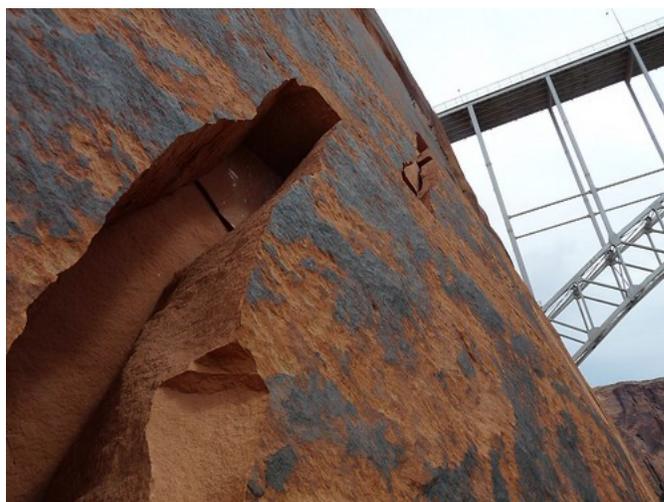
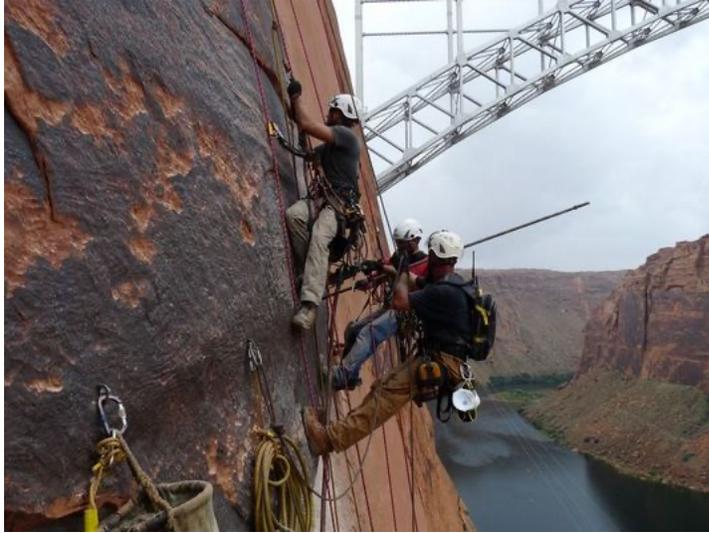
Glen Canyon Dam professionals are in the process of securing the 50-foot high, 30-foot wide and up to 4-foot thick slab of Navajo Sandstone to the canyon wall by installing 6- to 8-foot, 1-inch diameter bolts through the slab and into the wall by specialized Reclamation workers called scalers who drill into the rock and install the bolts while hanging from rappelling lines on the canyon wall.

Soon after the bolts were installed, Glen Canyon Dam operations staff reported several small rock falls and a notable crack opening around a large slab Friday, August 28. No one was injured from the rock falls.

There are some excellent images of this block in the various news stories that have been written over the weekend, all of which seem to have been taken by Mark Neeley from the Bureau:

This is clearly an extraordinarily difficult task. During the development of a canyon sheet joints ([https://en.wikipedia.org/wiki/Exfoliation\\_joint](https://en.wikipedia.org/wiki/Exfoliation_joint)) often form as a result of stress release. These joints often run parallel or subparallel to the face, allowing detachment of blocks to form rockfalls. What is unusual here is that there are few other joints, meaning that the slab that has started to detach is unusually large.
