TECHNICAL RECORD  
OF  
DESIGN AND CONSTRUCTION

# GLEN CANYON DAM AND POWERPLANT

Colorado River Storage Project  
Arizona-Utah

Denver, Colorado  
December 1970

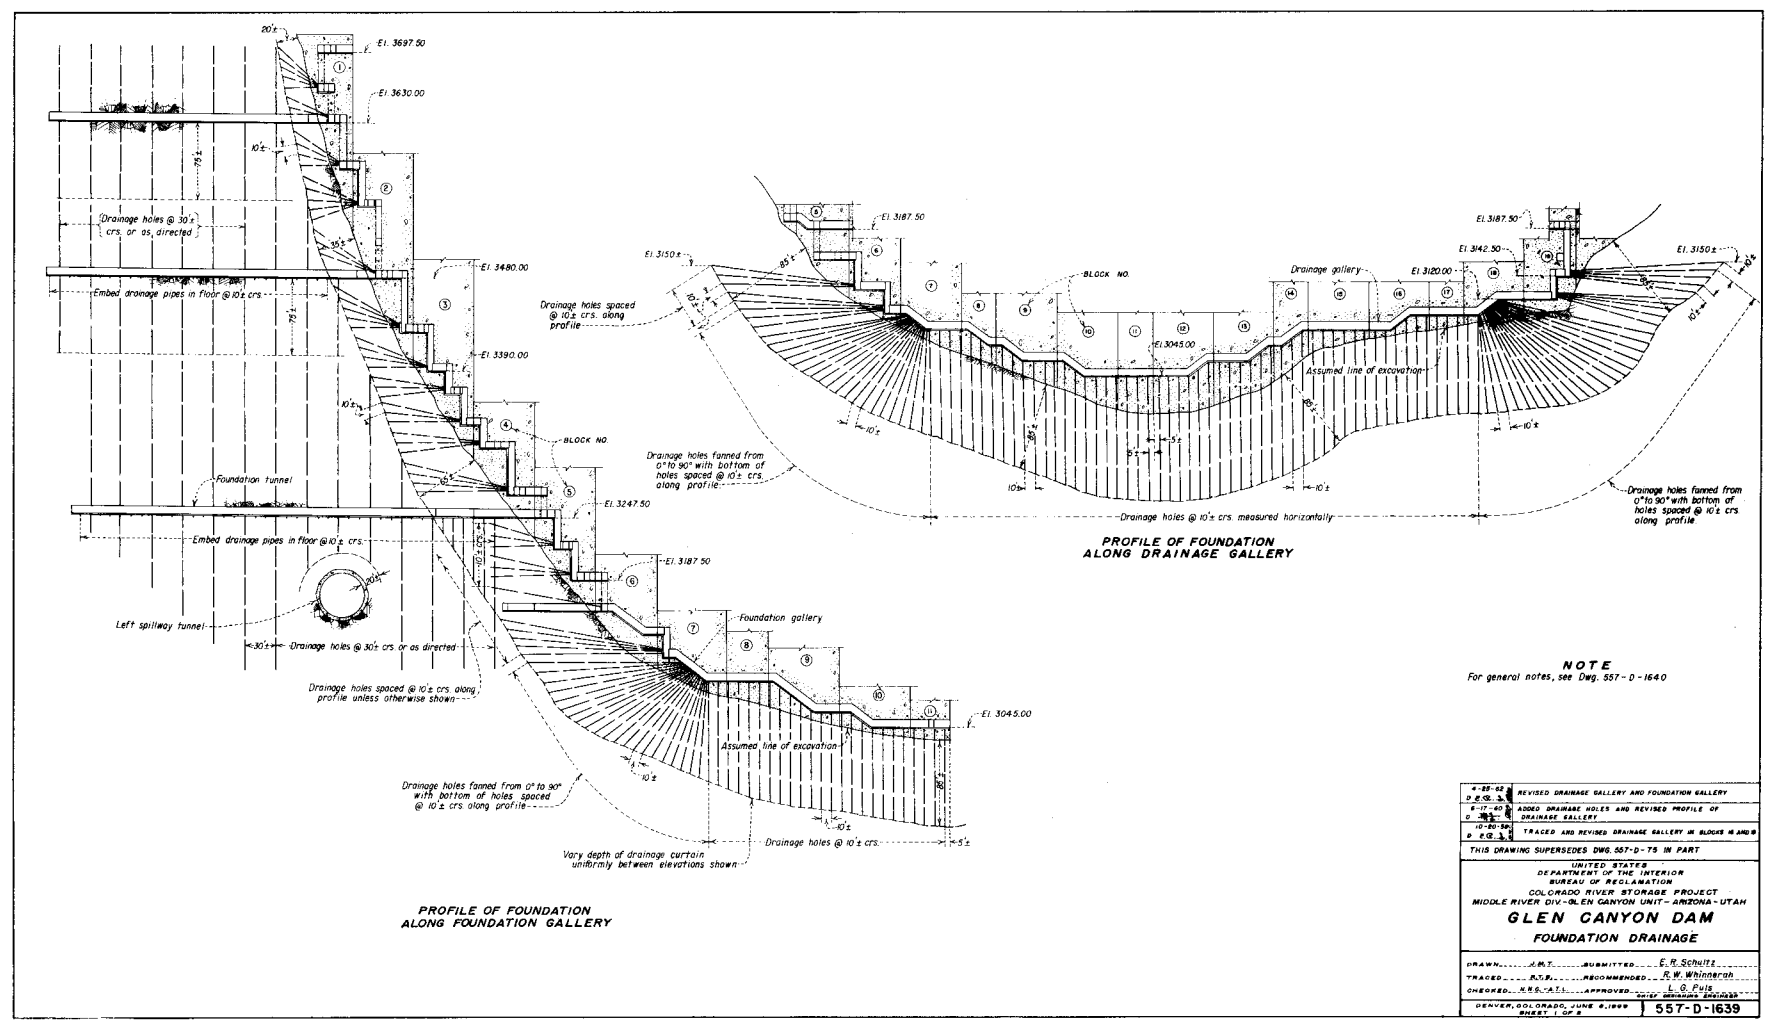
Figure 19.—Left abutment foundation drainage.

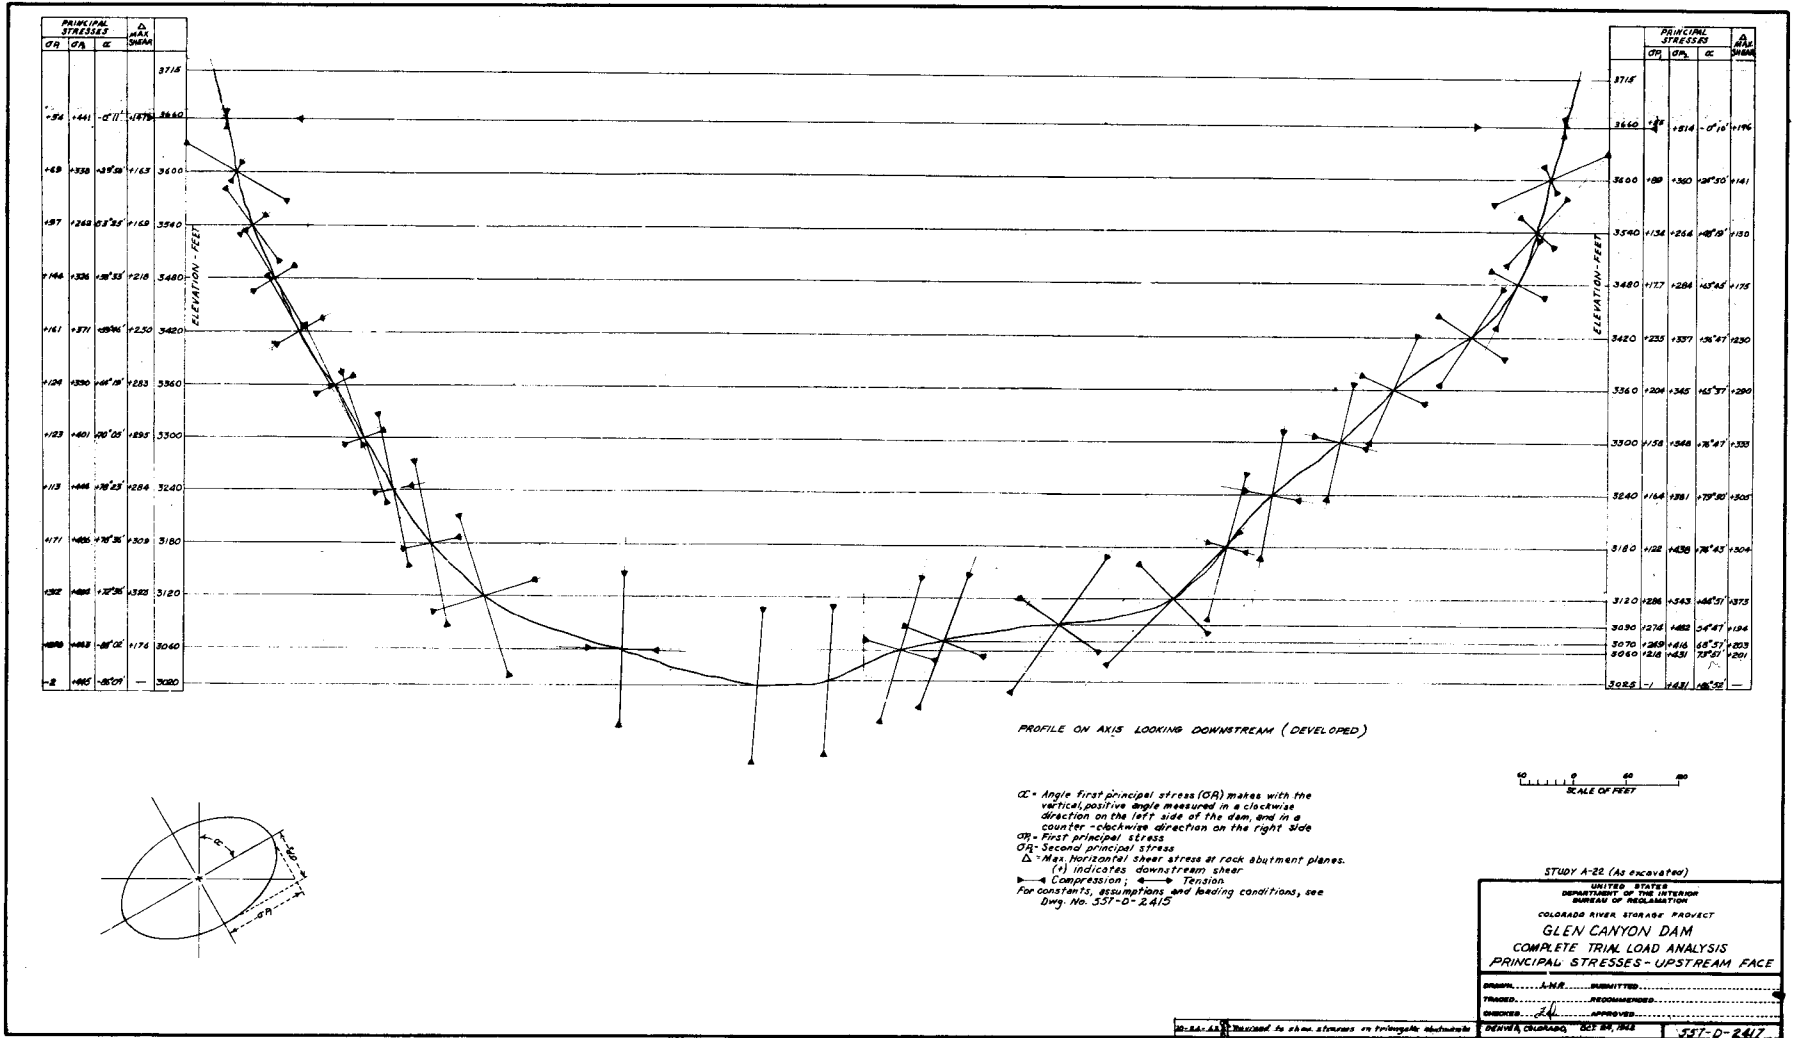
Figure 52.—Dam study A-22a (final), complete trial-load analysis—Principal stresses at upstream face.

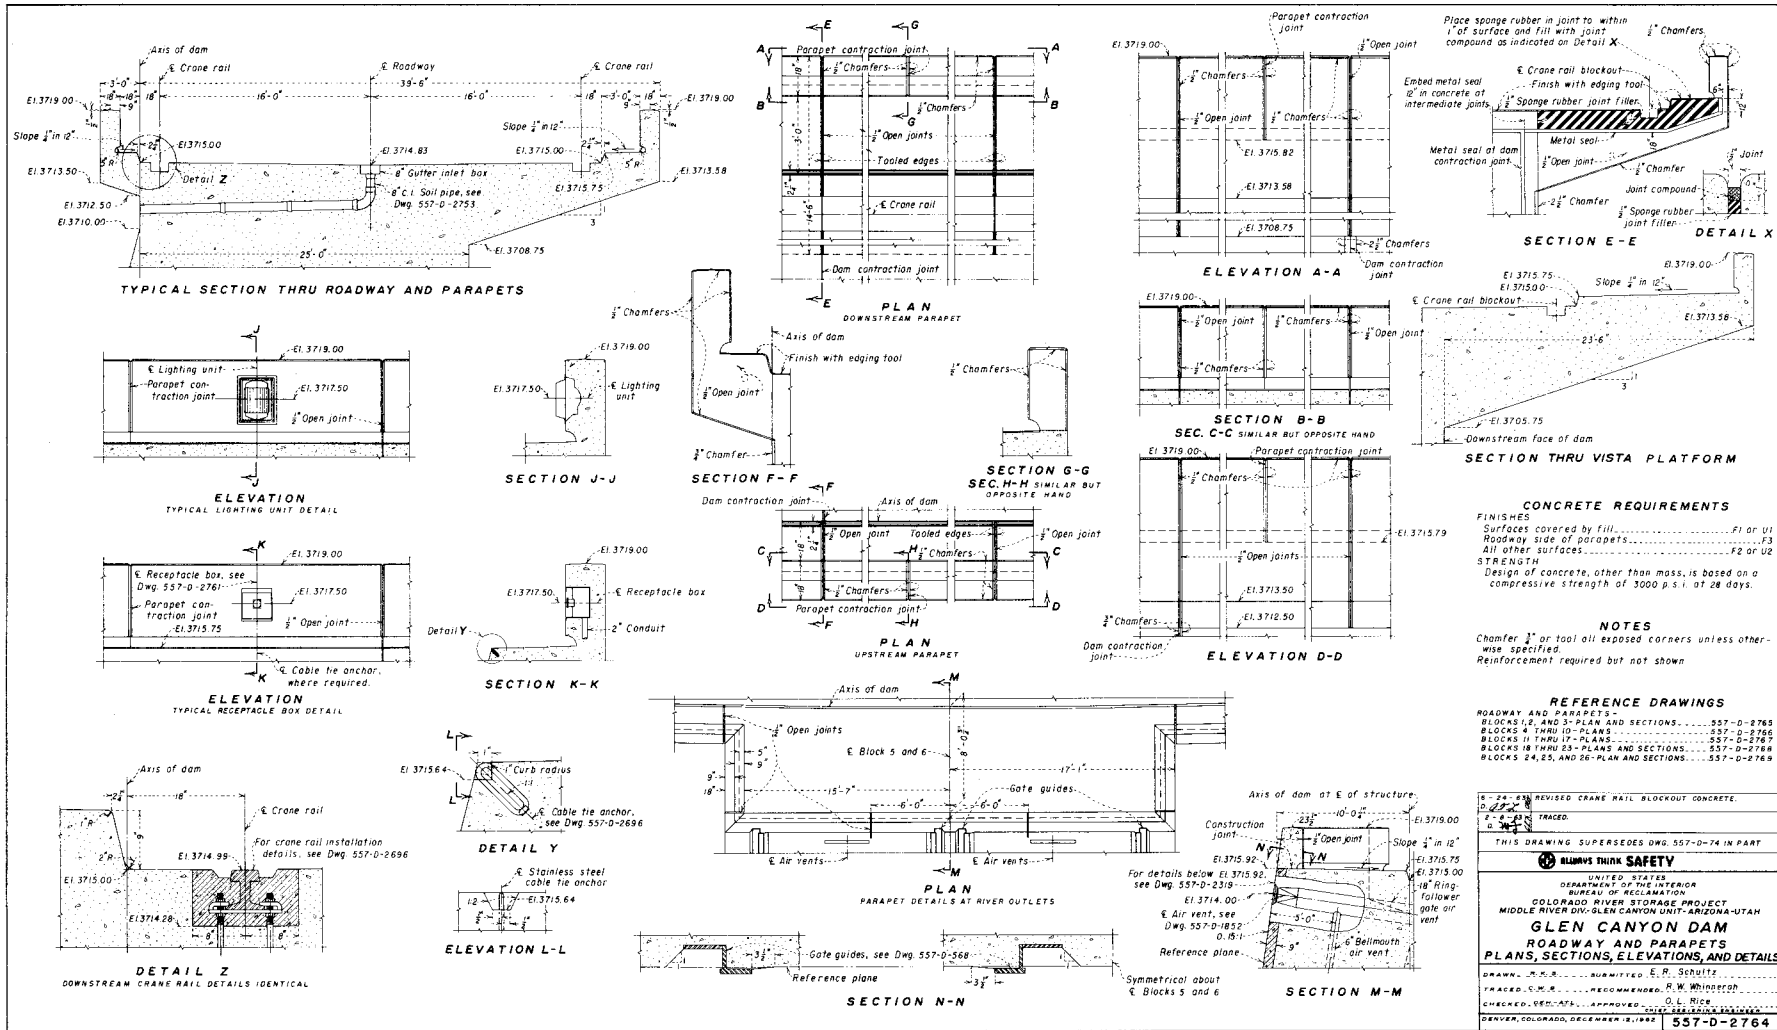
Figure 70.—Dam roadway and parapets—Plans, sections, elevations, and details.

(2) *Roadway.*—Because of the temperature differential between the top of the dam and the utility gallery at elevation 3697.50, two layers of 1-3/8-inch-diameter bars at 12-inch centers across the roadway tied by 1-inch-diameter bars at 12-inch centers were placed in the top of the dam to control temperature cracking.

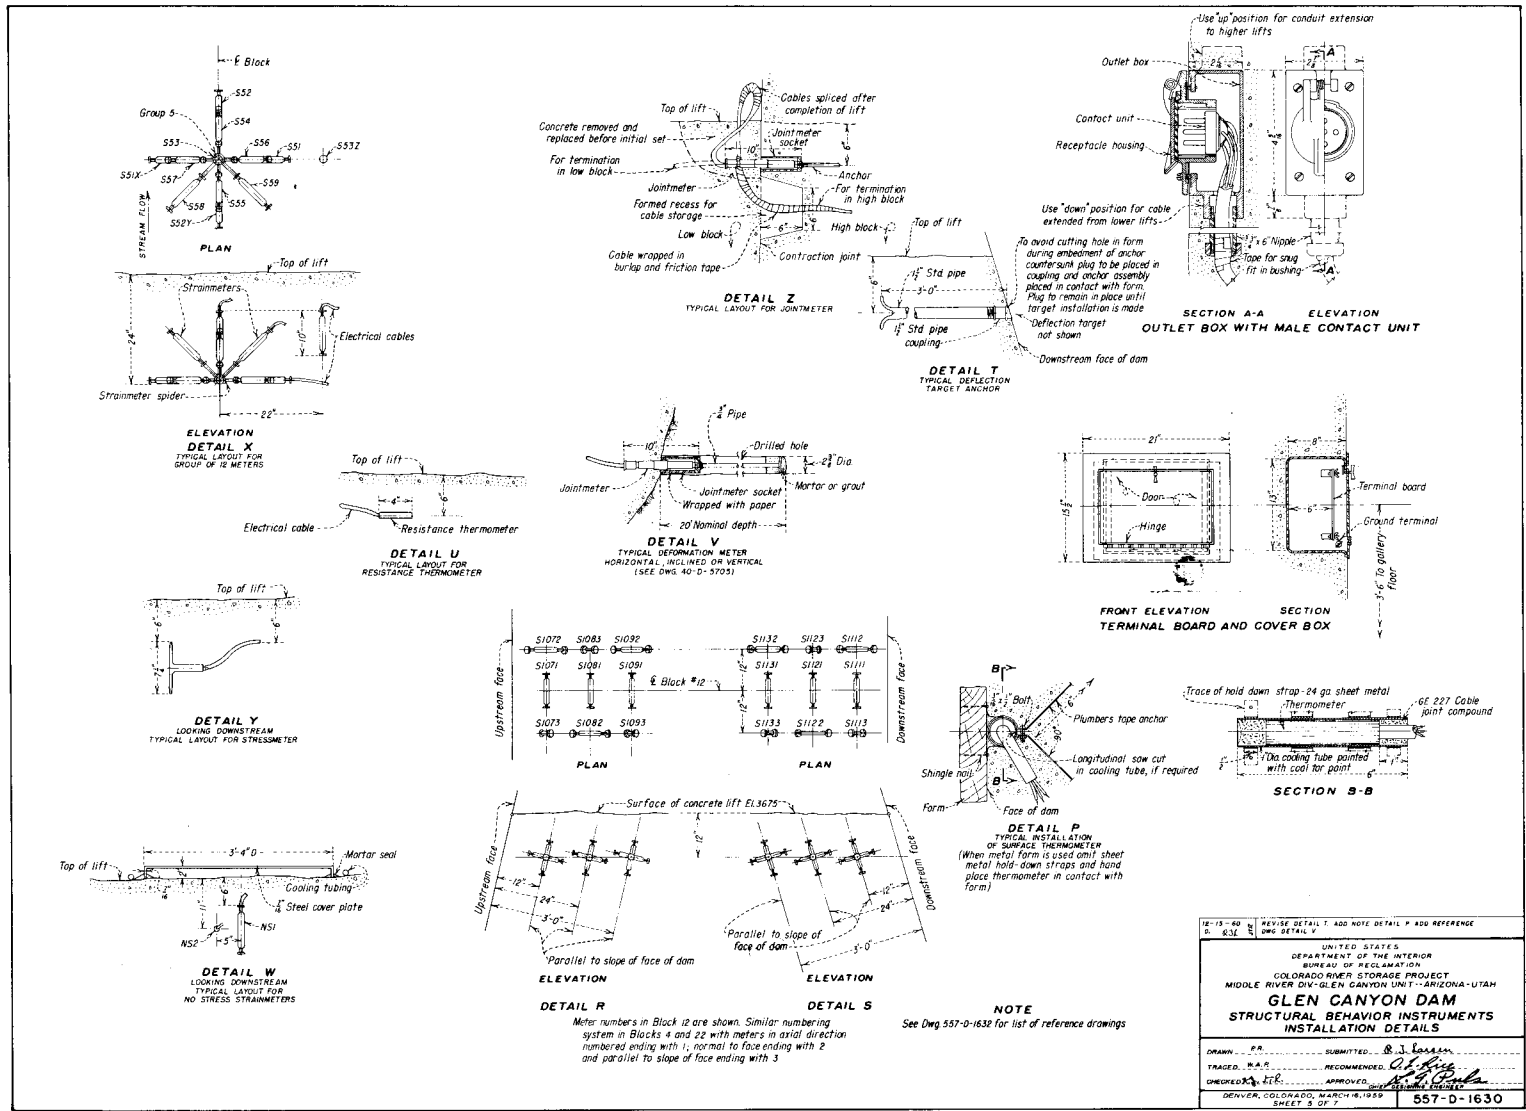
Figure 88.—Dam structural behavior instruments—Installation details.

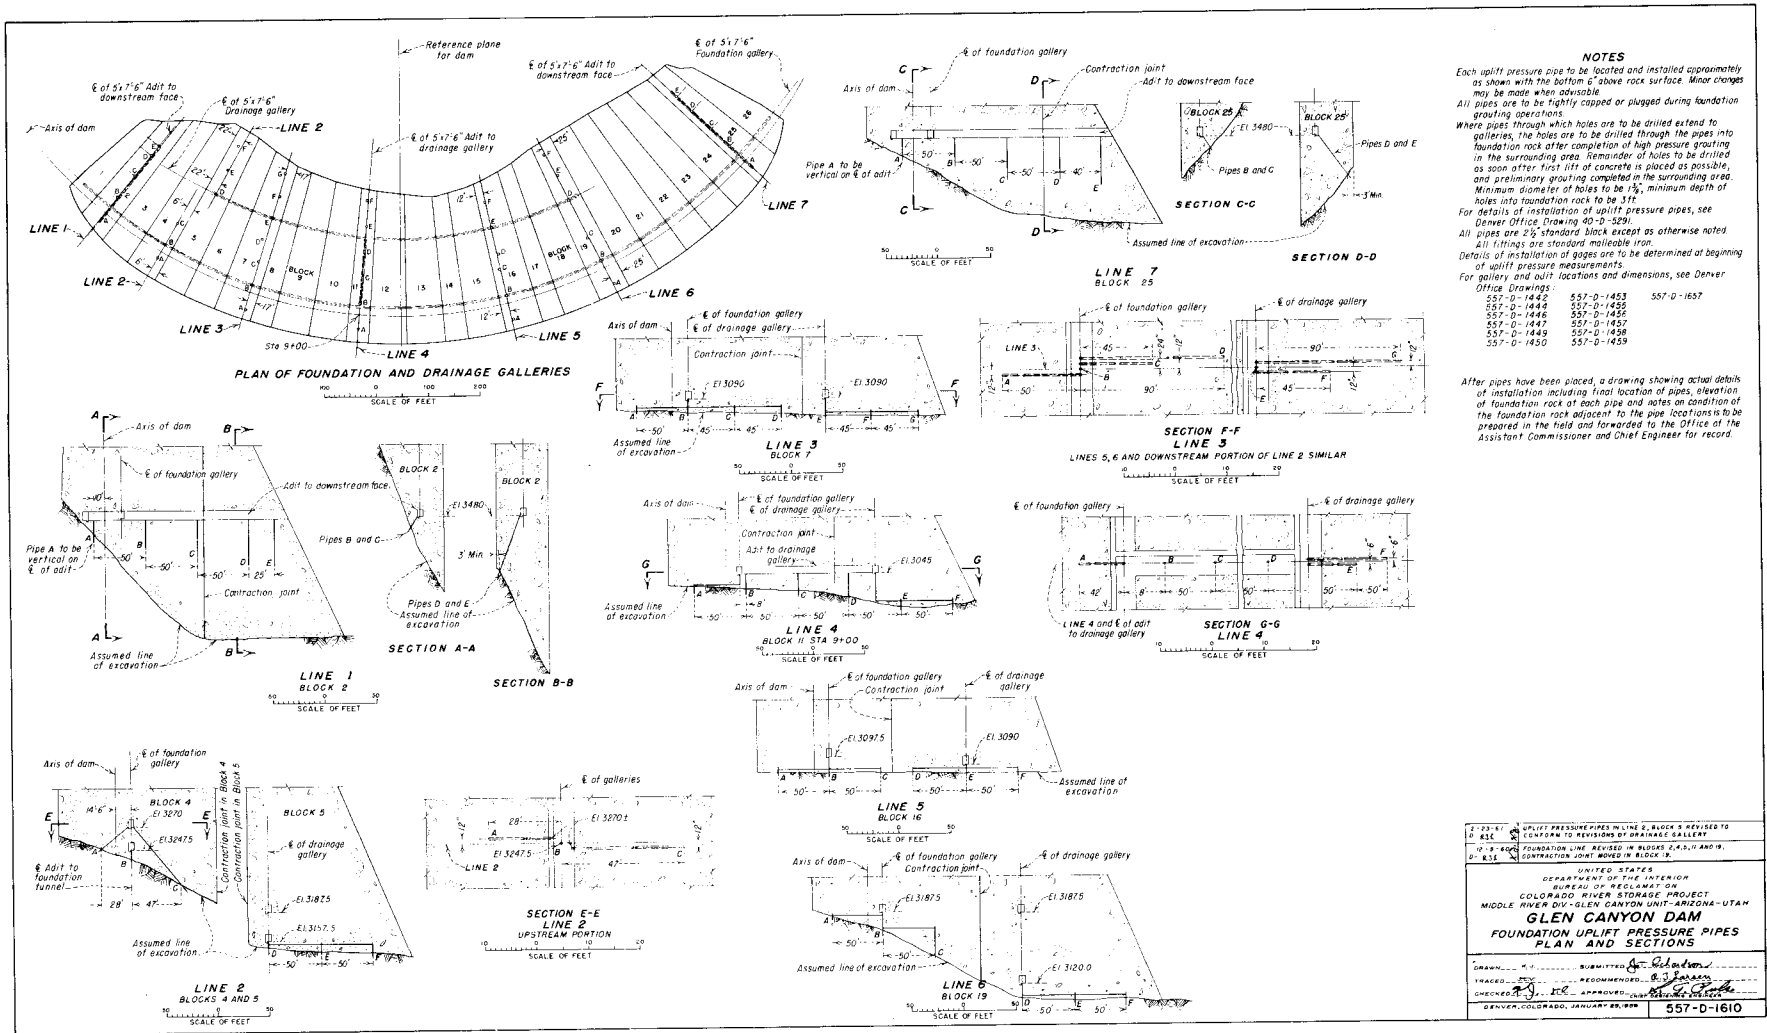
Figure 95.—Dam foundation uplift pressure pipes—Plan and sections.

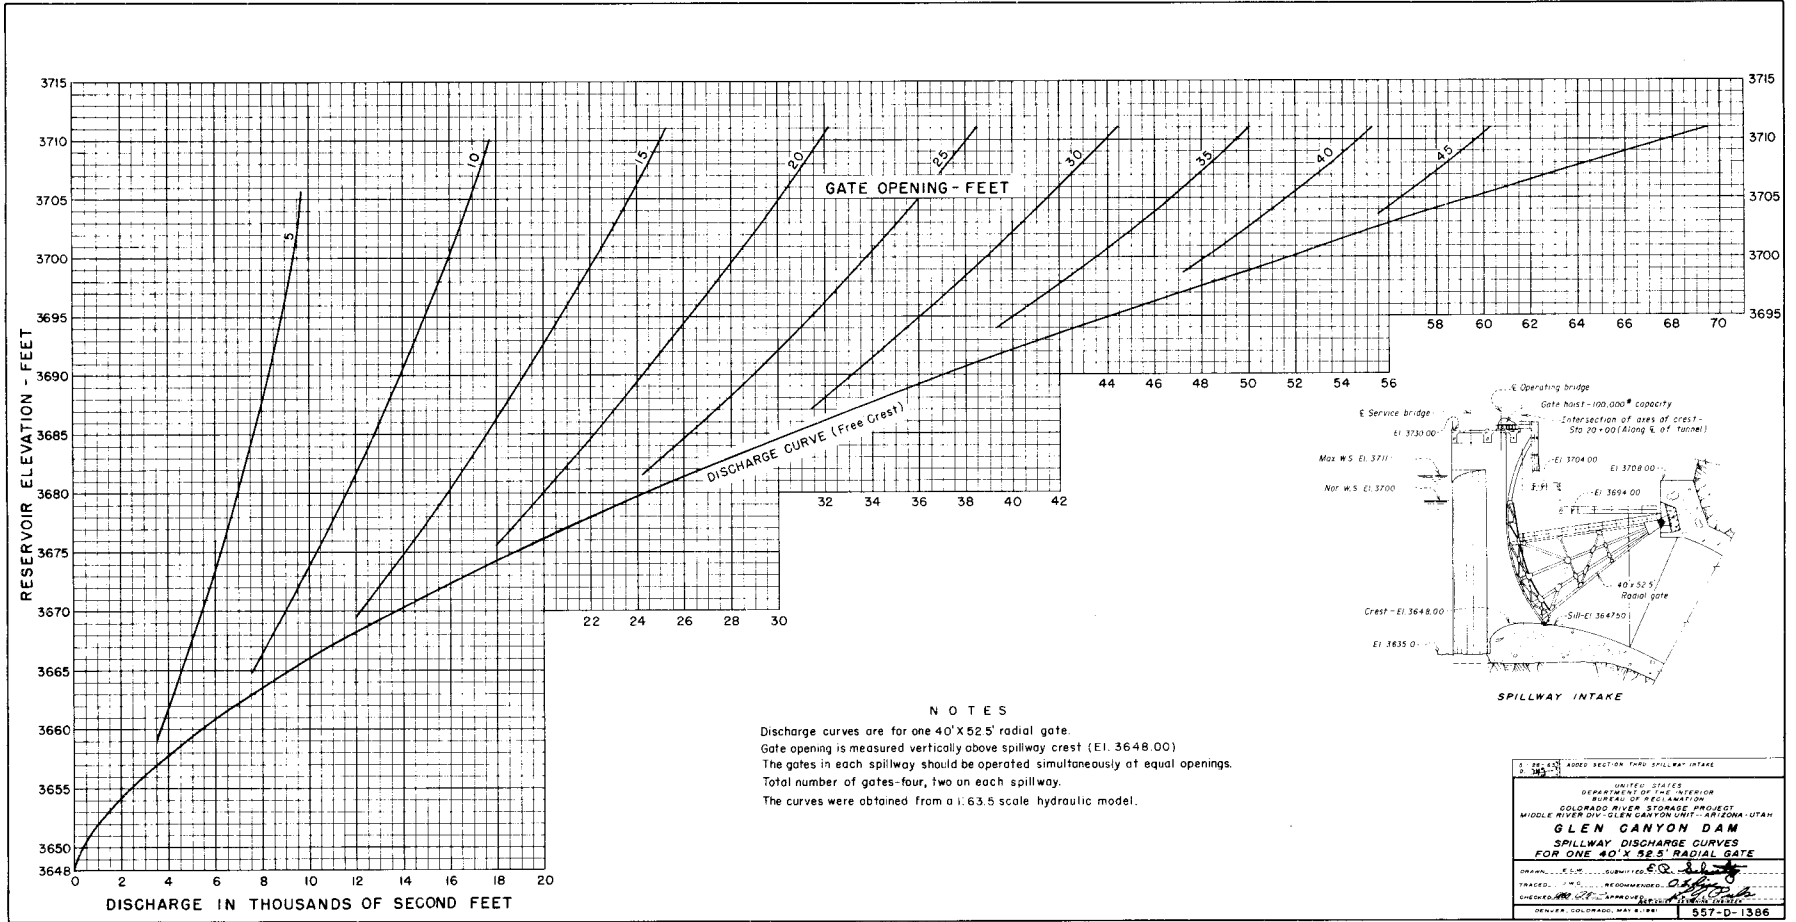
Figure 102.—Spillway discharge curves for one 40-by 52.5-foot radial gate.

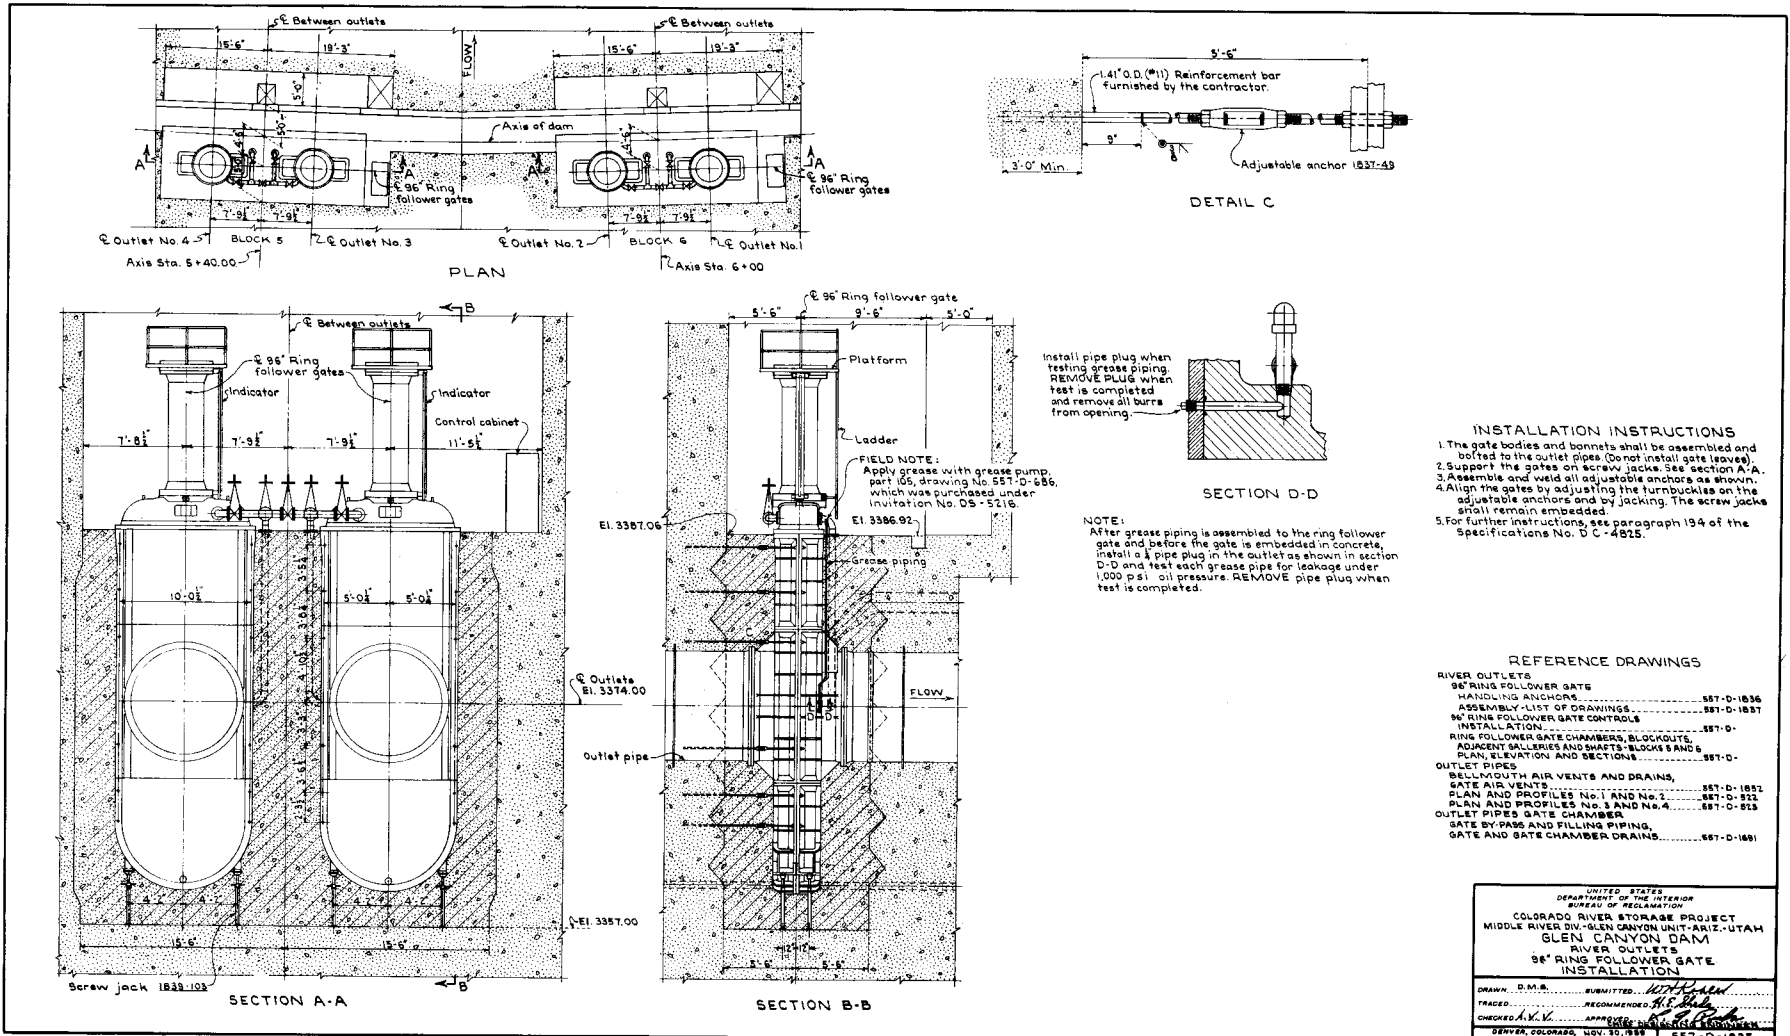
Figure 118.—River outlets, 96-inch ring-follower gate installation.

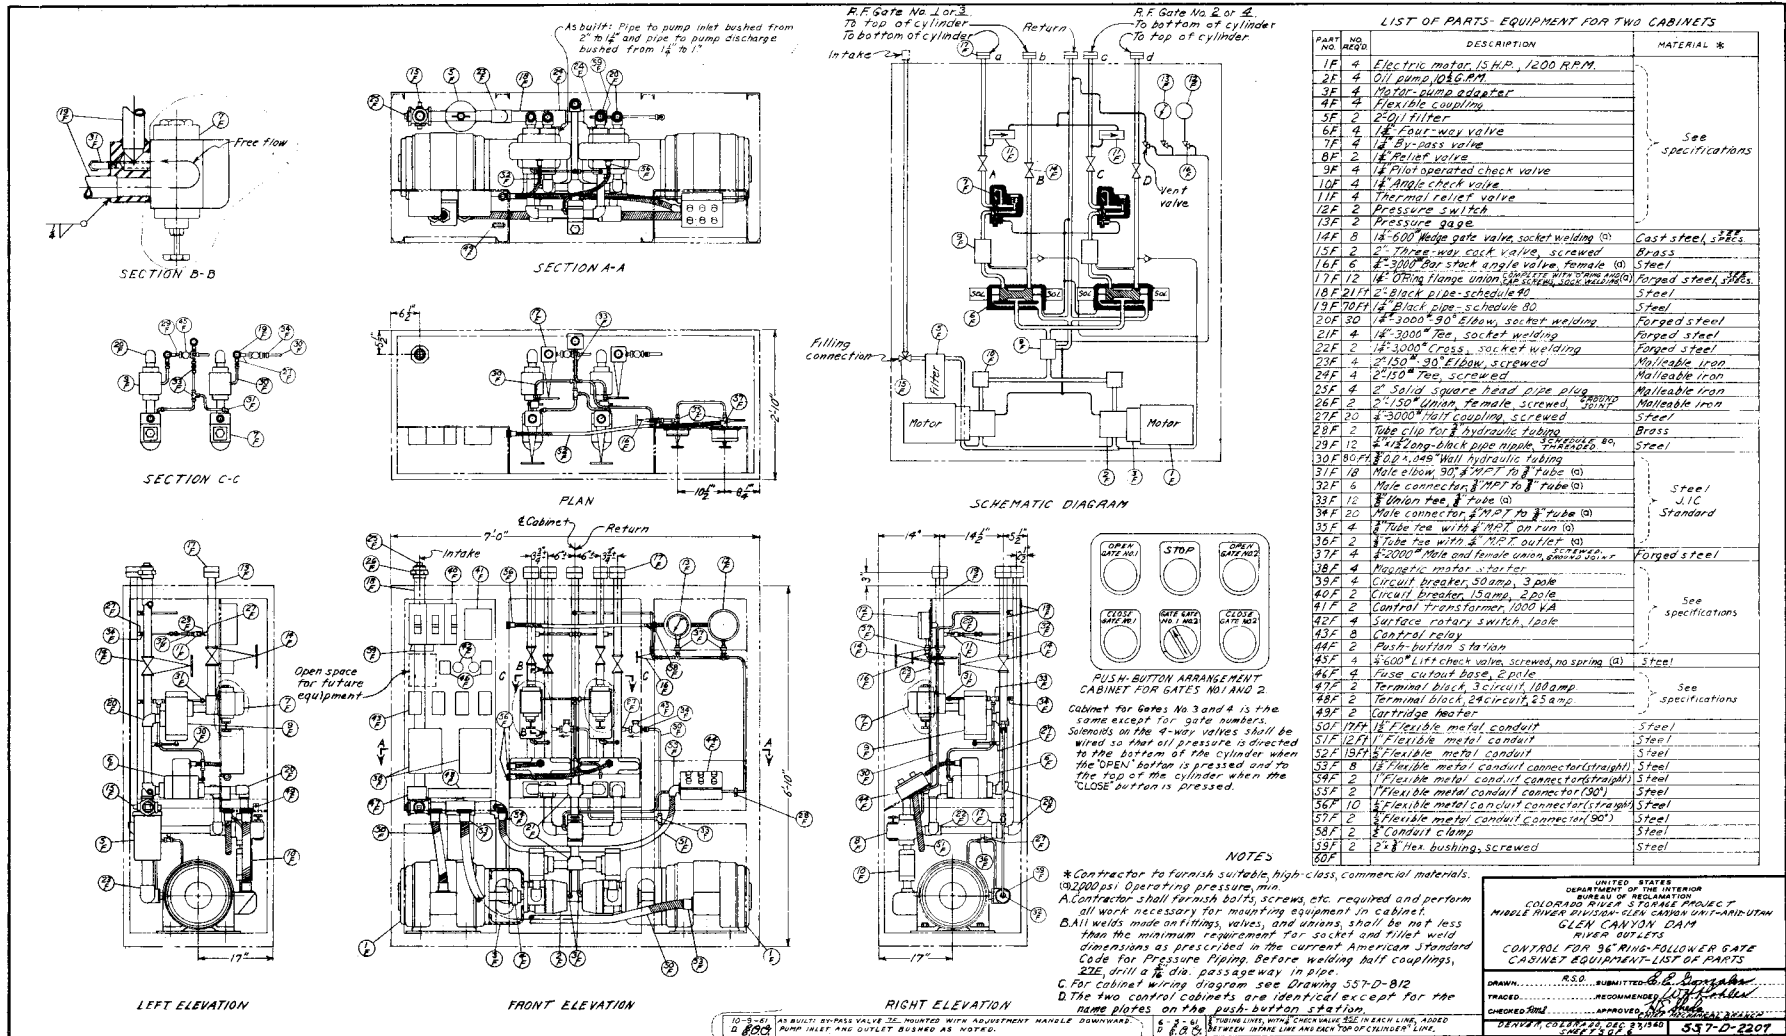
Figure 121.—River outlets, 96-inch ring-follower gate—Cabinet equipment.

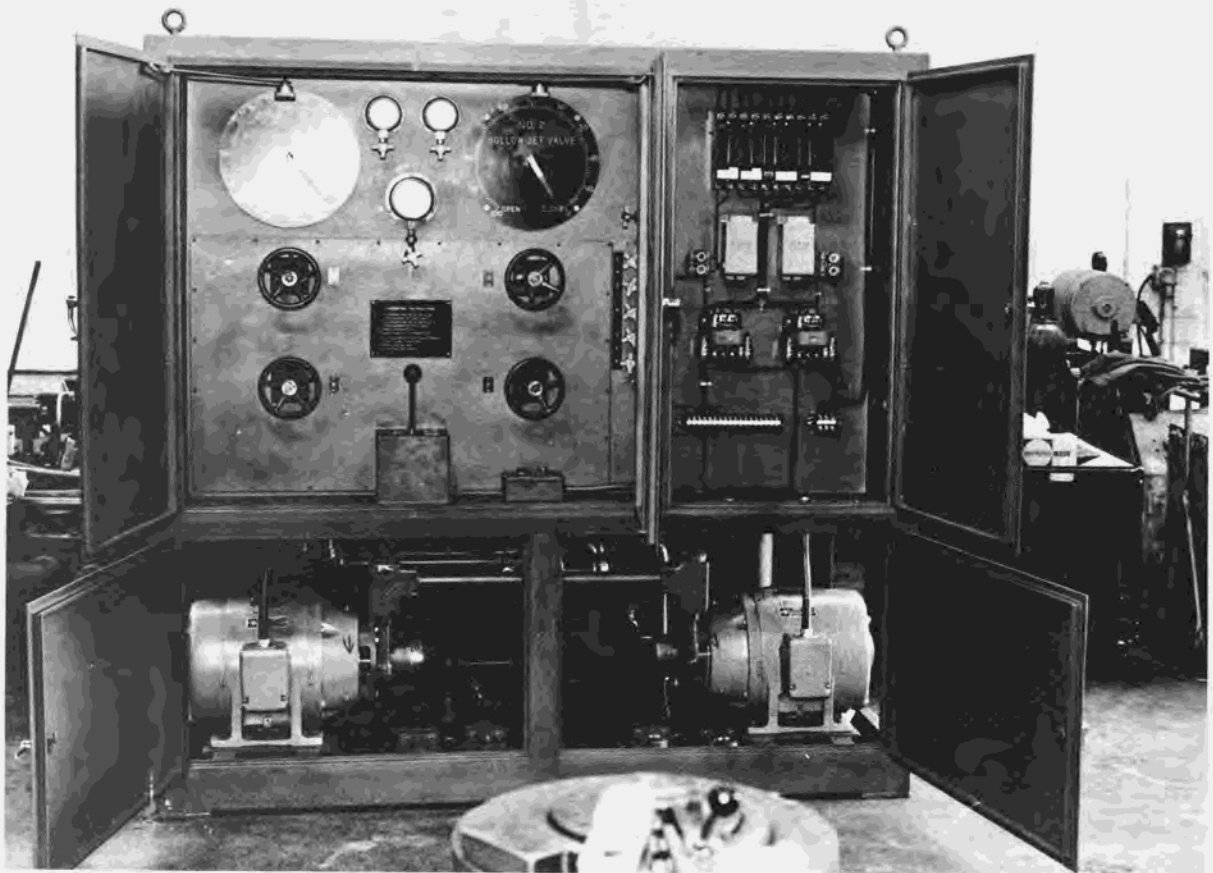
Figure 128.—Front view of 96-inch hollow-jet valve control cabinet. P557-D-31840.

Figure 127 shows a downstream view of the 96-inch hollow-jet valve and figure 128 shows a front view of the 96-inch hollow-jet valve control cabinet.

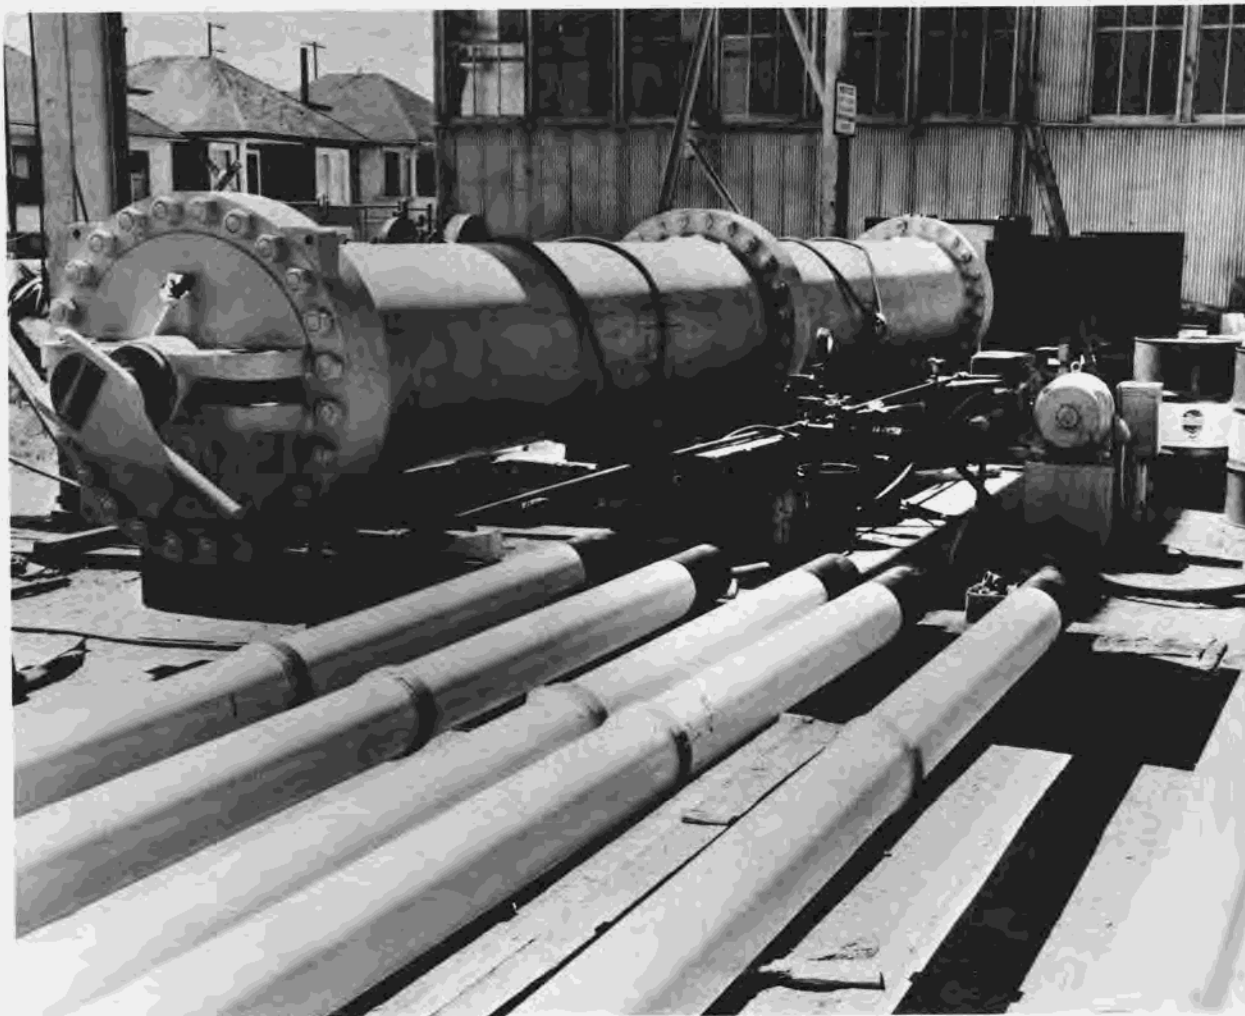
Figure 148.—Hydraulic hoist and intermediate stems for the 13.96- by 22.45-foot fixed-wheel gate. P557-D-37603.

Two constant-delivery pumps, having a combined delivery of 49 gallons per minute at a pressure of 1,000 pounds per square inch and a pump speed of 1,800

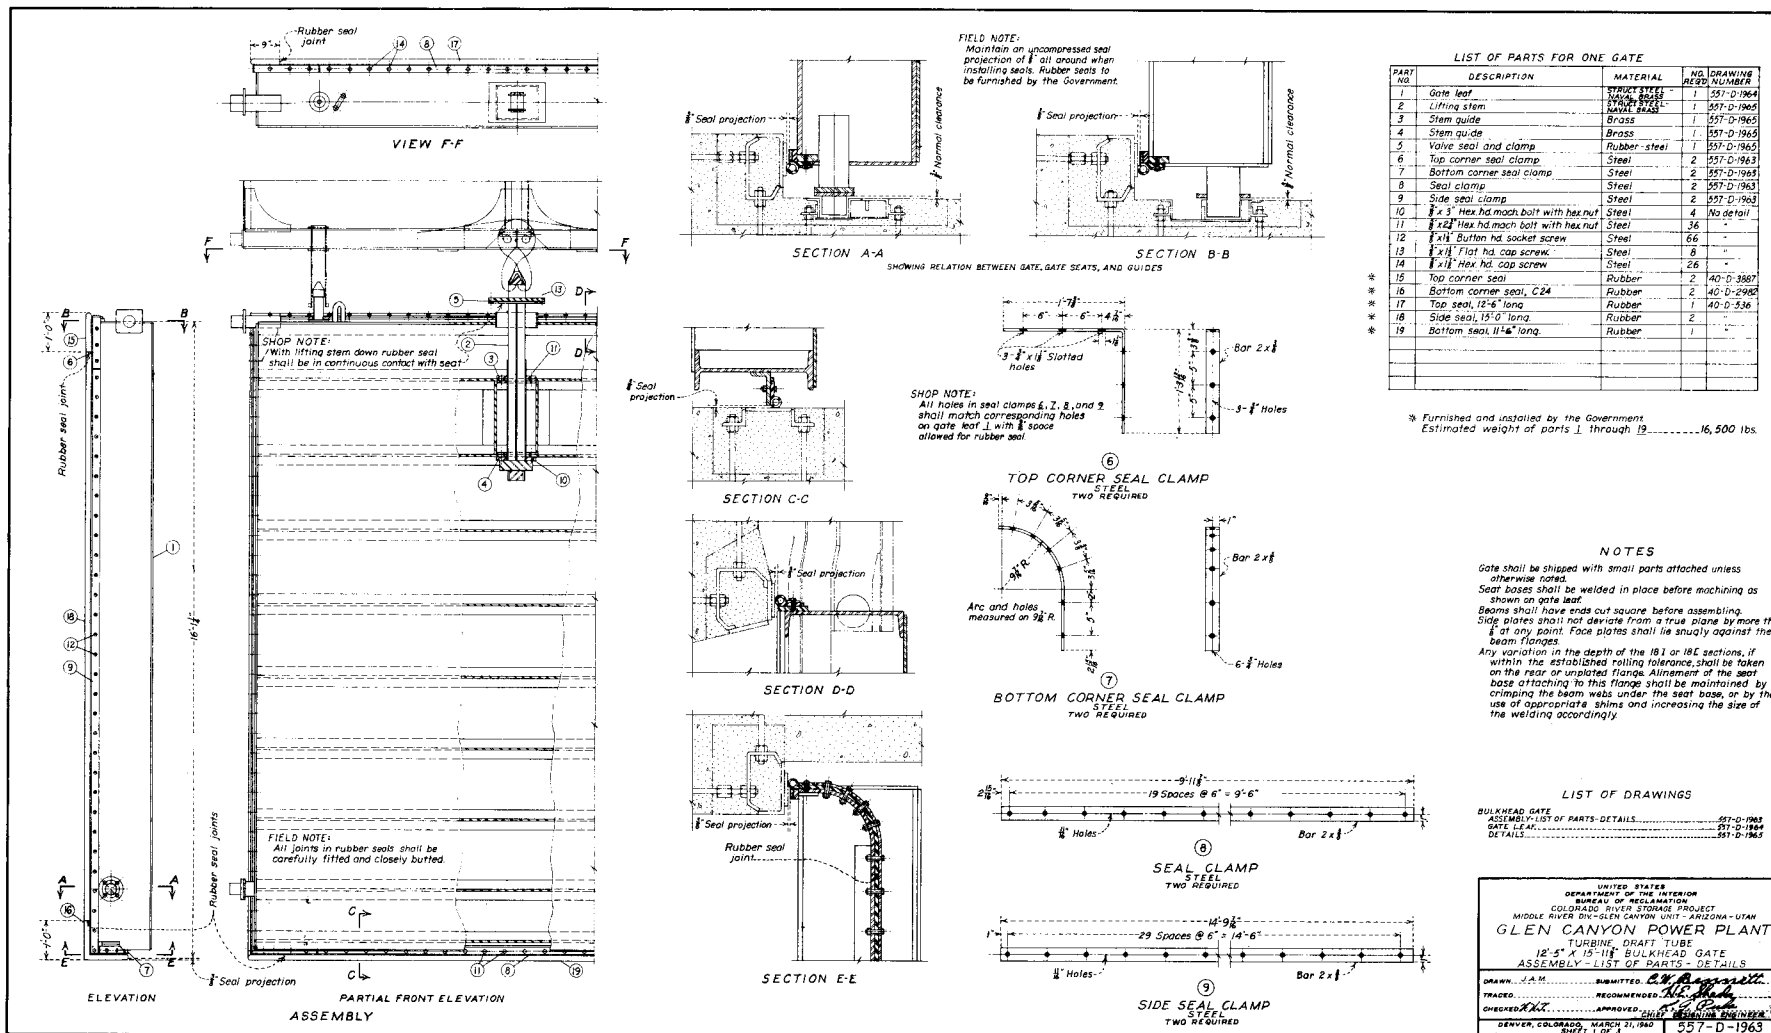
Figure 149.—Turbine draft tube 12.42- by 15.95-foot bulkhead gate assembly.

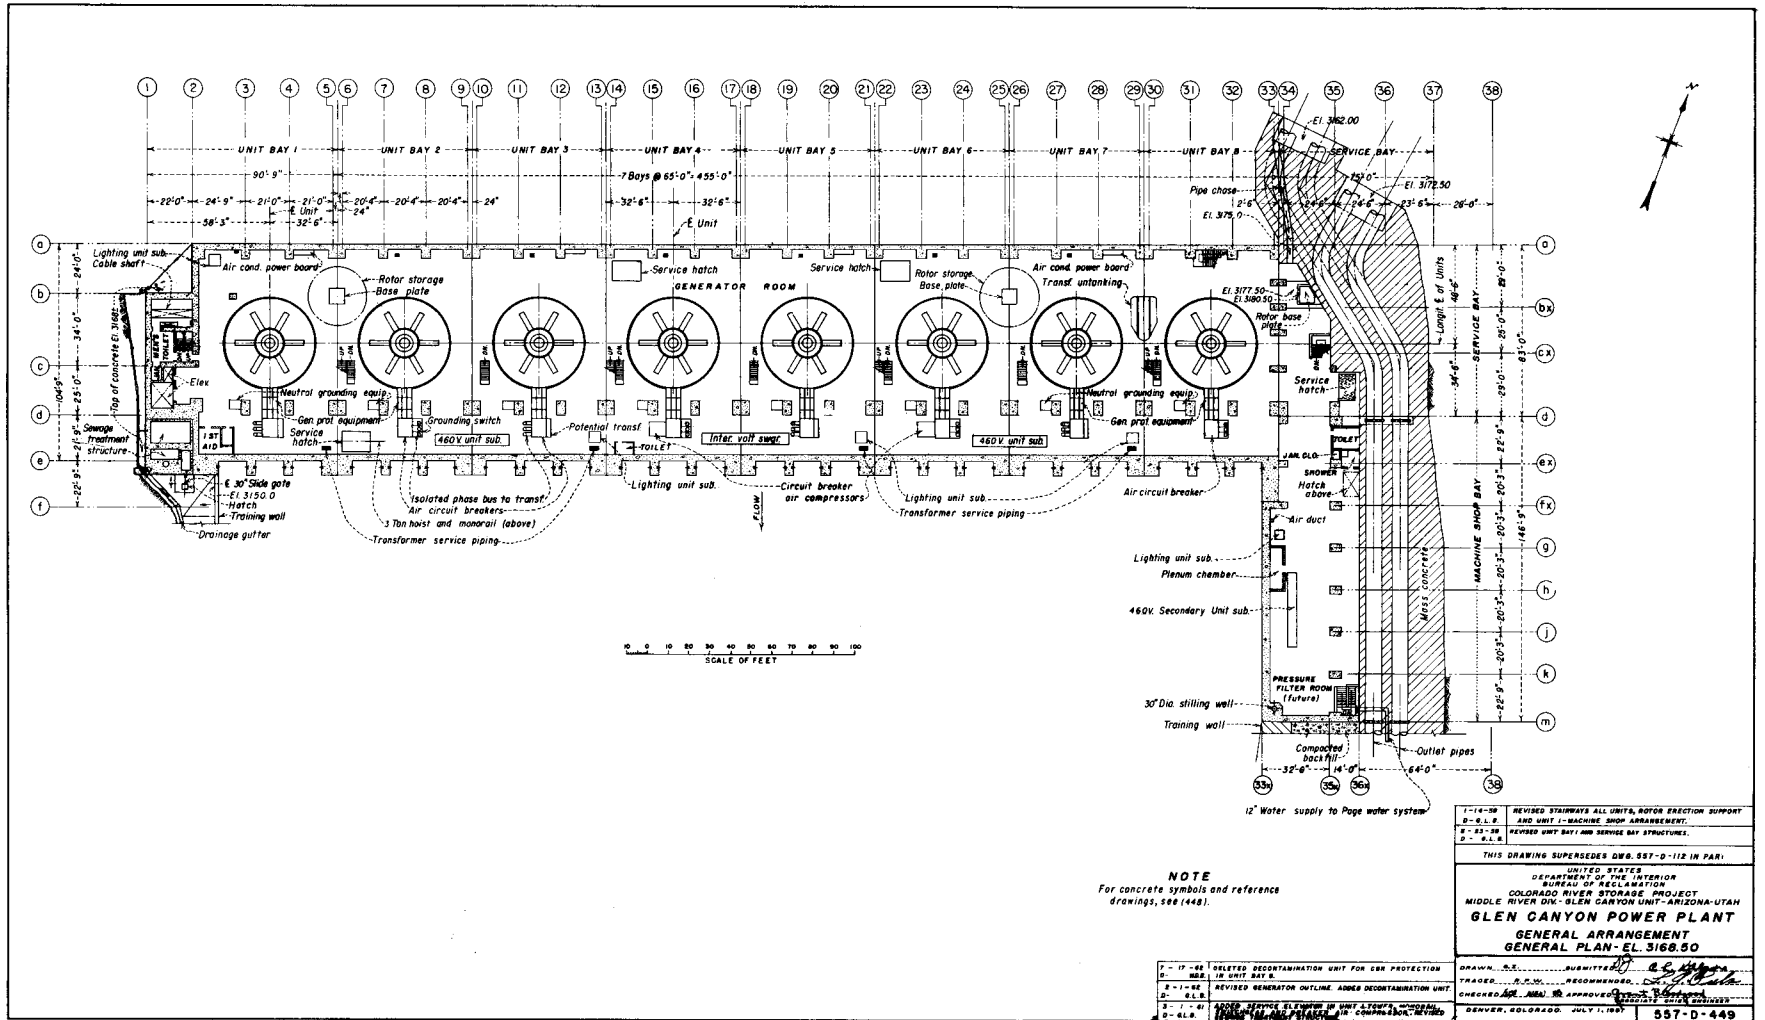
Figure 152.—Powerplant general arrangement—Plan, elevation 3168.50.

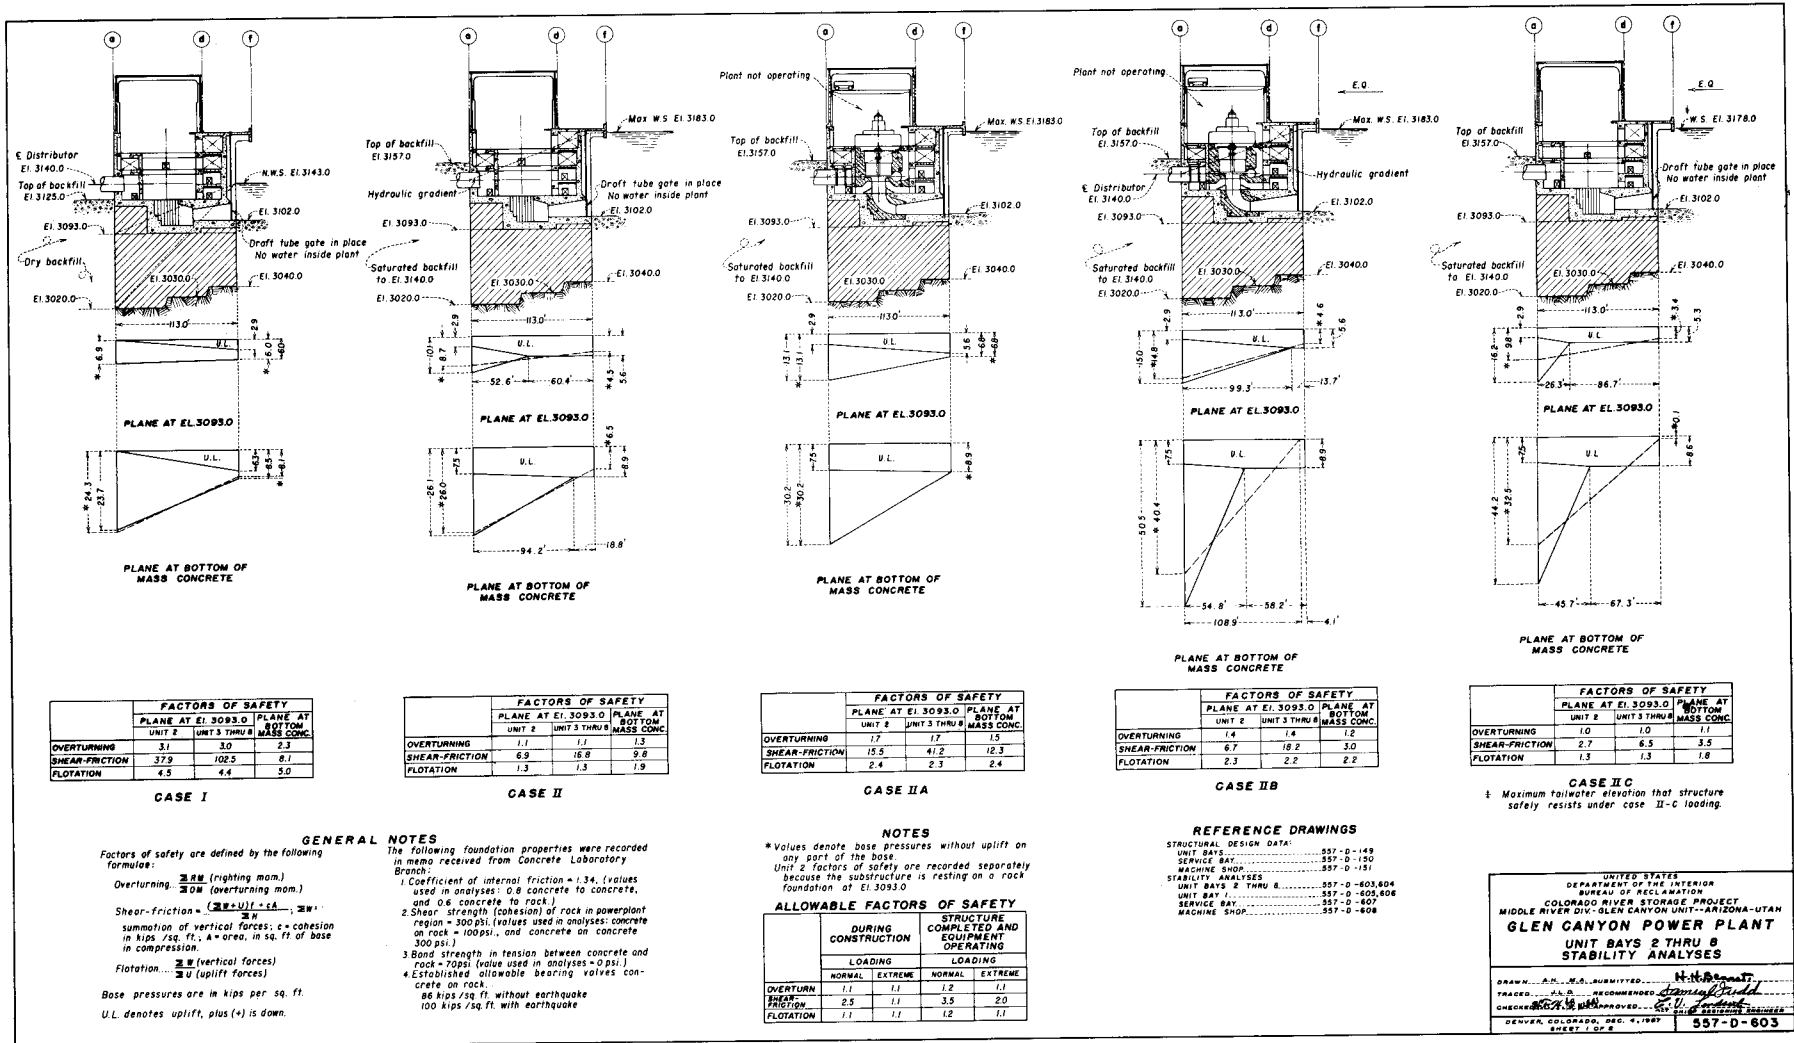
Figure 162.—Powerplant stability analyses—Unit bays 2 through 8. (Sheet 1 of 2.)
