TECHNICAL RECORD  
OF  
DESIGN AND CONSTRUCTION

# GLEN CANYON DAM AND POWERPLANT

Colorado River Storage Project  
Arizona-Utah

Denver, Colorado  
December 1970

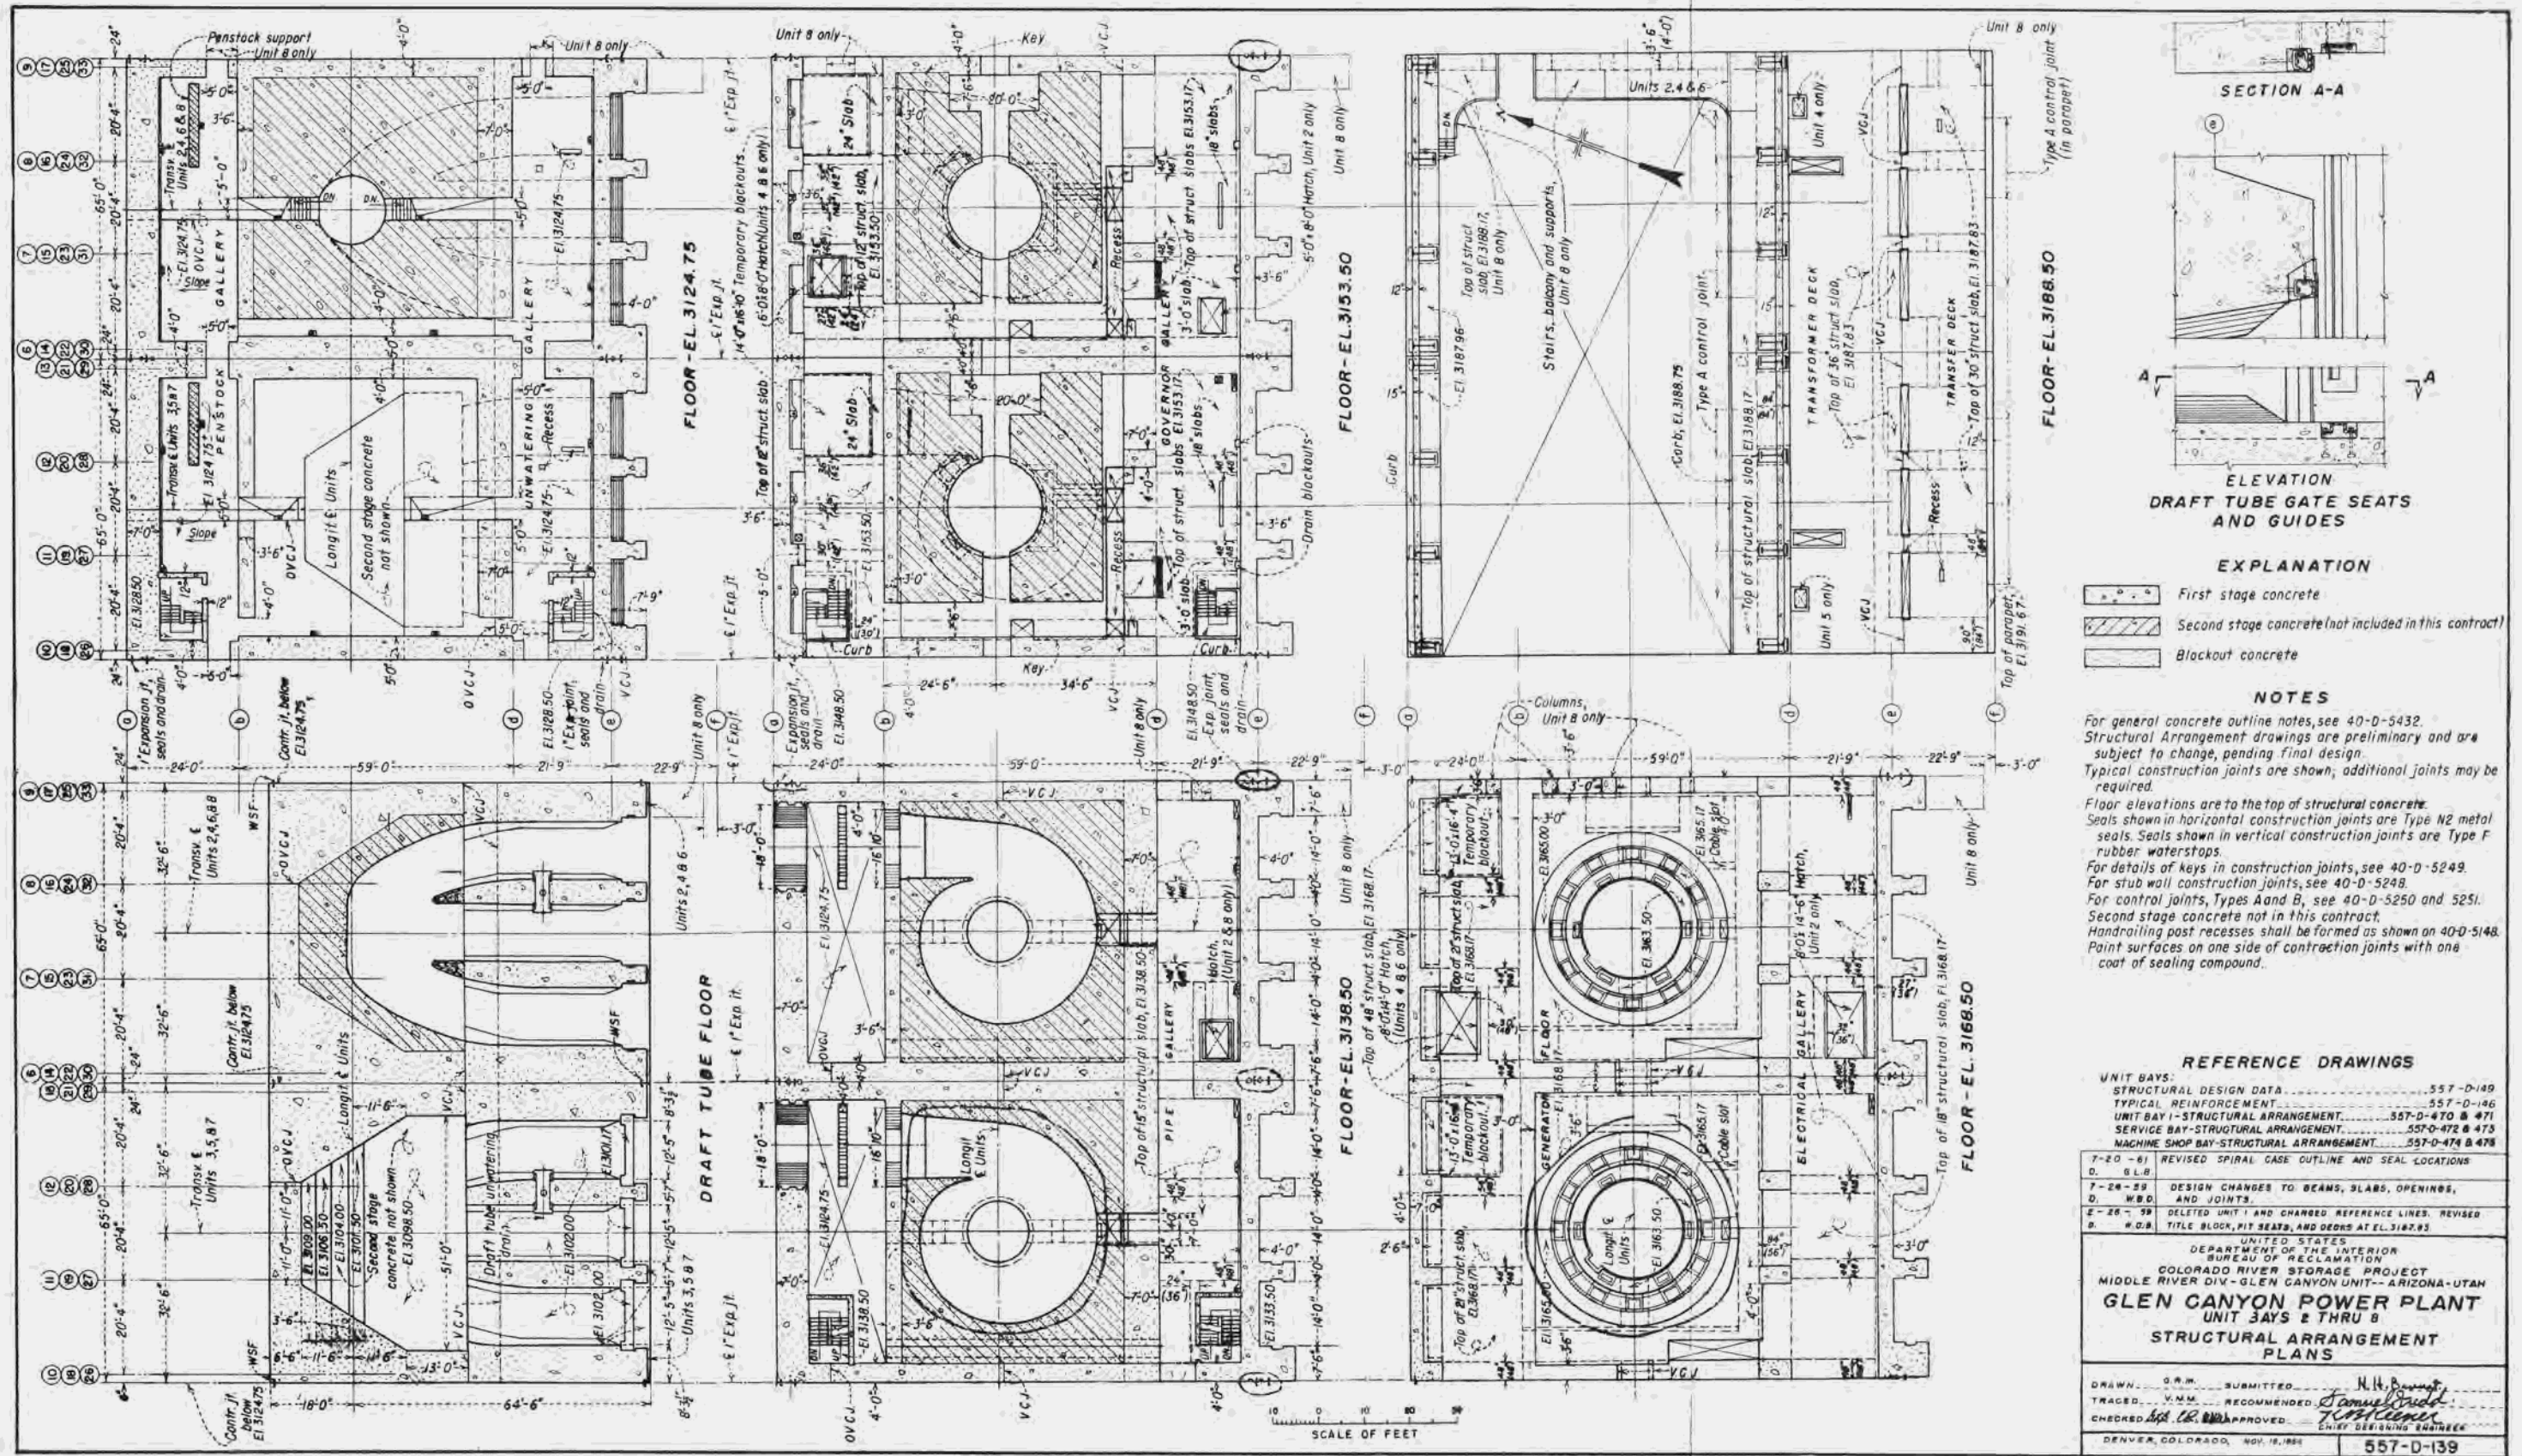
Figure 170.—Powerplant structural arrangement plans—Unit bays 2 through 8.

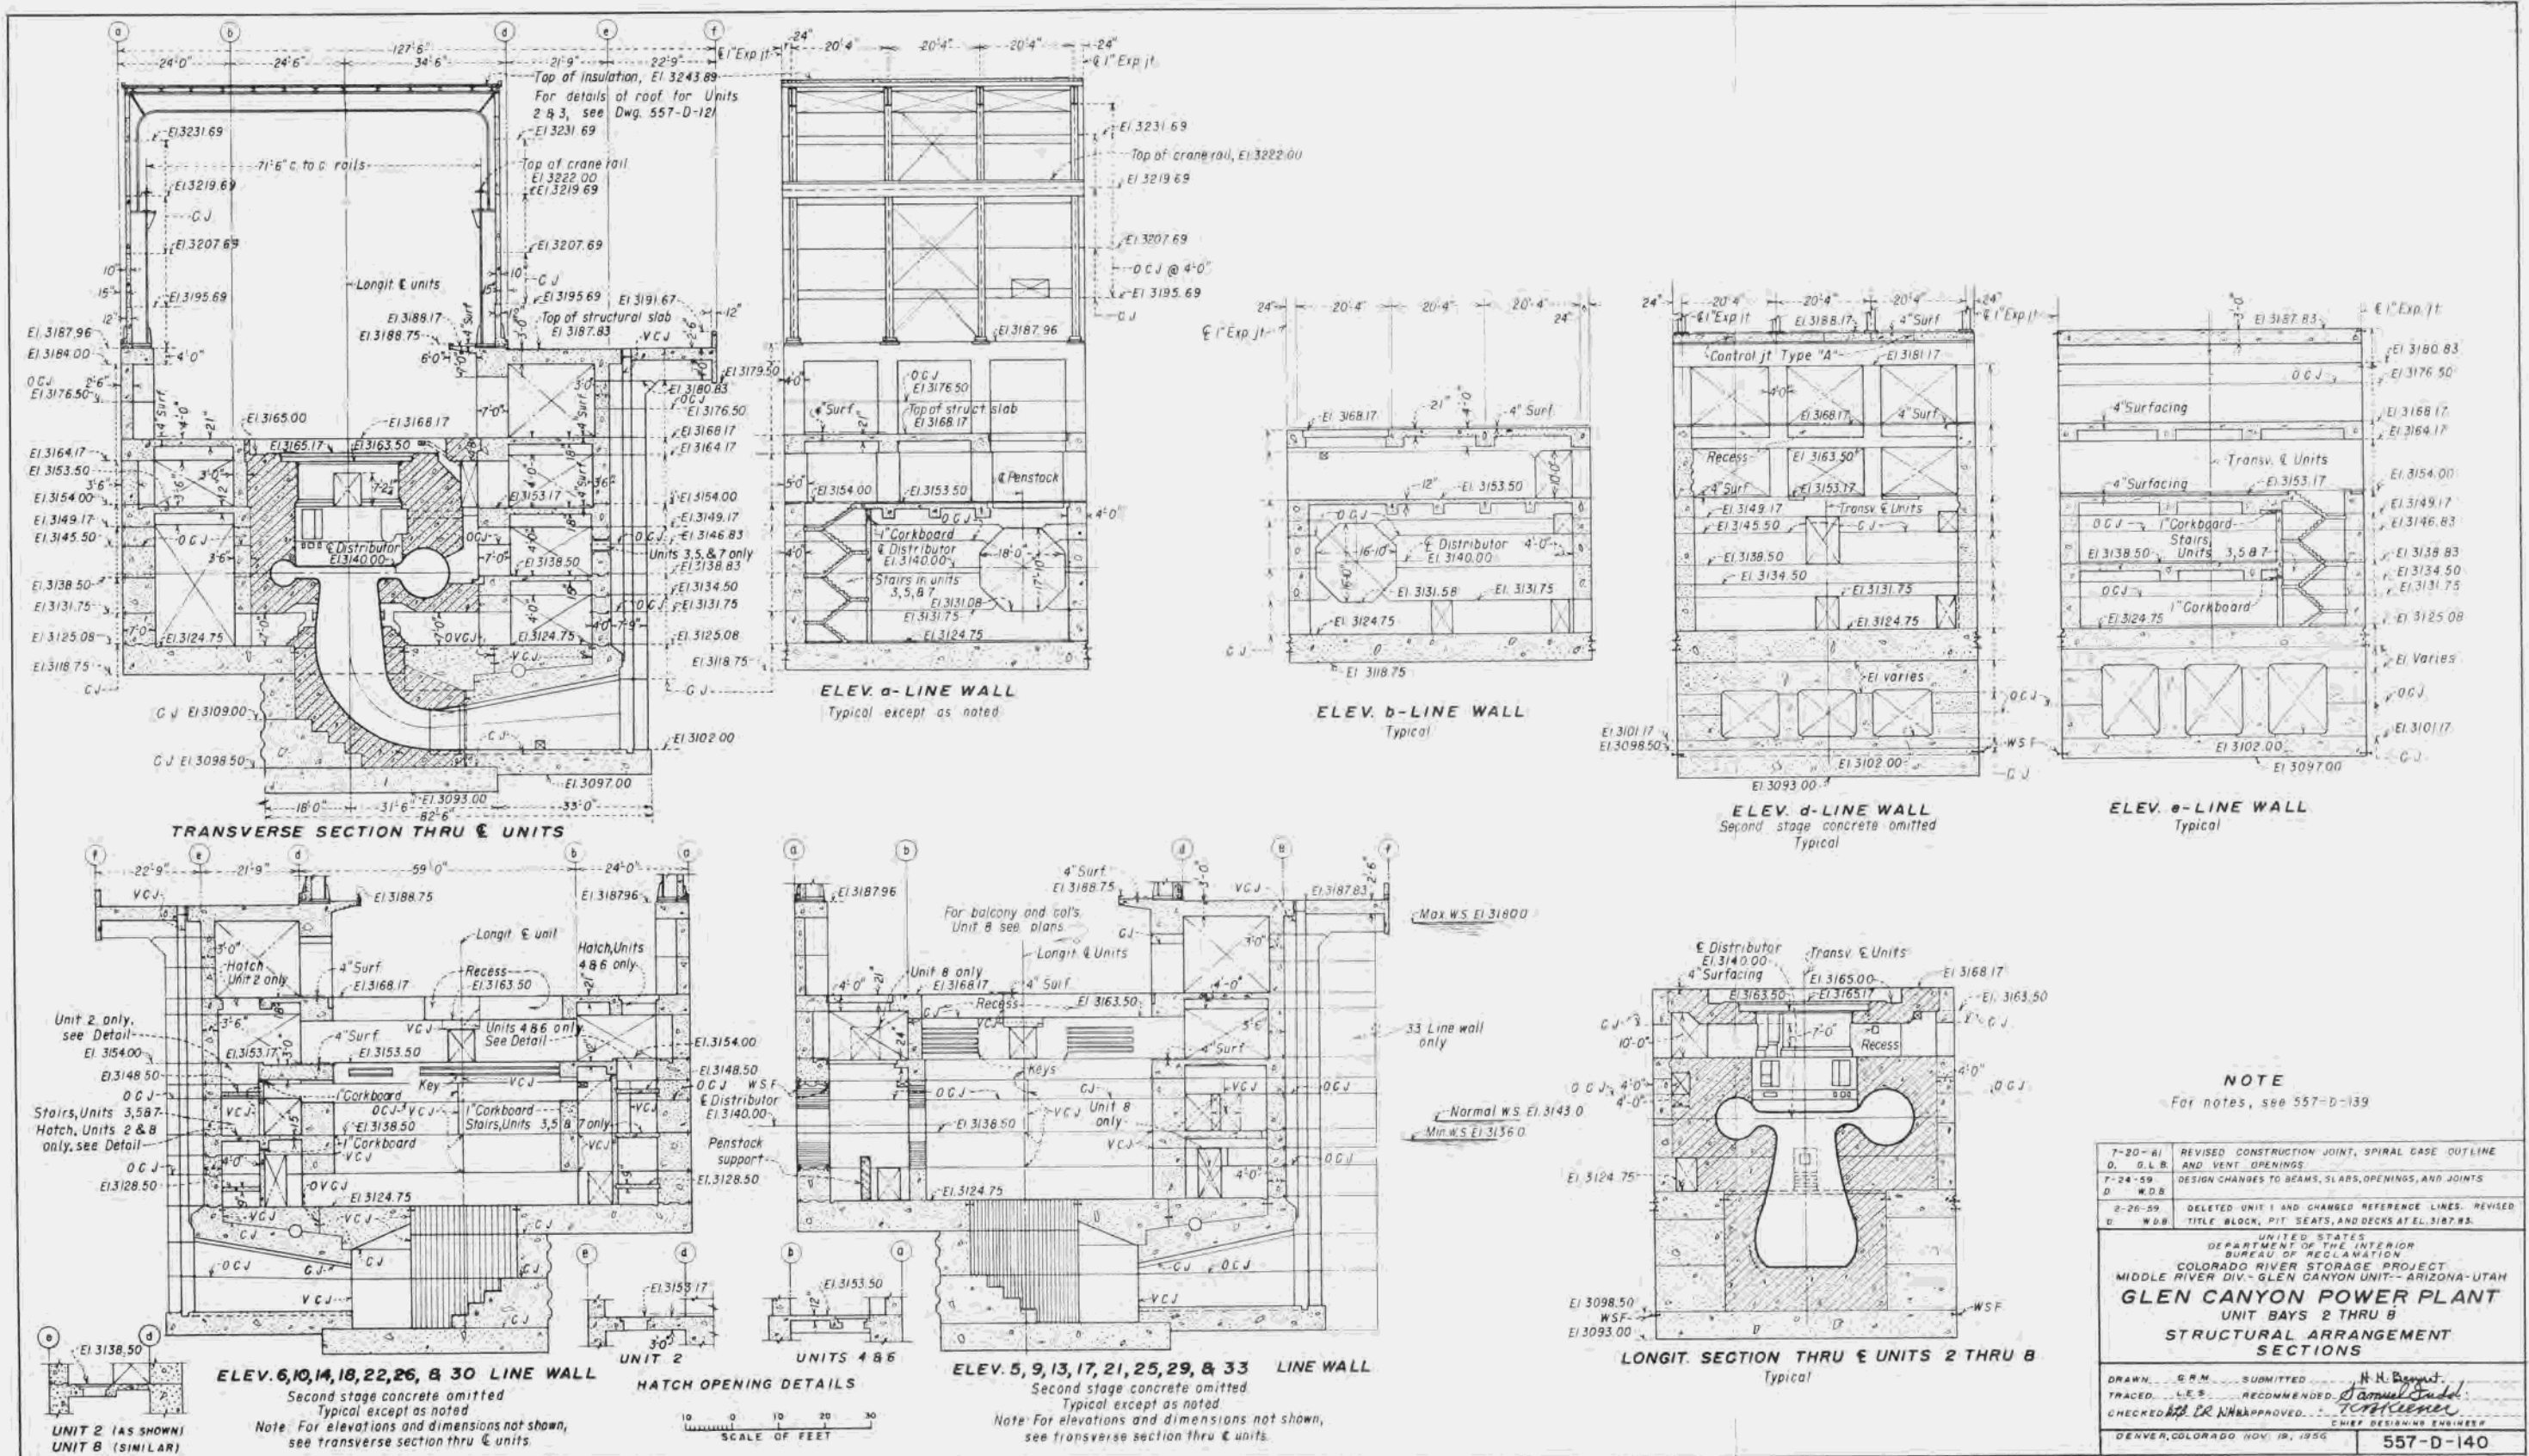
Figure 171.-Powerplant structural arrangement sections—Unit bays 2 through 8.

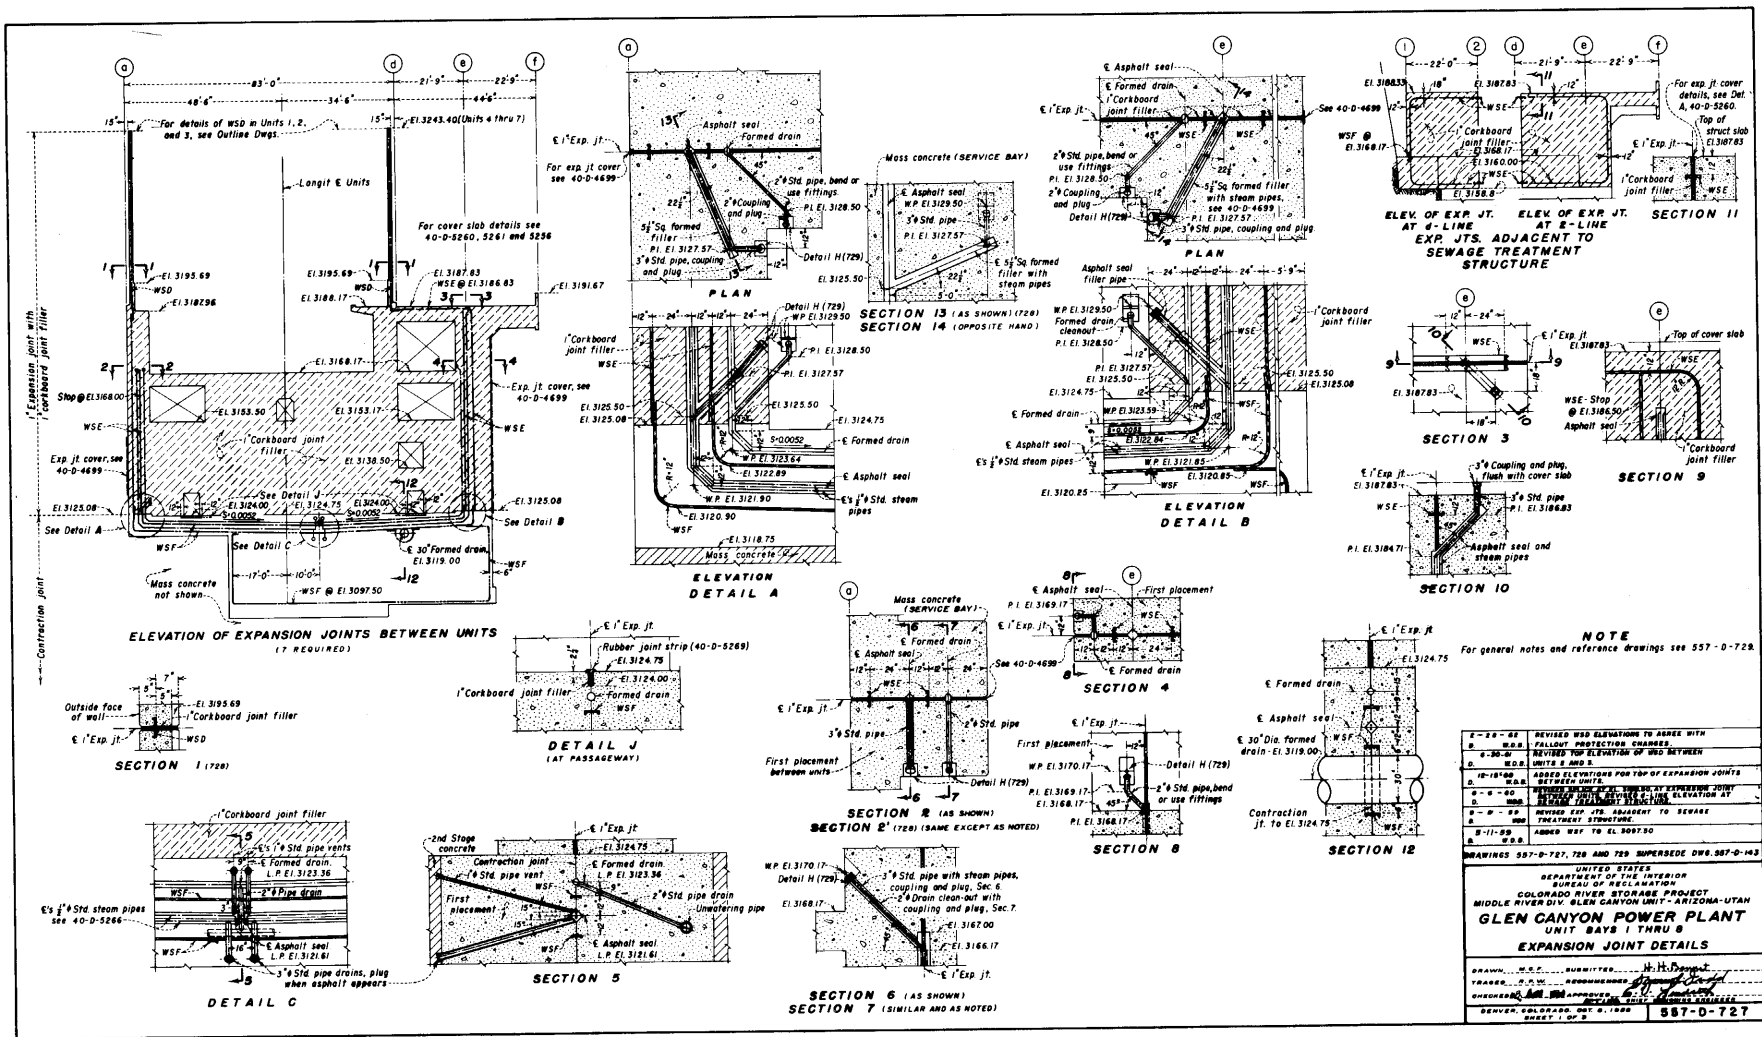
Figure 179.—Powerplant expansion joint details—Unit bays 1 through 8.

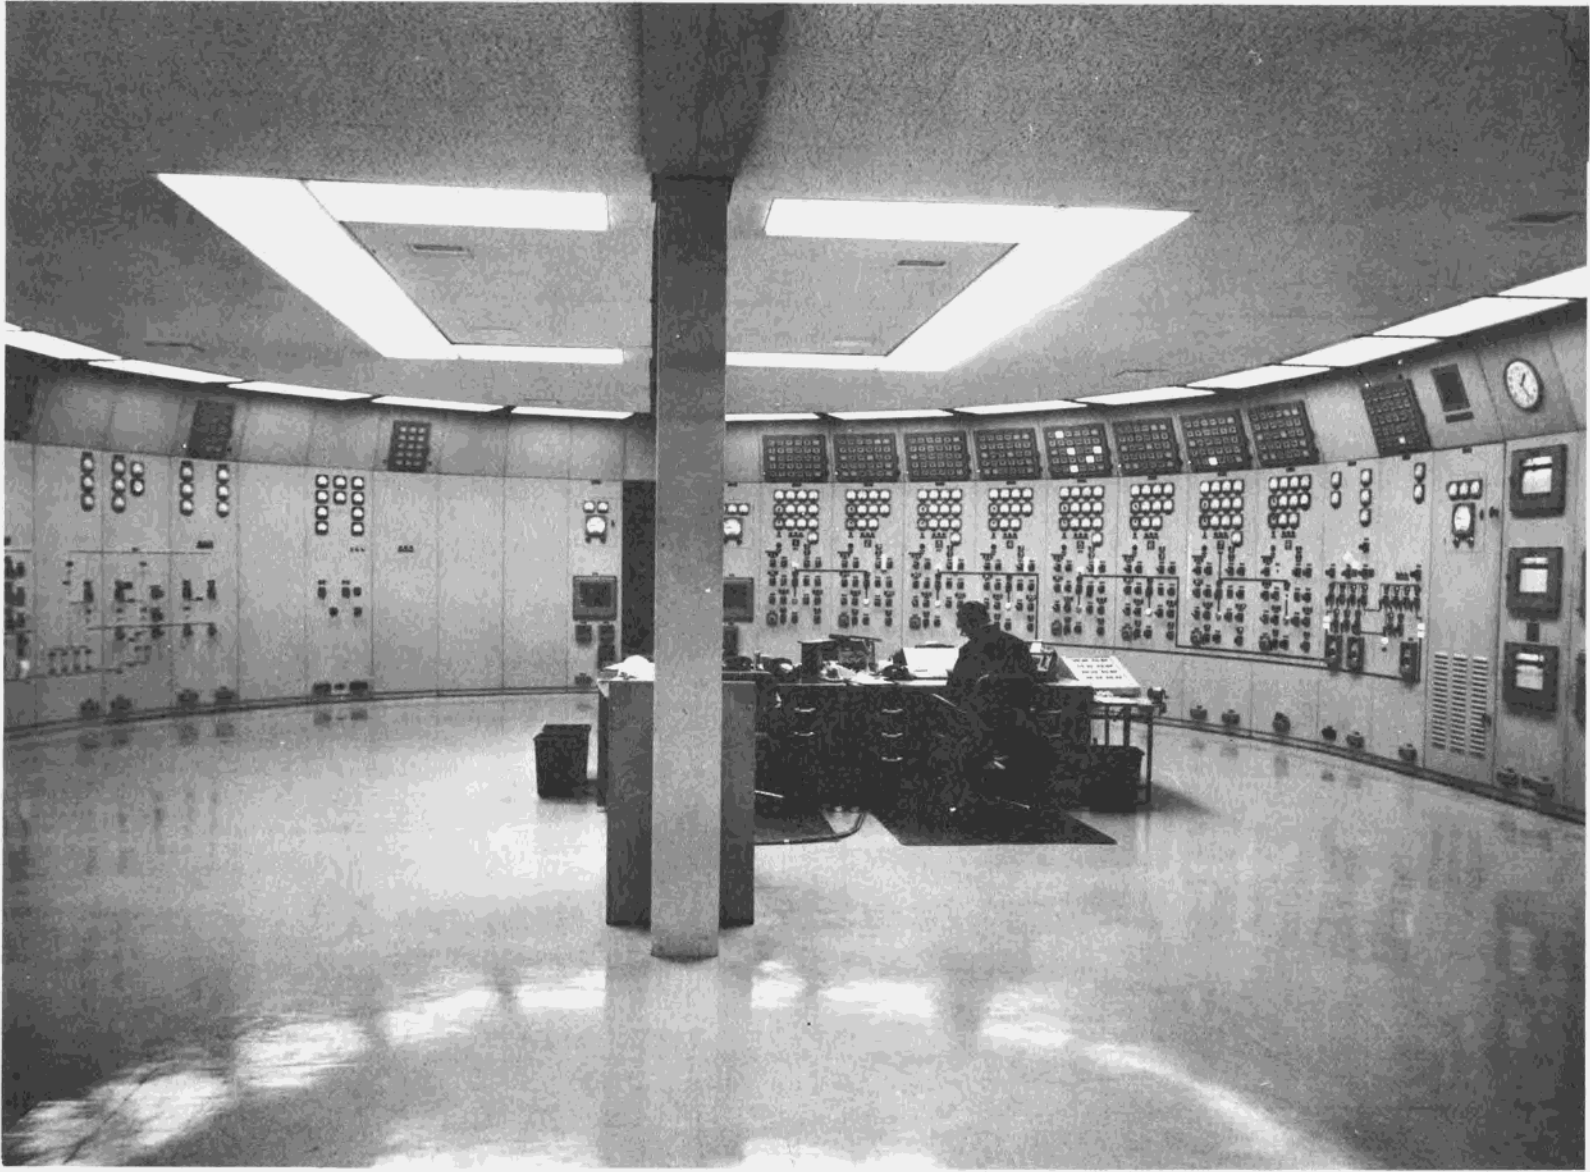
Figure 200.—Interior of control room at Glen Canyon Powerplant. P-557-420-11773, January 8, 1966.

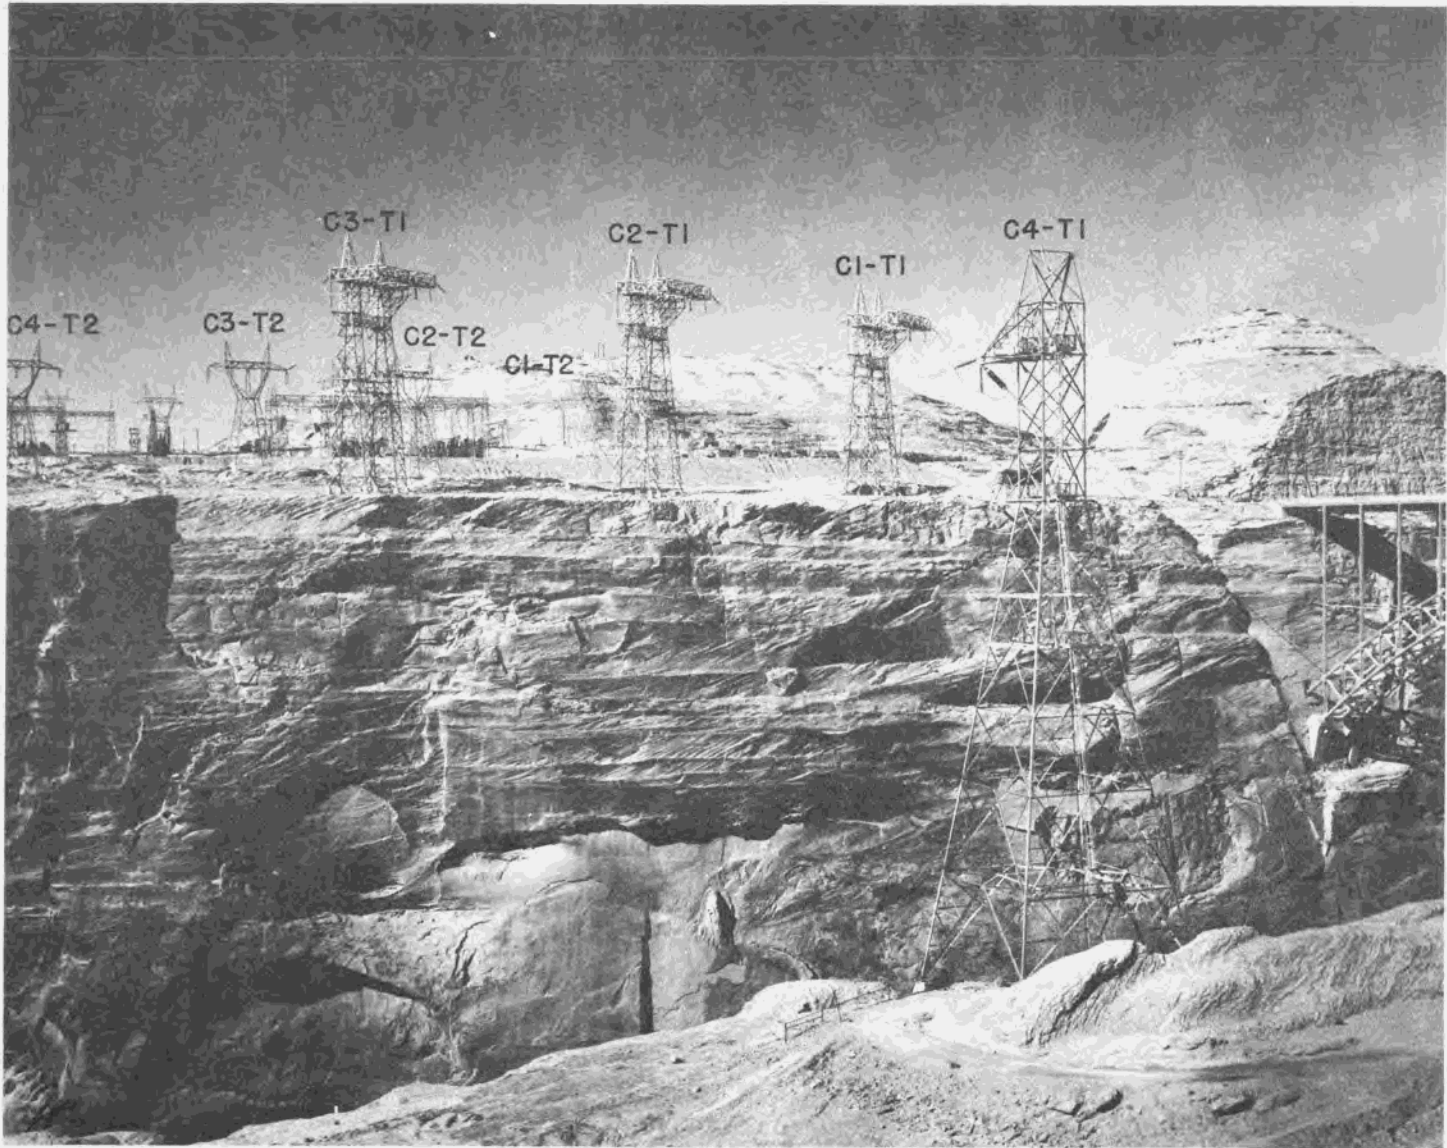
Figure 207.—Telephoto view of transformer circuit steel structures on canyon rim. P557-420-60090NA.

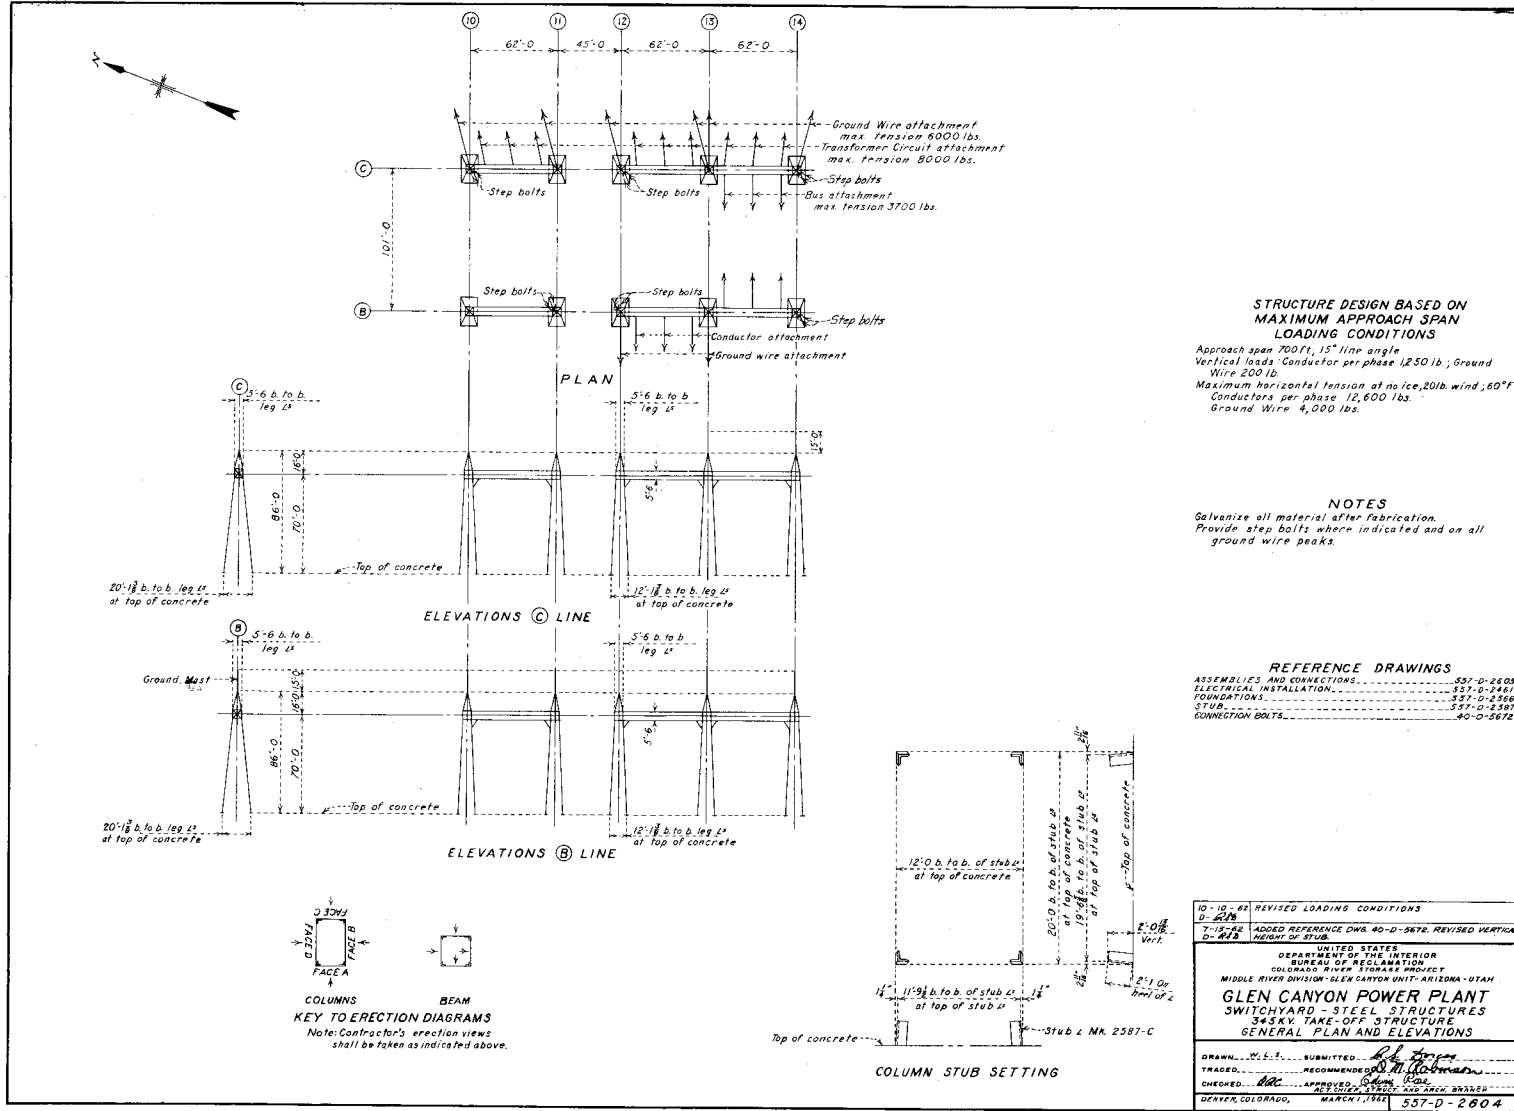
Figure 209.—Switchyard steel structures, 345-kilovolt takeoff structure—General plan and elevations.

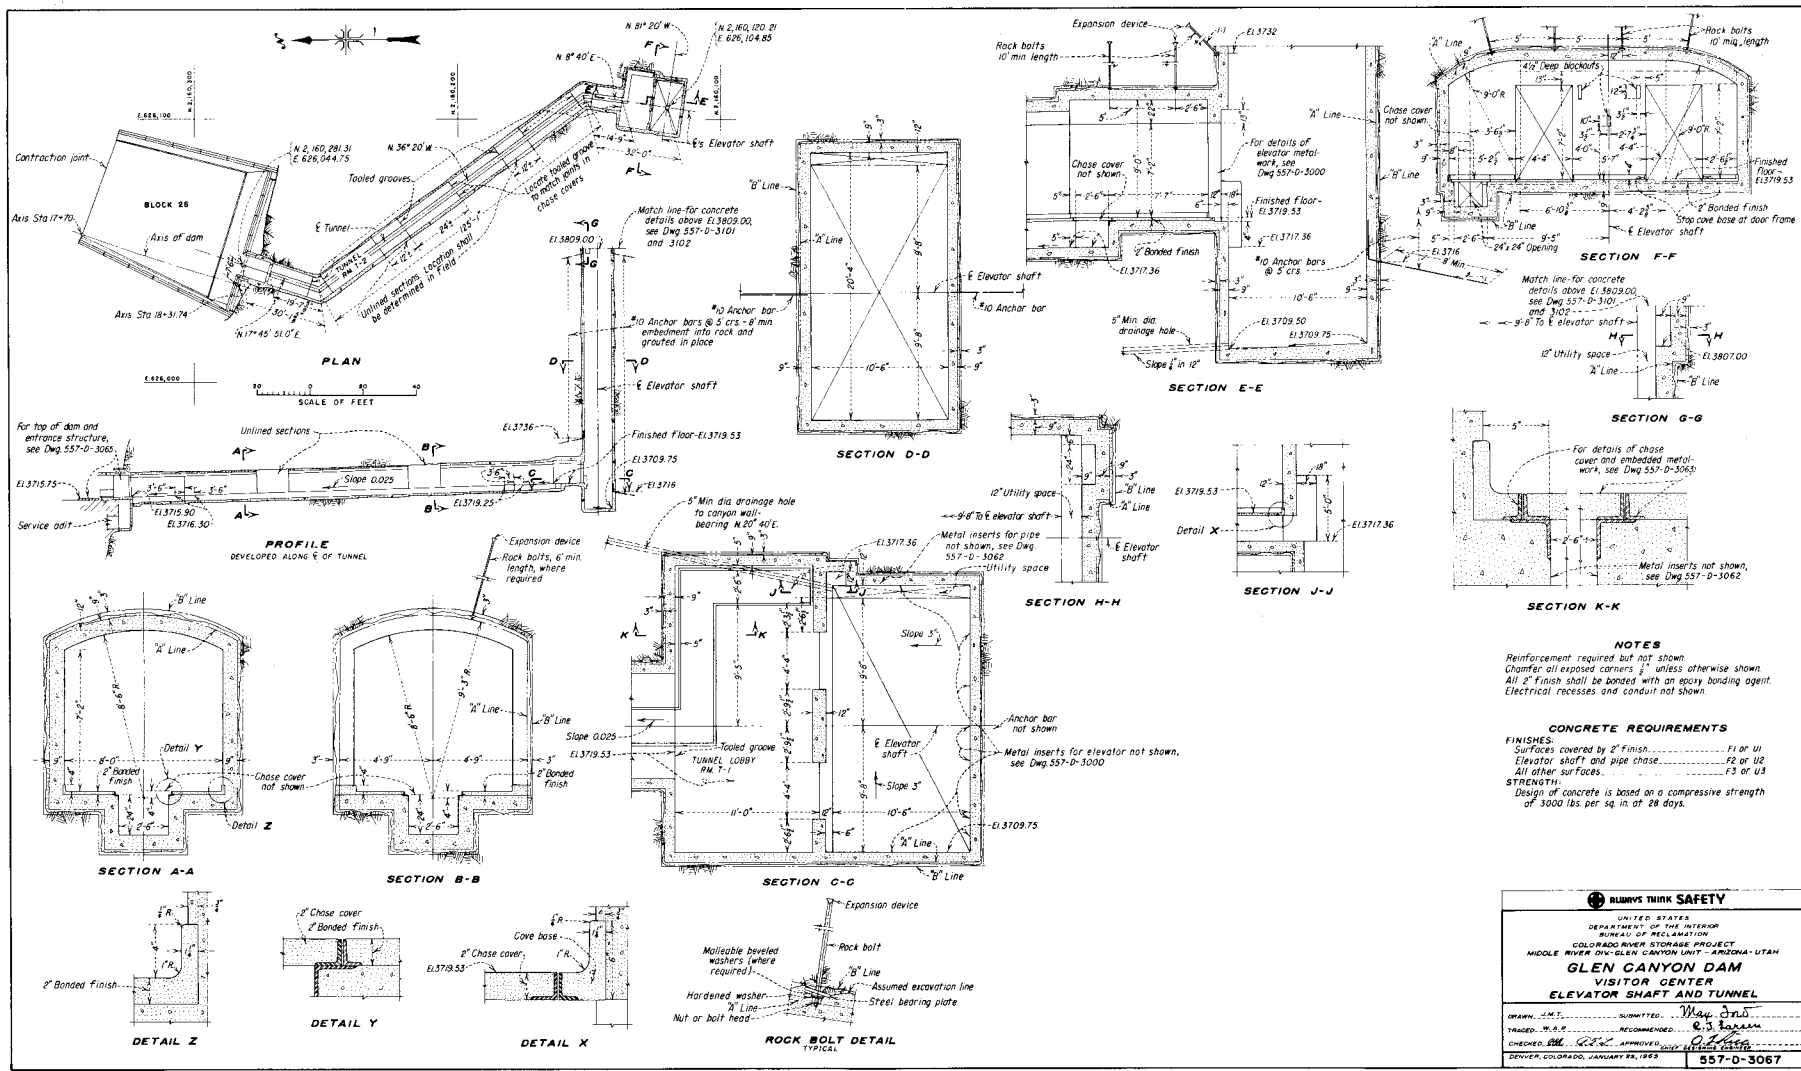
Figure 238.—Visitor center—Elevator shaft and tunnel.

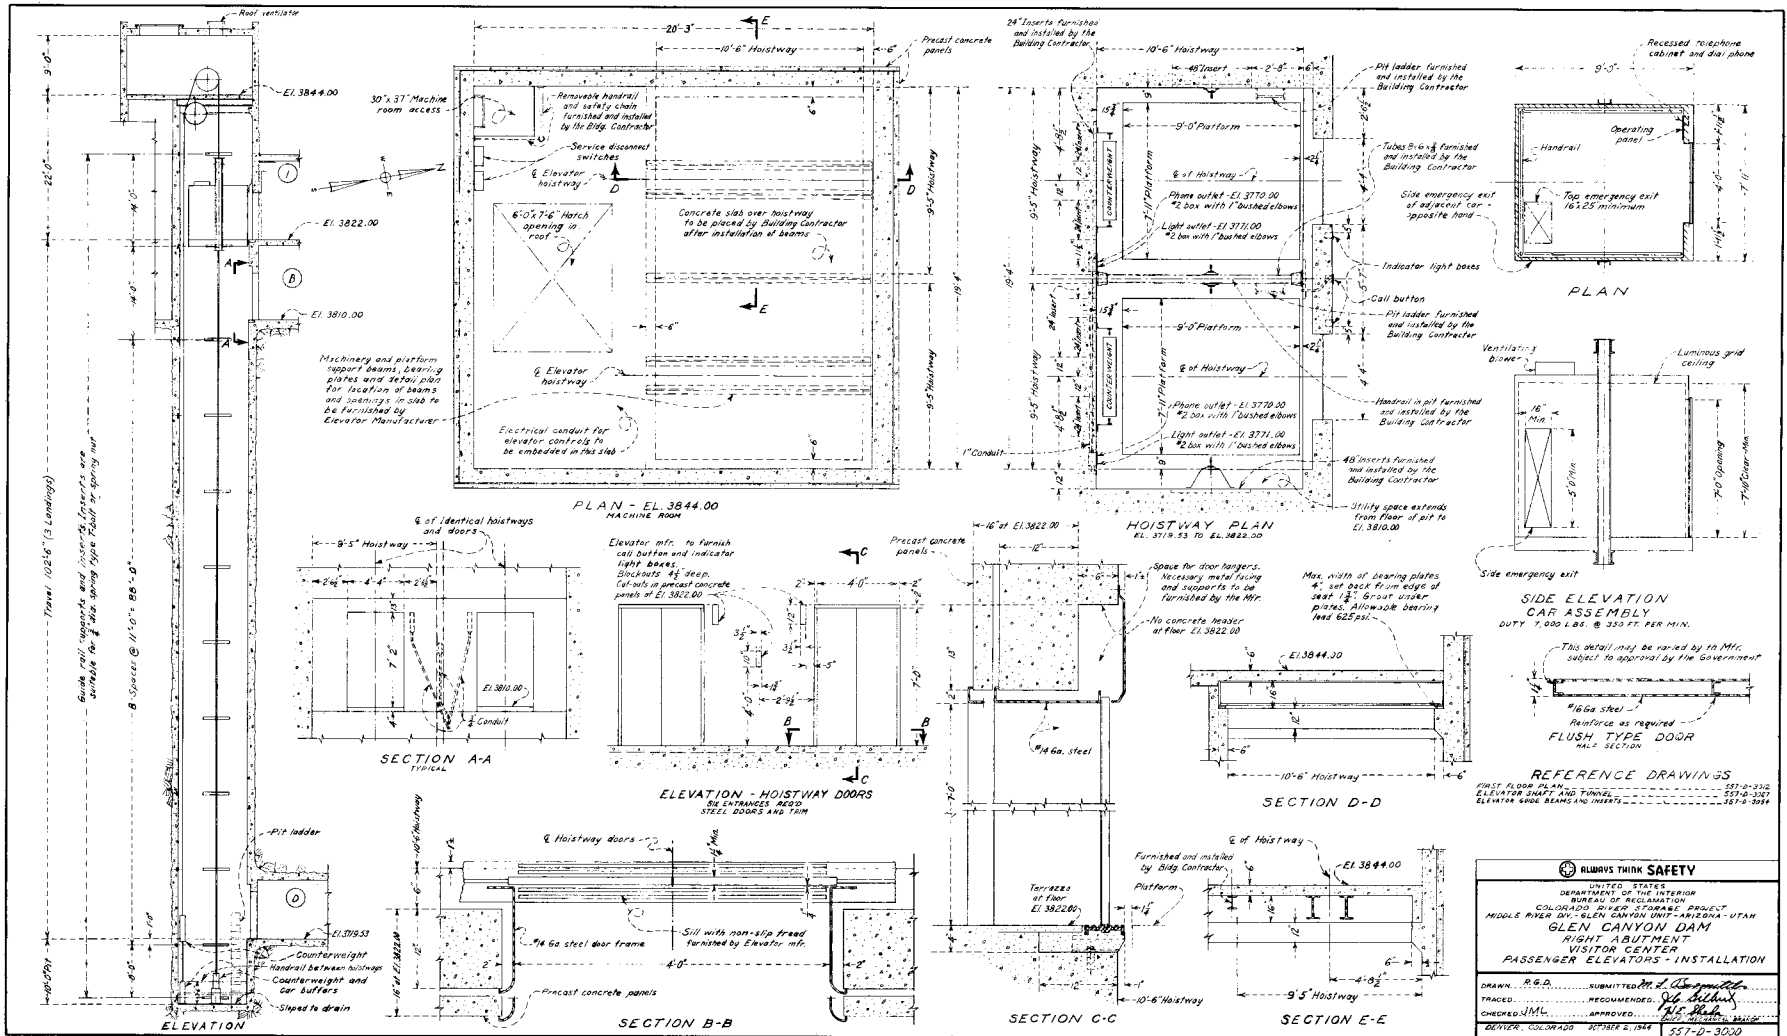
Figure 241.—Visitor center and right abutment passenger elevators—Installation.

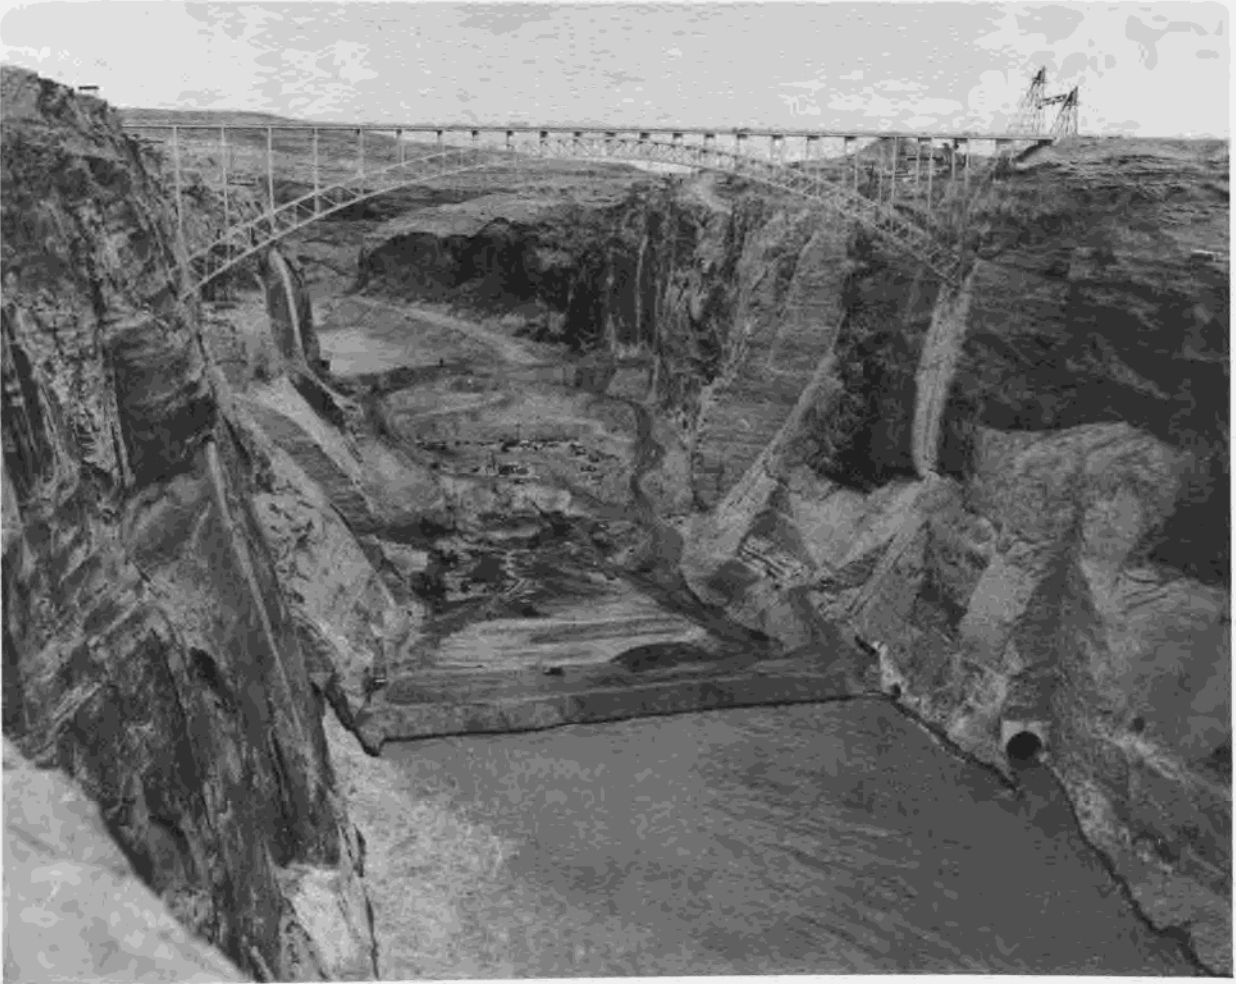
Figure 253.—Glen Canyon damsite as seen from progress photo point No. 1, approximately one-half mile downstream from the damsite on the west rim of the canyon. Note the heavy equipment working on the keyway foundation. P557-420-3817, May 20, 1959.

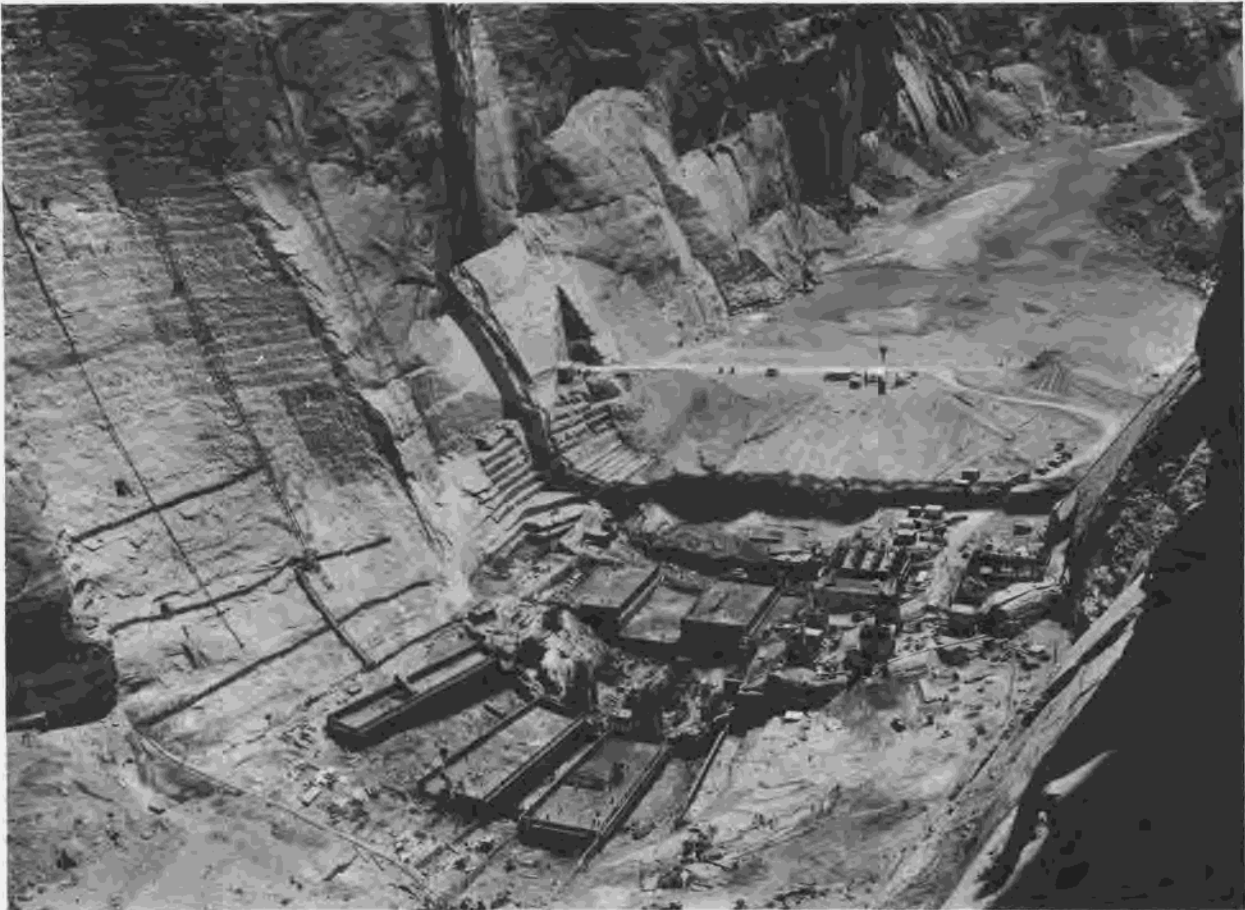
Figure 254.—View downstream from right spillway showing concrete blocks rising in dam and powerplant area. P557-420-5165, August 4, 1960.

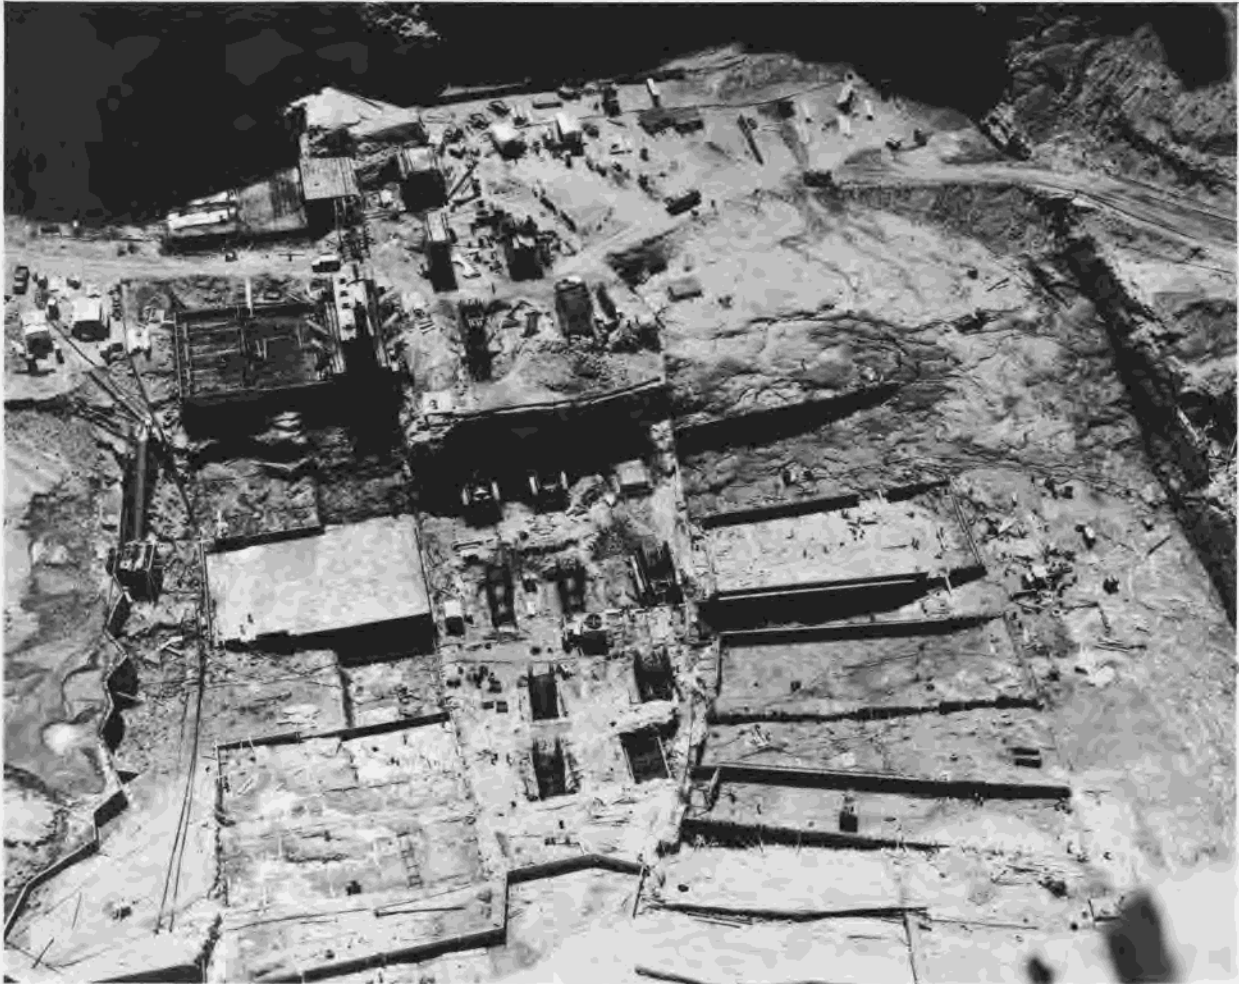
Figure 263.—View looking down on the damsite from the canyon rim. Powerhouse is at left, dam at right, with penstock foundations between them at center. P557-420-5038, July 7, 1960.
