TECHNICAL RECORD  
OF  
DESIGN AND CONSTRUCTION

# GLEN CANYON DAM AND POWERPLANT

Colorado River Storage Project  
Arizona-Utah

Denver, Colorado  
December 1970

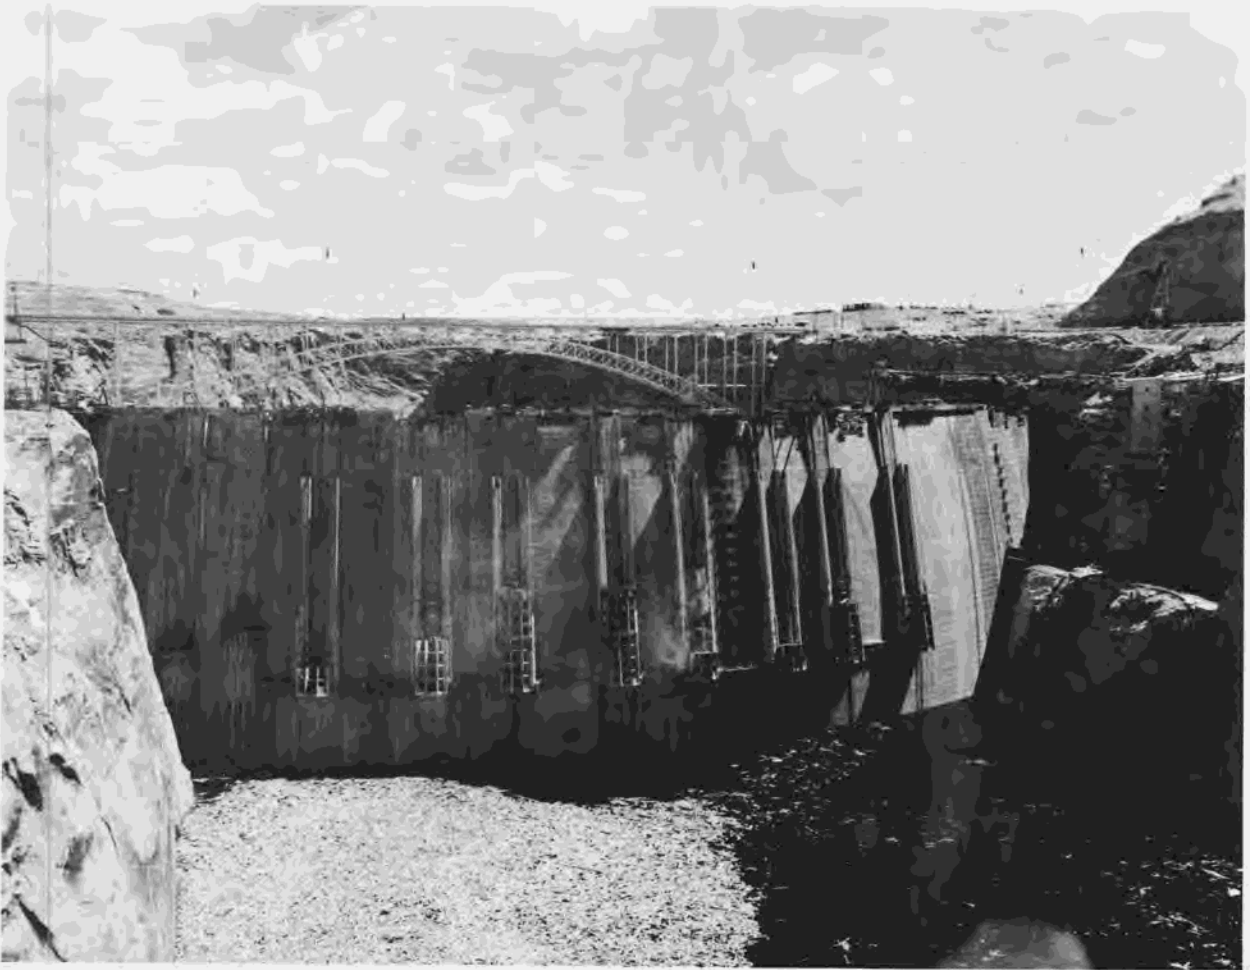
Figure 266.—Upstream face of Glen Canyon Dam during construction as seen from the footbridge. P557-420-8625, July 25, 1963.

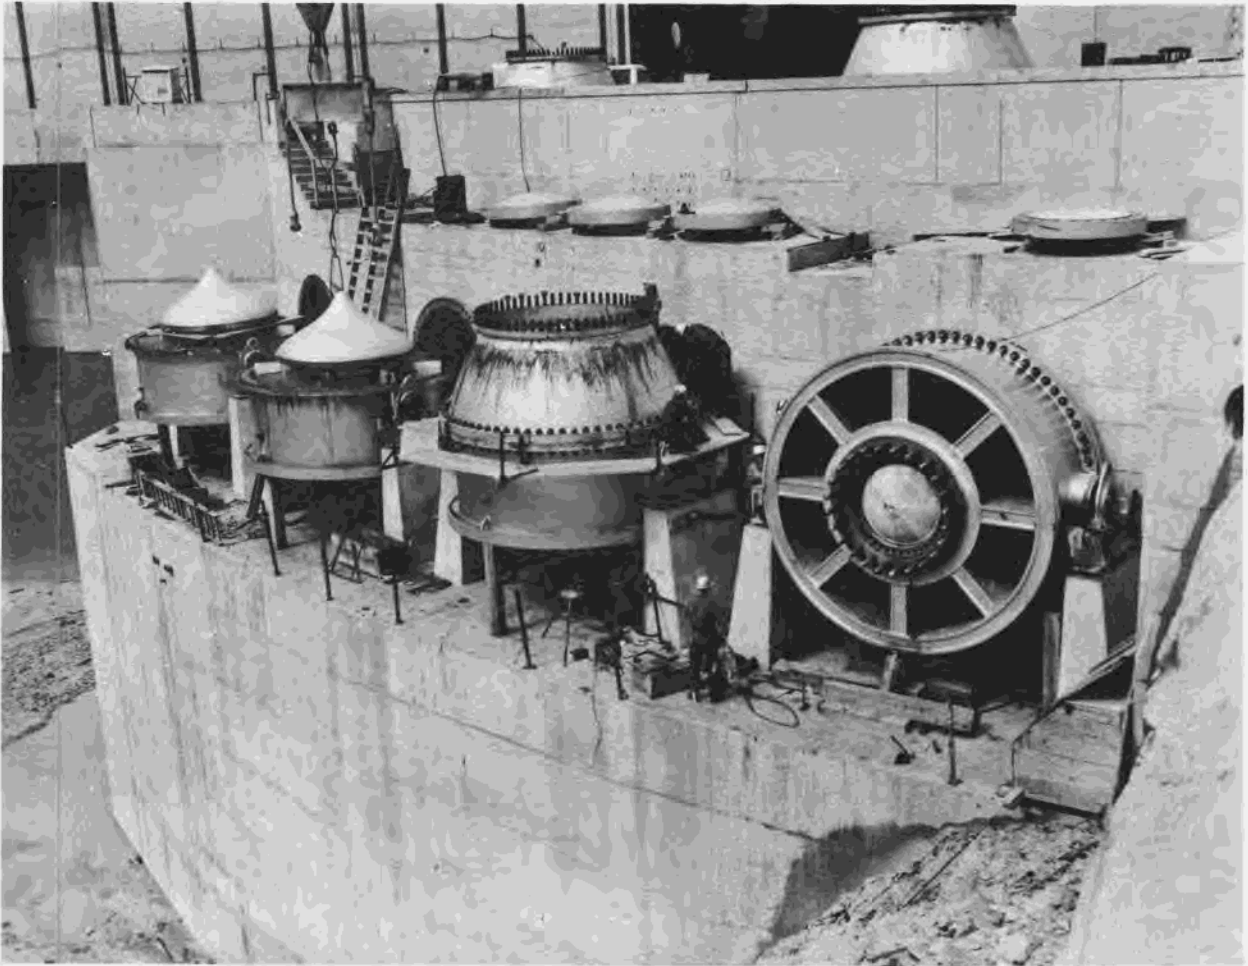
Figure 278.—Hollow-jet valves being installed in outlet works. P557-420-8140, March 18, 1963.
