Subject: Much of KCPD property should be protected wetlands

Author: Robert Phillips, Moab

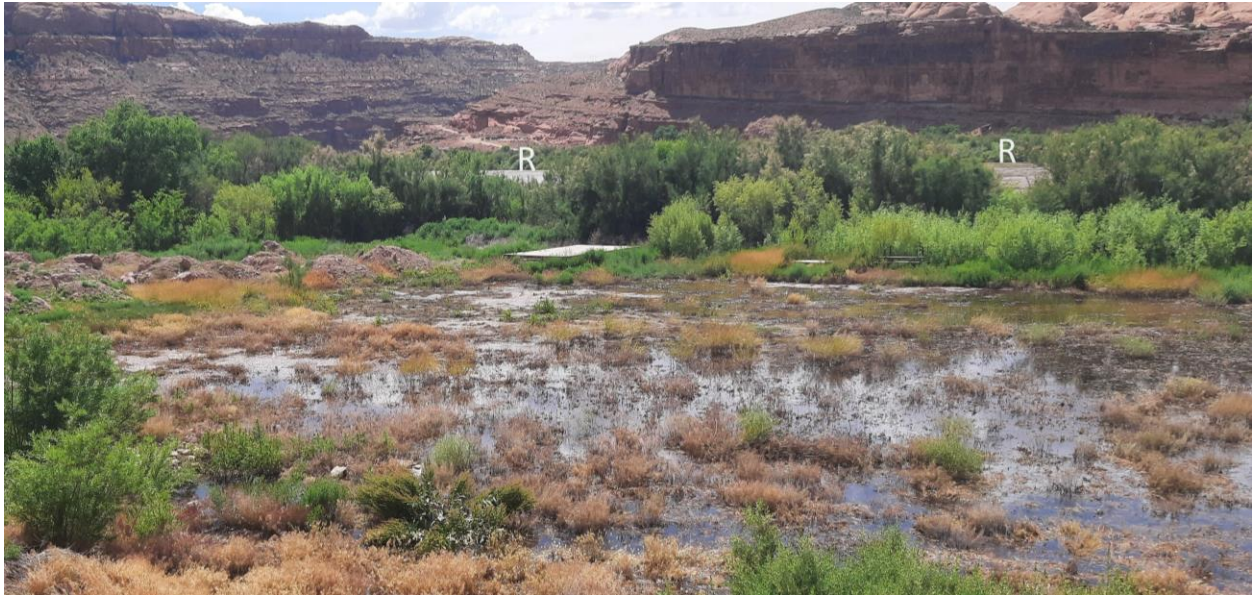
Figure 2. Photograph of flooded KCPD property looking SW from approximately “photo pt 1” in Figure 1, on 25 May 2023. The river (R) can be seen through the trees. The mouth of Pritchett Canyon is in the trees in the upper left.

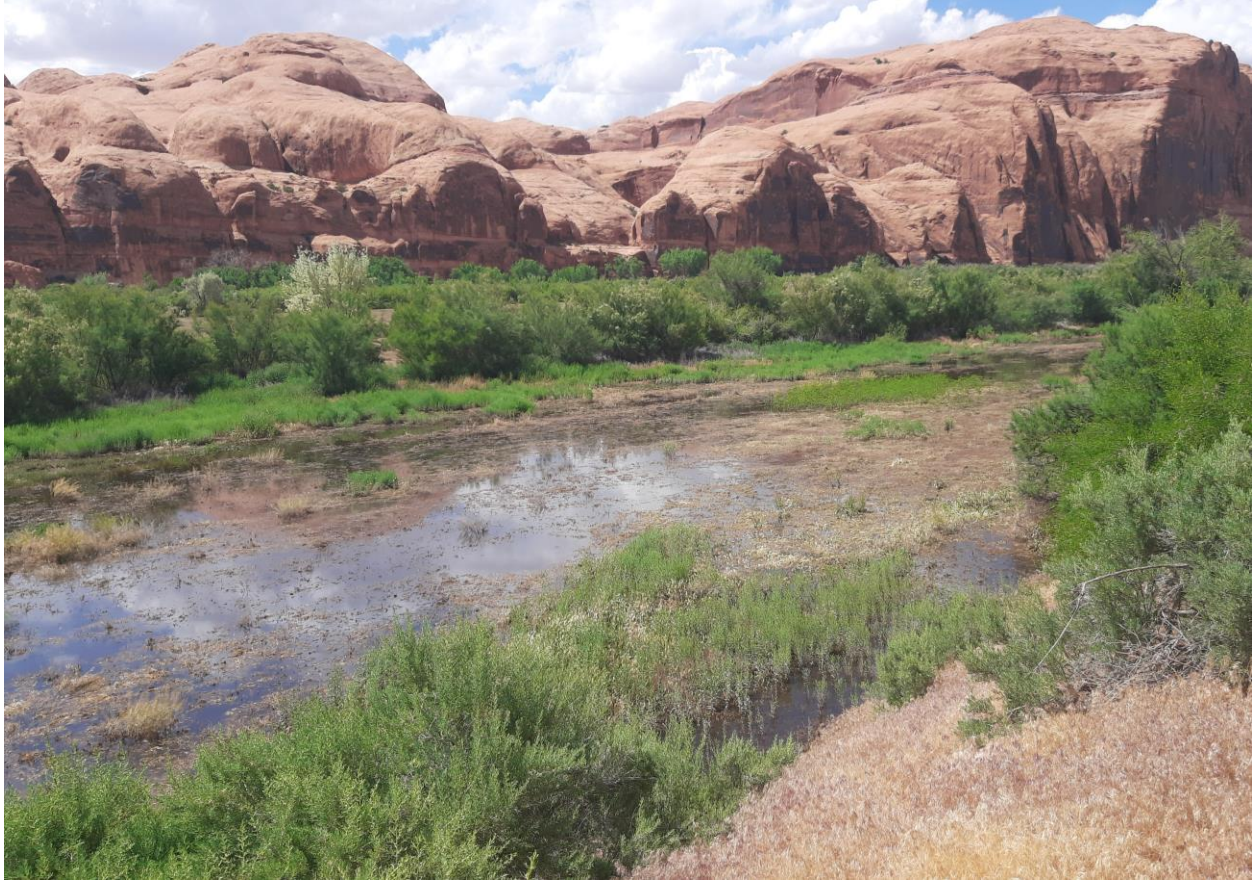
Figure 4. Photograph of flooded KCPD property looking NW from approximately “photo pt 1” in Figure 2, on 25 May 2023.

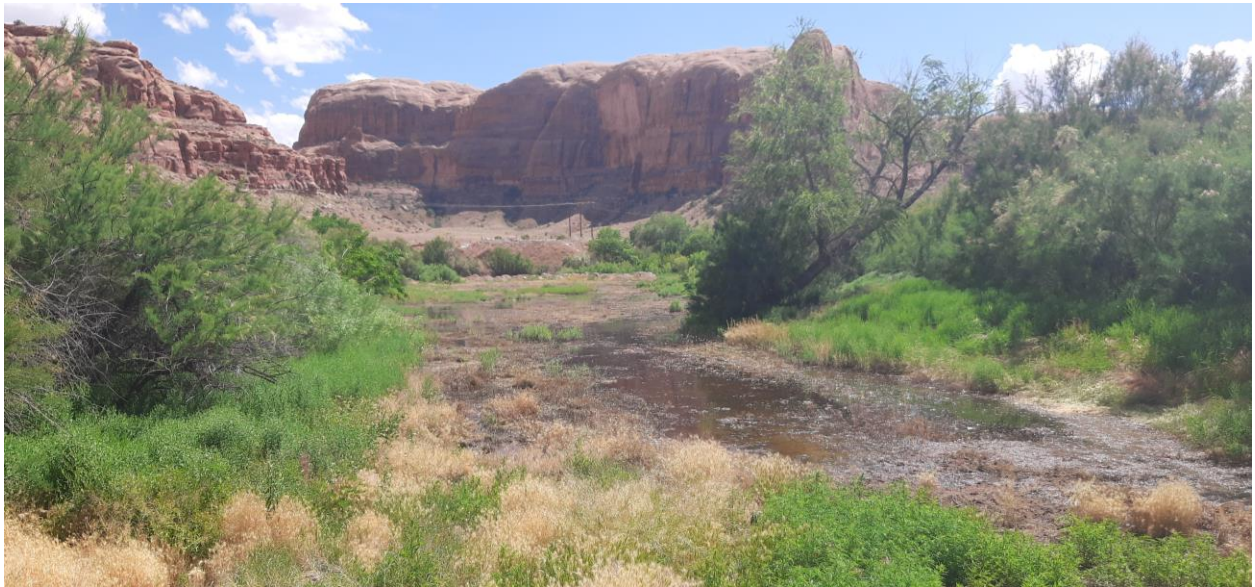
Figure 5. Photograph of flooded KCPD property looking SSW from halfway between “photo pt 1” and “photo pt 2” in Figure 2, on 25 May 2023.

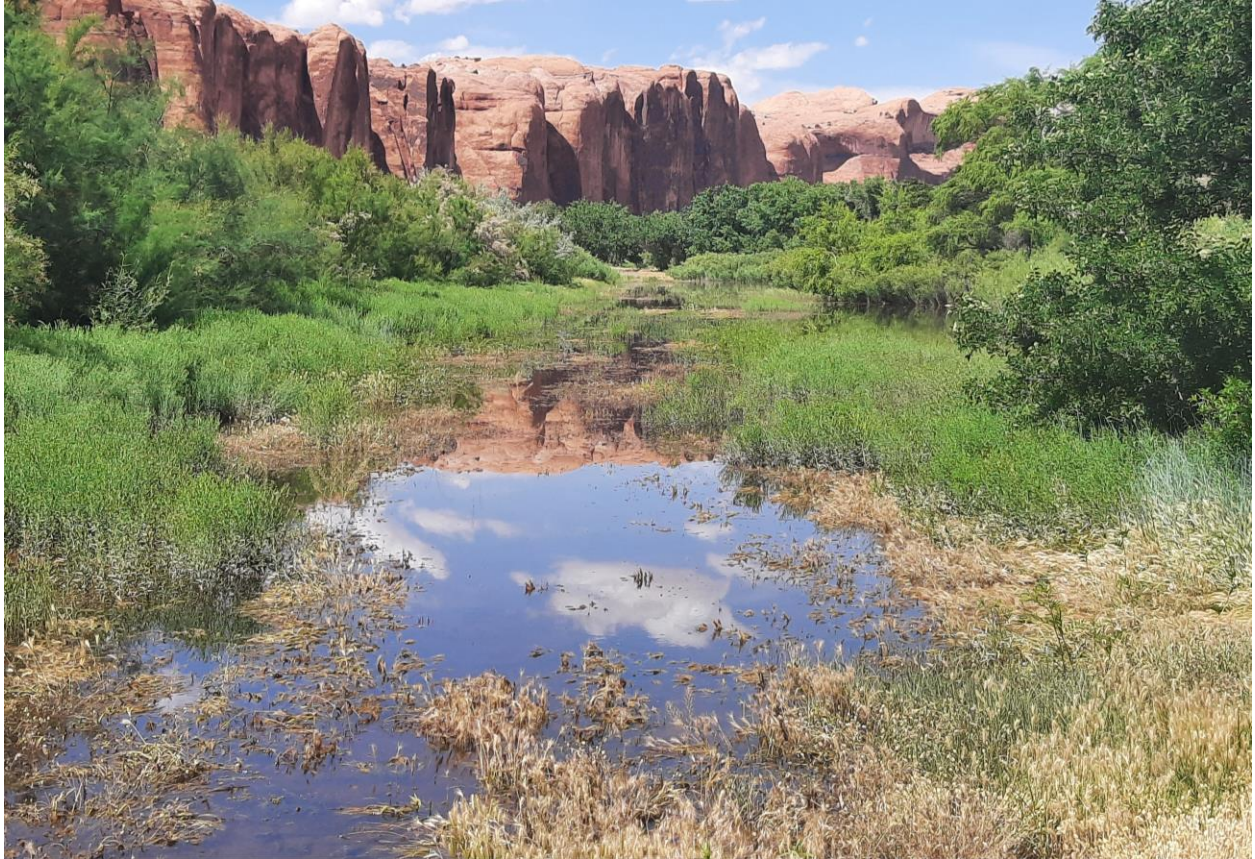
Figure 6. Photograph of flooded KCPD property looking N from halfway between “photo pt 1” and “photo pt 2” in Figure 2, on 25 May 2023.

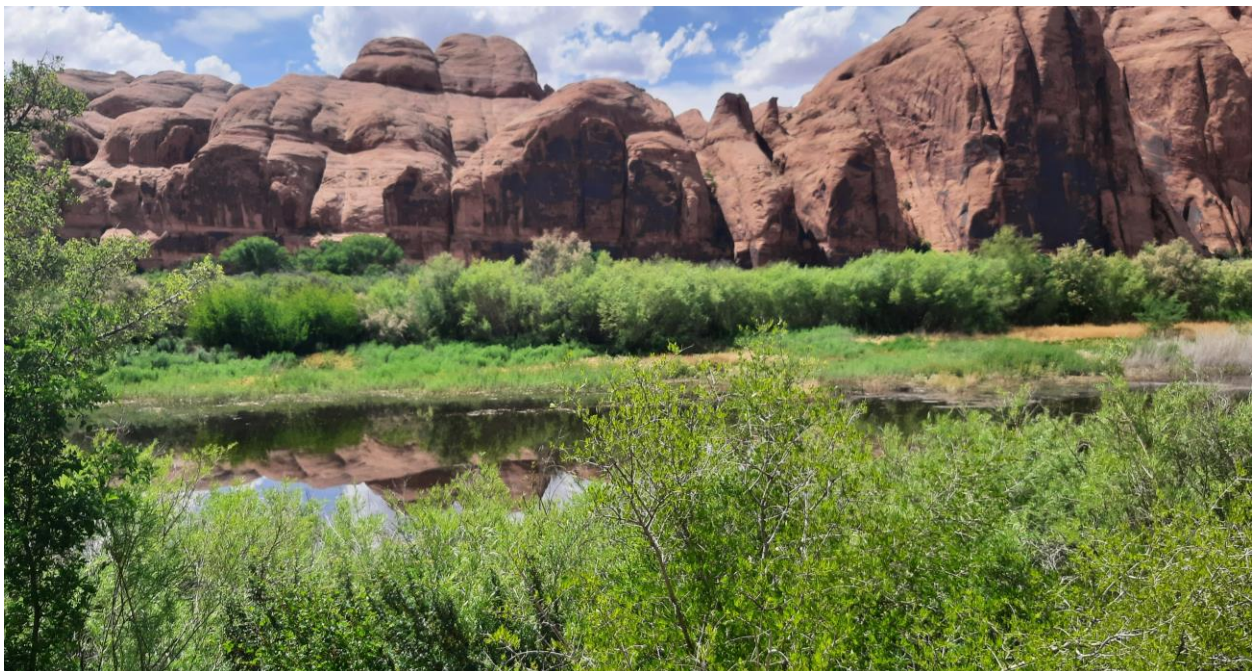
Figure 7. Photograph of flooded KCPD property looking W from near “photo pt 2” in Figure 2, on 25 May 2023.

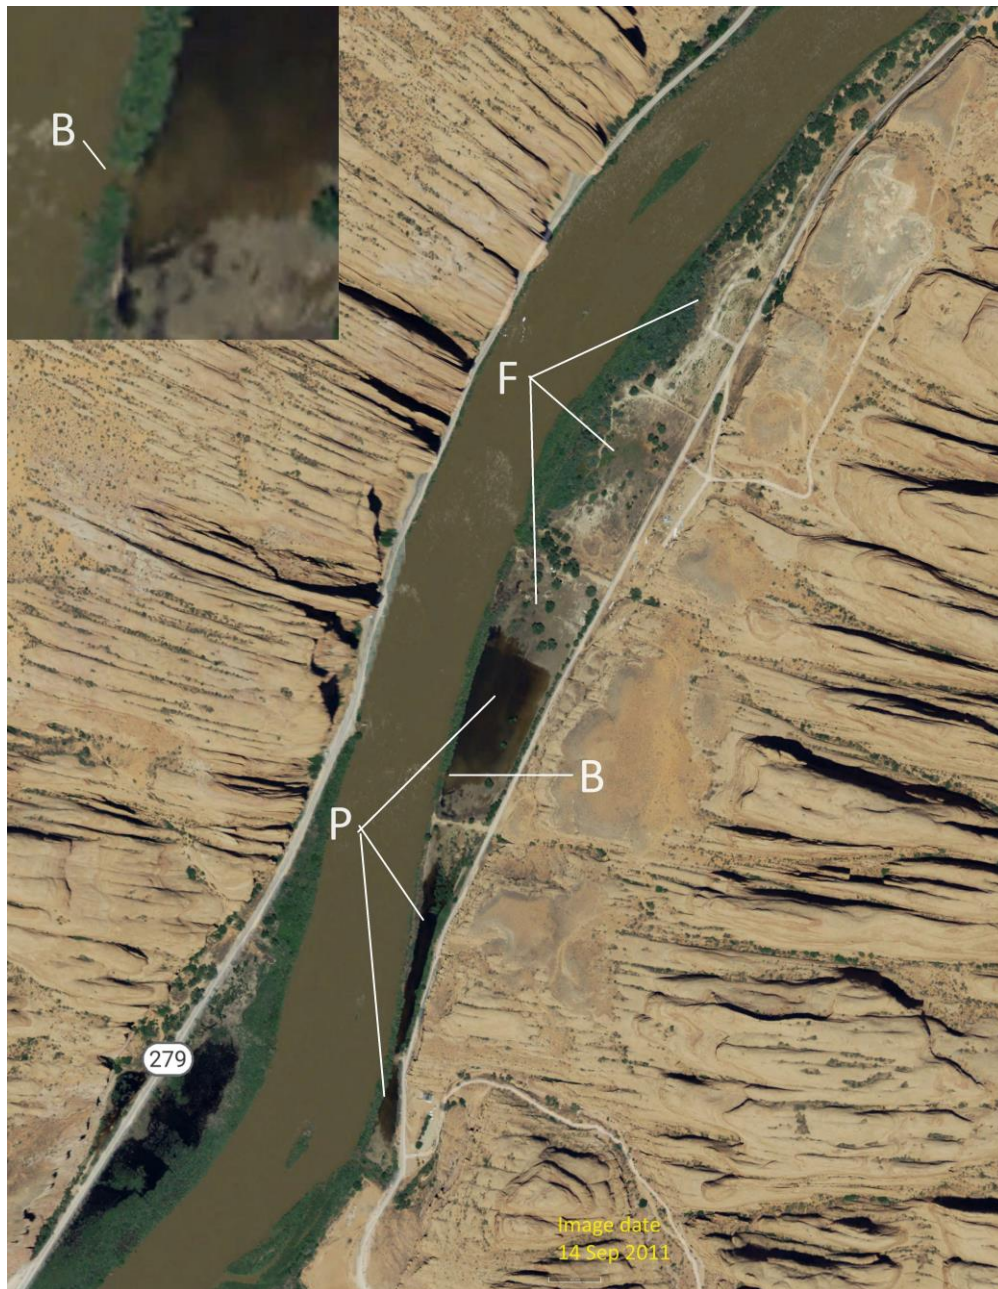
A Google Earth image of 14 September 2011 (Figure 8) shows residual river water inundation on the KCPD property and direct surface connection with the Colorado River more than three months after the river’s peak flow on 9 June; however, none of the IE or SME reports I found indicated that inundation of the property was visible on aerial imagery.

I observed natural levee failures in 1995 and 2011, which allowed river water to directly flood large portions of the property. (Levee failures occurred in other flood years, but I did not observe them as they were happening.) The Google Earth image of 14 September 2011 (Figure 8, B and inset) clearly shows an opening in the levee with a semicircular sediment fan inside the property, which is proof of direct Colorado River water flooding into the property. Furthermore, areas that are flooded only by groundwater upwelling (which is a direct subsurface connection with the river) tend to dry down, as the river water recedes, at about the same rate as when they flooded, depending on the rates of the river rising and falling. In contrast, areas that are flooded directly by silty Colorado River water retain their water much longer because the silt and clay carried in the water seal the bottom of the flooded basins. The facts that the flood ponds had fish (personal observation), that the ponds still existed more than 14 weeks after the 2011 49,000 cfs river peak and 4 weeks after river flow dropped to the 14 September flow rate of ~5,100 cfs (Figures 8 and 9), and that at least the northern pond maintained a synchronous elevation with

the river for more than 14 weeks (both at 1206 m elevation on 14 September) are proof of sustained direct river surface connections with flooded portions of the property.

Figure 8. Google Earth image of 14 September 2011 showing Colorado River from Moonflower Canyon to the mouth of Kane Creek 14 weeks after a peak flow of ~49,000 cfs on 9 June at the CRLU1 gauge. Much of the ground is still saturated in the lighter gray areas (F) in the northern portions of the property that had surface floodwater a month earlier. The dark brown areas (P) in the southern portion are ponds left from direct river flooding. Direct river flooding after groundwater upwelling was caused by early northward flow from the mouth of Pritchett Canyon into the southern-most area and from later flow into the more northern areas through levee failures and through backfilling and overtopping of stormwater drainage ditches. One of the levee failures (B) is distinctly visible with its sediment fan immediately inside the property (magnified inset image in upper left). After the breach, both the pond and adjacent river surfaces had synchronous levels, which on 14 September was 1206 m elevation.

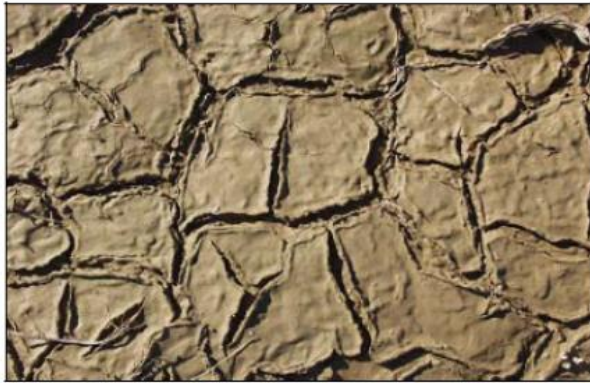
In various years during my tenure with the Mosquito District 1994–2016, I observed biotic crusts (primary indicator B12) like those figured in Appendix B, page 11 (excerpted figures 26–28 and 30 from page 71 of the Regional Supplement to the Corps of Engineers Wetland Delineation Manual: Arid West Region, Version 2.0 (September 2008) <https://usace.contentdm.oclc.org/utis/getfile/collection/p266001coll1/id/7627> [henceforth referenced as USACE manual]) on portions of the KCPD property after river inundation and dry-down. None of the IE or SME reports I found indicated they found biotic crusts.

Figure 26. Ponding-remnant biotic crusts on the surfaces of mud-crack polygons. Biotic crusts often have up-turned edges with the surface layer darker than the underlying material.

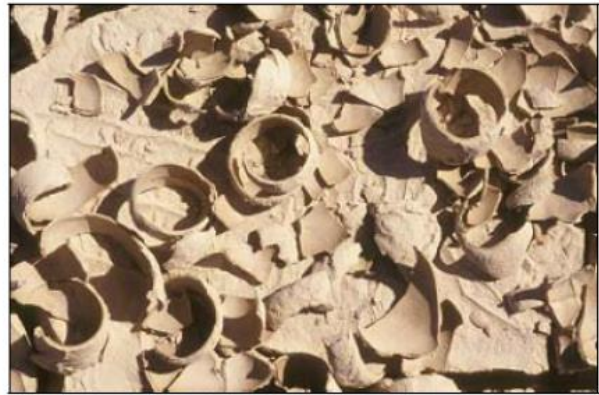
Figure 27. Ponding-remnant biotic crust showing polygons and curls detached from the underlying sediments.

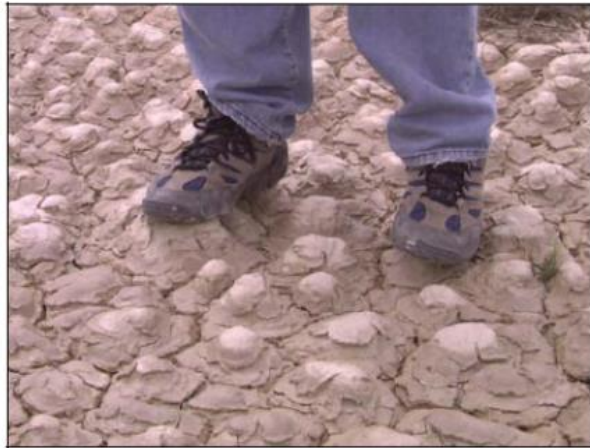
Figure 28. Ponding-remnant biotic crust, showing dried algal caps on a domed mud-crack surface.

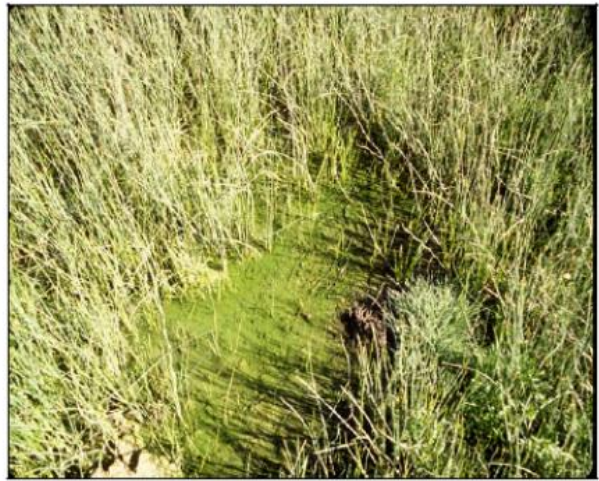
Figure 30. Remains of floating algal material in a seasonally inundated *Juncus*-dominated marsh.
