Fiscal Year 2004

Archaeological Site Monitoring and Management Activities along the Colorado
River in Grand Canyon National Park

RCMP Report No. 90
Flagstaff, Arizona

May 2005

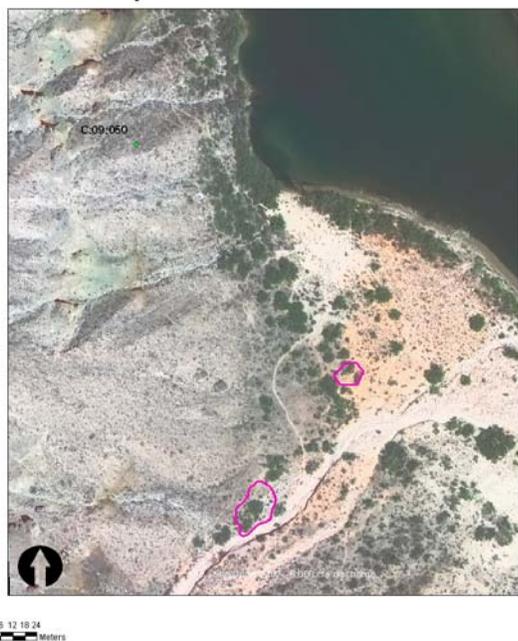
RCMP staff found that, in some cases, these data were substantially in error and additional field work was necessary to check the location information (Figure 1). The aerial photograph for the Little Nankoweap drainage shows the original location of a UTM plot, the site boundary digitized using the aerial photograph and the site boundary after completion of ground truthing (Figure 1).

Figure 1. Orthographic image with three different location data for the Little Nankoweap site. (The green circle is the UTM plot, the middle pink hexagon is the aerial photo transfer of the site boundary, and the larger pink polygon is the ground truthed site location polygon.)

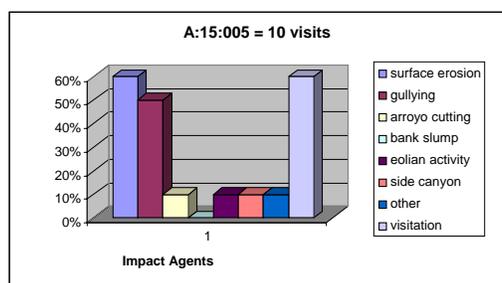
Gullyng and surface erosion at Locus C are the prime concern at this site. However, there are no direct impacts to the integrity of any features at this time. An active gully cutting trend was observed from 1993 to 1995 and again from 1998 to 2000. Checkdam construction has resulted in no new active downcutting in the gully. Surface erosion is incipient on-site. Visitation is evidenced by a faint trail adjacent to the two roasters at Locus C. Visitation to the pictographs does occur though no established trail is apparent due to the access up a side canyon drainage.

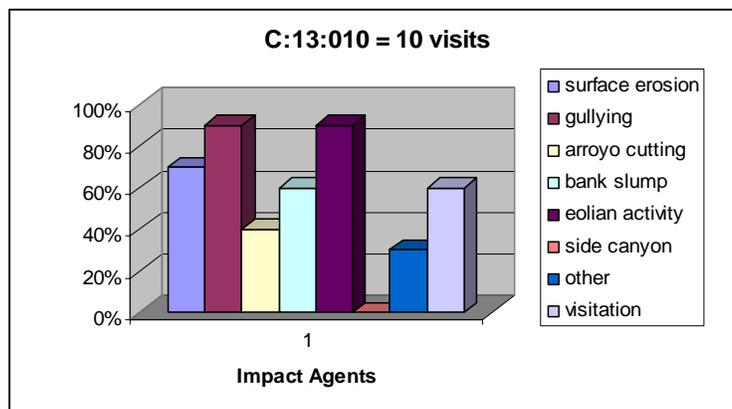
Gullyng and eolian erosion have been the most consistently observed impacts to this site, while surface erosion has also been active. Features at this site continue to be subjected to active rilling, gully and arroyo development, down cutting and headcut advancement and new channel initiation. Data recovery has been recommended with only minor feature based excavation conducted so far. Active gully and arroyo incision and expansion threaten the integrity of this site. Visitation has occurred despite the closure in 1985. However, visitation is minor compared to the physical erosion occurring on site.

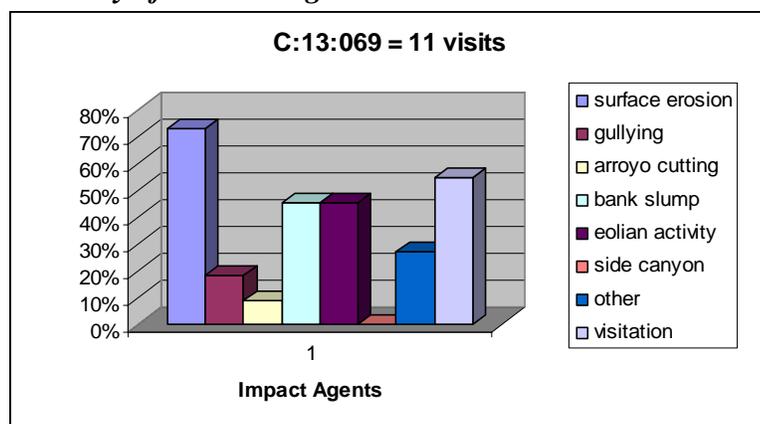
There was much erosive activity at the site in FY93, but after that year erosion was incipient throughout. Surface erosion, bank slump and eolian activity are incipient here. Active gully down cutting in FY02 resulted in the exposure of a burned beam adjacent to Feature 2. Checkdams within this gully are upstream of the features; some are adjacent to F1 and F2. Feature 1 and 2 integrity is threatened by continued drainage expansion due to bank slump. The gully and arroyo have not been active for a couple years now. Since the checks were installed there has been only one active year. Need to make sure the text reflects the table and visa versa. Visitation in the form of trailing adjacent to Features 1 and 2 and bisecting Feature 6 is being addressed by the NPS trail crew and does not currently affect feature integrity.

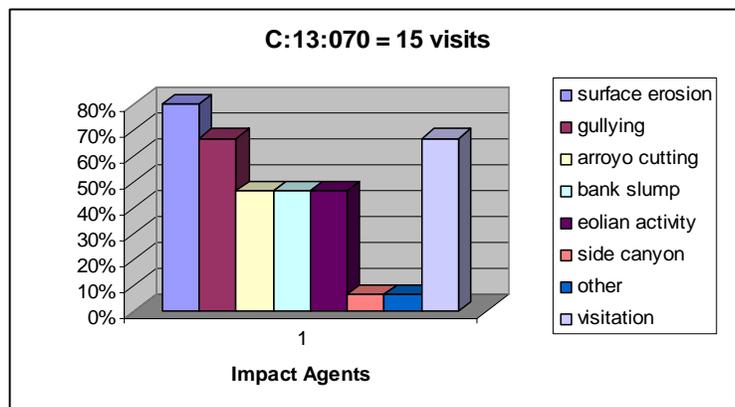
Incipient erosion through channeling occurs in the early years; however, beginning in FY99, the erosion becomes more consistent. There has been a trend of active gully and arroyo down cutting and expansion since at least just prior to the recording of this site. Both drainage down cutting and channel widening threaten the integrity of the feature at Locus D. The gully at Locus B does not threaten feature integrity at this time. Visitation to Locus B is active for tribal access and does not threaten feature integrity. Loci A and C are not currently threatened by the active channel down cutting and widening that is occurring at this time.

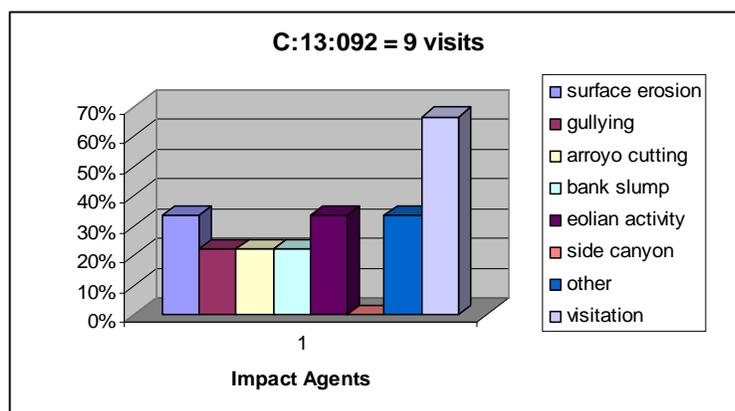
Surface erosion and eolian activity are incipient here as evidenced by newly exposed and recorded prehistoric artifacts. No active channel downcutting or expansion threatens site integrity. Visitation is evidenced by the movement of historic artifacts between monitoring episodes which does not threaten the integrity of the site at this time.

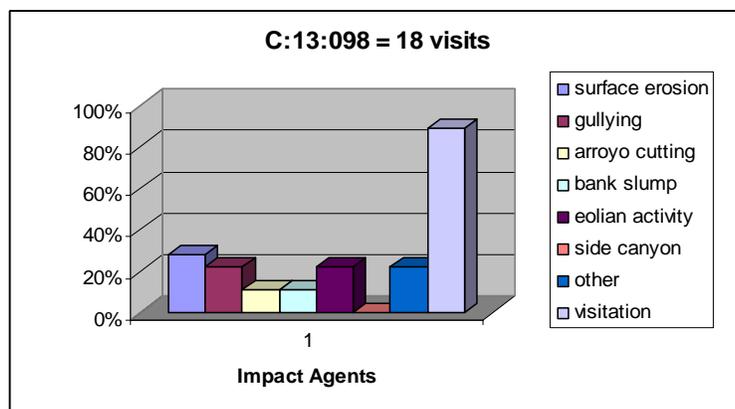
Surface erosion and eolian activity are incipient. It appears that visitor-related impacts have been the consistent impact to this site. Historic artifacts continue to be moved around the site and within the cabin. The prehistoric component of this site remains in good condition and has not had any new impacts observed since 2001. A small gully adjacent to the historic cabin has not actively down cut since 1994. Visitation does not immediately threaten site integrity and is being addressed by the NPS trail crew.

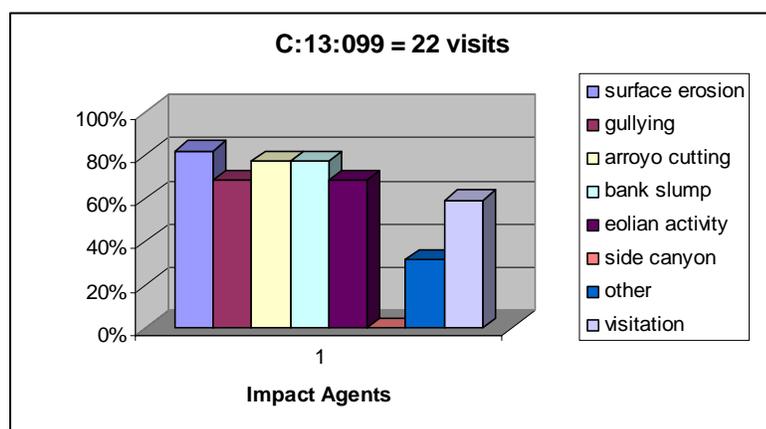
There has been active down cutting, and channel widening at least since the site was recorded in 1978. Active surface erosion, leading to the development of rills has resulted in the transition to a gully to an arroyo at Feature 1. Checkdam construction has resulted in sediment deposition, and possibly curtailing channel deepening. Breaching does occur and therefore widening of the drainage is evident. The experimental flood flows in 1996 did reach and plug up the mouths of the arroyos (see Yeatts, 1997 & 1998). The integrity of Features 1, 3, 4 and 6 is threatened by active channel incision and expansion. NPS trail crews maintain the Beamer Trail adjacent to this site. Visitation may threaten site integrity due to the continued exposure of new cultural material. Data recovery continues to be recommended at this site.

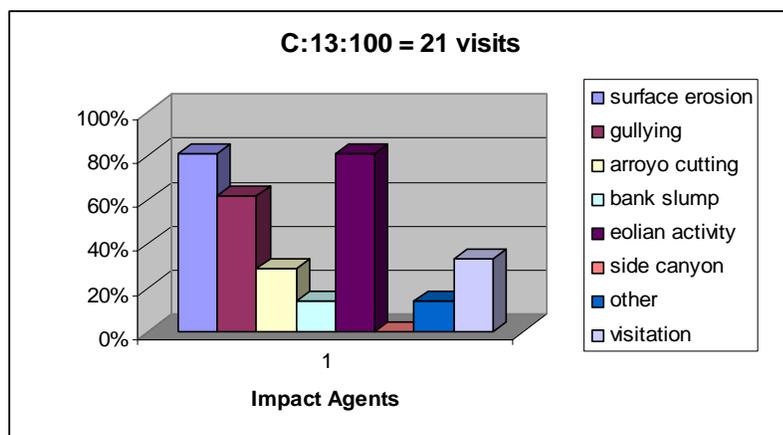
Surface erosion is the most consistently (over 80% of the time) identified impacts to the site followed by gullyng. Surface erosion and eolian activity are active at Features 3, 5, 7, 10 and 11. Active gully and arroyo expansion threaten the integrity of Features 4, 5, 6, 8 and 9. Data recovery has been recommended for Features 5, 6, 7, 8 and 9. Visitation is incipient though it does not affect the integrity of the site. The NPS trail crew routinely maintains the Beamer Trail adjacent to this site.

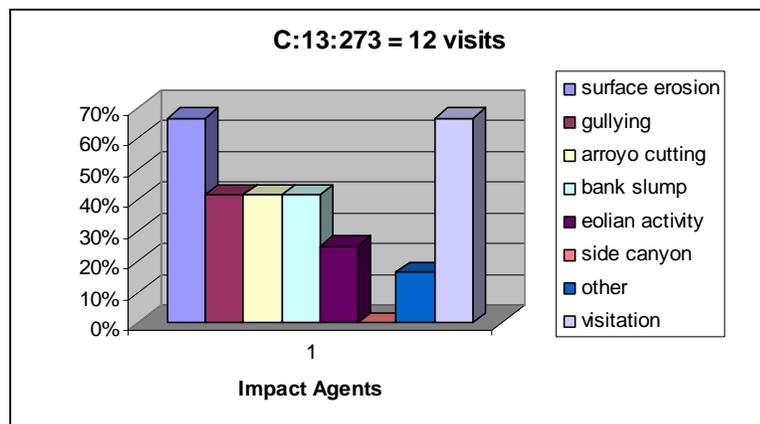
Surface erosion is the most frequently documented form of impact to the site however gullying, arroyo cutting and bank slump, although incipient can be detrimental to the sites integrity as several features are adjacent to these impacts, thus directly impacted by their activity. For example, Feature 3 is threatened by active gully and arroyo down cutting and expansion. Data recovery has been recommended at Feature 3 since 1997. As bank slump and headward movement of channels continue, Features 1 and 2 will be in a same predicament as Feature 3. Surface erosion is incipient at Feature 4. Visitation is adjacent to the site along the Tanner Trail however the features are quite obscure and visitor disturbance is currently not a threat to the site. This trail is routinely maintained by the NPS trail crew.

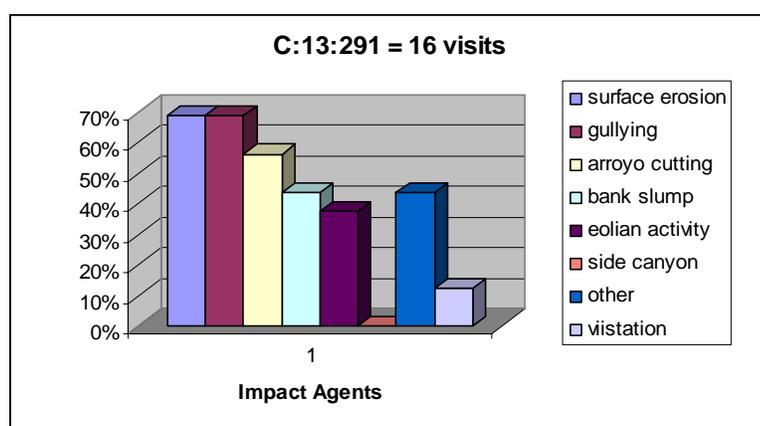
Surface erosion and gulying are the most common occurrences for site impact followed by arroyo cutting and bank slump and eolian activity. Active gully and arroyo cutting and expansion threaten the integrity of Features 1, 3, 4 and 7. Feature 7 was newly exposed in an active arroyo cutbank. Visitation has occurred along the site boundary and does not affect site integrity. Trailing to a nearby interpretive site is maintained by the NPS trail crew.

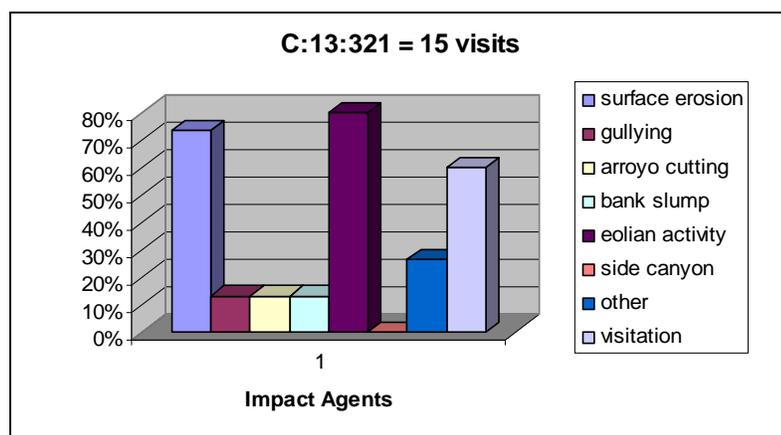
Surface erosion and eolian activity have been the driving forces for site change since the site was recorded. Previous gully and arroyo cuts have been in-filled by eolian activity. These drainages are again becoming exposed due to eolian activity in the form of sediment loss. The integrity of Feature 5 is threatened by the potential for gully activity –the feature is situated at the edge of the gully. Data recovery has been recommended for Feature 5. Visitation was previously an issue when the adjacent beach was used as a river camp, this is no longer the case because the beach has lost significant amounts of sand.

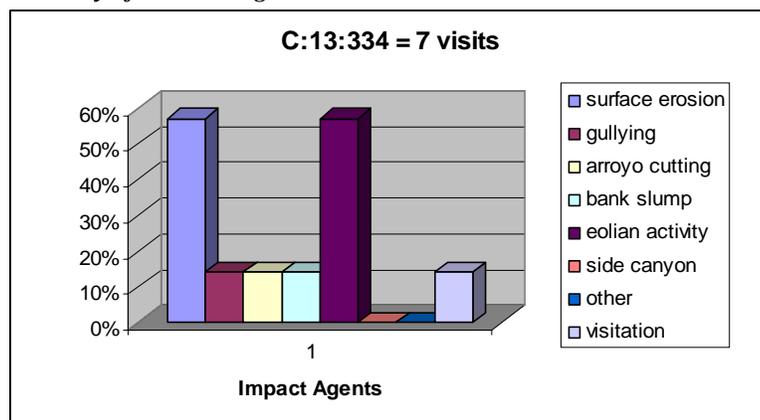
Surface erosion and eolian activity are the dominant impact agents. These agents do not pose a threat to site integrity. If the catchment area (the network actively threatening C:13:099) enlarges there is the potential for active channel down cutting and widening which may threaten feature integrity.

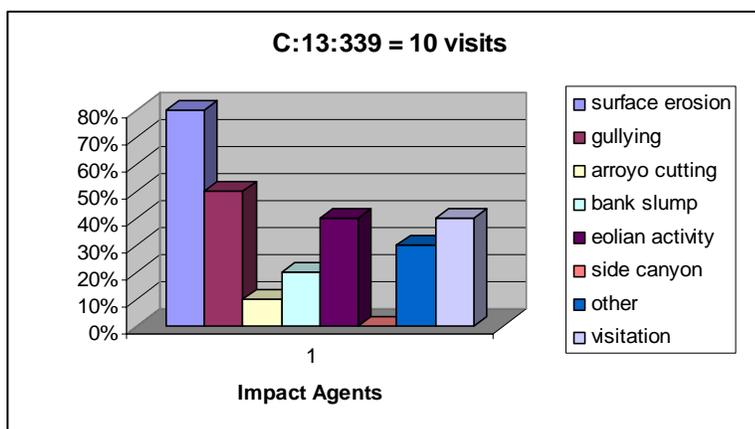
Surface erosion, particularly in the deflated areas has been observed as incipient though does not threaten feature integrity. Observations show active gully down cutting increasing slightly in the past 6 monitoring episodes with the potential to threaten the integrity of Features 2, 3 and 5. Checkdam installation may preserve integrity at this feature and more than likely decrease erosion of the gully. The Beamer Trail goes directly through the site; however, because these features are somewhat difficult to discern no direct visitor impacts have been observed. The only visitor impact agent is the trail and this is routinely maintained by the Park.

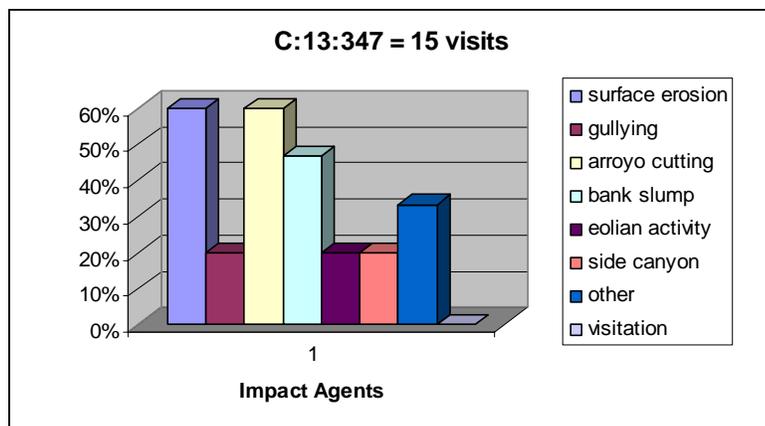
Active arroyo down cutting and expansion directly threatens the integrity of this site. Subsurface testing indicates additional buried cultural remains are present. Data recovery has been recommended here since 1995. Visitation does not occur at this location.

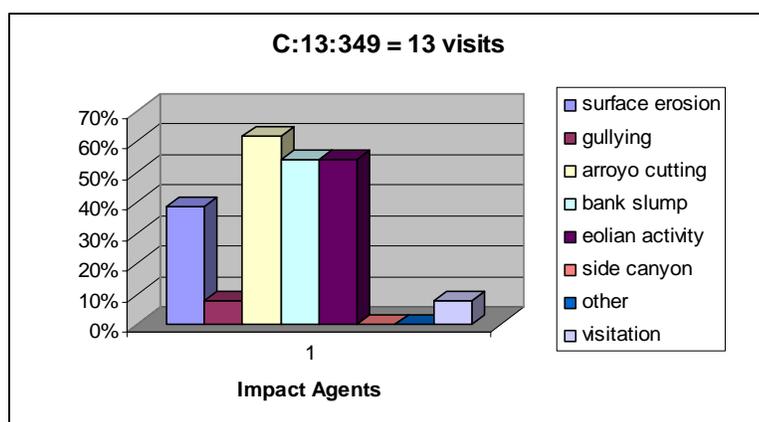
Active surface erosion and eolian erosion are incipient at Features 3 and 4 though they do not currently threaten the integrity of these features. Active arroyo cutting has resulted in the excavation of Features 2 and 5. Feature 1 is threatened by headward migration of the arroyo. An ephemeral gully adjacent to the arroyo developed in 2003. This gully and the arroyo have the potential to expose additional cultural materials. The visitation present in 2003 consisted of a single set of footprints directly through Feature 3.

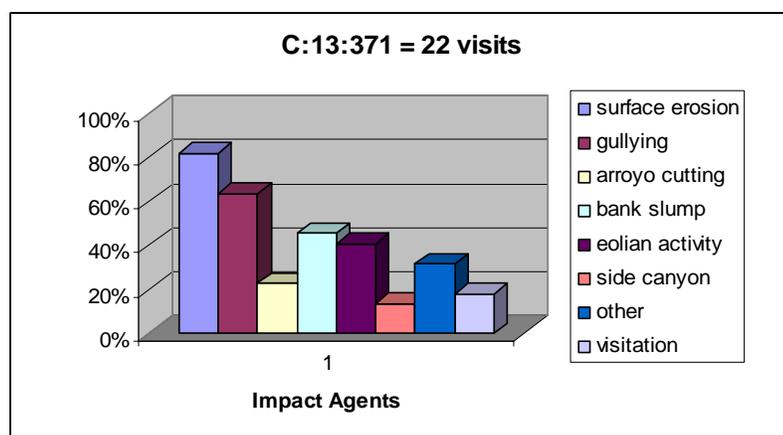
Surface erosion is incipient though does not threaten the integrity of any of the features. Increased gully down cutting and expansion threaten the integrity of Features 2, 3, and 5. Data recovery has been recommended for Features 2 and 3.

Checkdam construction in the drainage above Feature 5 appears to be slowing the down cutting of this gully. The gully at Features 2 and 3 continues to down cut and expand. Visitation does not occur at this site.

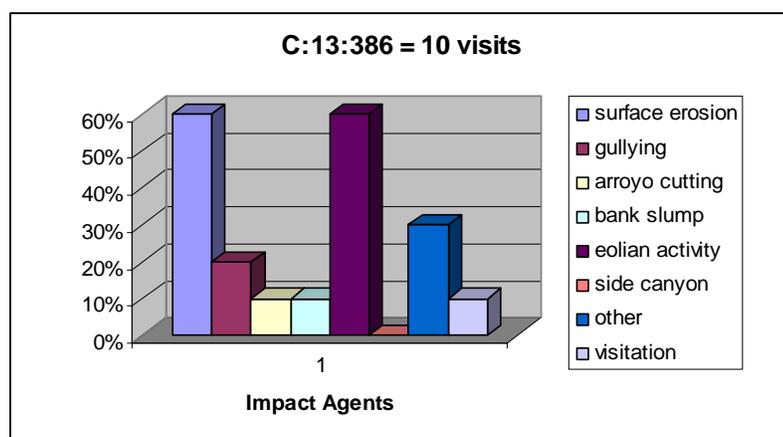
Surface erosion is incipient and continues to expose more of the features present. Eolian activity is primarily responsible for the exposure of the burial. Active gully down cutting directly threatens the integrity of the storage features and artifacts at Structure 2. Visitation present in 1996 consisted of a single set of footprints across the dune below the site and nothing has been observed since that time.

The artifact scatter at Structure 2 has minor surface erosion. The gully below it has been active with several knickpoints present. Structure 2 is unchanged. Minor eolian deposition and erosion at the burial are evident. One set of sheep tracks runs along the dune just below the brush stabilization. Grasses and four o'clocks are growing in the brush placed to stabilize the dune. Feature 1 the cist has minor surface erosion. No sign of human visitation was observed. Continue to maintain the brush stabilization. The site looks good with only minor physical impacts. Though due to the sensitive nature of the site, continue semiannual monitoring until the tribal consultation work is completed.

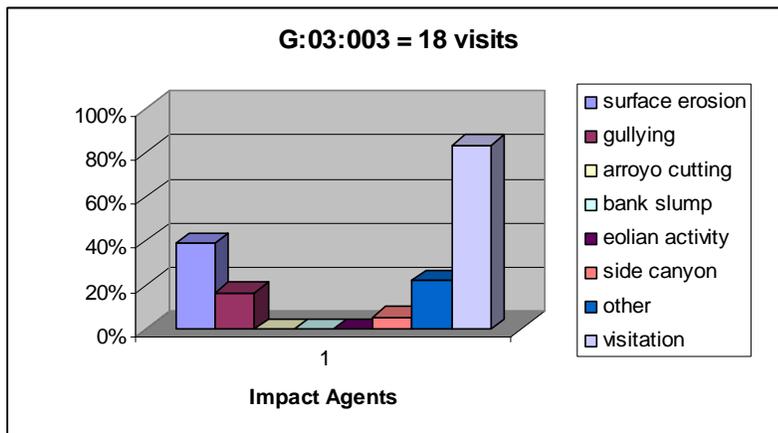
Surface erosion is incipient. Gully down cutting has likely been stabilized by the installation of checkdams in the gully below the site in 1996. Continued visitation has resulted in compaction adjacent to Features 2, 3, and 4 and disturbance at Feature 1. The integrity of the features is not threatened at this time. The NPS trail crew maintains trail obliteration work in this area.

rocks. No pattern to the type or size of the rocks was evident. These rocks were dispersed. The trail leading from the Granite Park drainage through the site to Feature 1 has faded somewhat, probably because of the winter season. Consider transplanting cryptobiotic soils onto the hardened soils of the trail to see if we could promote new growth. This would have to be completed after the tourist season so the soils could grow. Staff collected cross section data at profiles #1, 2, and 3. The drainage containing the checkdams has not been active. All checkdams are in excellent condition and no maintenance work is recommended. Continue annual checkdam monitoring and arroyo profiling. Continue site monitoring due to the fragile nature of Features 1 and 2.

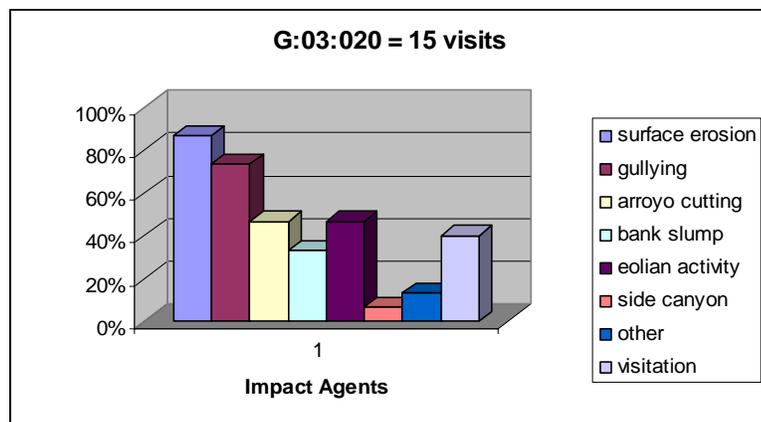
Incipient surface erosion and eolian activity has been observed. Active rilling resulted in the establishment of new gullies and existing gullies have actively down cut and expanded, transitioning into arroyos in 1999. Excavation at Features 7, 8 and 9 occurred in 1998. Active arroyo expansion threatens the integrity of Feature 2. Data recovery has been recommended for this feature since 2000. No visitation has been observed here since the NPS conducted trail obliteration work in 1999.

The gully north of Feature 2 is less pronounced with eolian deposition occurring probably due to drought conditions. No alluvial erosion was observed in this drainage. Feature 2 is the most important and most threatened feature on this site. Gullyng and arroyo cutting are threatening this feature. Feature 5 is very stable and encrusted with cryptobiotic soils. Feature 6 is also stable and has not changed. The northeastern section of this fire-cracked rock concentration does not have as much cryptobiotic soil so if anything begins to erode it will occur here first. Feature 1 no longer has visible artifacts on the surface and there has been no change since 1996. No visitation was observed. Cross section data was collected from profiles #1 and 2. Recommend assessment for checkdams or a water diversion structure to divert runoff away from Feature 2. If the Zuni Conservation Project decides checkdams are not feasible, then data recovery is recommended for Feature 2. Continue annual site monitoring due to the fragile nature of Feature 2.

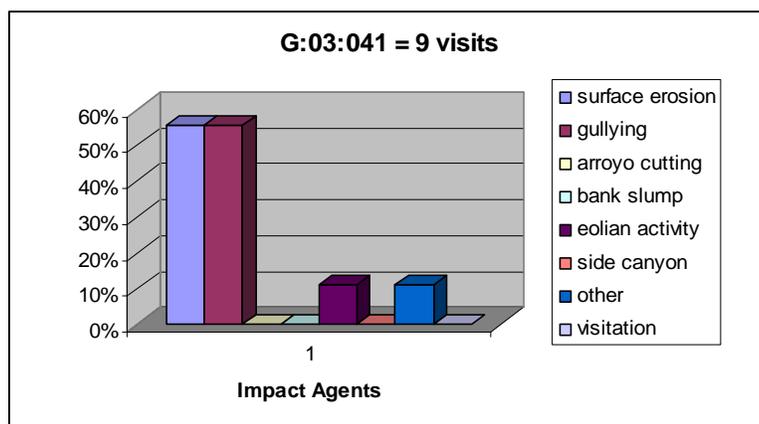
Surface erosion and eolian activity are incipient. Active gully downcutting and expansion resulted in the construction of checkdams near Feature 3 in 1997. Continued activity has resulting in occasional checkdam maintenance. The headward advancement of the gullies has the potential to threaten the integrity of Features 2, 3, and 4. Visitation has not been observed at this site.

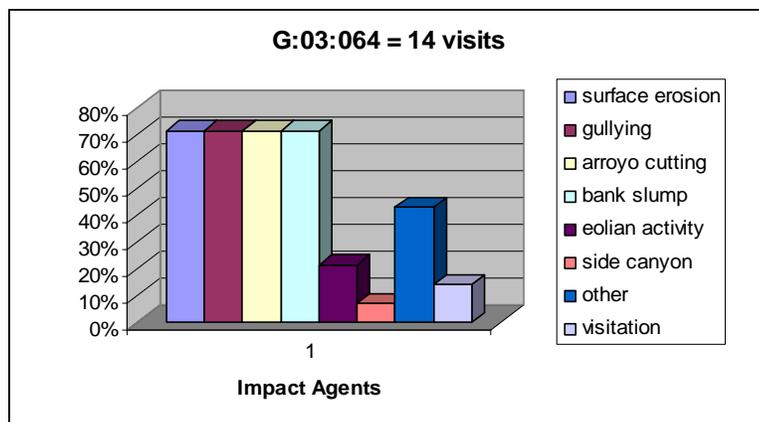
Surface erosion and eolian activity are active. Active gully and arroyo down cutting and expansion threaten the integrity of this site. There is evidence of recent alluvial activity in the drainage bottoms and slumping of arroyo walls. The arroyos continue to be active, exposing artifacts, features, and charcoal lenses. Visitation has not been observed since 1999 and does not threaten the integrity of this site.

Feature 15 has increased vegetation noted since October 2000; however the gully to the east should be monitored. The gully is approximately 50 centimeters deep and the knickpoint is 20 centimeters deep. Feature 1 has increased vegetation since Oct. 2000. Feature 2 has not changed since Oct. 1994. Feature 3 has not changed since Nov. 1998, though the bush on the northeast end of the feature is now dead. Feature 7 has abundant vegetation and is stable. Feature 4 has no change, though the arroyo cut adjacent to this feature is very active. No change at Features 5, 9, 10, 11, or 12. No change at Feature 6 though many piping holes were observed. Feature 8 is very stable. No change at Feature 13 since 2003. Feature 14 could not be relocated, the photograph only showed a knickpoint in the drainage, not the feature. No human visitation was noted or observed. This is a great area to monitor arroyo cuts with aerial photographs. Data recovery is recommended especially at the features adjacent to the arroyo cuts, including Features 1, 4 and 8. The eolian transport research may profile sections of the arroyo wall in May, 2004. Continue annual site monitoring.

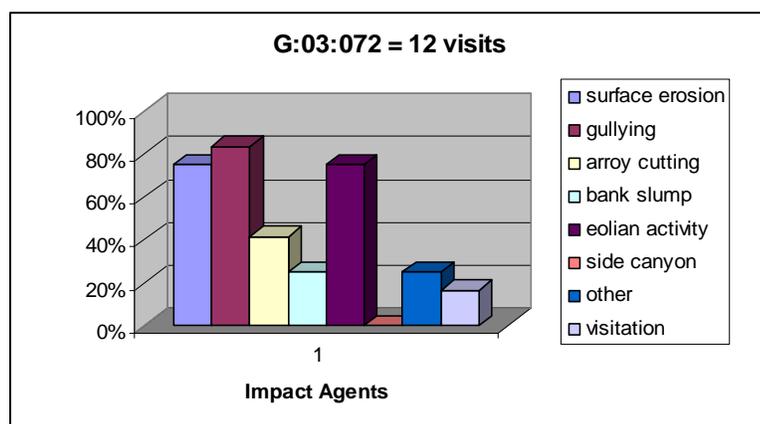
Surface erosion and eolian activity are active here. Continued gully down cutting and expansion led to the transition into arroyos in 2000. Checkdam construction in 1998 may have slowed the expansion of the gully at Feature 3. Active gullyng and continued arroyo cutting have been identified as having the potential to threaten the integrity of Features 5, 9, 10, 11, 14, and 15. Visitation observed in FY04 consisted of a collection pile of four sherds near Feature 9. Monitoring staff noted that no other signs of visitation were observed and the collection pile could be extremely old. Visitation does not currently threaten the integrity of this site.

1996. There is the potential for arroyo cutting here. Feature 6 has active sheetwash because of its location on a steep slope. Drought conditions have resulted in the feature appearing stable since Nov. 1994, though with less soil and minor displacement of artifacts. Feature 7 has the potential for sheetwash. Cryptobiotic soils are abundant here although there is new and prominent rodent burrowing in the center of the feature. Feature 8 is unchanged. Feature 15 has abundant cryptobiotic soil though no other vegetation. Rodent burrowing is also occurring at Feature 15. The gully below the feature is unstable. Feature 10 has soil loss on the northwest bank of the feature and vegetation loss from bank slump. The edge of the arroyo is very steep at this feature. Rodent burrowing is abundant. Feature 9 has an arroyo forming at the base of the roaster. The slope is steep on the river-side of the feature making it susceptible to increased erosion. A small collection pile of Pai sherds are in the inner portion of the feature. Feature 11 is in danger of complete erosion. The arroyo cut is now 50 centimeters deep on the south side of the feature. There is extreme headward erosion and soft, sandy soil creating a high potential for complete removal of the feature. The fire-cracked rock does not appear to have changed. Feature 12 changes since Oct. 2000 are due to eolian transport of the dune sand over the feature. The checkdam is successful. Feature 14 fire-cracked rock is stable on the west end. The flat surface towards the river (east) has a high potential for erosion. The southeast portion has a gully forming but it is lined with rocks. Most of the feature appears covered in cryptobiotic soil. Some soil loss on the south slope and decrease in vegetation is evident since the last photograph in April 1996. Feature 13 was not relocated. Feature 9 collection pile of 4 Pai sherds on the north side near the center portion of the roaster. This may be a very old collection pile since there are no other signs of visitation at this site. The drainages at this site have the potential to be very active once rainfall begins. No other work is recommended. Continue annual checkdam monitoring and annual site monitoring.

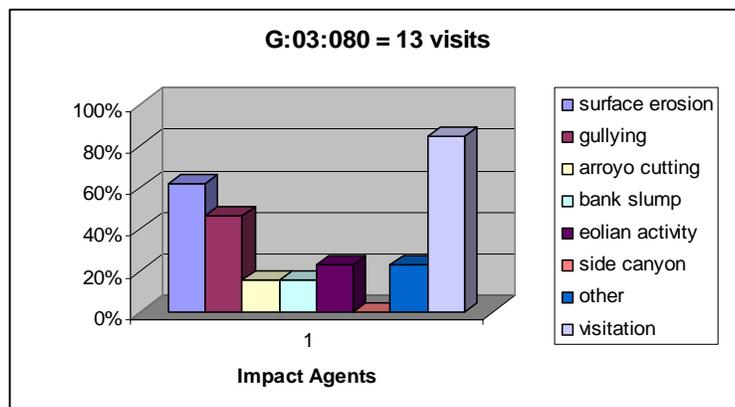
Surface erosion in the form of rills has resulted in the development of a gully in 1999. The integrity of Feature 4 has the potential to be threatened by gully down cutting and expansion. Visitation is present and compaction of trails leading to the development of entrenched drainages does have the potential to threaten feature integrity in the future.

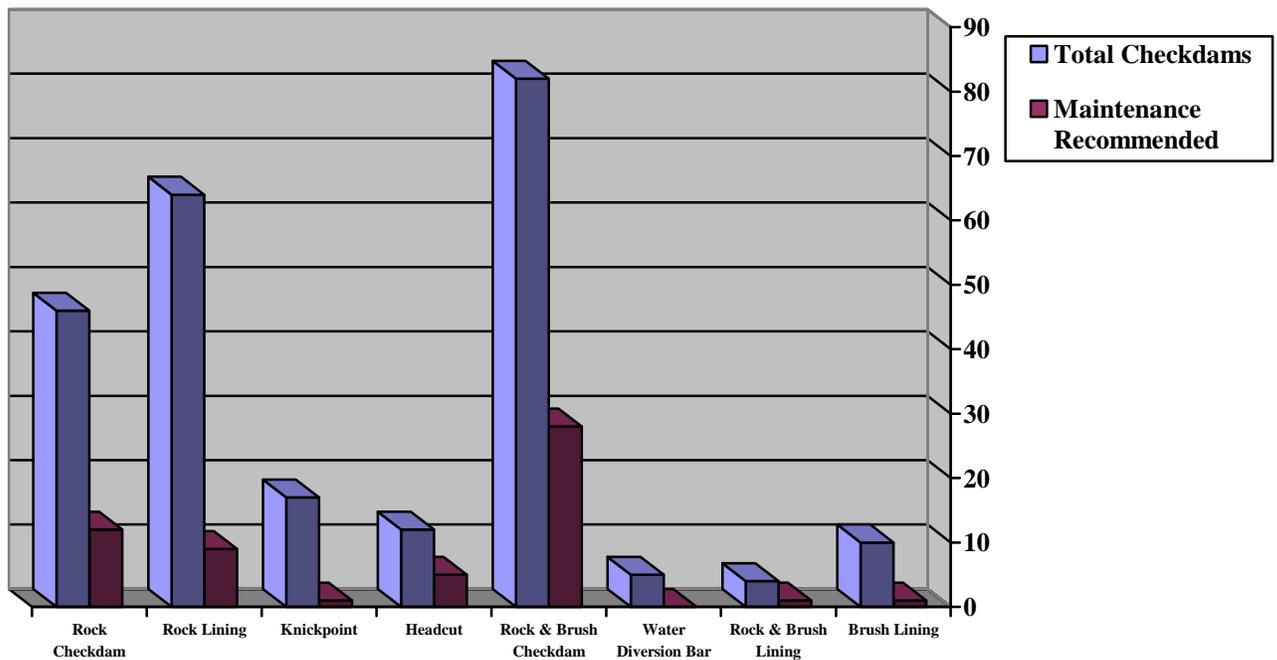
Figure 15. Number of checkdams by type and the number recommended for maintenance.

During the course of FY04 checkdam monitoring, 46 checkdams were recommended for general maintenance. These checkdams retain their structure but require additional rock or brush (Figure 12). Eleven checkdams were identified as failing and recommended for reconstruction because they no longer retain their original structure. Six checkdams were identified as obliterated but were not recommended for reconstruction because of the advanced stage of the drainage (one checkdam at G:03:041 trapped so much sediment that it is completely buried in alluvium). Maintenance is recommended at 11 of the 27 sites with checkdams. Of the 240 checkdams, 19% are recommended for maintenance. It is possible that the extremely wet winter of 2004-2005 will affect the amount of maintenance work necessary at checkdams in 2005.

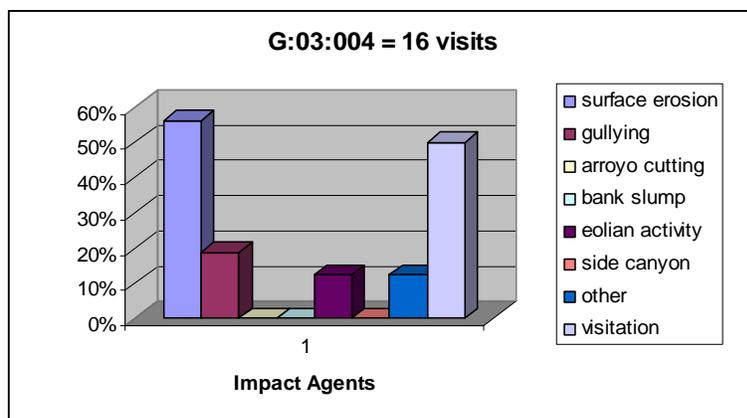
Summary of Monitoring Observations

Feature 2 is unchanged though there appears to be a slight increase in vegetation at the feature. Feature 7 seems to have some minor downslope movement of the fire-cracked rock. Features 3, 4, 5 and 6 are stable and unchanged. There are footprints in the trail leading from the camp through the entire site to Feature 1. This is the trail that the NPS has continued to rehabilitate with no success. The Bundy Jars have been rearranged since the last photograph was taken. No collection piles were observed this

monitoring episode. Feature 1 and the rock art above show no signs of deterioration since the last visit. This site should be monitored annually due to visitor impacts however beginning next fiscal year this site will be turned over to the Backcountry Archaeology Department and no longer monitored by this program. Visitation is the largest threat to this site.

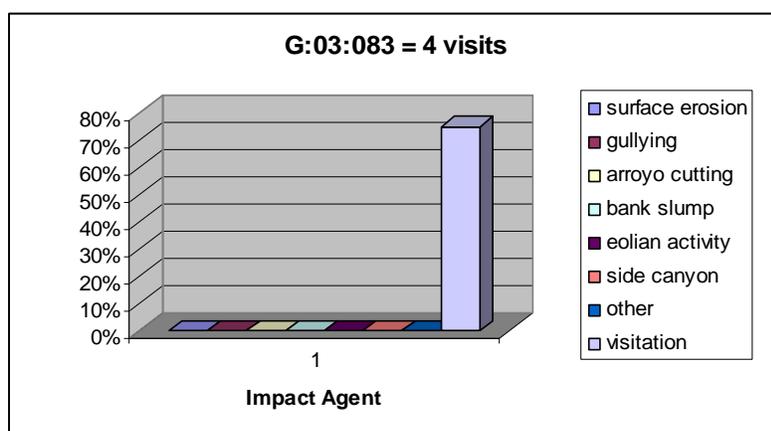
Summary of Monitoring Observations

The site appears undisturbed by physical impacts. No sign of visitor-related disturbances were observed. No physical or visitor-related impacts were observed. River patrol will monitor the site annually.

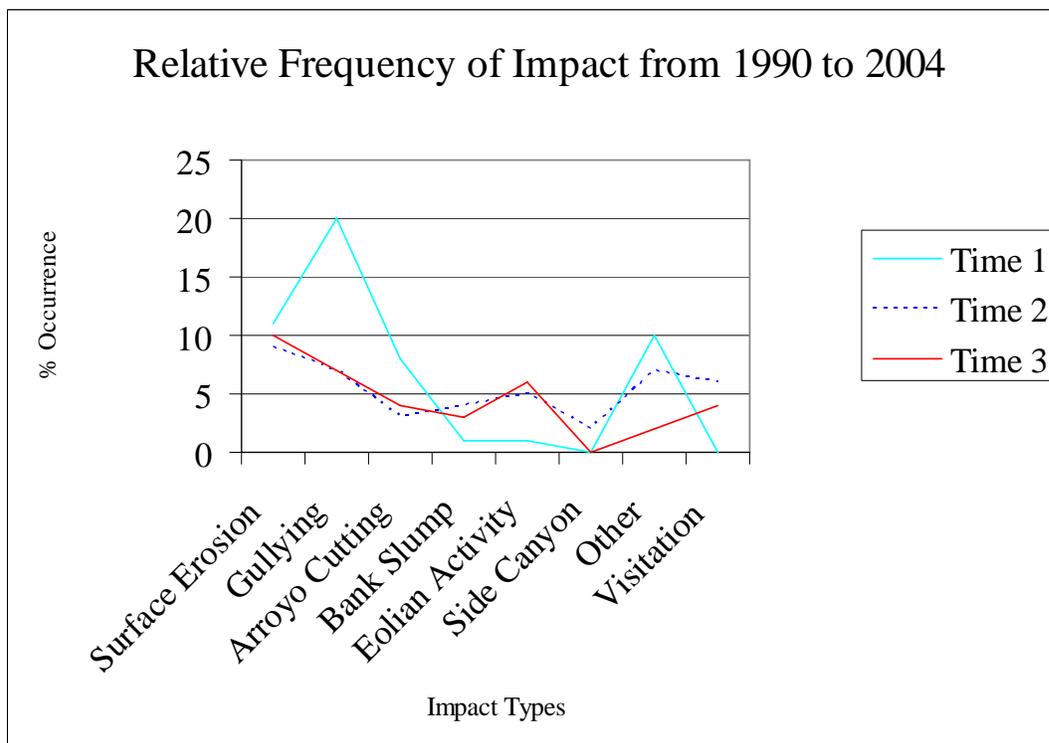
Figure 18. Impact Frequency between 1990 and 2004 at the 37 FY04 sites monitored in FY04.

Looking at the 37 sites monitored in FY04 through time reveals that surface erosion has been consistently observed and recorded approximately 10% of the time between 1990 and 2004. The observation of gullying decreased from the baseline recording to the Time 2 recording and has since remained relatively constant. Arroyo cutting also decreased initially and has since remained consistently recorded. Bank slump shows an increase through time. Eolian activity has also increased through time.

Side canyon impacts remain consistently low or not present as a physical impact since baseline data was collected. The “Other” category has also decreased through time. Because this category is a catchall, understanding the decrease in this category requires further examination of the individual occurrences identified in the comment fields of the forms. The same argument could be made for understanding visitation to historic properties. In addition to the types of visitation, it is recommended that visitor-related impacts should be understood in terms of accessibility and use areas by conducting spatial analyses.

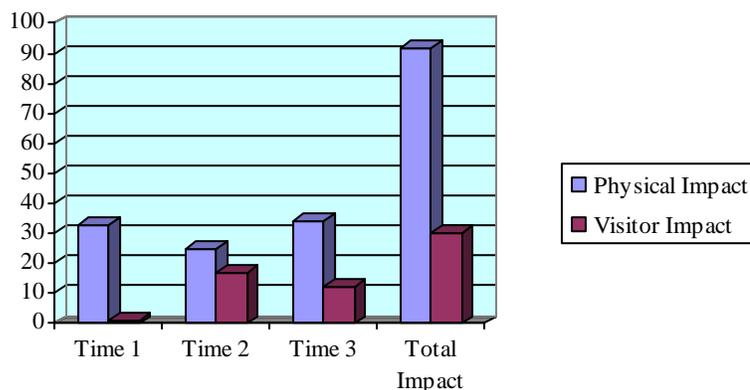
Figure 19. Bar graph representation of the physical and visitor-related impact through time for the 37 sites monitored in FY04.

The impact frequency data have also been collapsed into Figure 19 showing the number of occurrences by impact class (physical or visitor). This shows only the presence of physical or visitor-related impact and the total through the time series described above in Figure 18. Physical impact is consistently the leading impact class threatening the sites monitored in FY04.

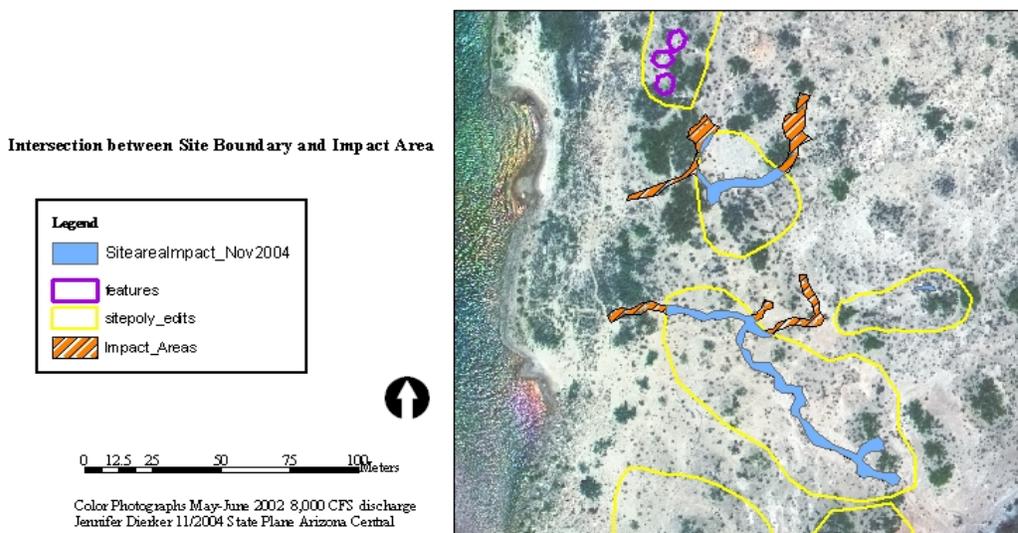
Figure 20. Example of RCMP Spatial Analysis of Site Condition.

“Sitepoly_edits” is the GIS layer for the site boundary. Features are outlined in the “features” layer. The impacted areas identified during FY04 monitoring are shaded with diagonal lines. The intersection between the impact areas and the site boundary are shaded in opaque coloring. This impact representation visually displays the impact through or adjacent to a site and also clearly displays areas that while not within the site boundary, may still have the potential to impact sites in the future.
