P 557-420-10772  
NA

Glen Canyon Unit--C.R.S.P.

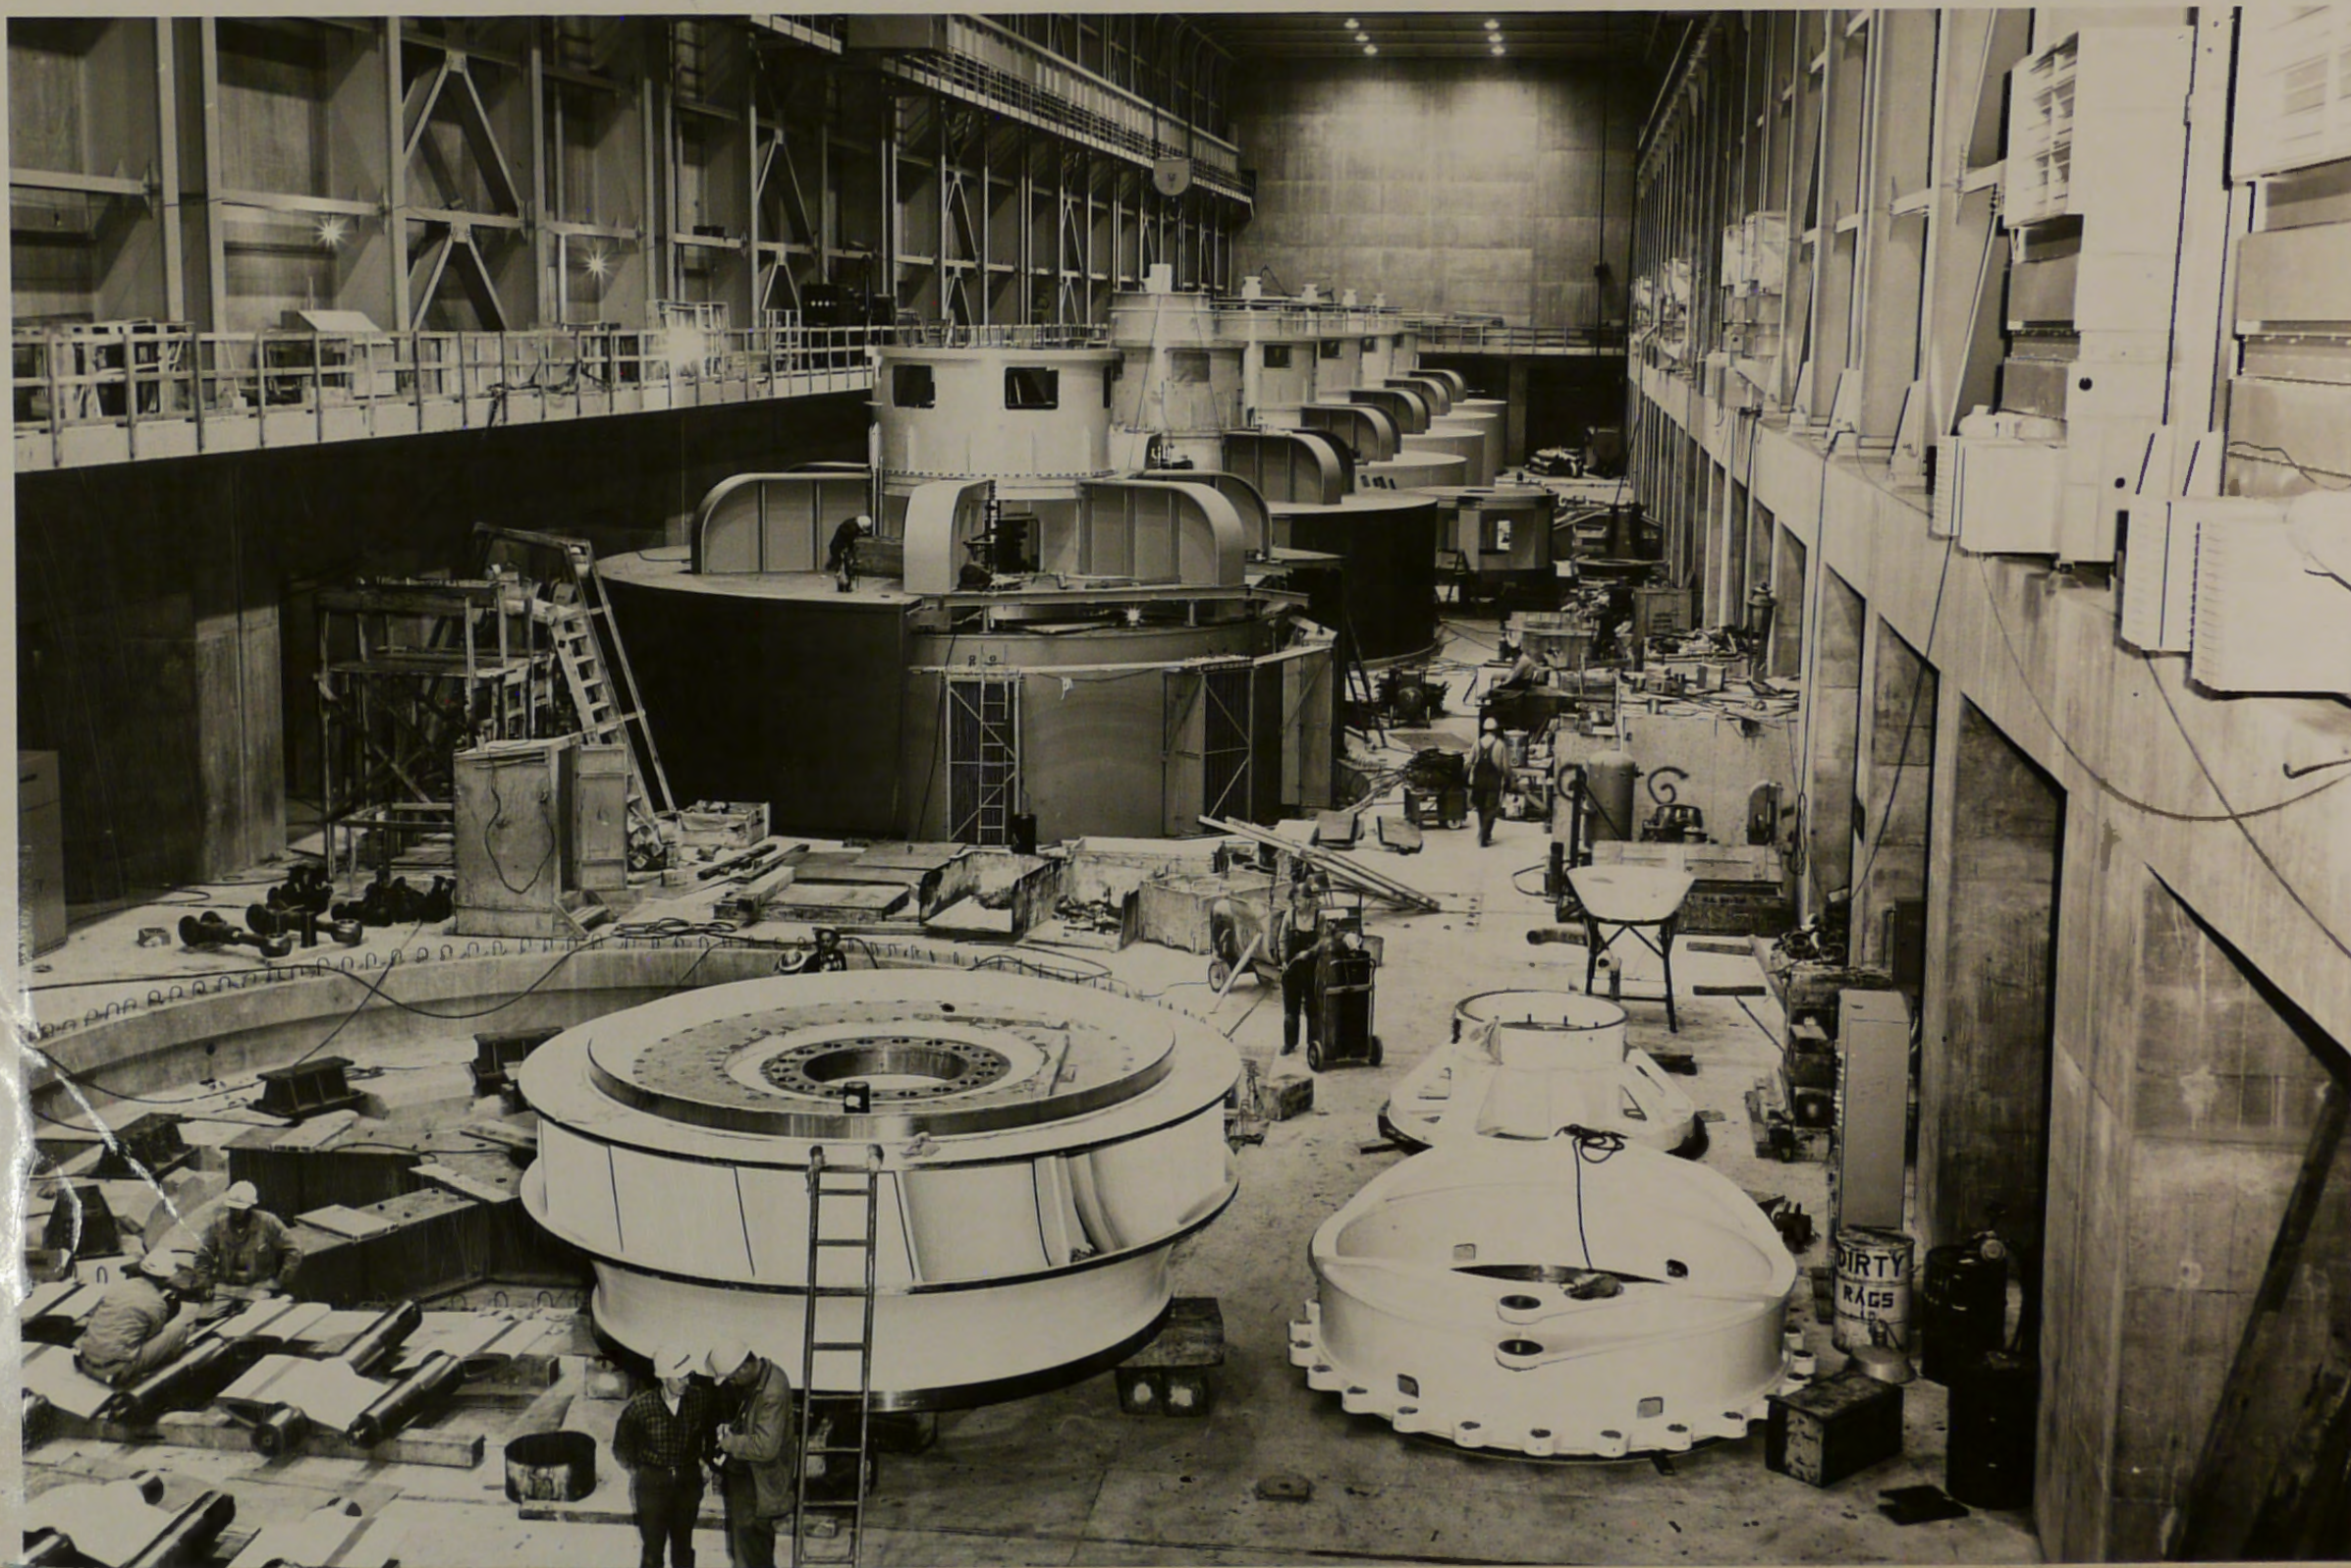
View through the power plant from Unit 7 through Unit 1. Runner, operating ring, lower guide bearing bracket and cone for the snorkel for Unit 8 in foreground. Contractor: Ets-Hokin Corporation, Contract No. 14-06-D-4429. Specs. No. DC-5750. 3-17-65 F. Finch

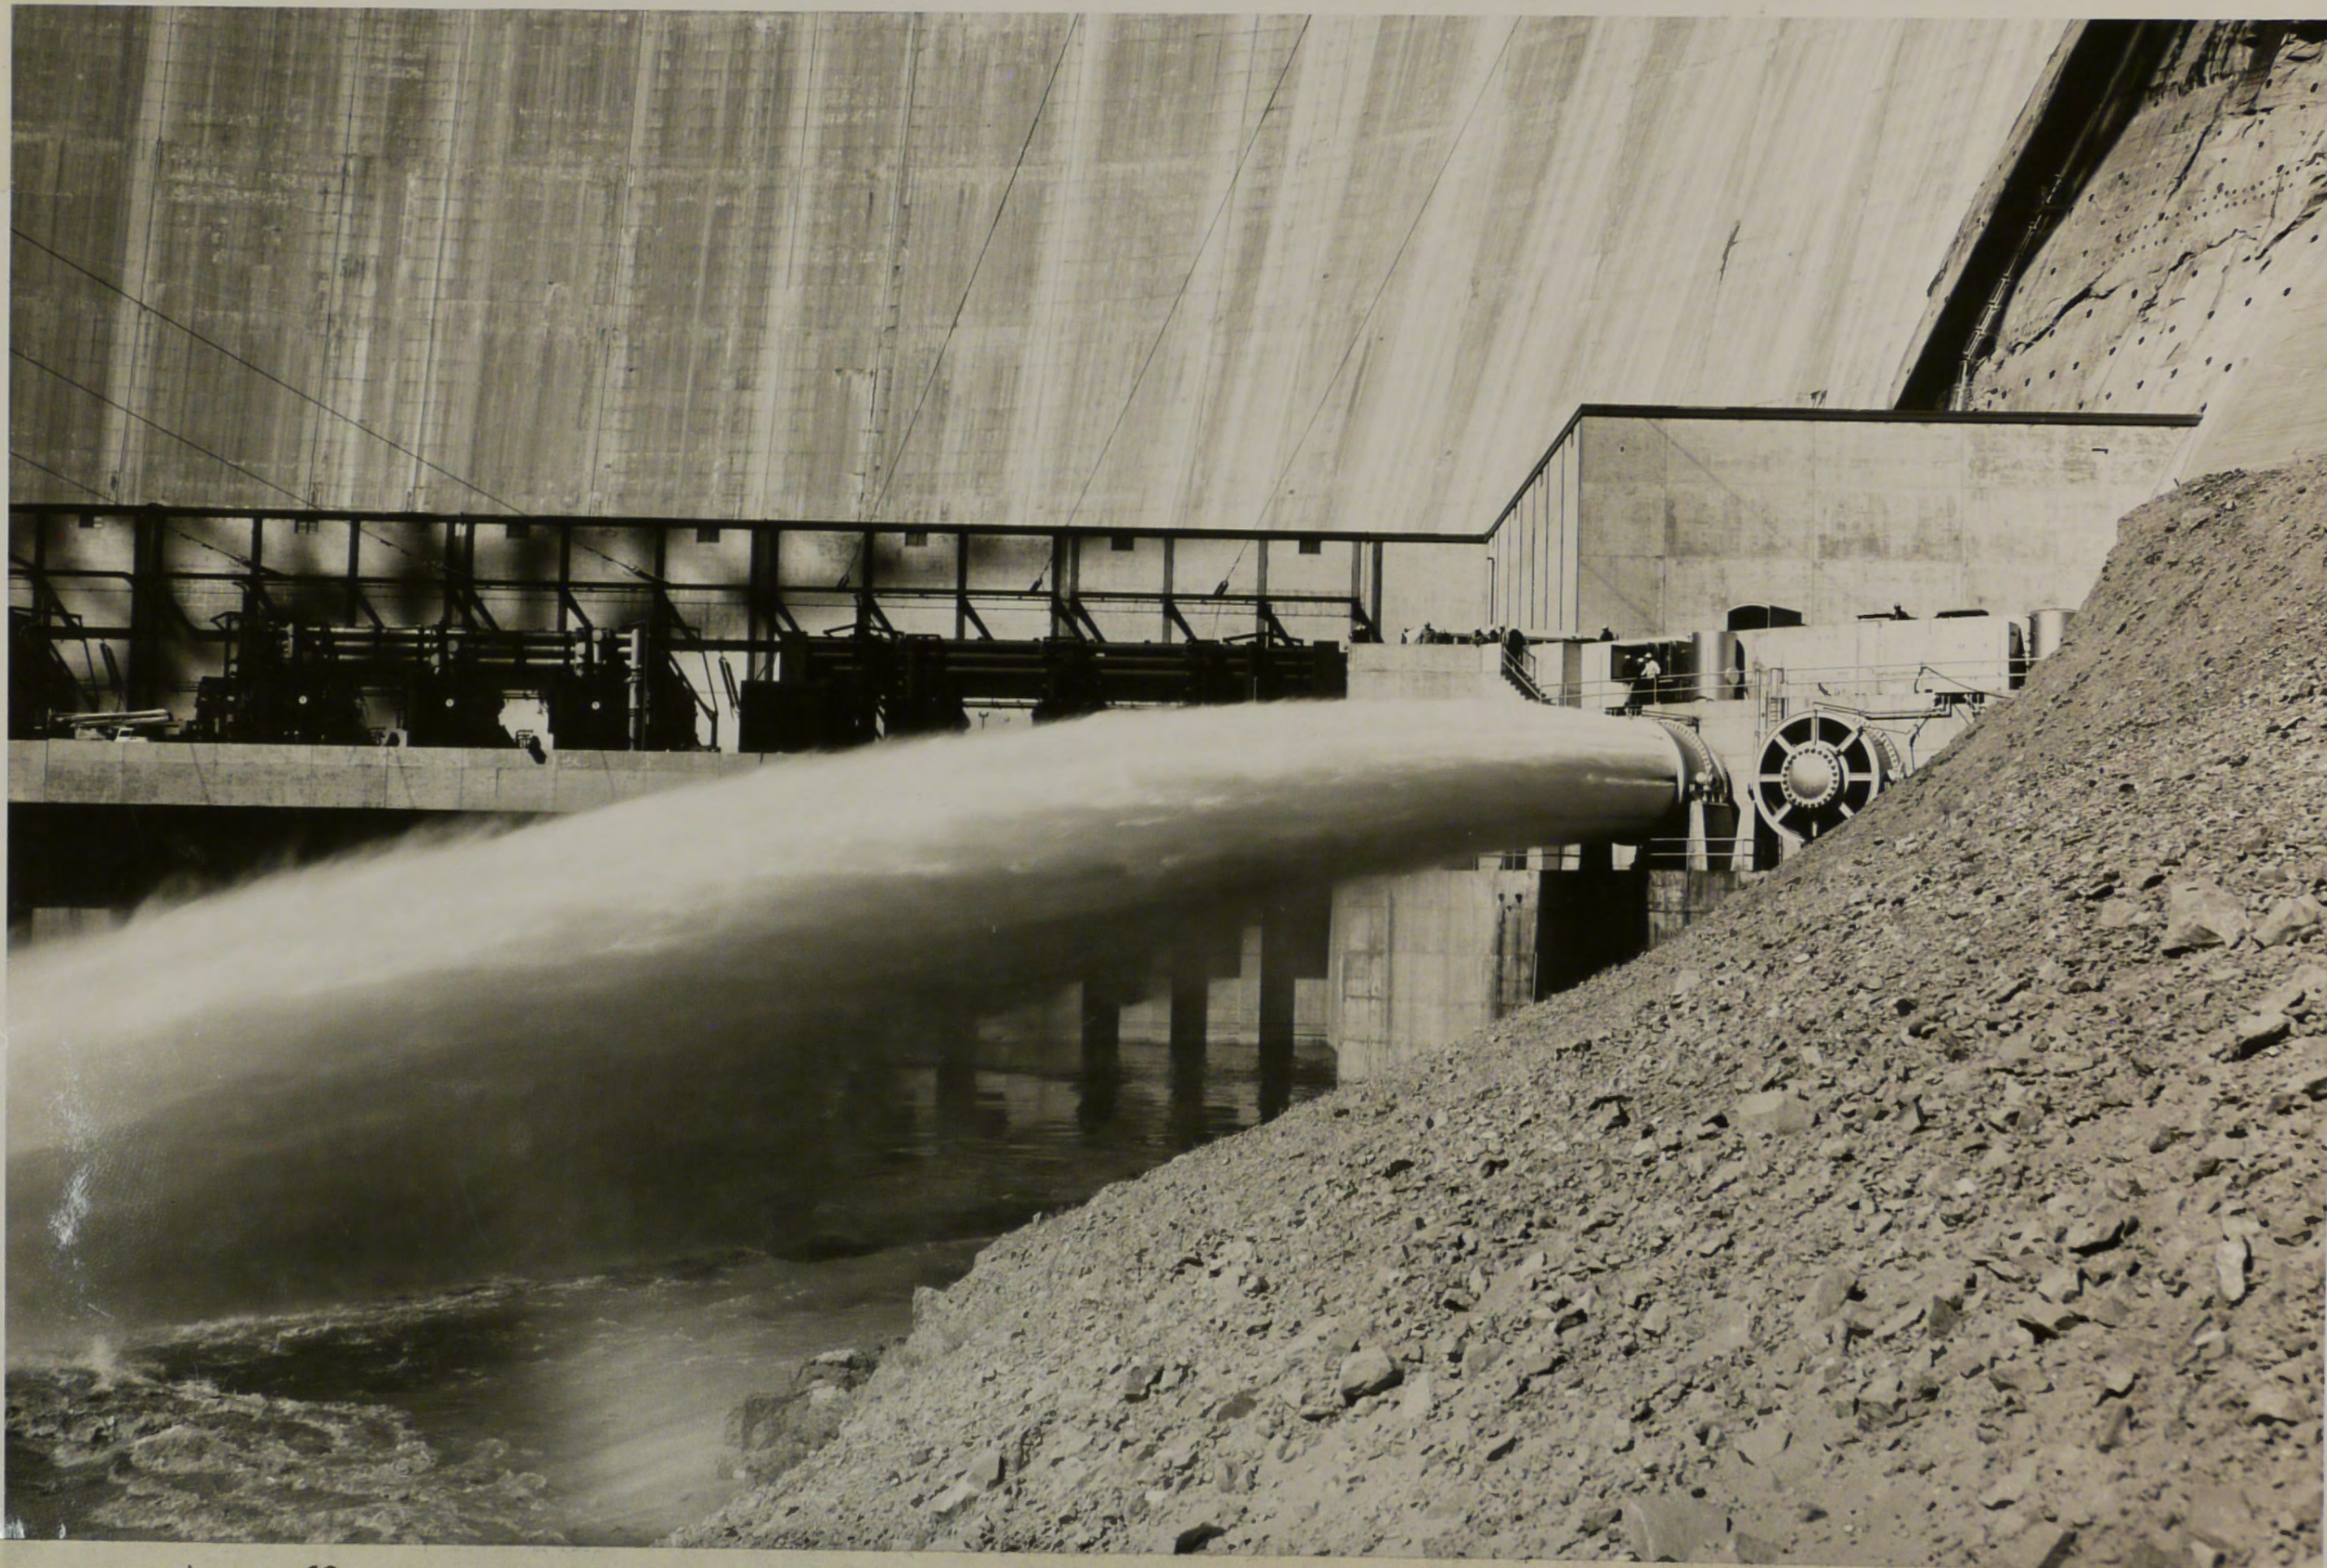
P 557-420-10681- Glen Canyon Unit--C.R.S.P.

Flow through Outlet Gate No. 2 during check of hollow-jet valve. The valve is fully open at  
this time.

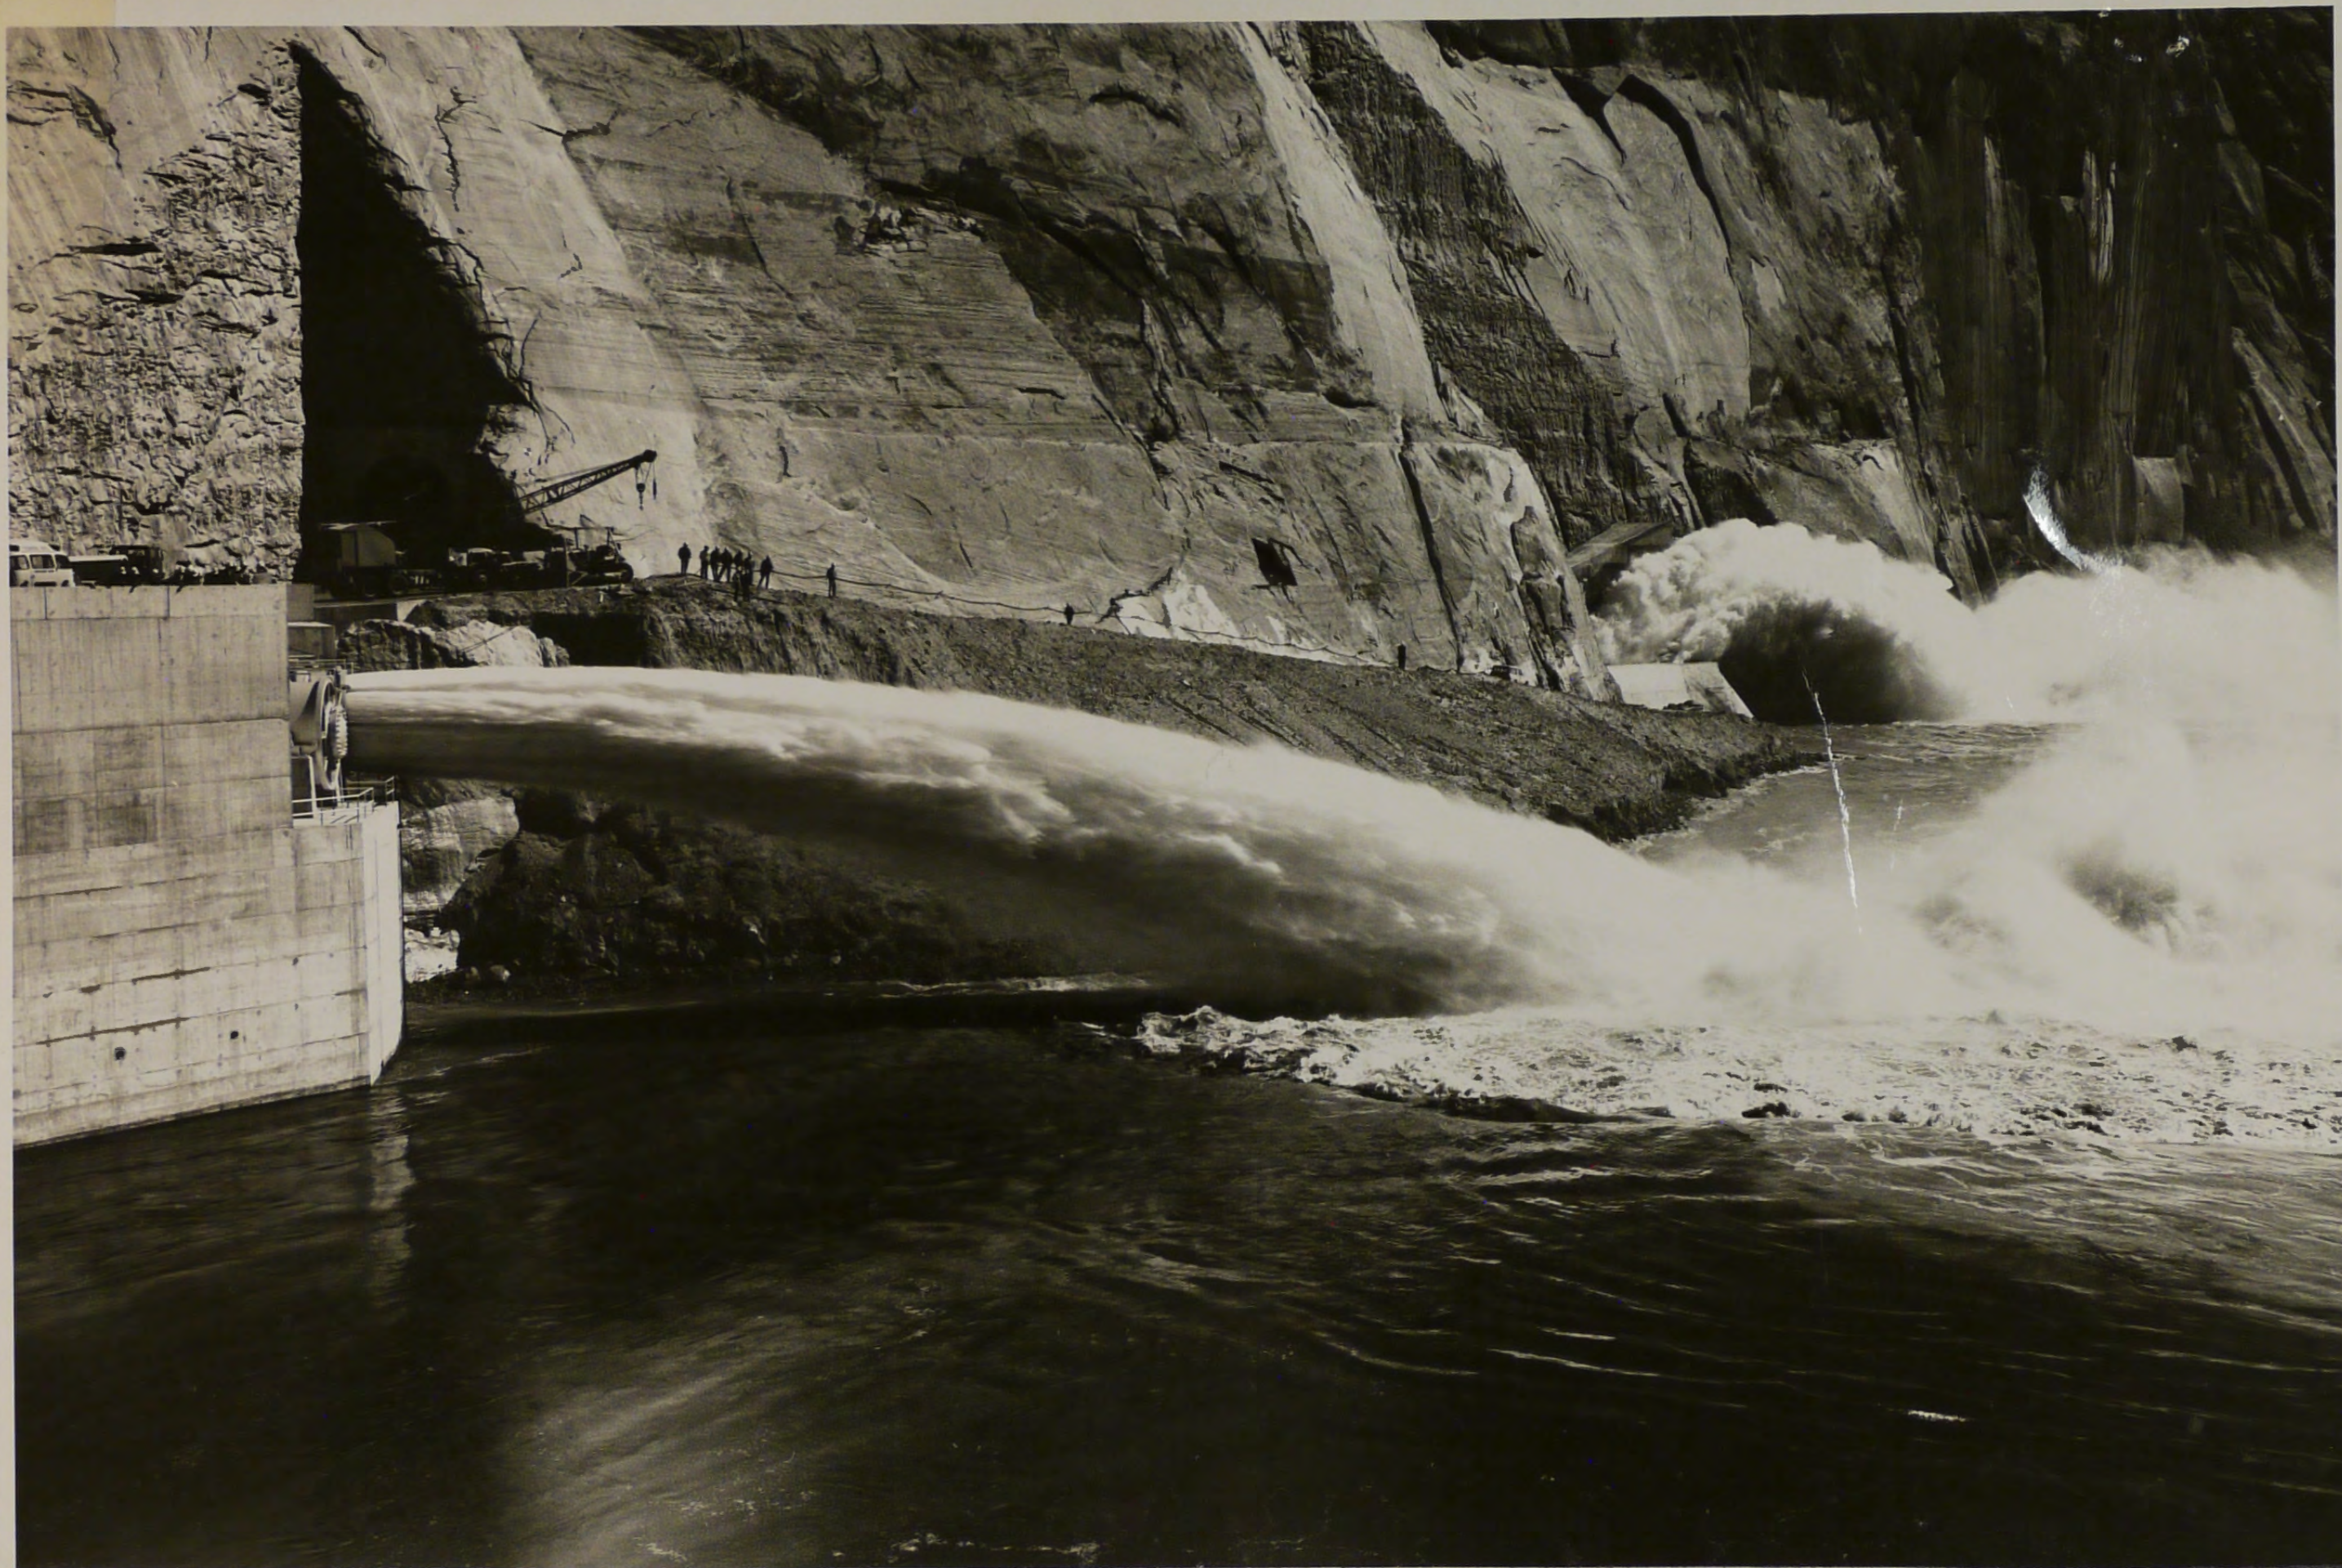
P 557-420-10686- Glen Canyon Unit--C.R.S.P.

Approximately 12,000 second-feet being discharged over the flip bucket during the 24-hour test run and Outlet Gate No. 2 discharging approximately 3,700 second-feet during the testing of the hollow-jet valve. Testing was done by Government forces.
