Studies near the Hite Area

Late winter – Early spring 2023

The perched river, a deteriorating boat ramp,
and a wild sedimented wasteland

Returning Rapids

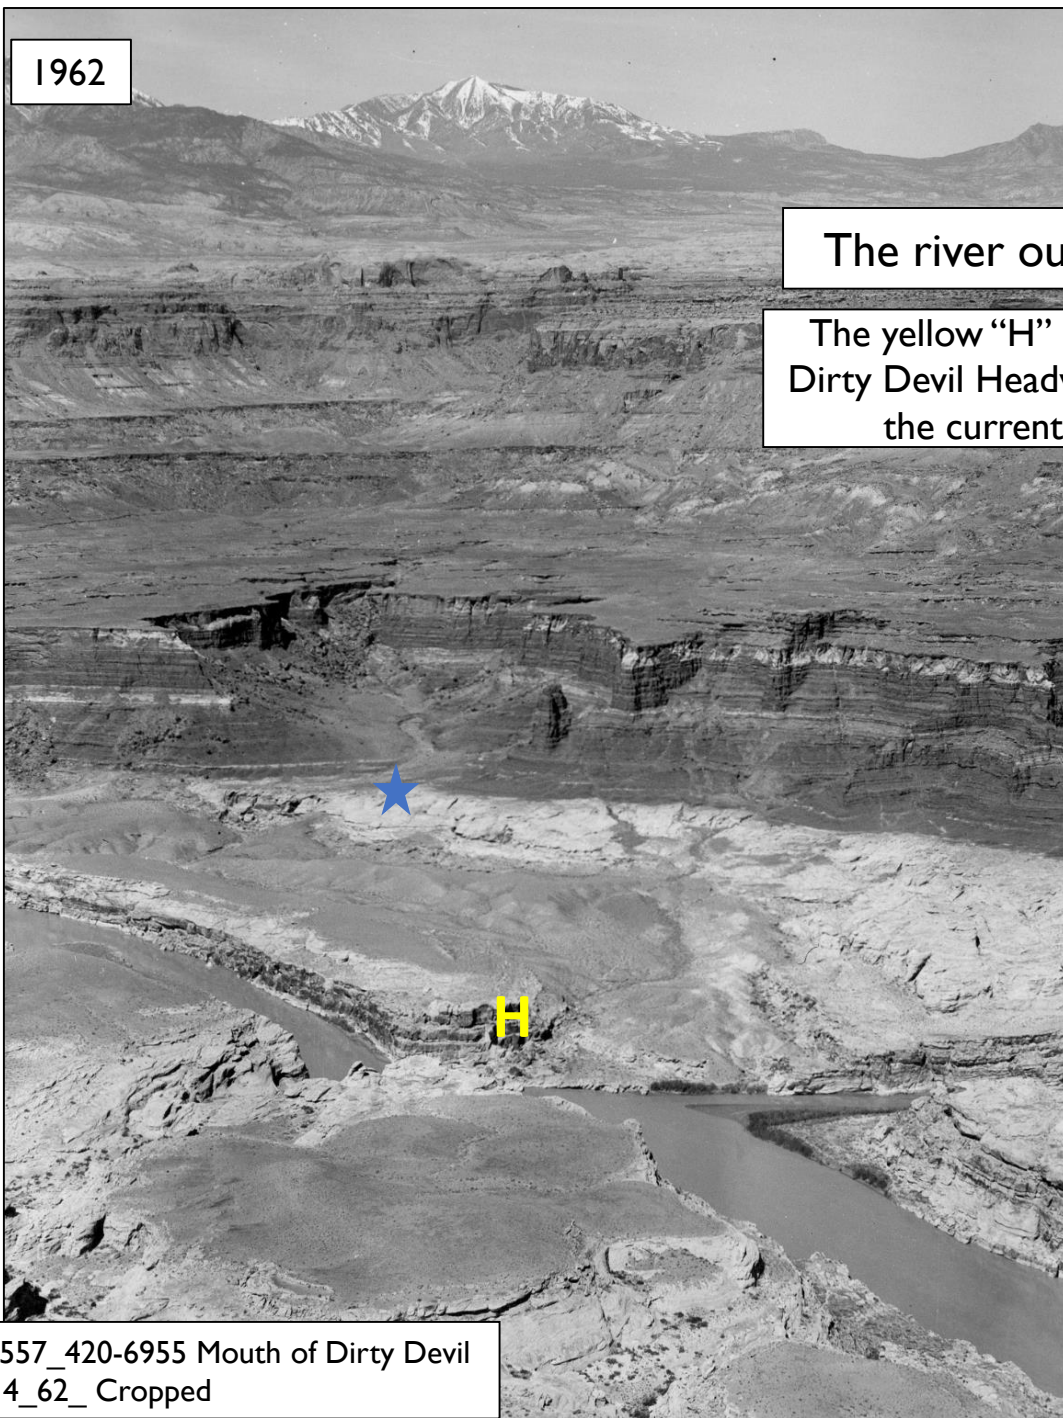
1962

The river out of its channel

The yellow "H" is what we call the Dirty Devil Headwall. The blue star is the current takeout area.

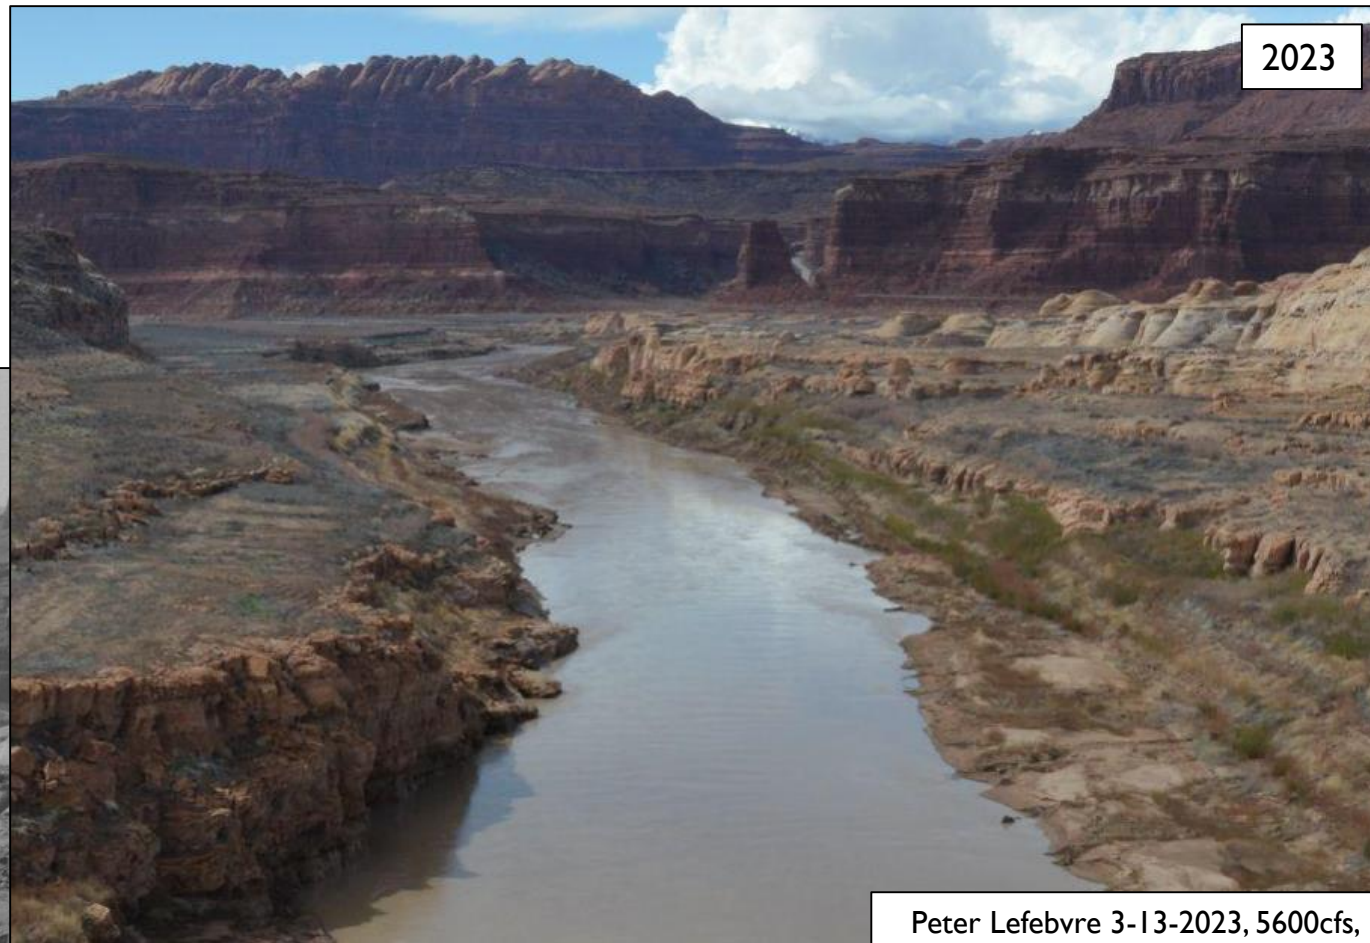
2023

Peter Lefebvre 3-13-2023, 5600cfs,
Bridge gage 3579 ft

Things of note:

The rock point emerging midway down the channel on the left,
how steep the right cliff is in the Crampton shot,
and the river flowing through the cobble hills right of the headwall.

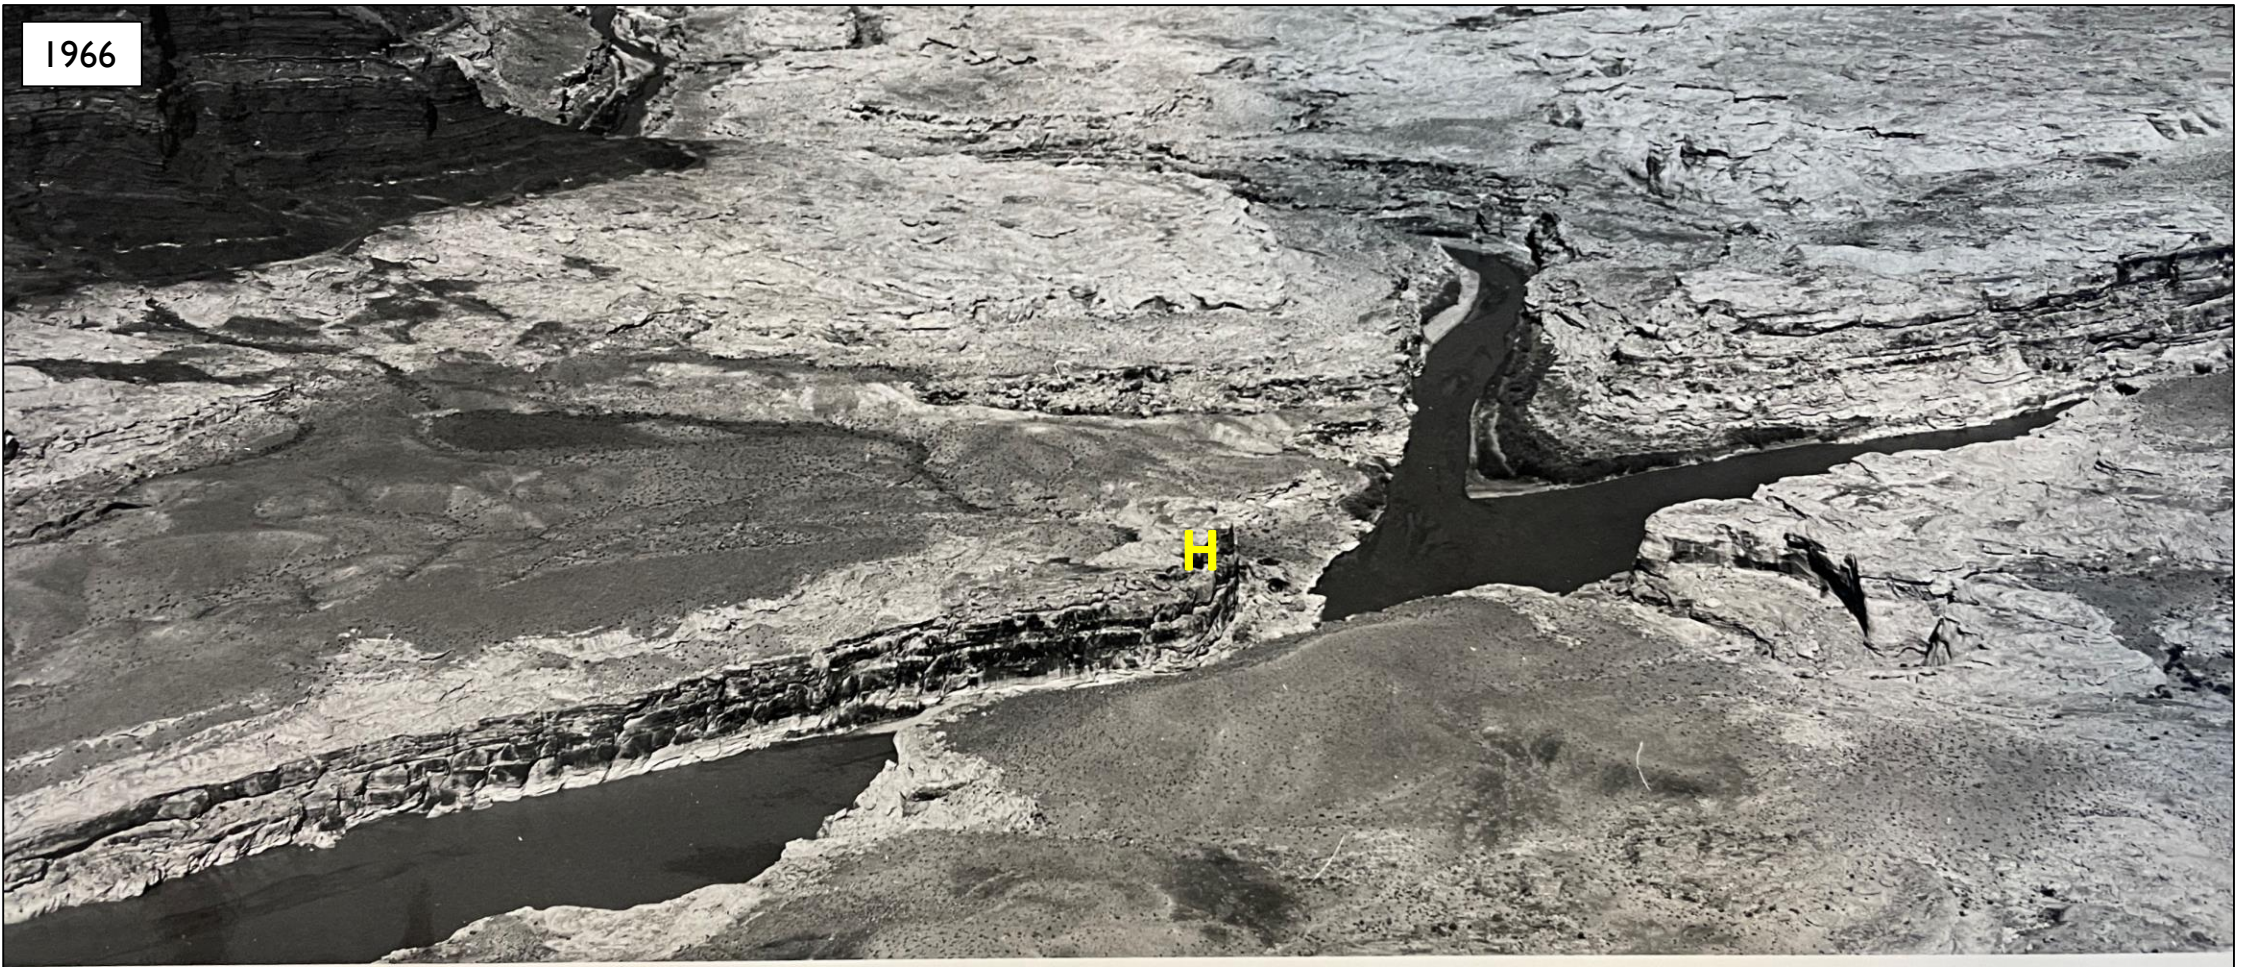
Another aerial view from 1963

The Headwall is just downstream of the confluence of the two rivers. The ledge landing/ camp can be seen at river level on the downstream side of the confluence also

This shot also shows the gravel terrace that the river is now flowing over at a historic elevation of ~3600-3620ft

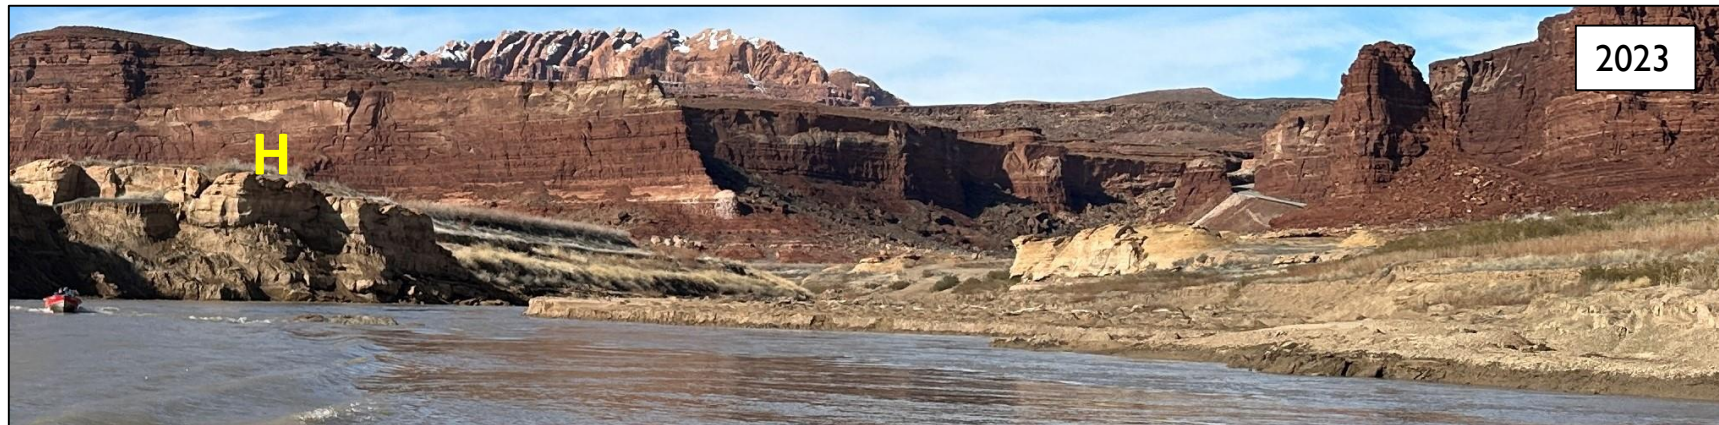
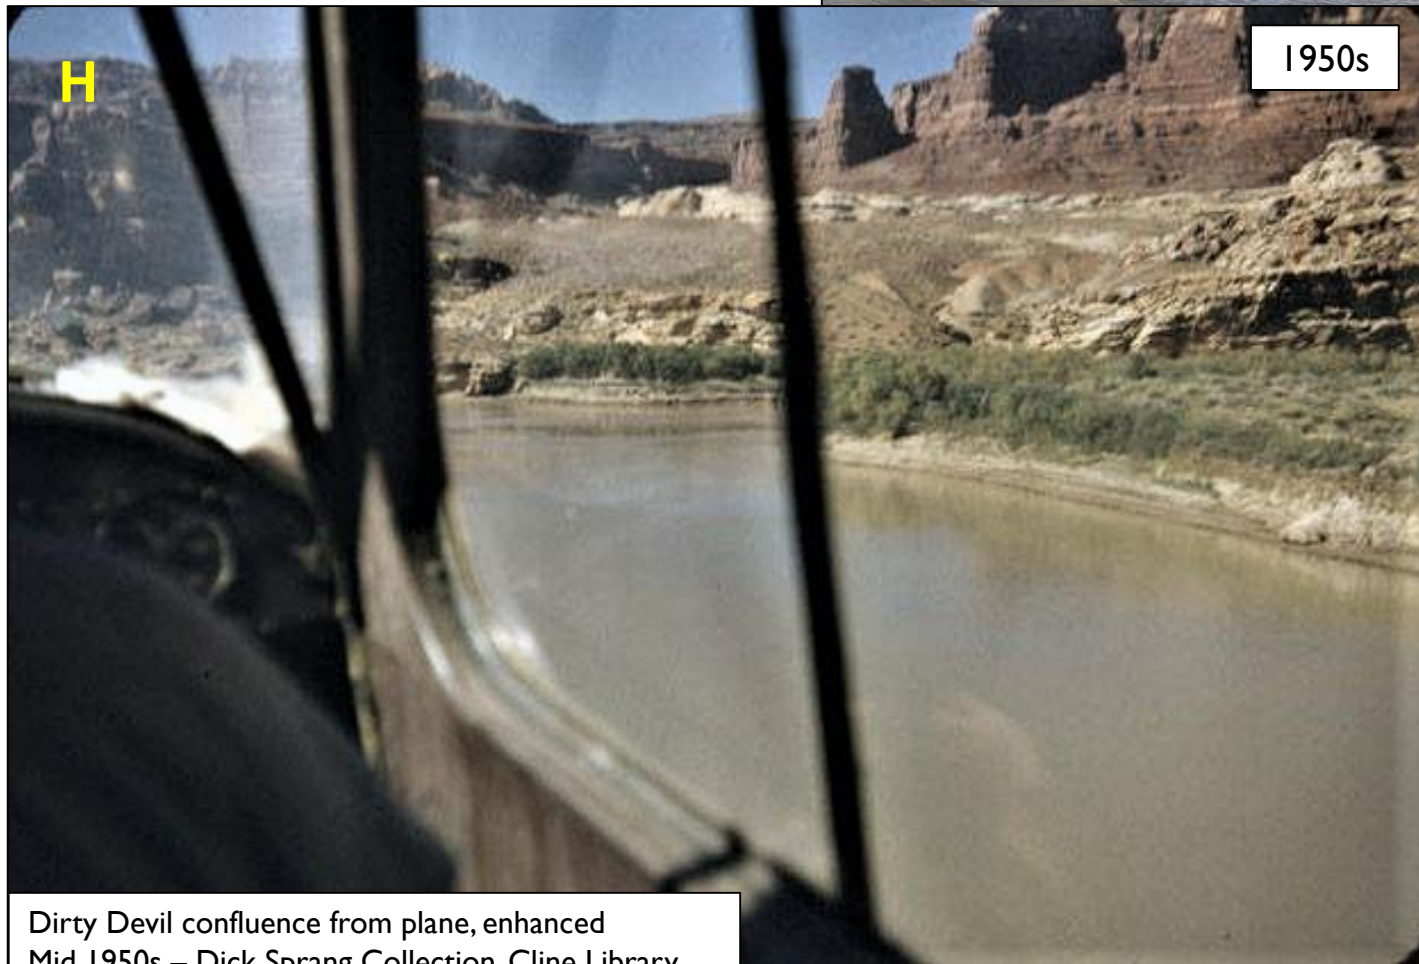
Dirty Devil Confluence 3-2-2023 3579 bridge
5400 cfs

Another comparison of a photo from low flying plane near the Dirty Devil from the 1950s that is at or below water/sediment delta level in 2023.

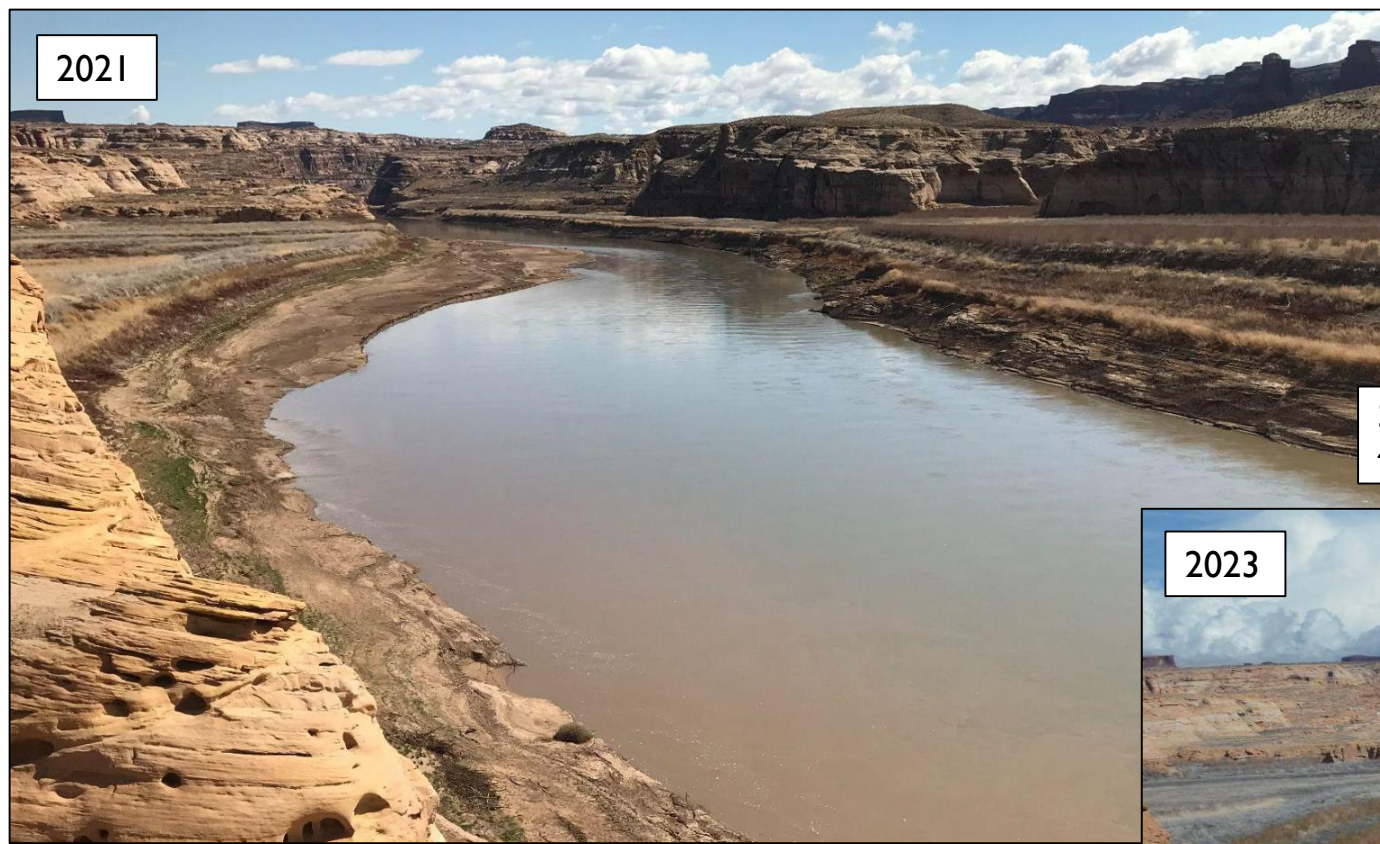
2021

The river surface is 21 feet lower,
deposits from the Dirty Devil
push way further into the channel,
and major amounts of sediment
have eroded from the face of the
headwall.

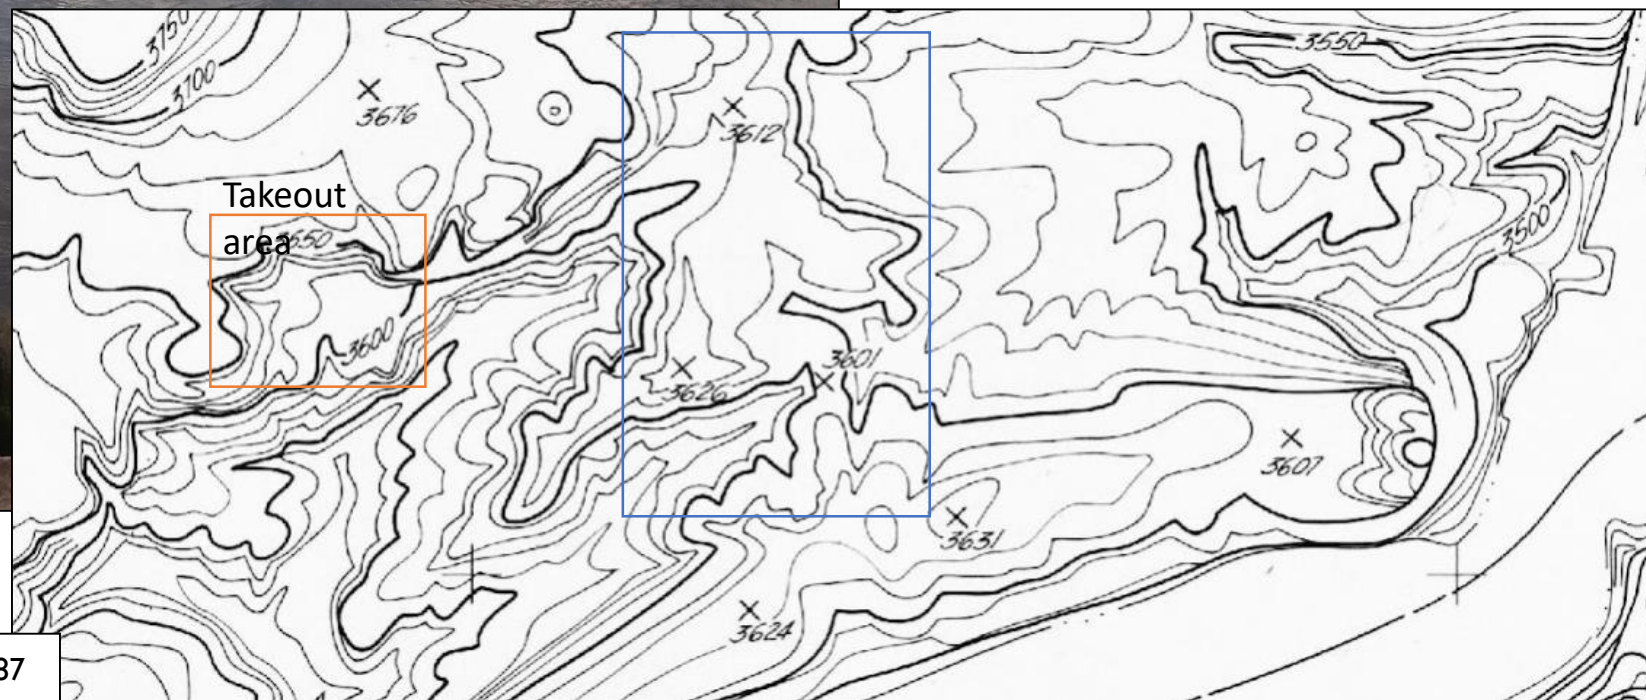
7-6-2022 Peter Lefebvre
8500cfs, bridge gauge 3584 ft

In the blue box you can see rocks sticking out of the mud banks and below the water's surface. This is pinching the river and probably the early signs of a riffle/rapid that may form here. This is the exact location of the saddle shown in the previous slide. In this topo map of the area (pre dam) you can see the elevations of the saddle. With a high point of 3626 and the bridge gauge currently at 3582.6 the river has already carved through 20-40ft of pre dam strata. The saddle was comprised of cobble on top, but at some point, bedrock must be hit.

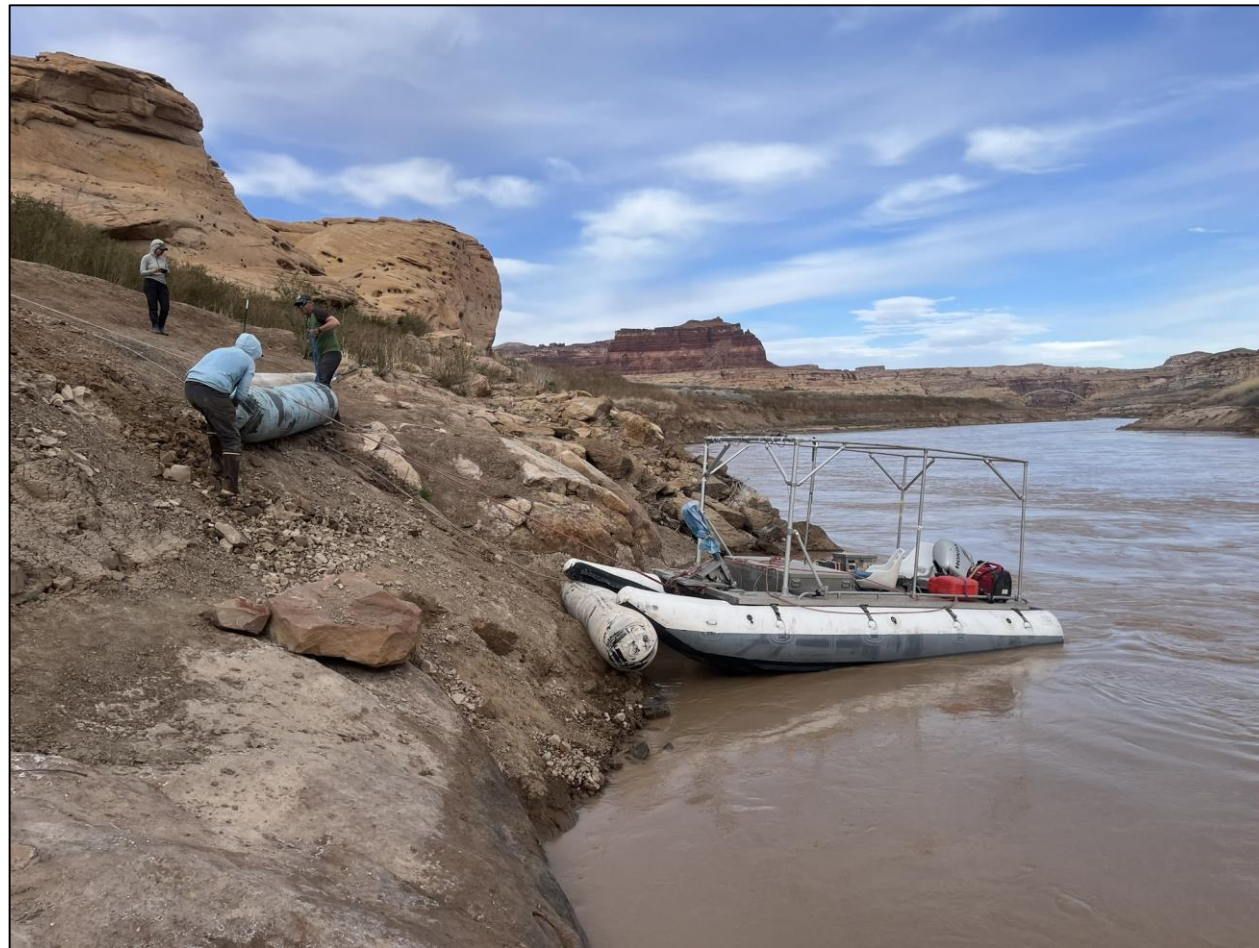
What it looks like to get a boat out of the River at the North Wash Boat Ramp

Prepping roller tubes to take the GCMRC Snout rig out at North Wash-
Peter Lefebvre 3-29-2023
Bridge Gauge 3580.6 ft, approx. 8500 cfs

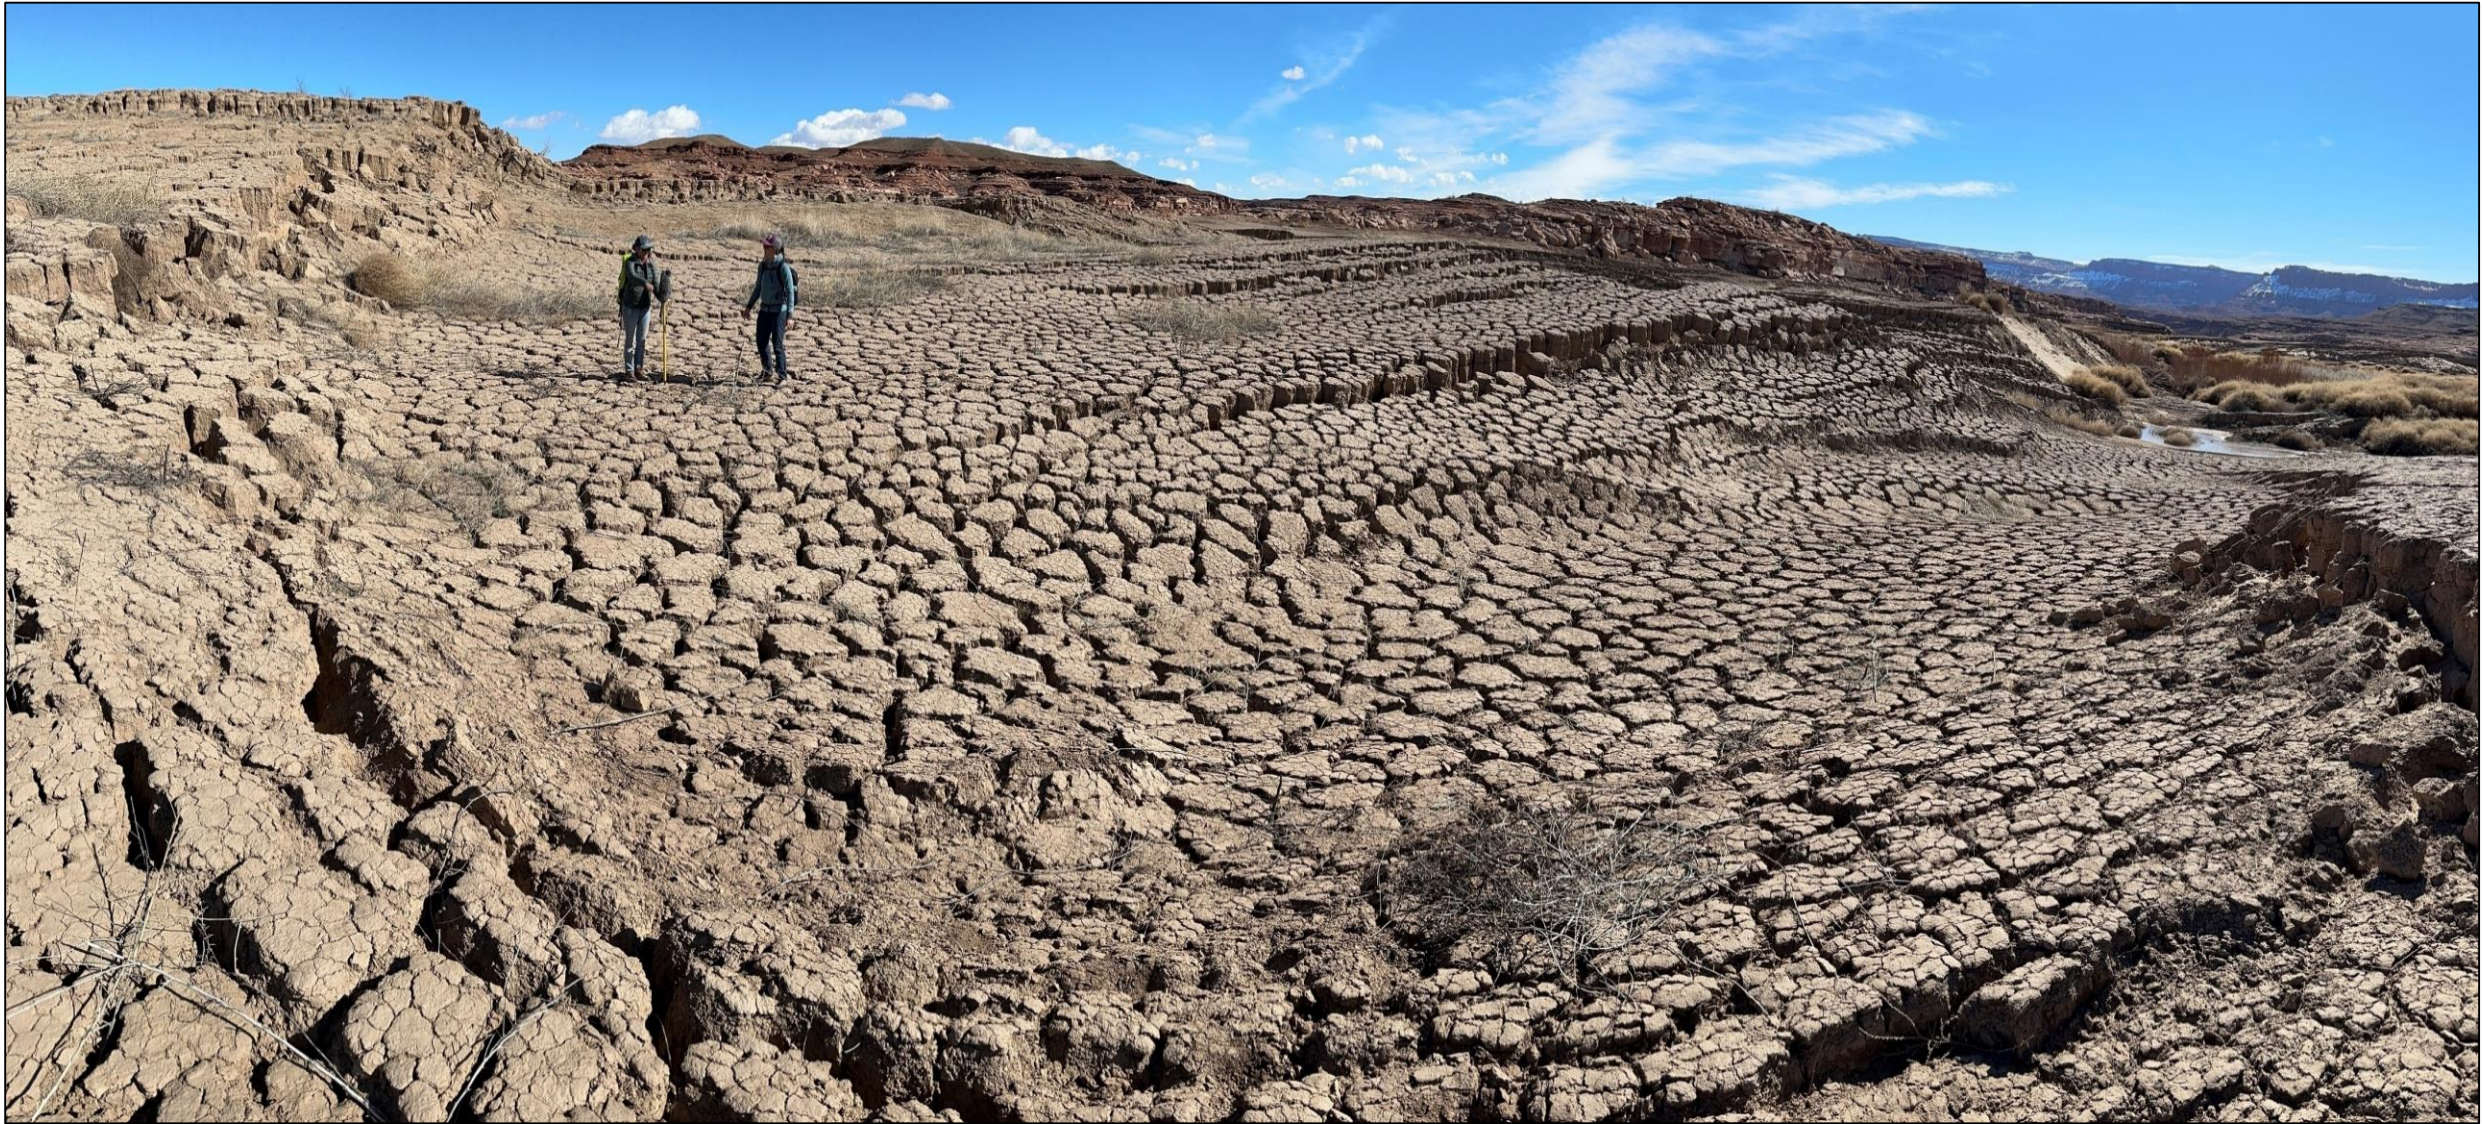
Warping sediment flats near the mouth of White Canyon
3-13-2023

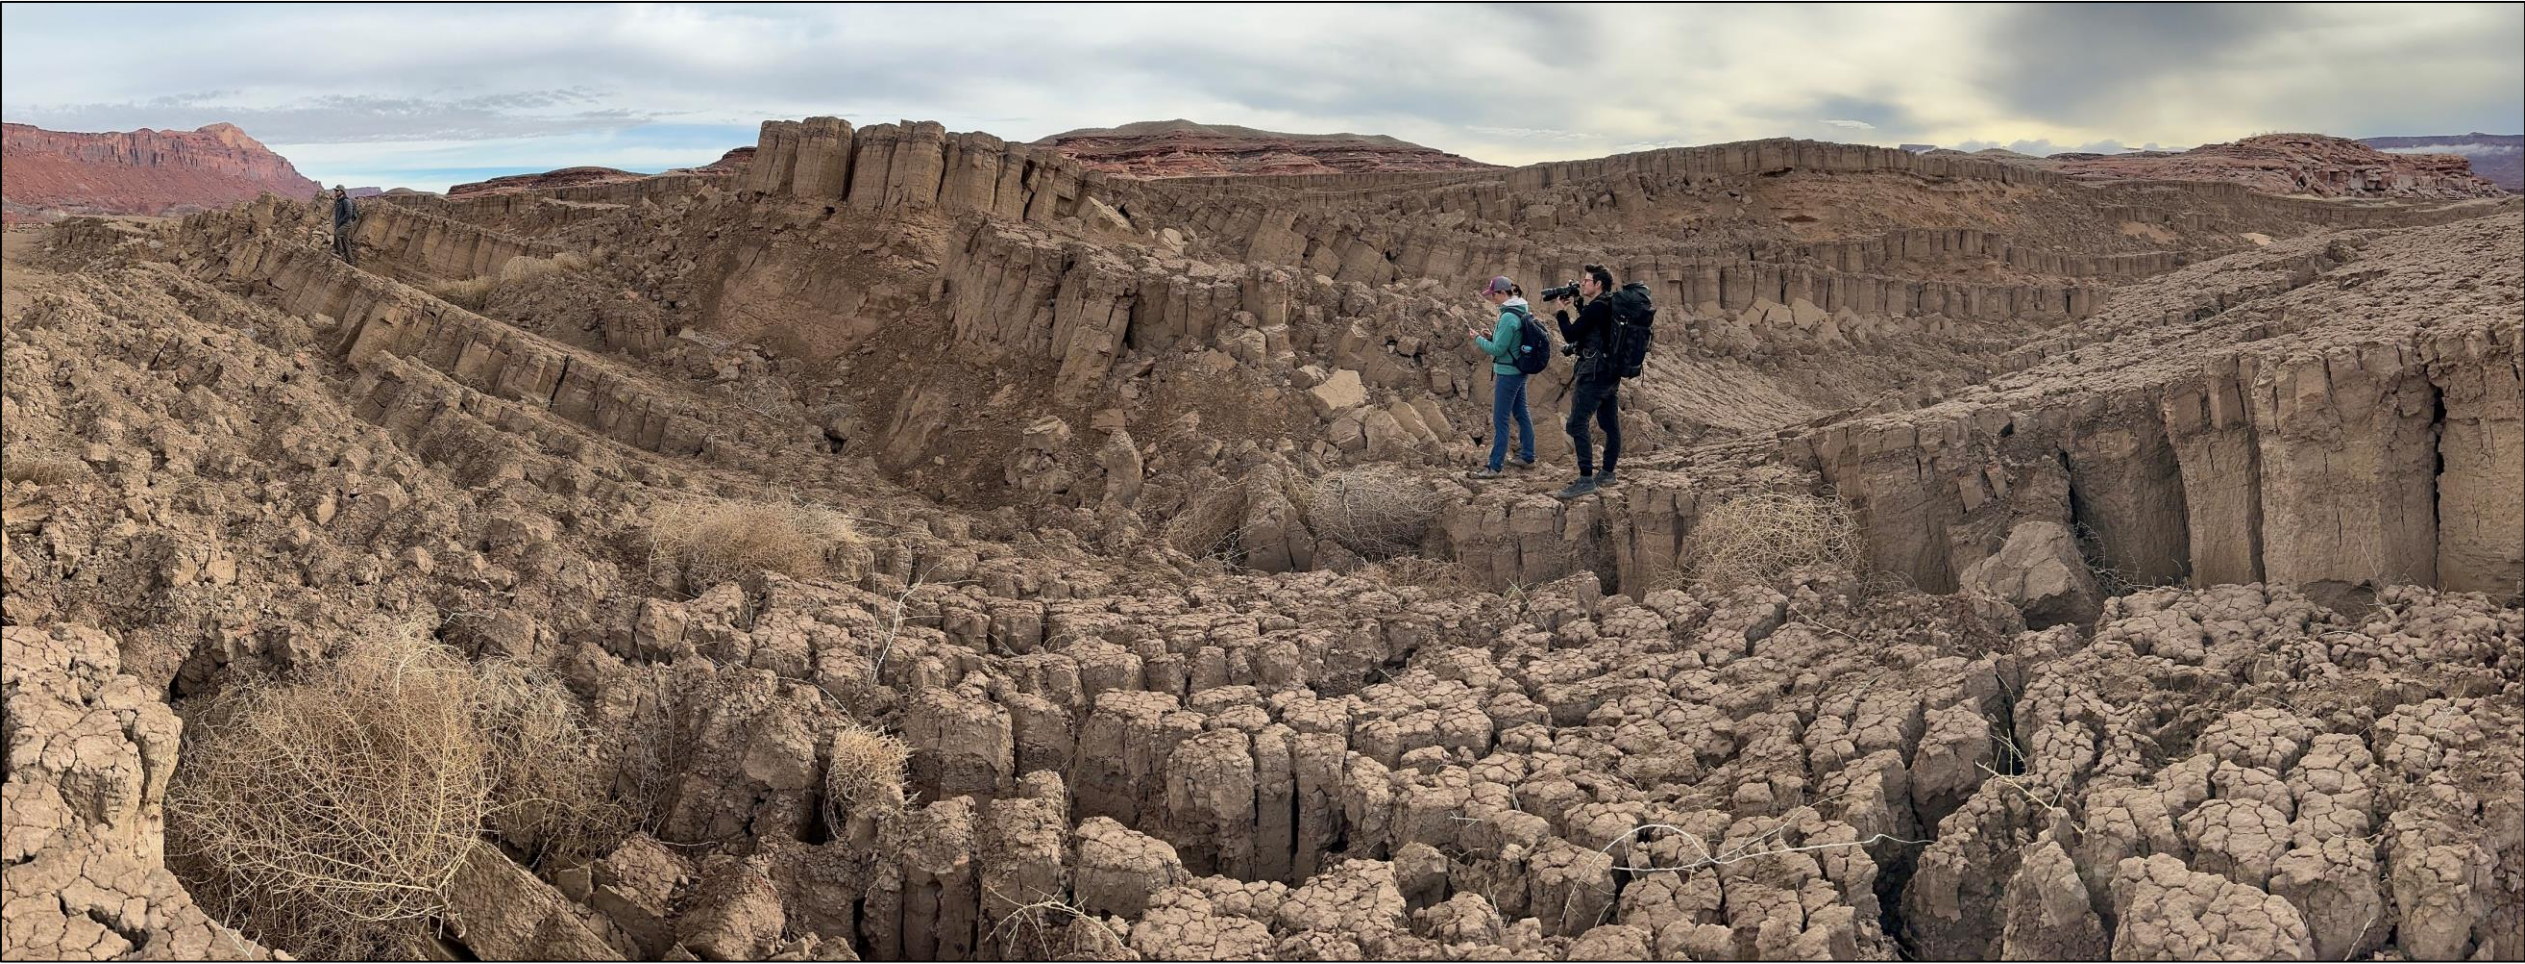
Brenda Bowen and Meg Flynn on distorted mud flat
3-5-2023 Mike DeHoff

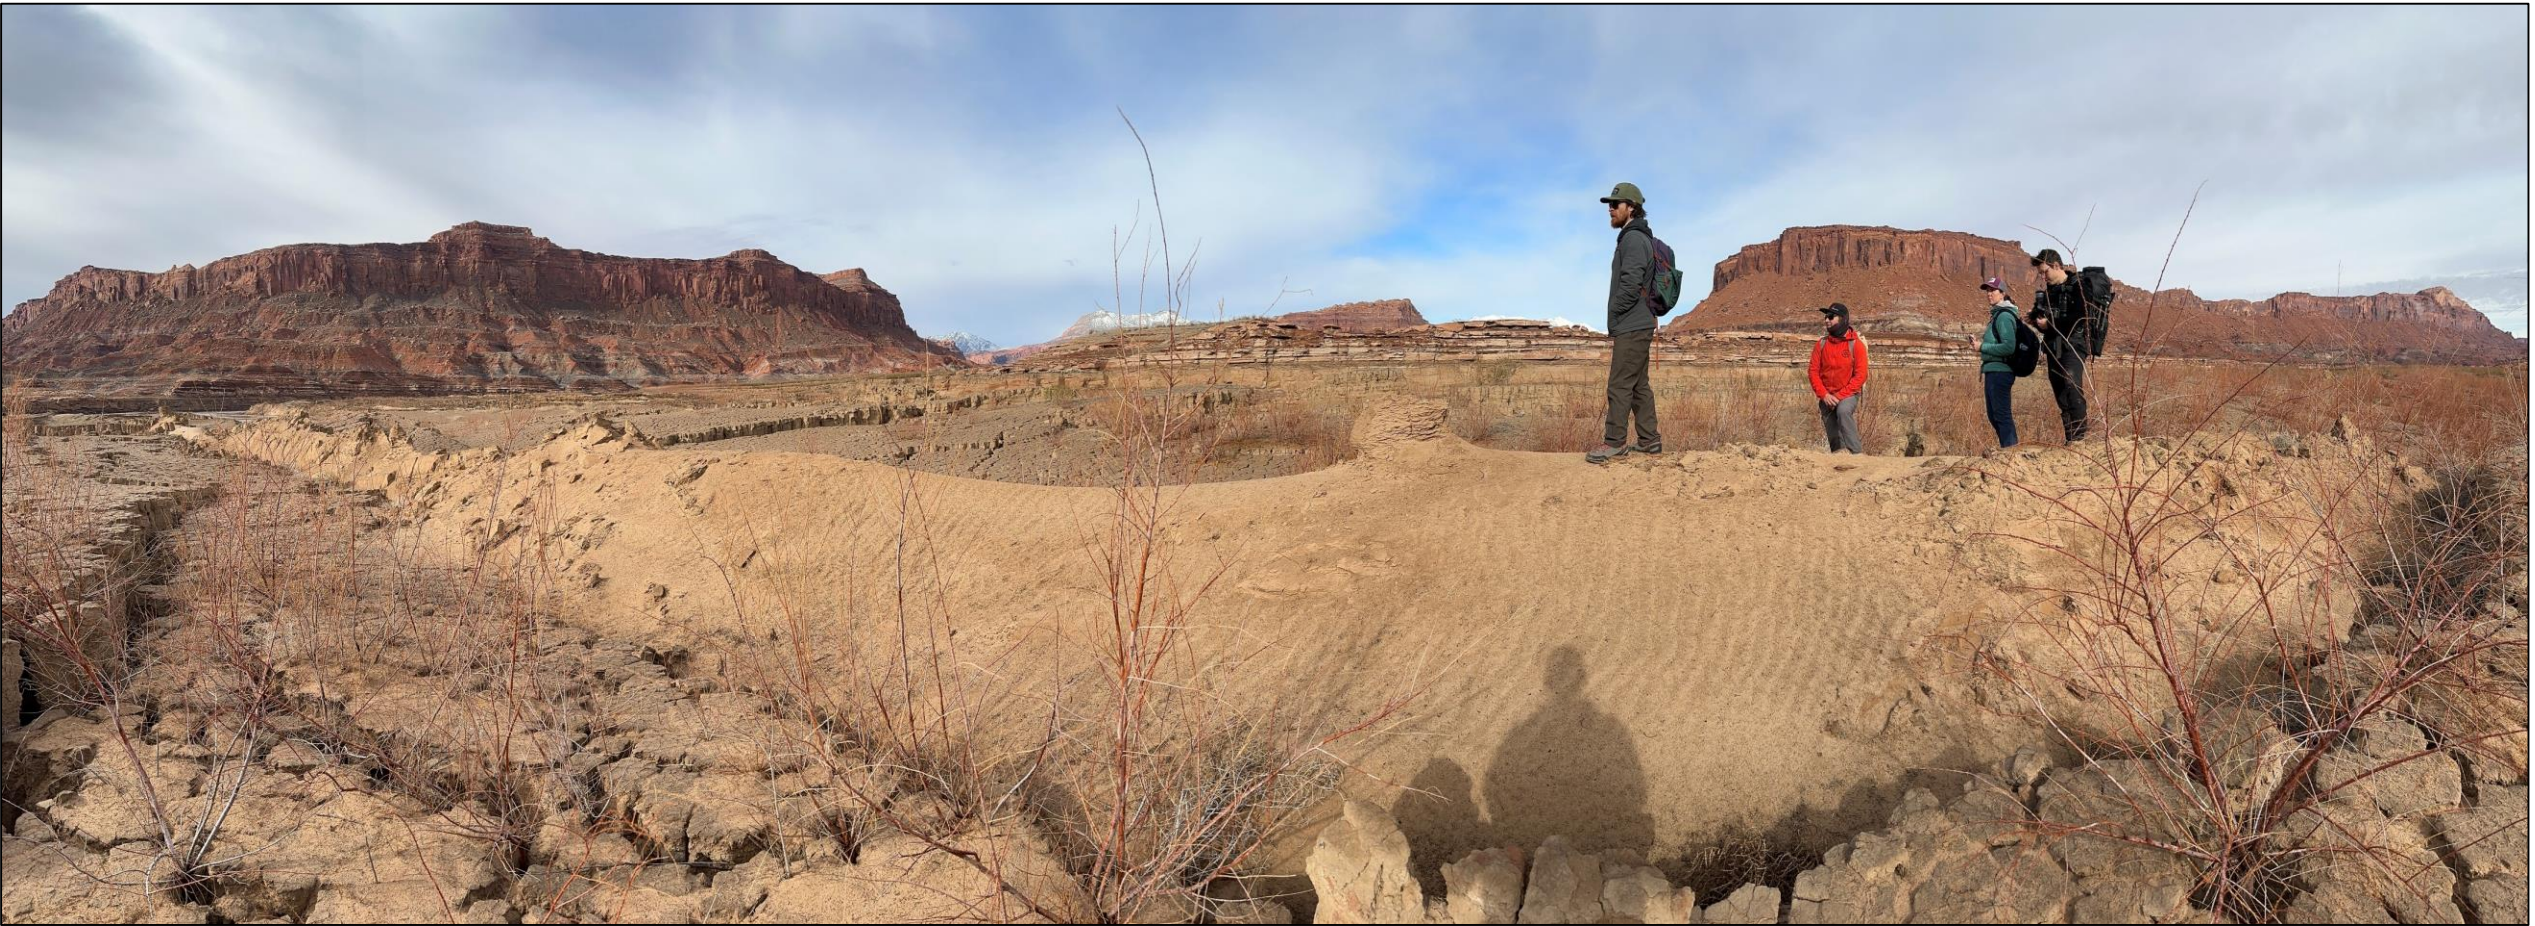
Peter, Meg, and Cody in the fun house mirror part of the sediment flats
3-13-2023

The team on a weird sand pressure ridge that led towards the Methane Volcano
3-13-2023

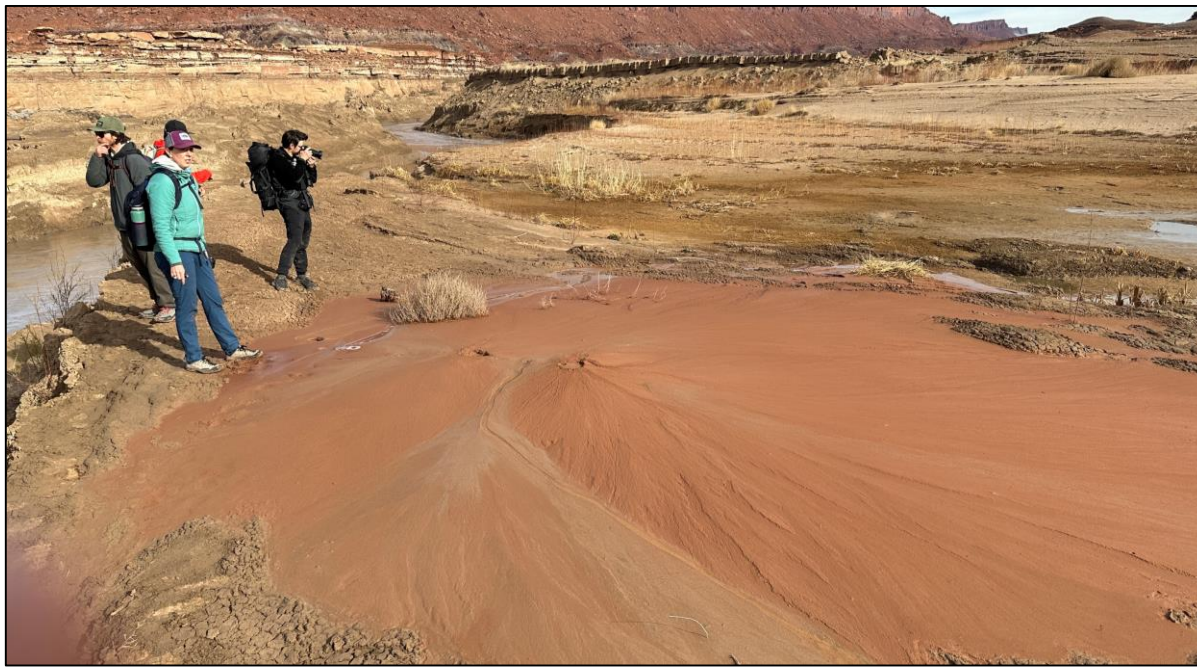
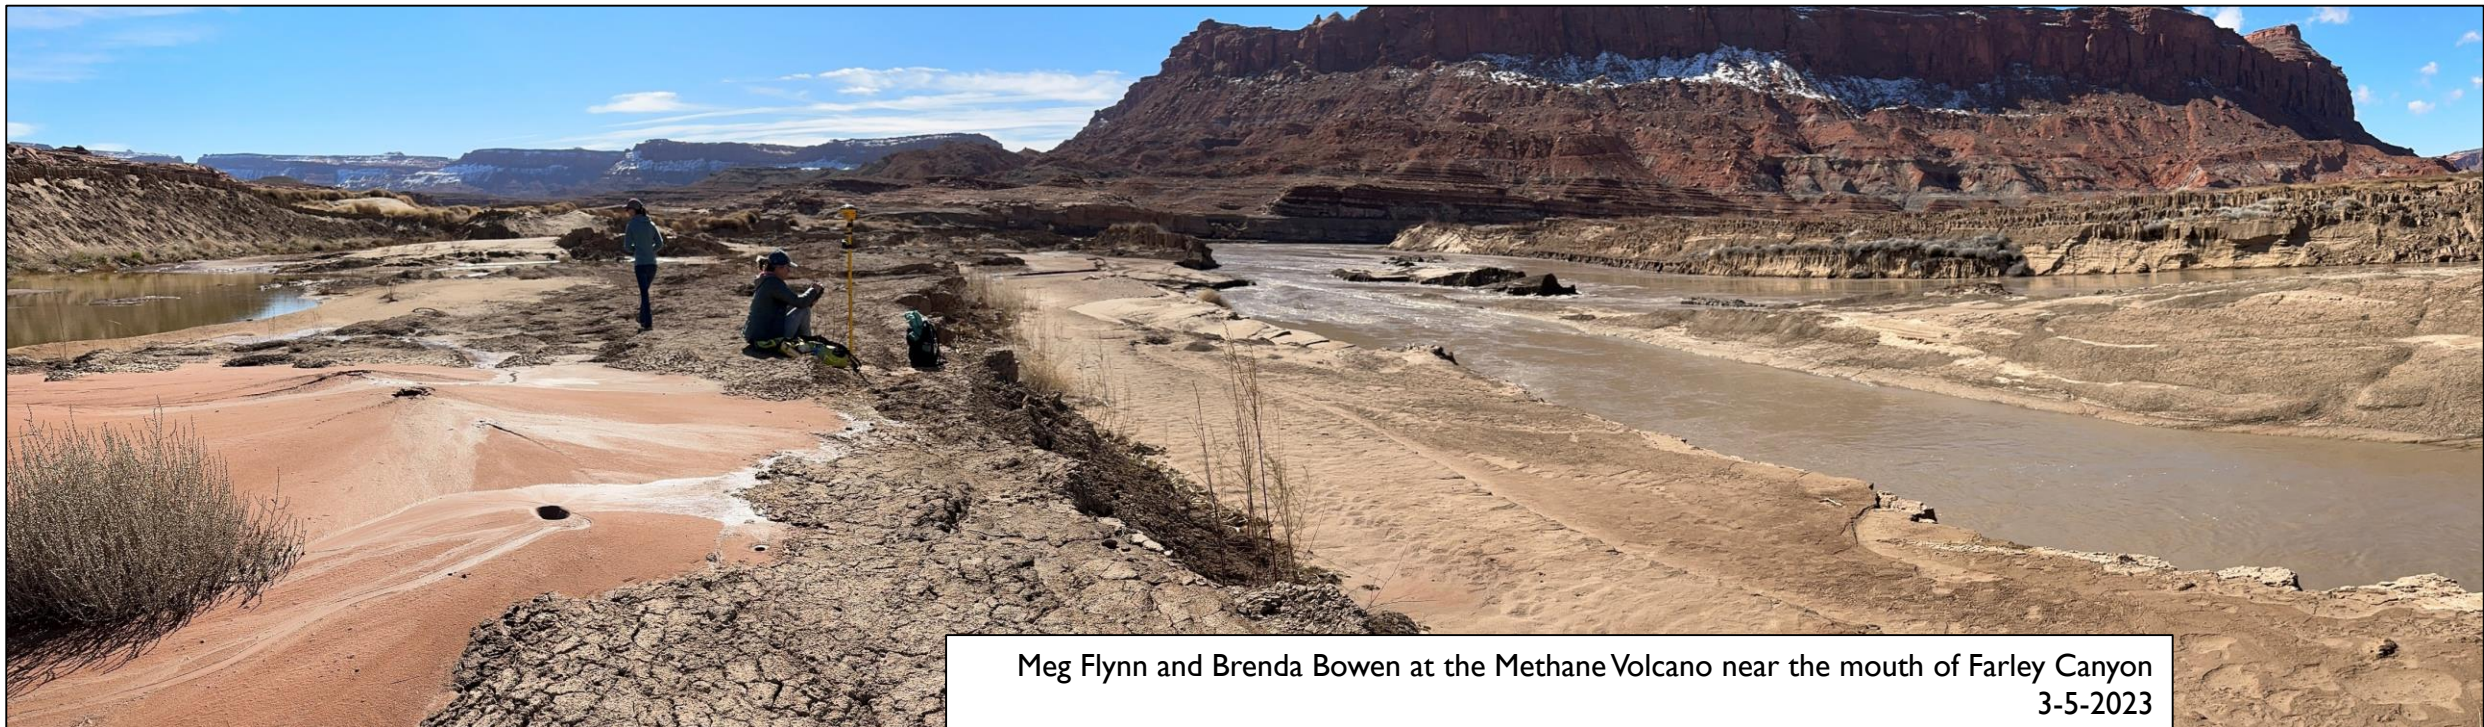
Visiting the Methane Volcano

Meg, Peter,
Benson, and
Cody at the
Methane Volcano
3-13-2023

In the fall of 2022, the expedition group came across odd sediment cone w a gas and water vent. During the spring of 2023 we wanted to visit it and monitor the changes.

Meg Flynn and Brenda Bowen at the Methane Volcano near the mouth of Farley Canyon
3-5-2023
