Colorado River Storage Project
Glen Canyon Dam Inundation Map
Index of Cross Sections Used in Dam Failure Study

Colorado River Storage Project
 Glen Canyon Dam Inundation Map
 Key Areas Around Lake Mead
 August 1998
 Sheet 3 of 10

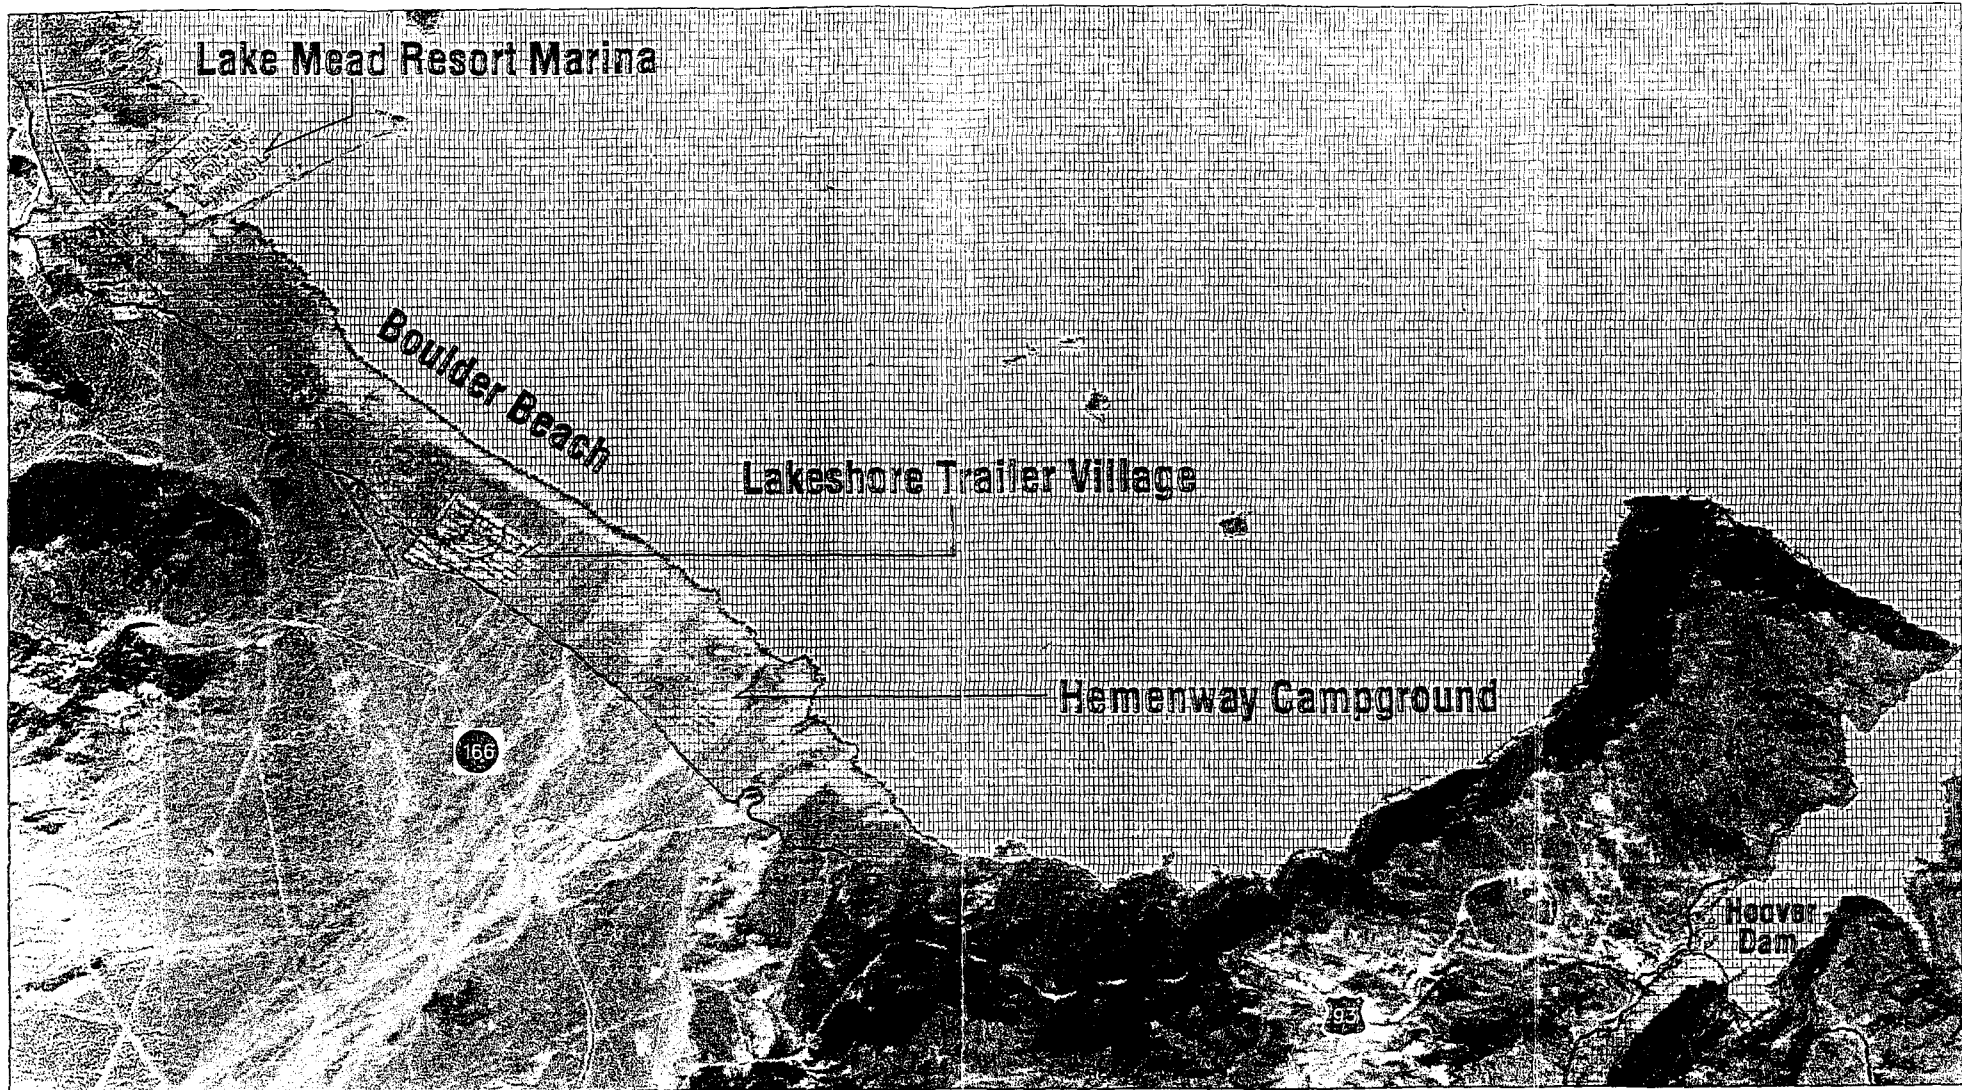
Flooding of Lake Mead shorelines resulting from failure of Glen Canyon Dam.

For dam failure study, Lake Mead water surface elevation was assumed to be 1214.5 feet (for a December failure) or 1219.6 feet (for a July failure).

Failure of Glen Canyon Dam would result in the Lake Mead water level rising by approximately 85 to 90 feet.

Arrival time of leading edge: 15 to 18 hours after Glen Canyon Dam failure.

Time to maximum water surface (elevation 1304 feet): 73 to 75 hours after Glen Canyon Dam failure.

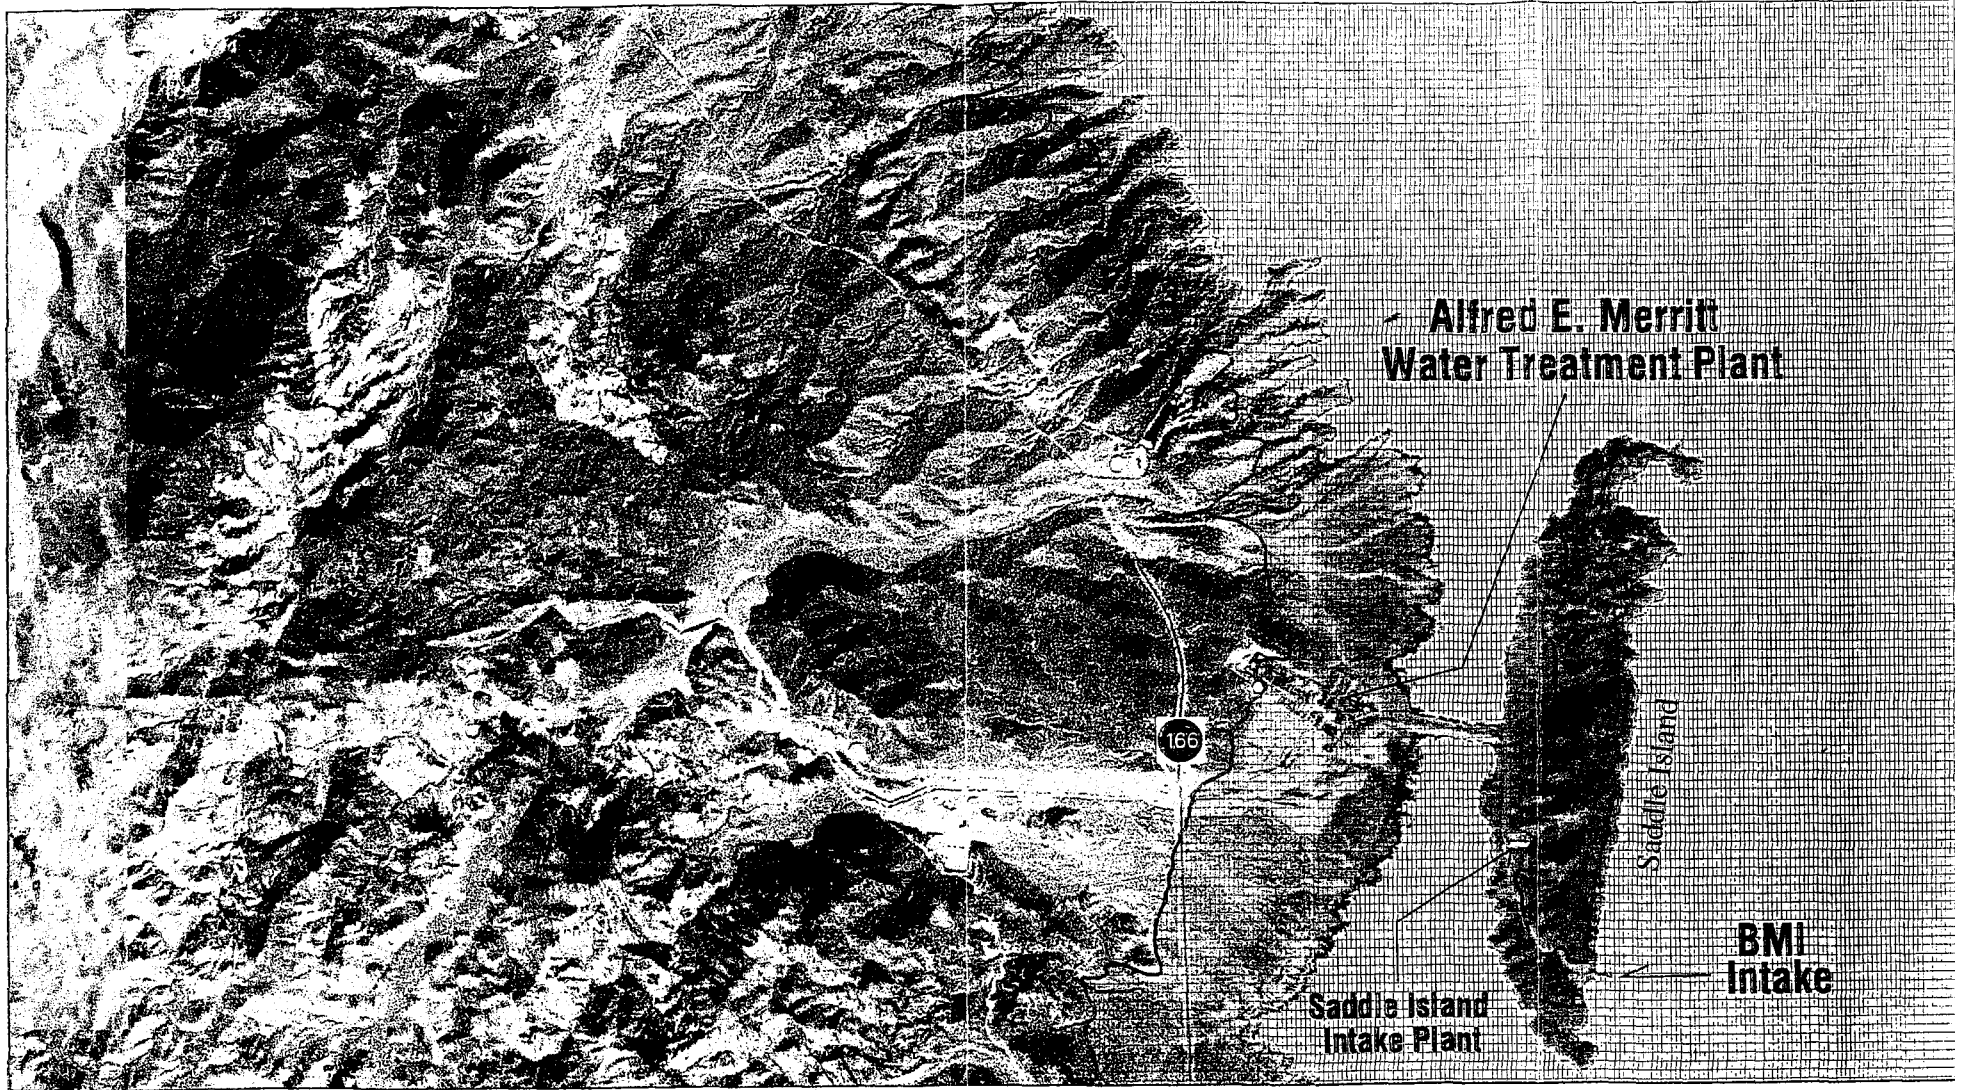
August 1998
 Sheet 2 of 10

Flooding of Lake Mead shorelines resulting from failure of Glen Canyon Dam.
 Maximum water surface elevation is 1304 feet (397 meters).

FLOOD VALUES:
 For dam failure study, Lake Mead water surface elevation was assumed to be 1214.5 feet (for a December failure) or 1219.0 feet (for a July failure).

Failure of Glen Canyon Dam would result in the Lake Mead water level rising by approximately 85 to 90 feet.
 Arrival time of leading edge: 15 to 18 hours after Glen Canyon Dam failure.
 Time to maximum water surface (elevation 1304 feet): 73 to 75 hours after Glen Canyon Dam failure.

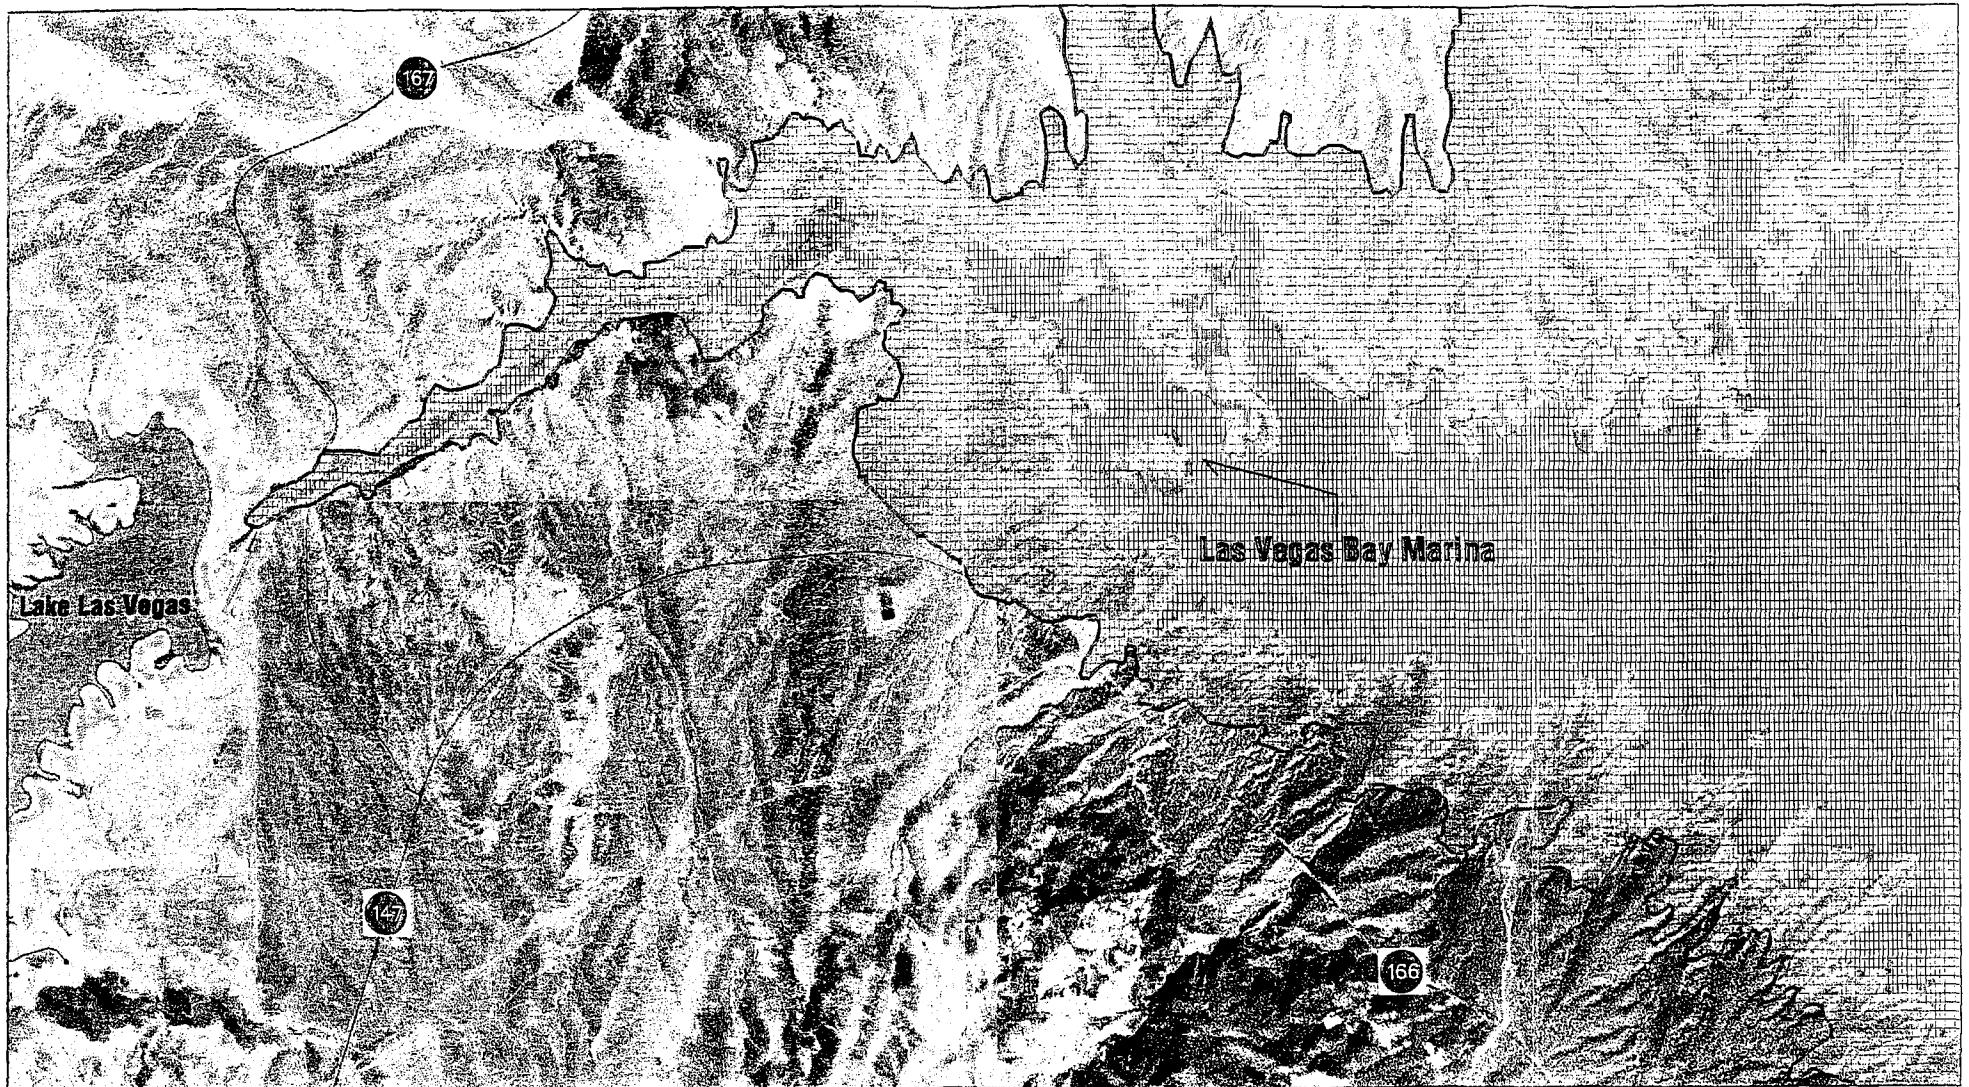
Flooding of Lake Mead shoreline resulting from failure of Glen Canyon Dam.
 Maximum water surface elevation is 1304 feet (397 meters).

FLOOD VALUES:
 For dam failure study, Lake Mead water surface elevation was assumed to be 1214.5 feet (for a December failure) or 1218.6 feet (for a July failure).

Failure of Glen Canyon Dam would result in the Lake Mead water level rising by approximately 85 to 90 feet.
 Arrival time of leading edge: 15 to 18 hours after Glen Canyon Dam failure.
 Time to maximum water surface (elevation 1304 feet): 73 to 75 hours after Glen Canyon Dam failure.

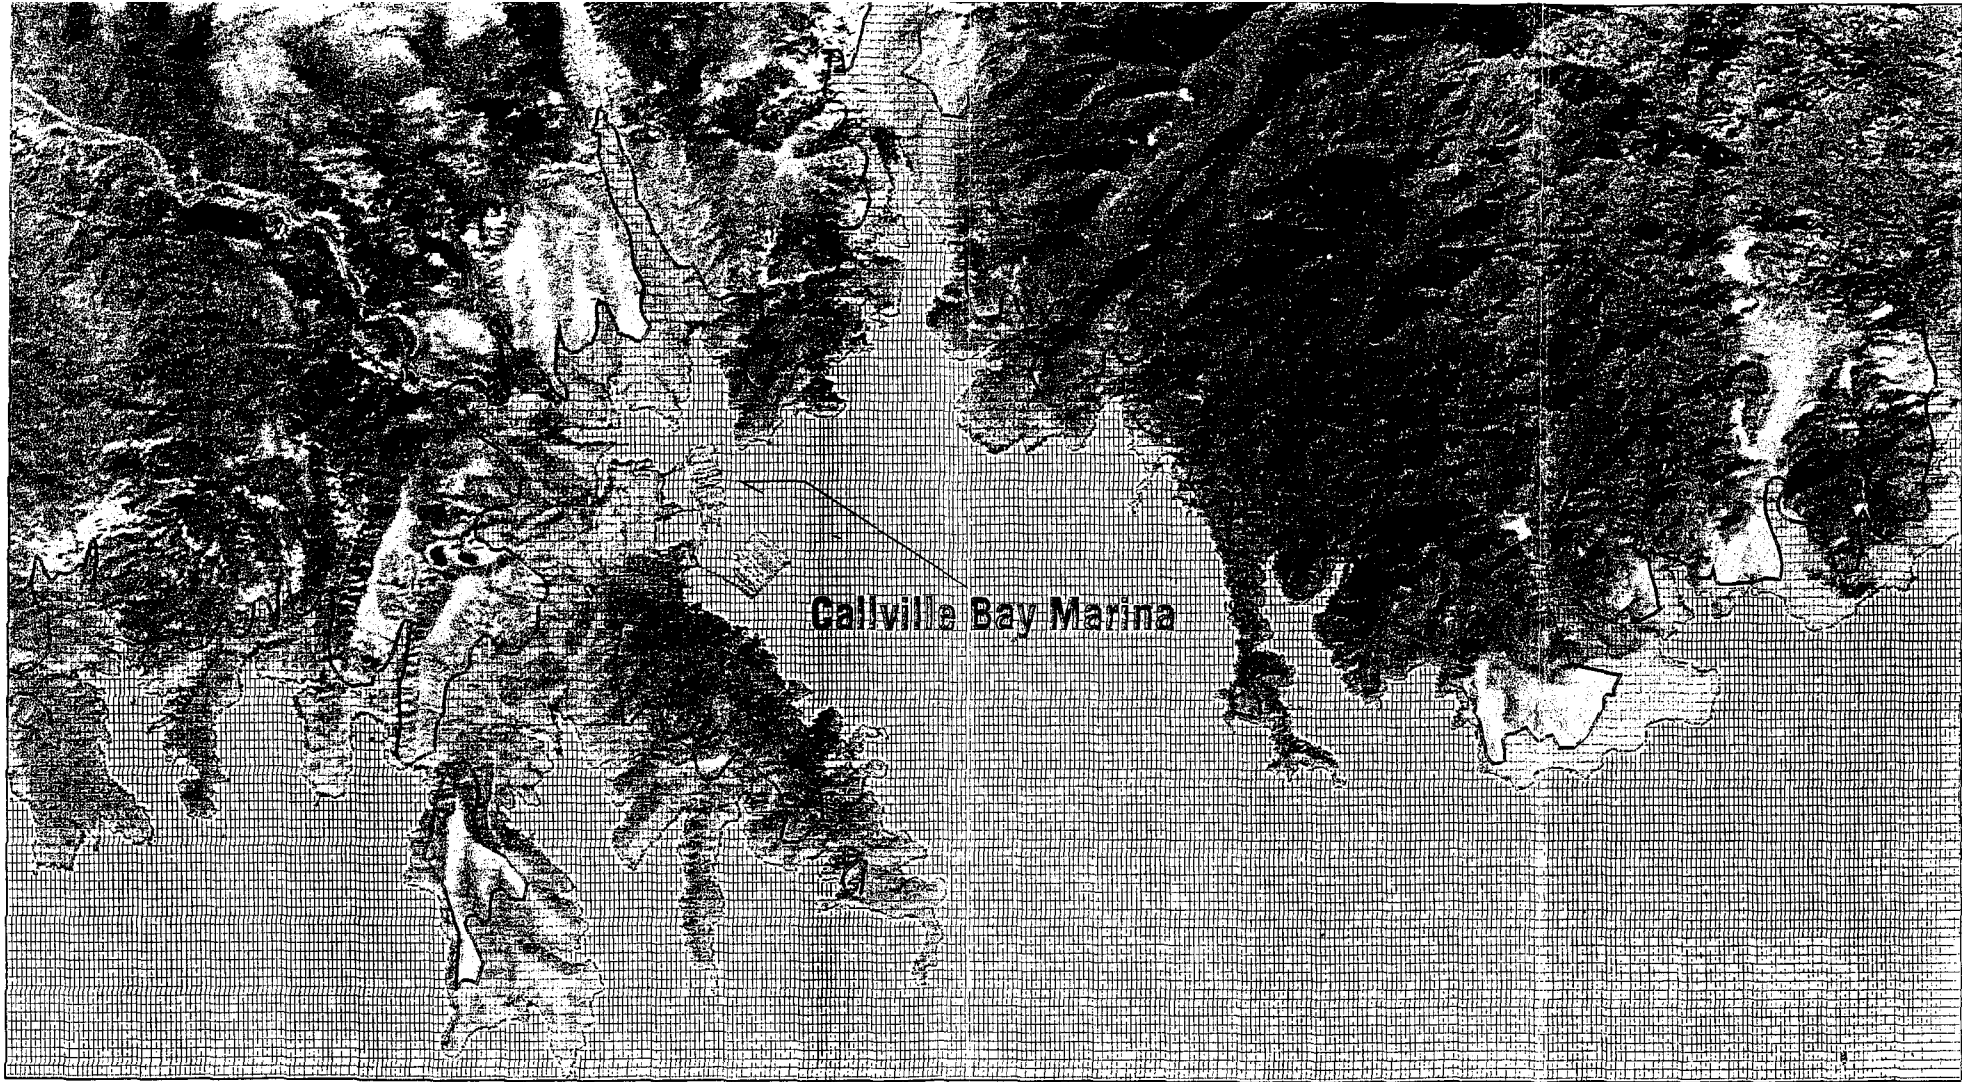
CALLVILLE BAY AREA

Flooding of Lake Mead shoreline resulting from failure of Glen Canyon Dam.

For dam failure study, Lake Mead water surface elevation was assumed to be 1214.5 feet (for a December failure) or 1219.6 feet (for a July failure).

Failure of Glen Canyon Dam would result in the Lake Mead water level rising by approximately 85 to 90 feet. Arrival time of leading edge: 15 to 18 hours after Glen Canyon Dam failure. Time to maximum water surface (elevation 1304 feet): 73 to 75 hours after Glen Canyon Dam failure.

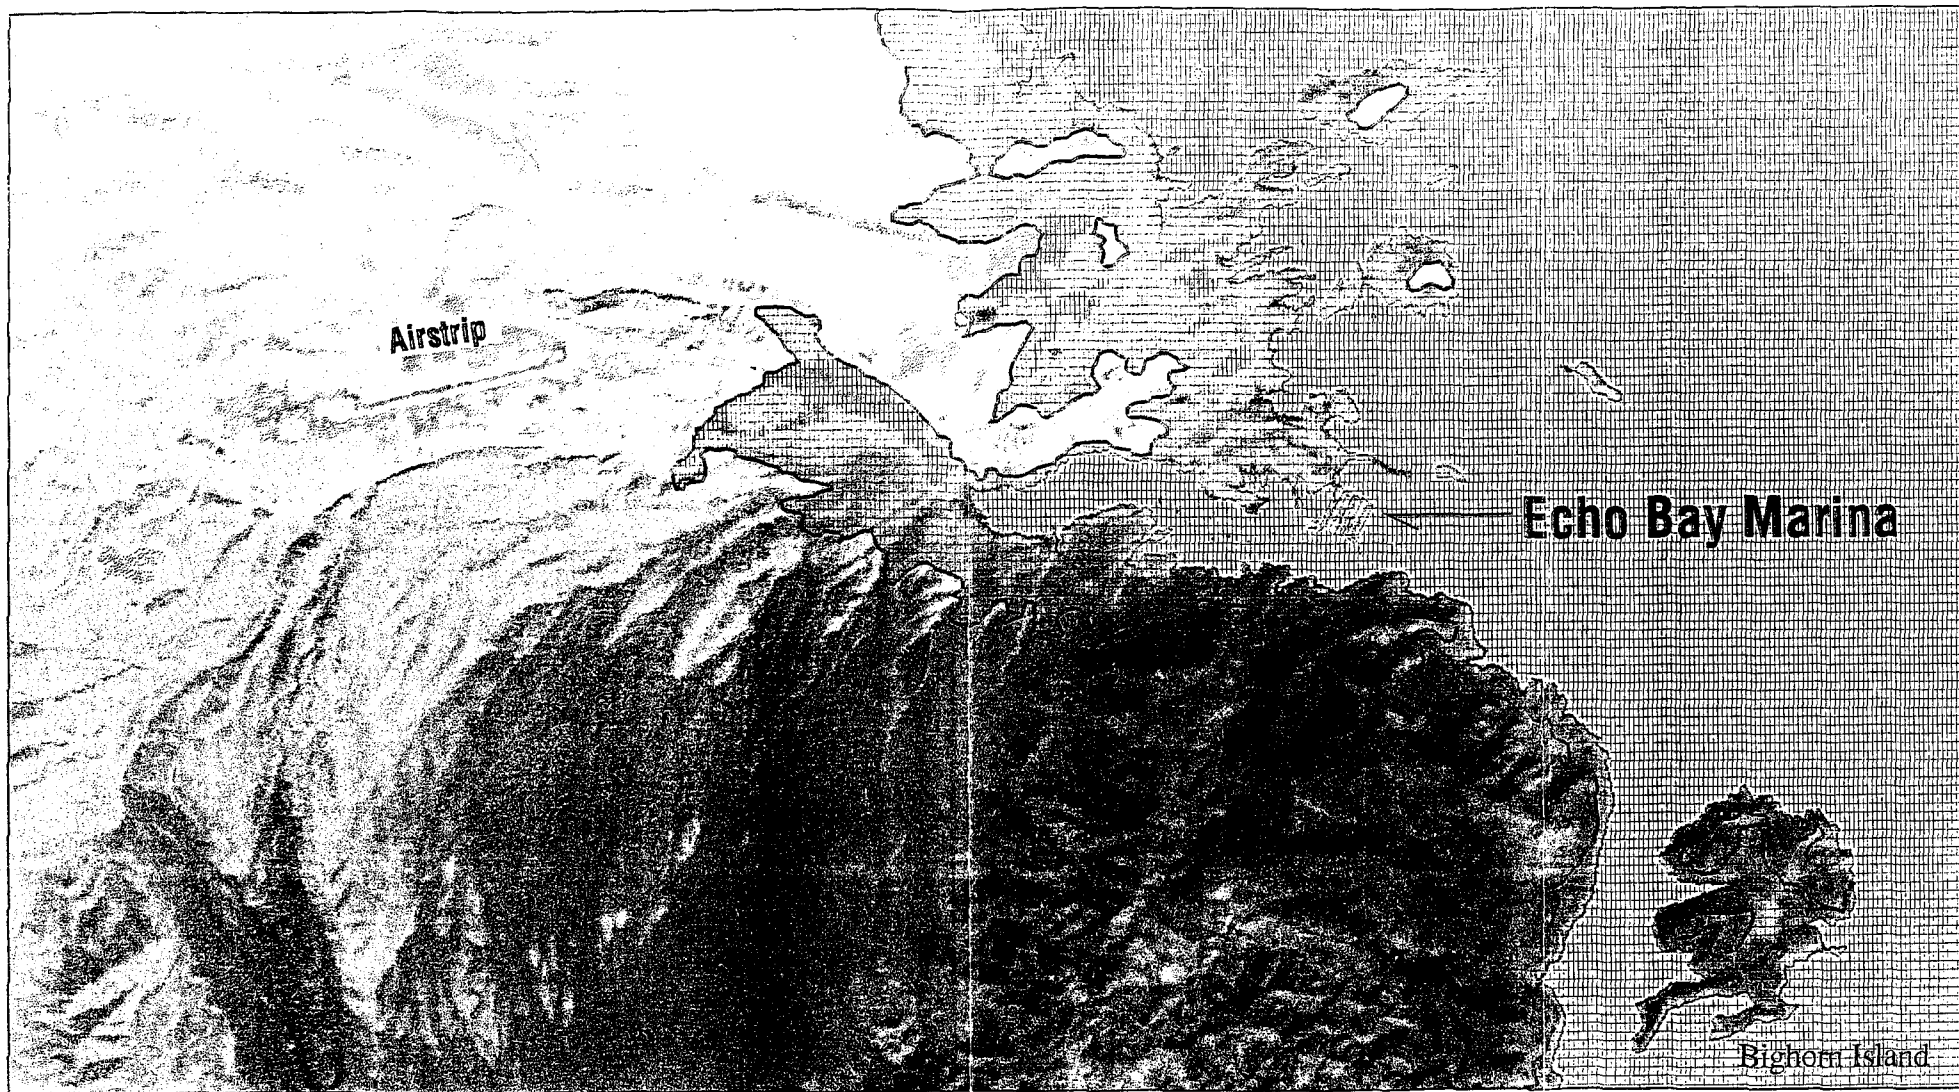
ECHO BAY AREA

Flooding of Lake Mead shoreline
 resulting from failure of
 Glen Canyon Dam.

For dam failure study, Lake Mead water surface elevation was assumed to be 1214.5 feet (for a December failure) or 1219.6 feet (for a July failure).

Failure of Glen Canyon Dam would result in the Lake Mead water level rising by approximately 85 to 90 feet.
 Arrival time of leading edge: 15 to 18 hours after Glen Canyon Dam failure.
 Time to maximum water surface (elevation 1304 feet): 73 to 75 hours after Glen Canyon Dam failure.

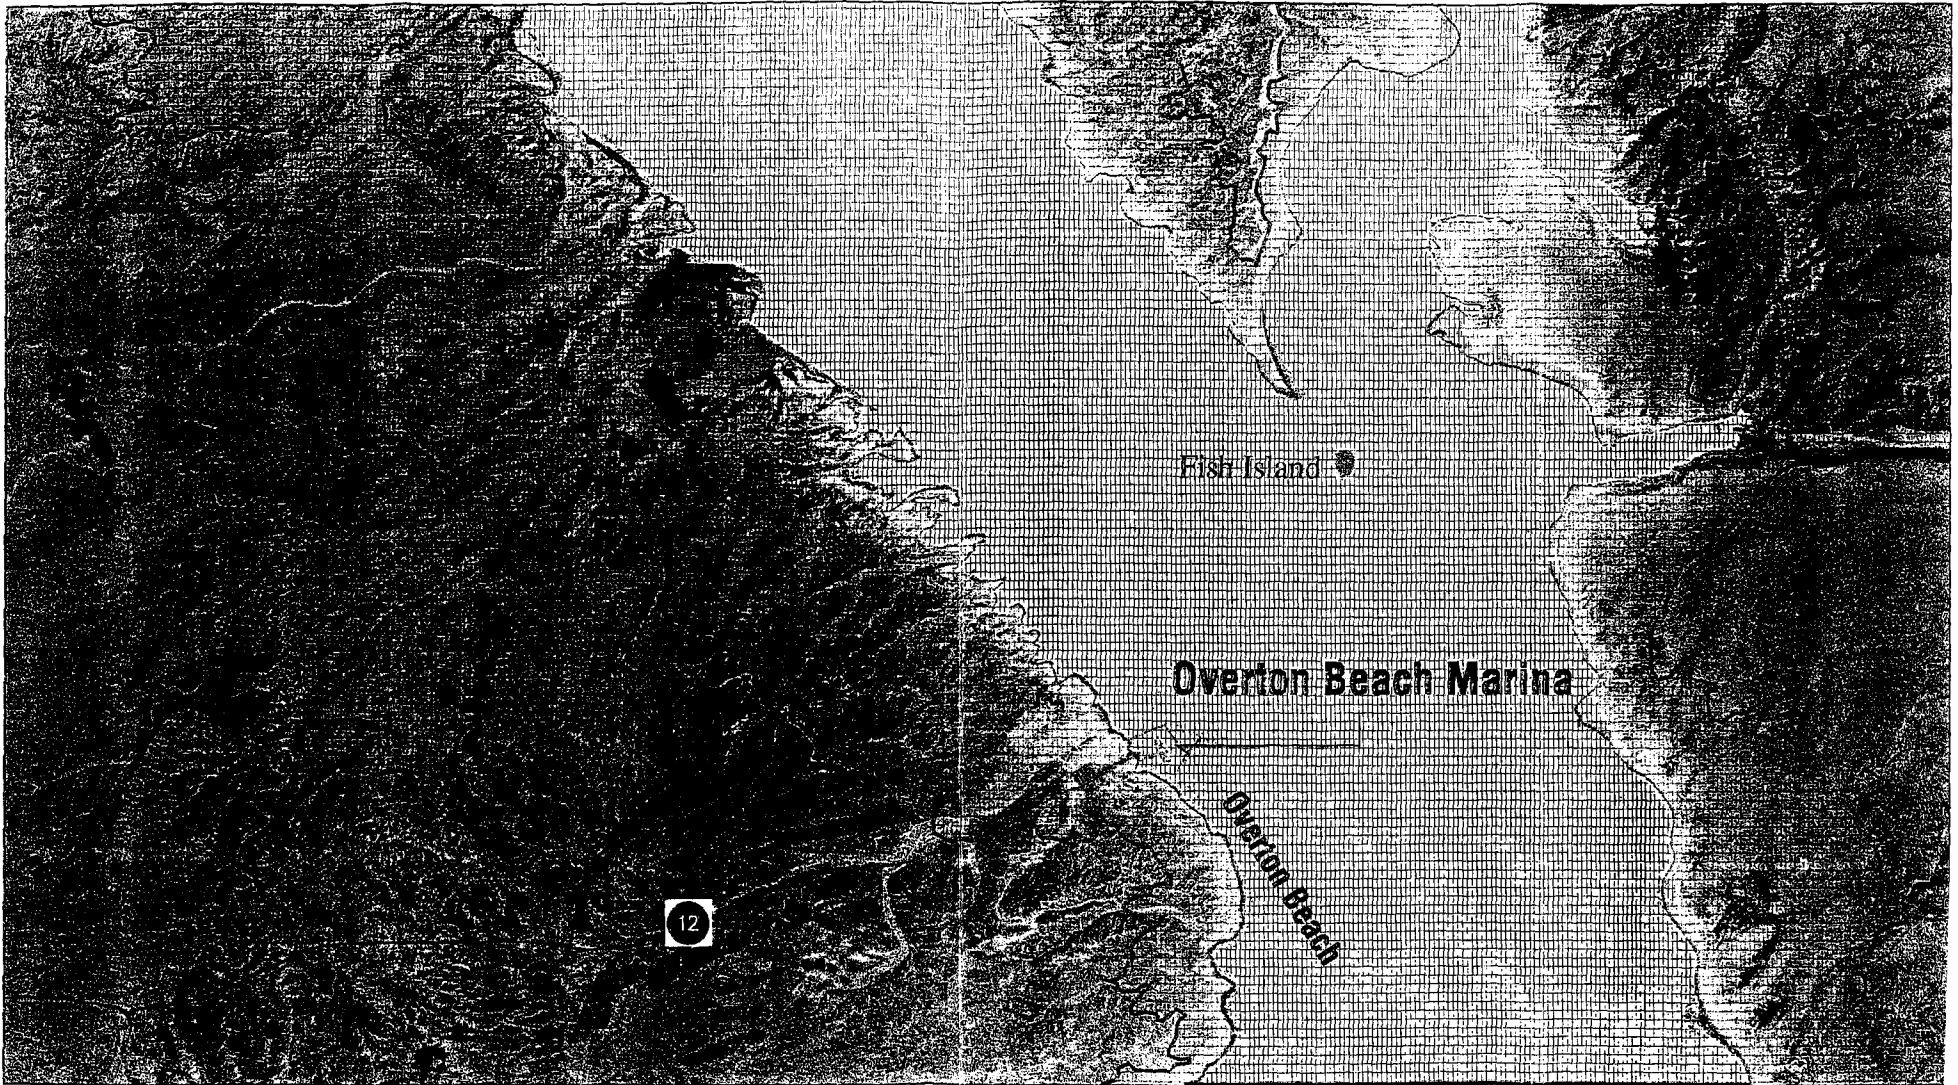
August 1998
Sheet 6 of 10

Flood Boundary:
Flooding of Lake Mead shoreline
resulting from failure of
Glen Canyon Dam.
Maximum water surface elevation
is 1304 feet (397 meters).

FLOOD VALUES:
For dam failure study, Lake Mead water surface elevation was assumed to be 1214.5 feet (for a December failure) or 1219.6 feet (for a July failure).

Failure of Glen Canyon Dam would result in the Lake Mead water level rising by approximately 85 to 90 feet.
Arrival time of leading edge: 15 to 18 hours after Glen Canyon Dam failure.
Time to maximum water surface (elevation 1304 feet): 73 to 75 hours after Glen Canyon Dam failure.

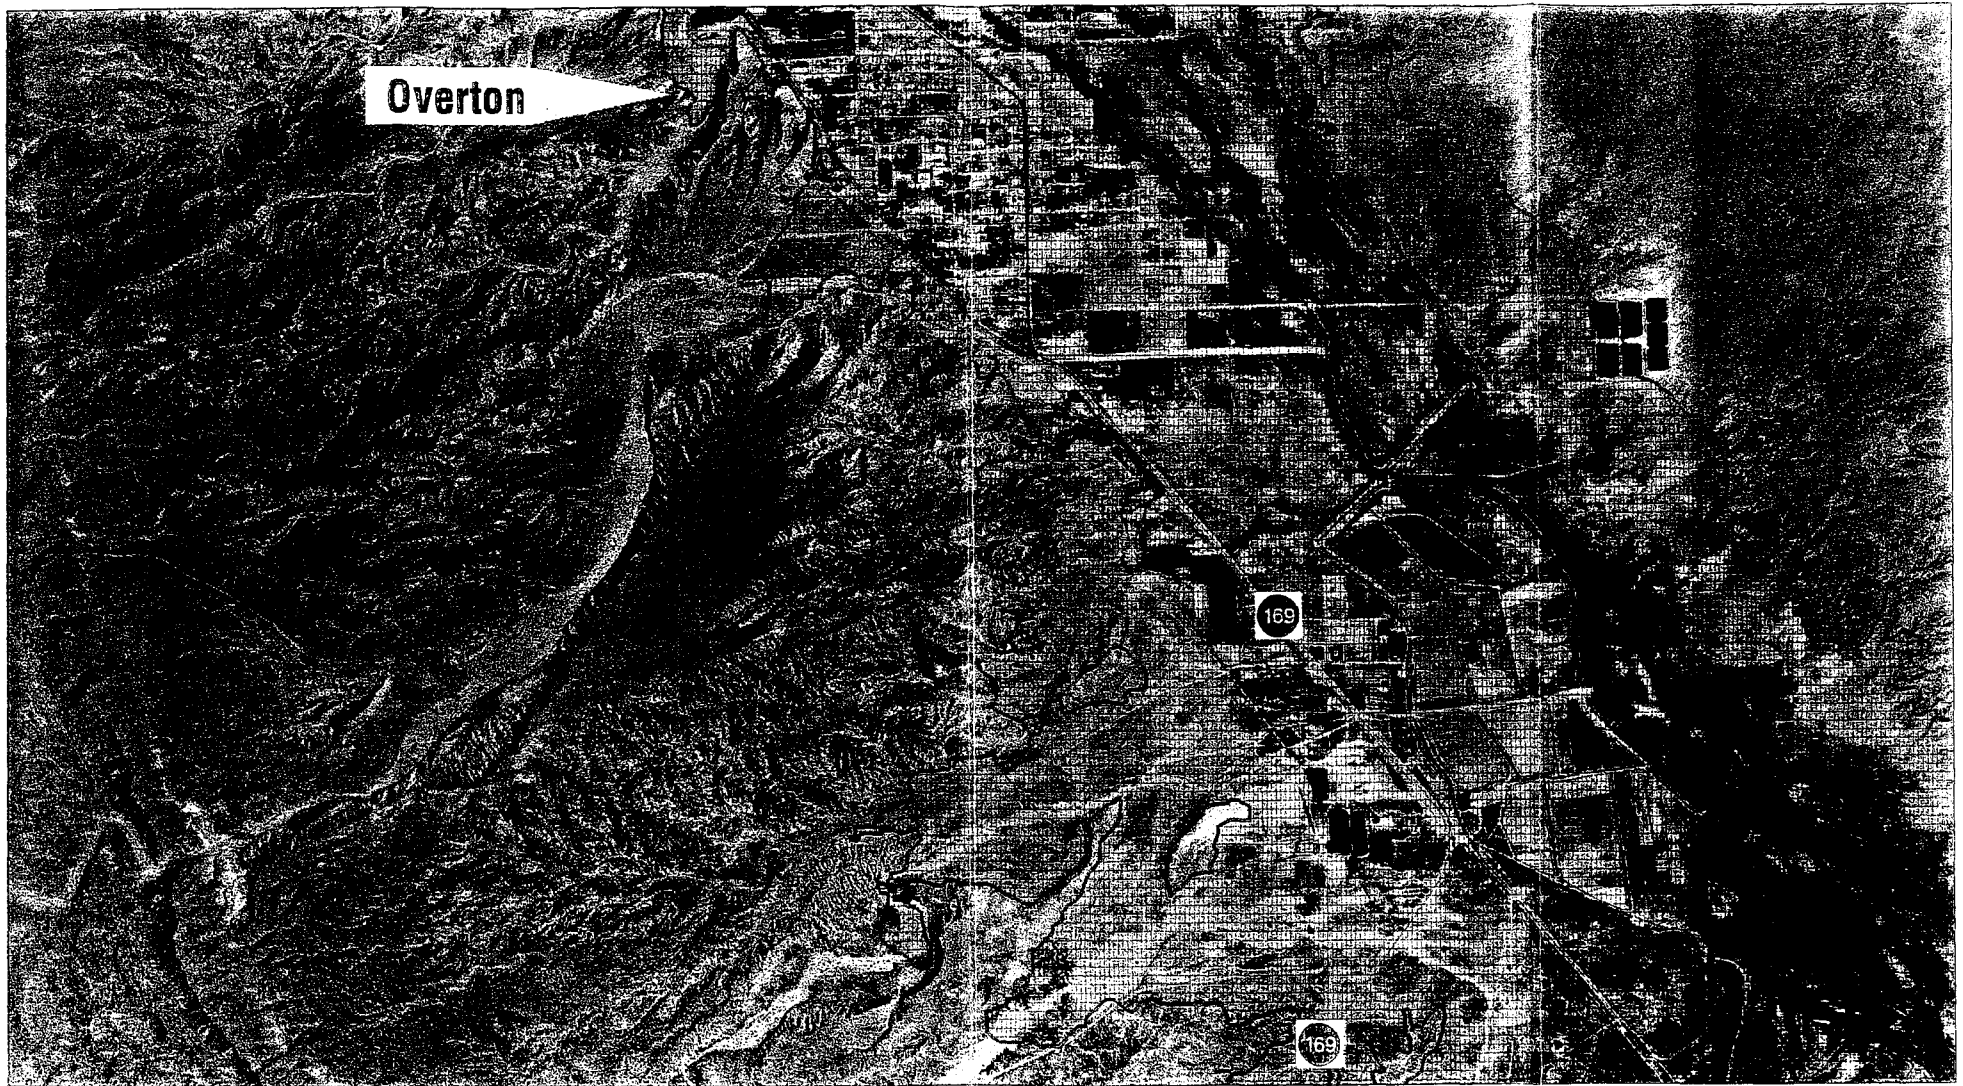
Flood Boundary:
Flooding of Lake Mead shoreline
resulting from failure of
Glen Canyon Dam.
