This is a printer friendly version of an article from **DurangoHerald.com**
To print this article open the file menu and choose Print.

Article published Oct 9, 2011

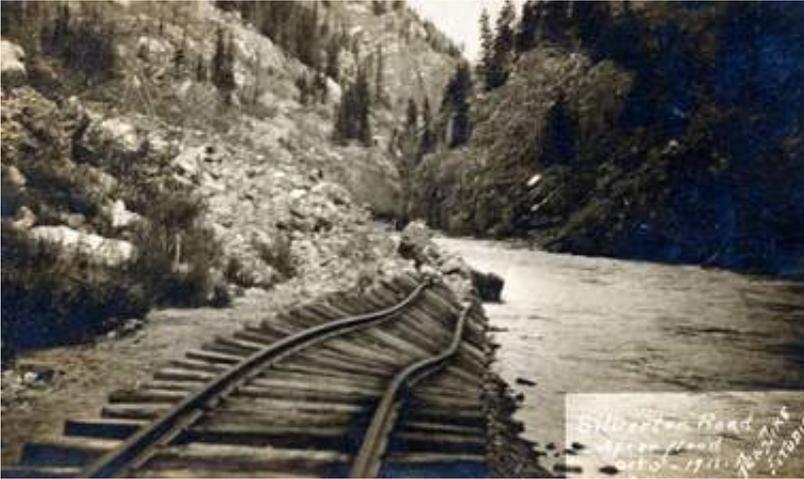
Photo by: Courtesy of Center of Southwest Studies
This postcard from the Nina Heald Webber collection is a photo taken by Pen-Dike Studio after the Flood of 1911 destroyed 22 miles of track, including the road bed in many places, on the Denver & Rio Grande Railroad between Durango and Silverton.

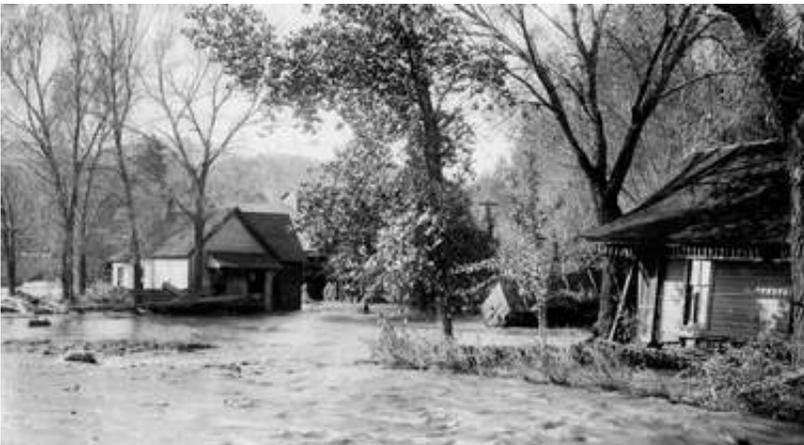
Photo by: Courtesy of Center of Southwest Studies

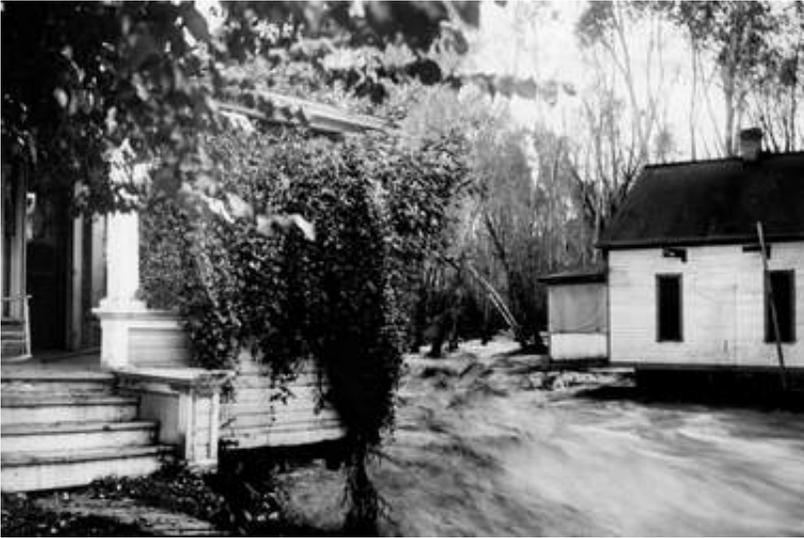
Photo by: Courtesy of Center of Southwest Studies

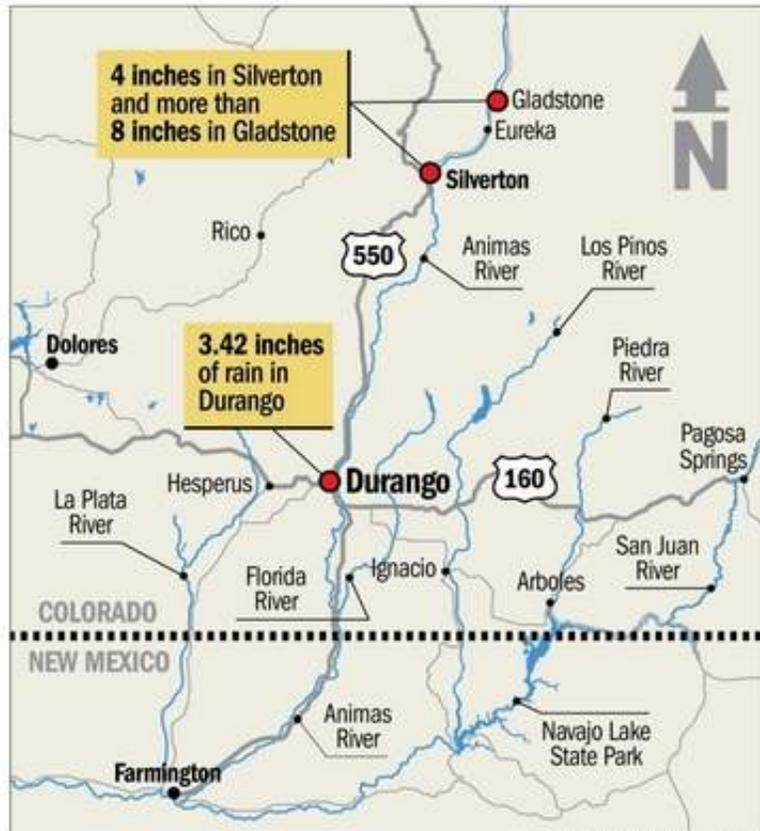
GERMAN ROJAS/ Durango Herald
