Water-Supply Paper 994

# CLOUDBURST FLOODS IN UTAH 1850-1938

RALF R. WOOLLEY

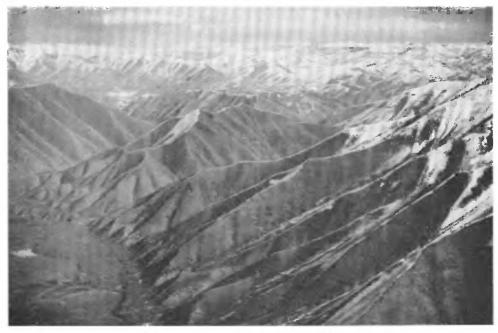
4. WASATCH RANGE EAST OF SPRINGVILLE.

Shows an unglaciated and maturely dissected part of the western margin of the range. Note the roughly triangular, gully-scarred fault-facets (A) steeply notehed on their lower margins by wave-cut cliffs alined along an ancient heach of Lake Bonneville. A recent fault scarp associated with the Wasatch fault zone appears as a dark shadow at left of beach. Note accordant summit levels of the range in the background where it merges with the Uinta Mountains on the horizon. View looking northeastward. Air photo by R. E. Marsell.

The escarpment is due in part to dislocation of the earth's crust along two major zones of fracture and movement. The Wasatch fault zone coincides with the base of the scarp for a distance of about 150 miles in its northern section. The Hurricane fault zone. which lies within the plateaus south of Cedar City, follows the escarpment for an unknown distance to the north, possibly to a point 20 or 30 miles south of Beaver. Toward the middle of the scarp, between Levan and a point several miles south of Beaver, the slopes are more gentle and very irregular. Here evidence of faulting is obscure. There are no great continuing faults but only occasional faults and parts of the front where the beds are warped downward into the Great Basin. Apparently the division of the State into two general physiographic regions has been brought about by repeated movements along the front, both by warping and faulting. The cumulative effect has been to raise the eastern part of the State along this zone from 3,000 to 6,000 feet above the western part. Evidence of geologically recent movement along the Wasatch fault zone is conspicuous (see pl. 2) and has been ably described by Gilbert<sup>17</sup> and others.

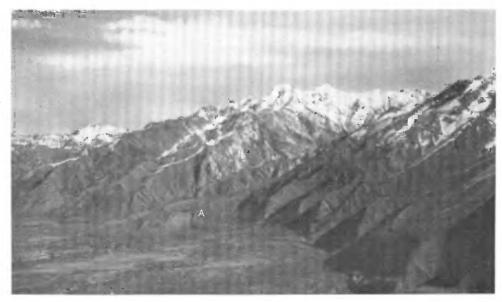
B. WASATCH RANGE SOUTHEAST OF SALT LAKE CITY.

Shows horseshoe-shaped glacial moraine 700 feet high at mouth of Bell Canyon (lower left of center). Note sharply truncated ends of ridges, these triangular fault-facets being faintly notched by a shore terrace of Lake Bonneville in lower right corner of photograph. Recent fault scarp, plainly shown below (west of) these facets, has dislocated the moraines at A. View looking northeastward. Air photo by R. E. Marsell.

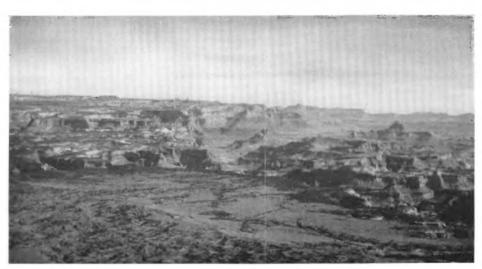
$\boldsymbol{B}.$  A TYPICAL LANDSCAPE IN THE CANYON LANDS.

San Rafael district of the Canyon Lands section of the Colorado Plateaus province. Note labyrinth of cliff-walled gorges separated by flat-topped benches or pinnack-capped ridges, with isolated buttes and mesas. Book Cliffs erosional escarpment dimly visible on the horizon. View looking southeastward. Air photo by R. E. Marsell.

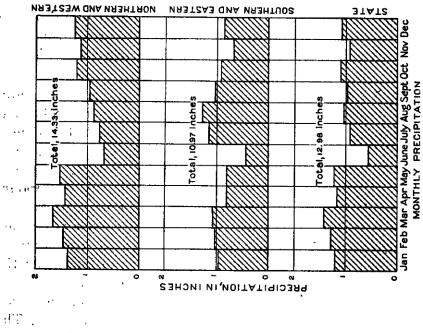
FIGURE 2.--Climatological charts for Utah showing average temperature and precipitation, 1891-1938.

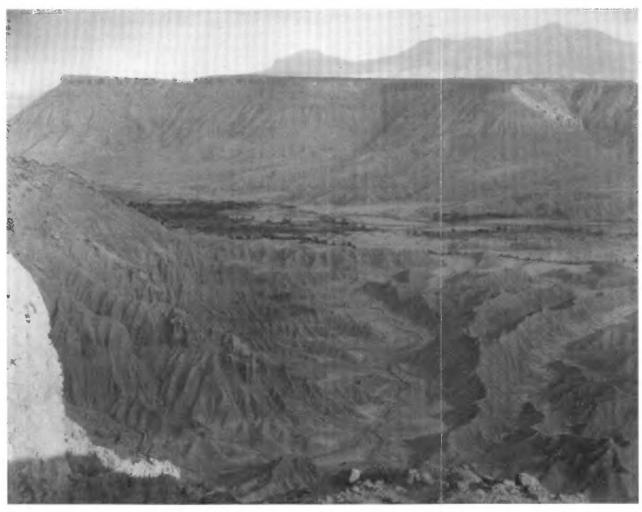
A. MOUNT ELLEN, HENRY MOUNTAINS.

Shows northernmost of the isolated laccolithic mountain groups along the western margin of the Canyon Lands. Note typical badland topography developed on the soft mudstones and shales of the Moenkopi formation. Bench in middle distance is capped by resistant Shinarump sandstone. Photo by J. E. Broadaus.

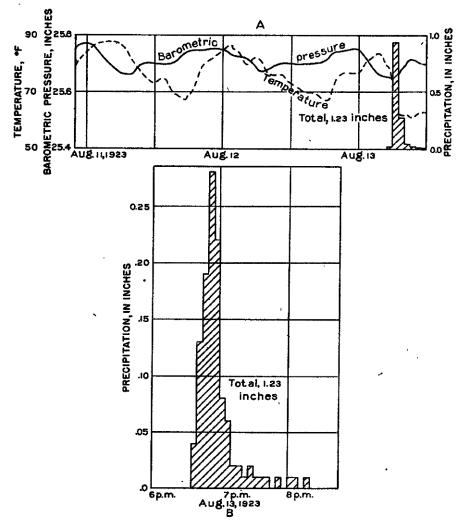
. FIGURE 4.—Characteristics of cloudburst storm of August 13, 1923. From records of United States Weather Bureau at Salt Lake City.

drowned. The characteristics of this storm and the barometric and thermal conditions at Salt Lake City from August 11 to 13, inclusive, are shown in figure 4. Uniformly high temperatures and pressures prevailed prior to the storm. As the storm developed the barometric pressure and temperature fell rapidly. Figure 4, A shows the hourly quantities of precipitation during the storm, and figure 4, B shows the 5-minute intensities, as recorded by the tipping-bucket gage during the most violent period. Of the total of 1.23 inches of rainfall, 0.96 inch fell in a period of 25 minutes. On ground with an absorption rate of 1 inch an hour, 0.54 inch of this would be surface runoff.

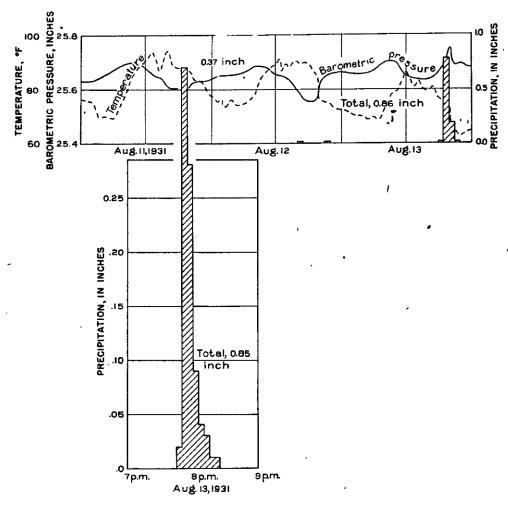
FIGURE 5.—Characteristics of cloudburst storm of August 13, 1931. From records the United States Weather Bureau at Salt Lake City.

Another storm of this kind occurred August 13, 1931 (fig. 5). It was not so severe as that of 1923 but was severe enough to

cause considerable damage. Two mudflows emerged from the canyons between Salt Lake City and Farmington, burying several automobiles on the State highway. The State spent over \$8,000 in clearing away the debris and mud. Characteristics of this storm from records at Salt Lake City are shown in figure 5.

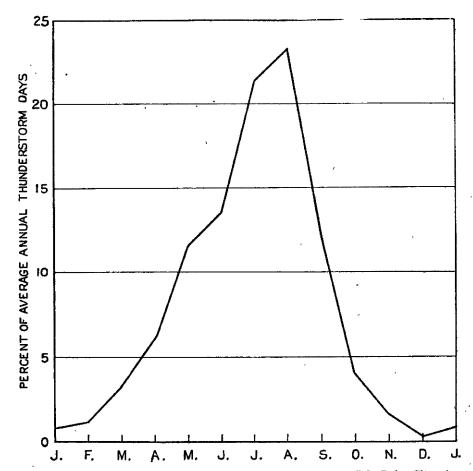
FIGURE 7.—Average annual distribution of thunderstorm days at Salt Lake City. Average annual number of thunderstorm days was 35 for period 1904 to 1938.

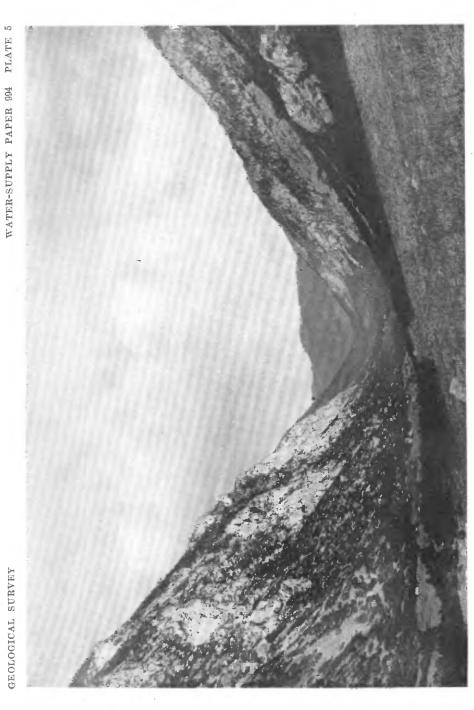
LITTLE COTTONWOOD CANYON, WASATCH RANGE. Note troughlike U-shaped profile of glaciated mountain valley.

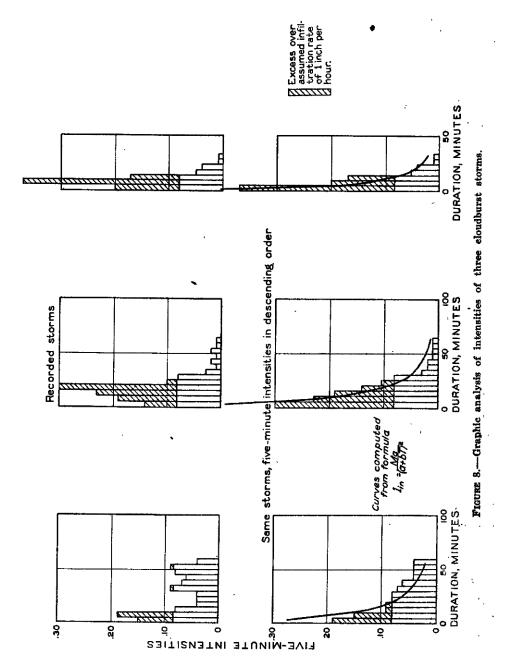
In figure 8 three of the 18 storms are shown graphically, first, showing the variations in intensity as they actually occurred and then with the intensities arranged in descending order of magnitude. In an actual storm, preliminary fall often satisfies, at least partially if not completely, the requirements of initial interception and surface detention and permits the maximum intensities to contribute to surface runoff, which is then reduced only by the infiltration. In the rearranged storm the initial requirements of interception and detention must be satisfied during the high intensity period, which has the effect of reducing the maximum intensity. As far as the scantily vegetated watersheds of the semiarid West are concerned, this difference does not appear important. For the purpose of comparing storms an assumed infiltration rate of 1 inch an hour has been applied to these storm graphs regardless of the actual hydrologic conditions that prevailed during the storms, but no interception and surface-detention factors have been applied. The excess over the infiltration rate therefore represents theoretical surface runoff from a small unit area of exposed ground. In the decreasing-intensity arrangement of the storms the cumulative percentage of precipitation "F" is plotted against the percentage of duration "T" from the beginning of the storm. Percentages rather than dimensional data were used in order to reduce storms of widely varying total precipitation and duration to a standard basis of comparison. Regardless of volume of precipitation or duration, the shape

of these graphs approximated very closely the simple hyperbolic expression  $F = \frac{T}{a+bT}$ , in which a and b are constants determining the curvature and therefore the intensity deviation from the mean for any given storm.

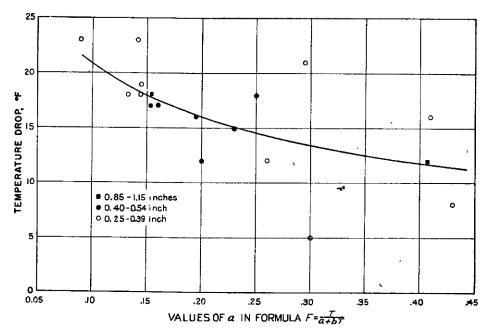
FIGURE 9.—Association of temperature drop with deviations from mean intensity. Points on chart are values of a computed for individual storms recorded at Salt Lake City.

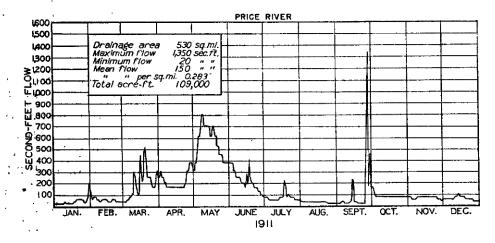
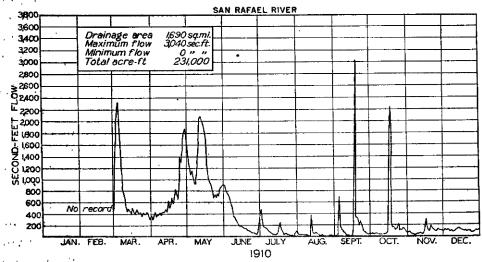
Figure 10.—Typical regimen of Price and San Rafael Rivers. High peaks, July to October, due to thunderstorms.

volume to produce a notable flood in any stream. In the larger drainage basins a heavy rainfall on a snow cover will usually cause maximum high-water stages, but this cannot be ascribed entirely to the rain storm. A cloudburst, as defined in the Century Dictionary and Cyclopedia and as used in this report, "is a violent downpour of rain in large quantity and over a limited area." In Utah it is of thunderstorm origin. A flood produced by a cloudburst is usually a flash peak discharge followed by a quickly diminishing flow, as shown by the hydrographs of Price and San Rafael Rivers in figure 10.

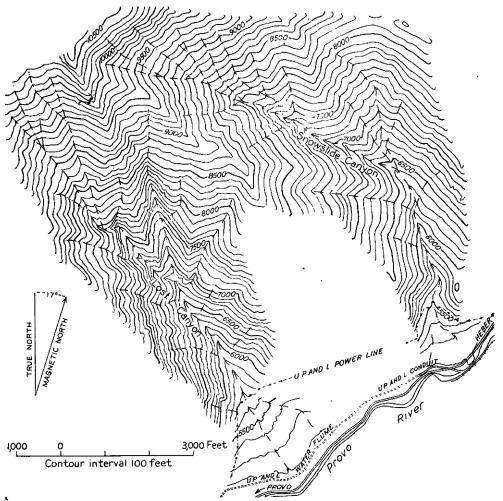
FIGURE 14.-Plan of Snowslide Canyon and Lost Canyon.

Location.—In T. 5 S., R. 3 E. Salt Lake base and meridian. Tributary to Provo Canyon about 8 miles from the city of Provo. Stream course.—The stream channel through Snowslide Canyon lies in the bottom of a sharp V-shaped basin that drains southeastward from the steep barren slopes of Mount Timpanogos for a little more than a mile, then bears southward nearly another mile, where it joins Provo River. The total length of the course is little more than 12,000 feet, and the total fall in that distance is from 10,650 to 5,500 feet above sea level, or slightly more than 5,000 feet in a distance of approximately 2½ miles. (See fig. 14.)

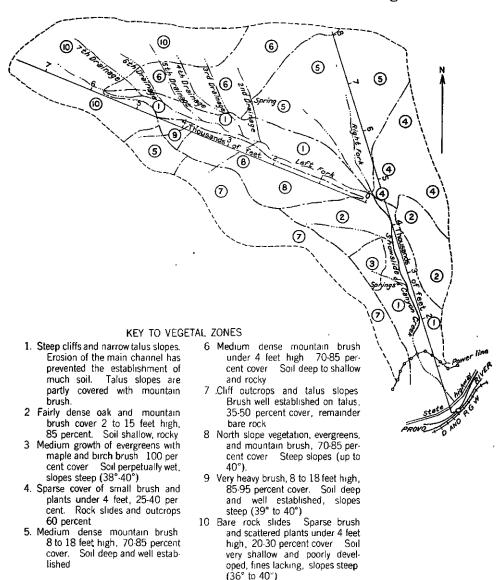
FIGURE 15.—Map of Snowslide Canyon showing vegetal cover.

from the north. (See pl. 16, A.) A number of small springs issue at different places throughout the basin, and on areas of soil that are kept moist by them a good stand of trees and other vegetation is found. (See pl. 16, B.) In general, the soil of the basin is very stony and is easily water-washed. Vegetal cover over the basin is indicated in figure 15.

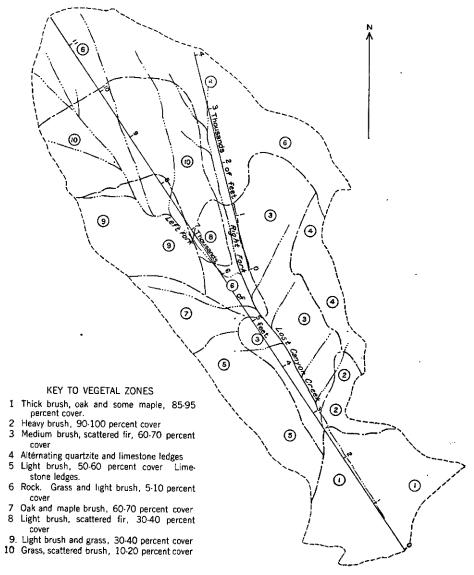
FIGURE 16.-Map of Lost Canyon showing vegetal cover.

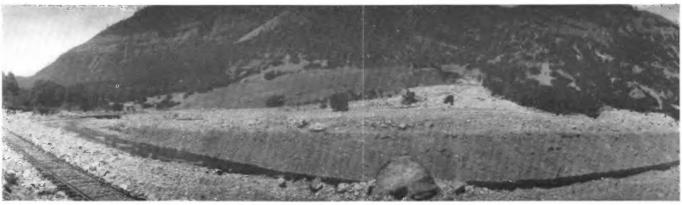
C. LOOKING UP ALLUVIAL CONE AT SNOWSLIDE CANYON, IN PROVO CANYON, NEAR PROVO.

The channel is usually dry in the lower 2,000 feet of its course. The small natural flow of the stream sinks into the fan deposits that fill the mouth of the canyon and extend southward across Provo Canyon. (See pl. 14, C.) At a point about 4,600 feet above

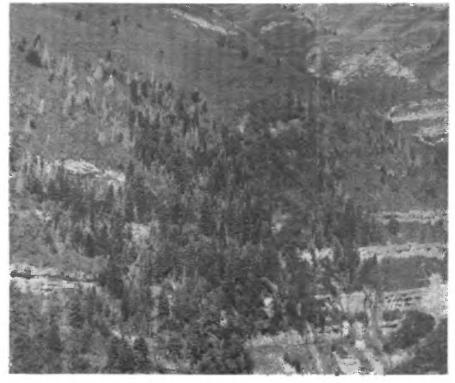
$\emph{\textbf{B}}.$  PART OF WEST SLOPE OF SNOWSLIDE CANYON SHOWING DENSELY WOODED MOIST AREA.

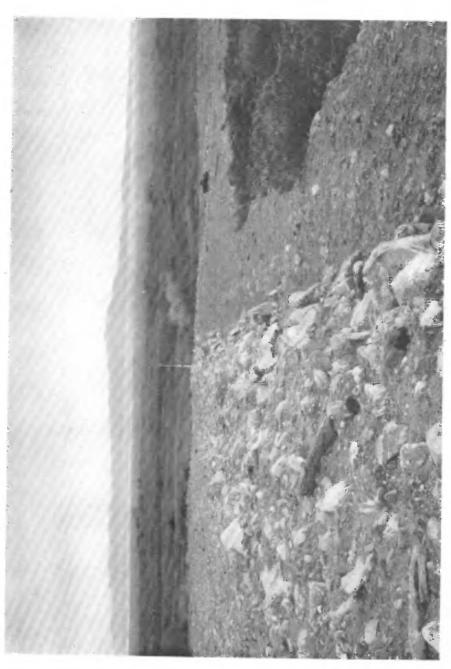
TWO SUCCESSIVE MUDFLOWS NEAR LAYTON, DAVIS COUNTY.
